⑨ BUREAU OF SHIPS GROUP
TECHNICAL INSPECTION REPORT

⑥ OPERATION CROSERoad.
FAILURES OF MASTS, YARDARMS,
BOOMS AND RIGGING E.U.J.

JOINT TASK FORCE ONE

FAILURES OF MASTS, YARDARMS, BOOMS, AND RIGGING

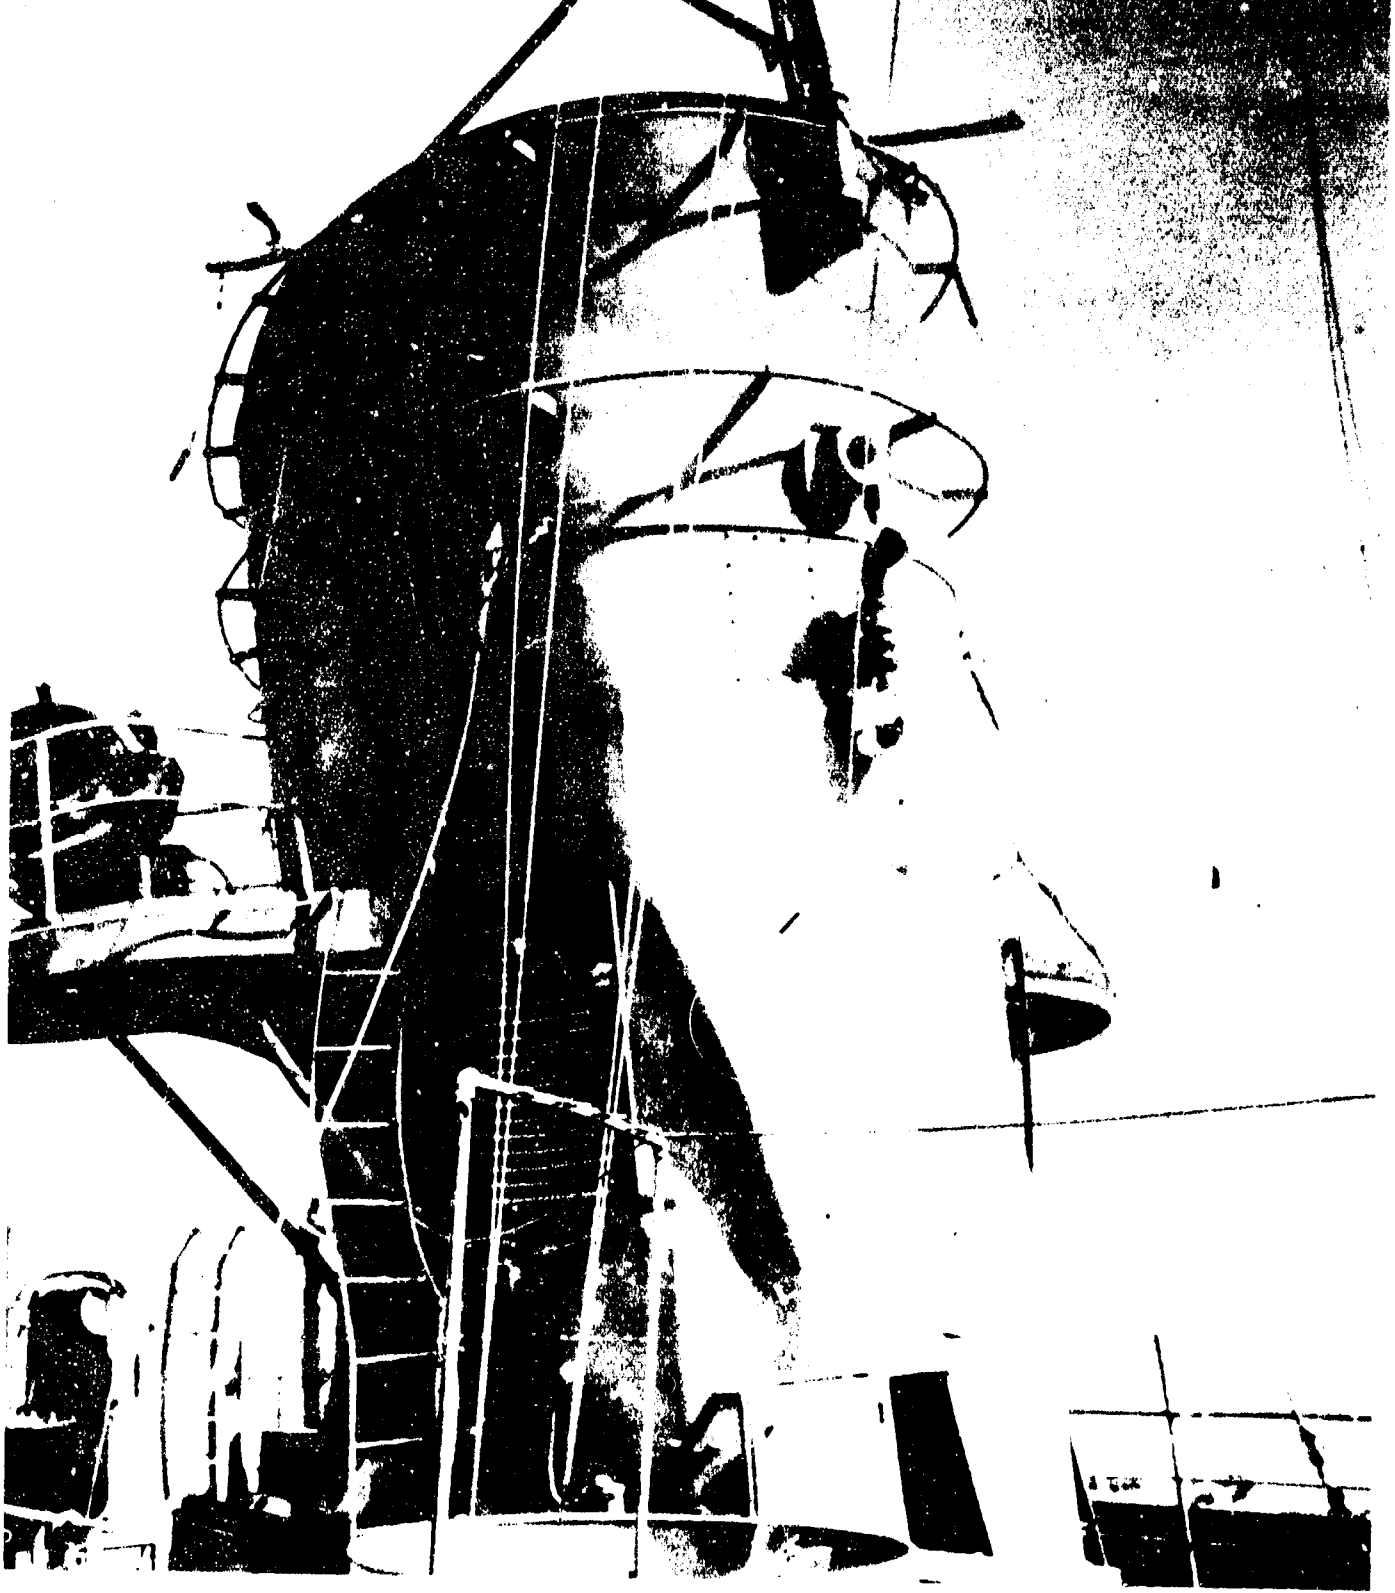
photos 1904-7, 2058-9, and 1922-8; pages 34 , 35 ,and 36 . Just above the braces, at mid-height, the mast bends sharply aft and slightly to starboard. The braces are sharply bowed. The port yardarm bends sharply at the mast and extends somewhat to starboard. The starboard yardarm is broken off about six inches from the mast.

AA-CR-59-2058-9. USS CRITTENDEN (APA77). Forward smokestack showing lower portion of signal mast.

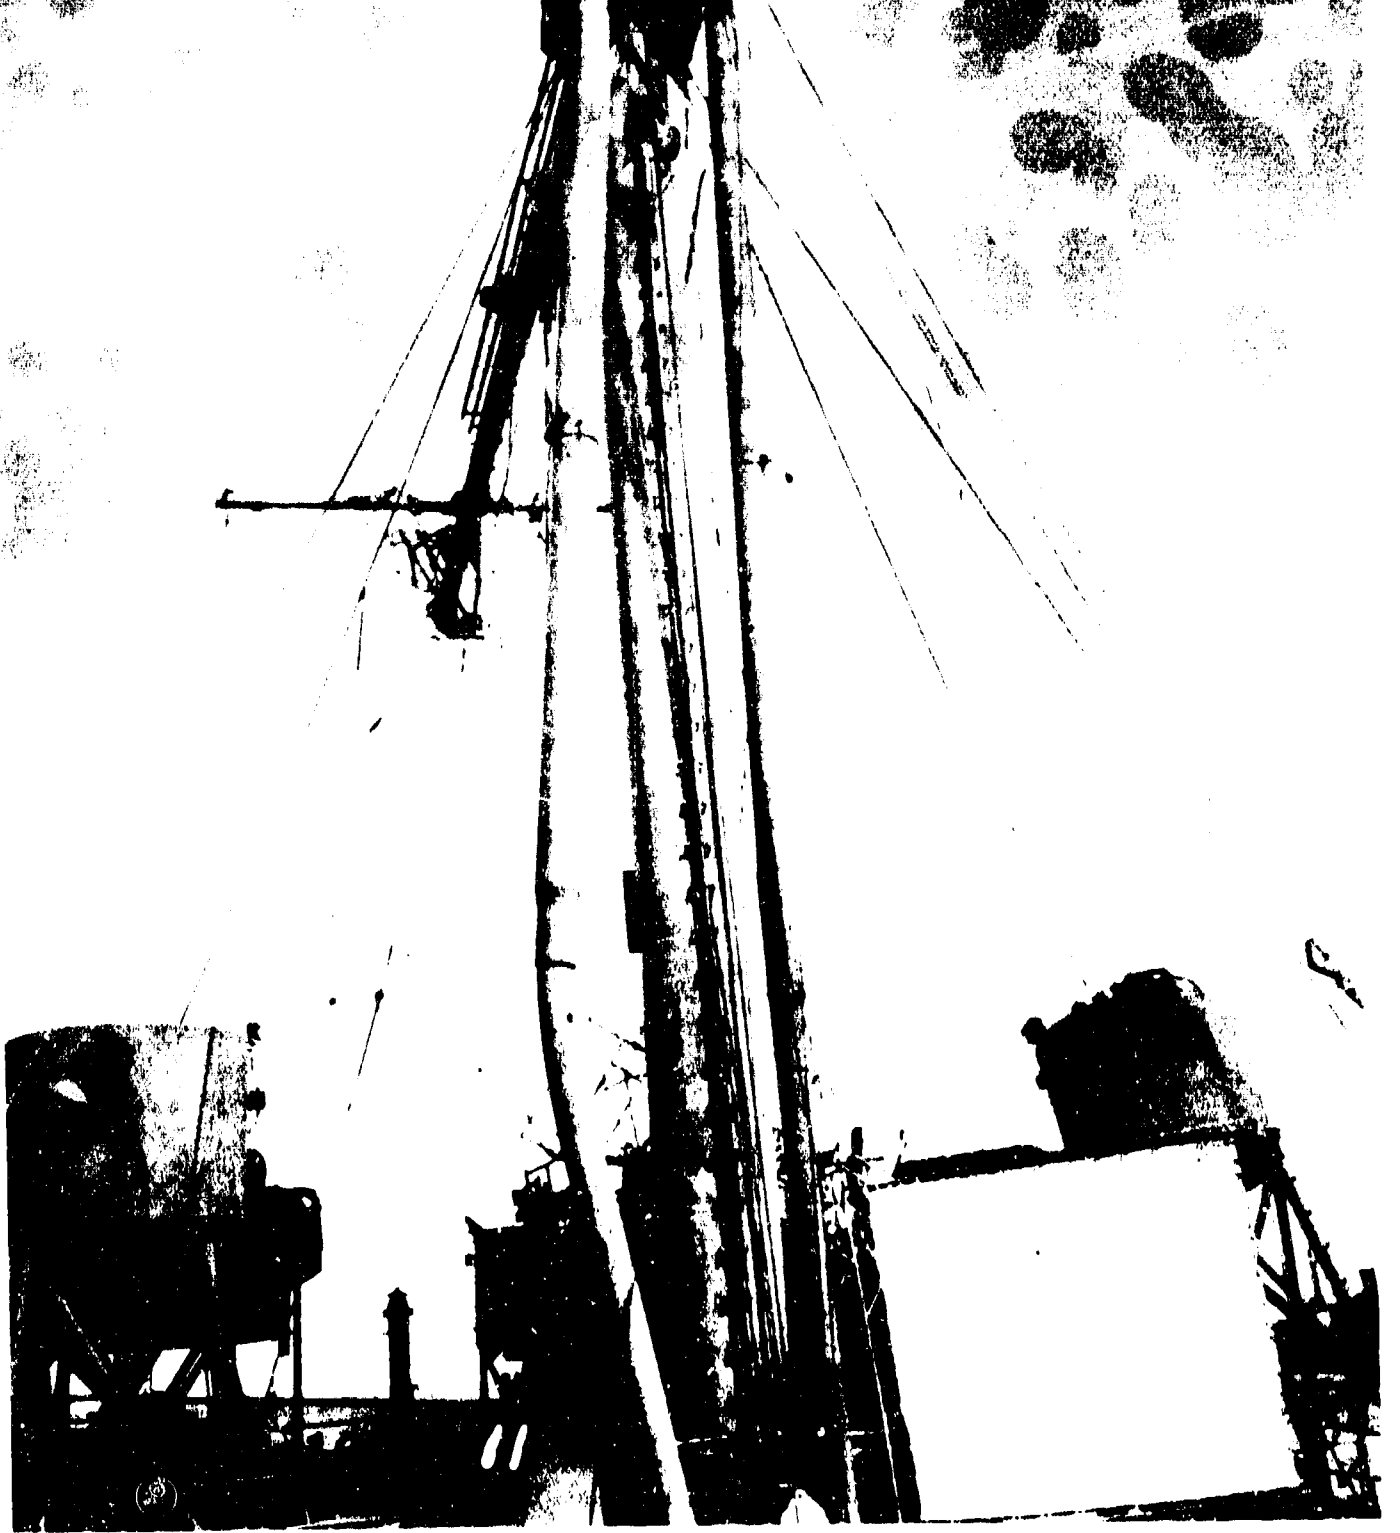
AA-CR-80-1905-11. USS CRITTENDEN (APA-77). Mainmast. Note bend and kink in starboard cargo boom.

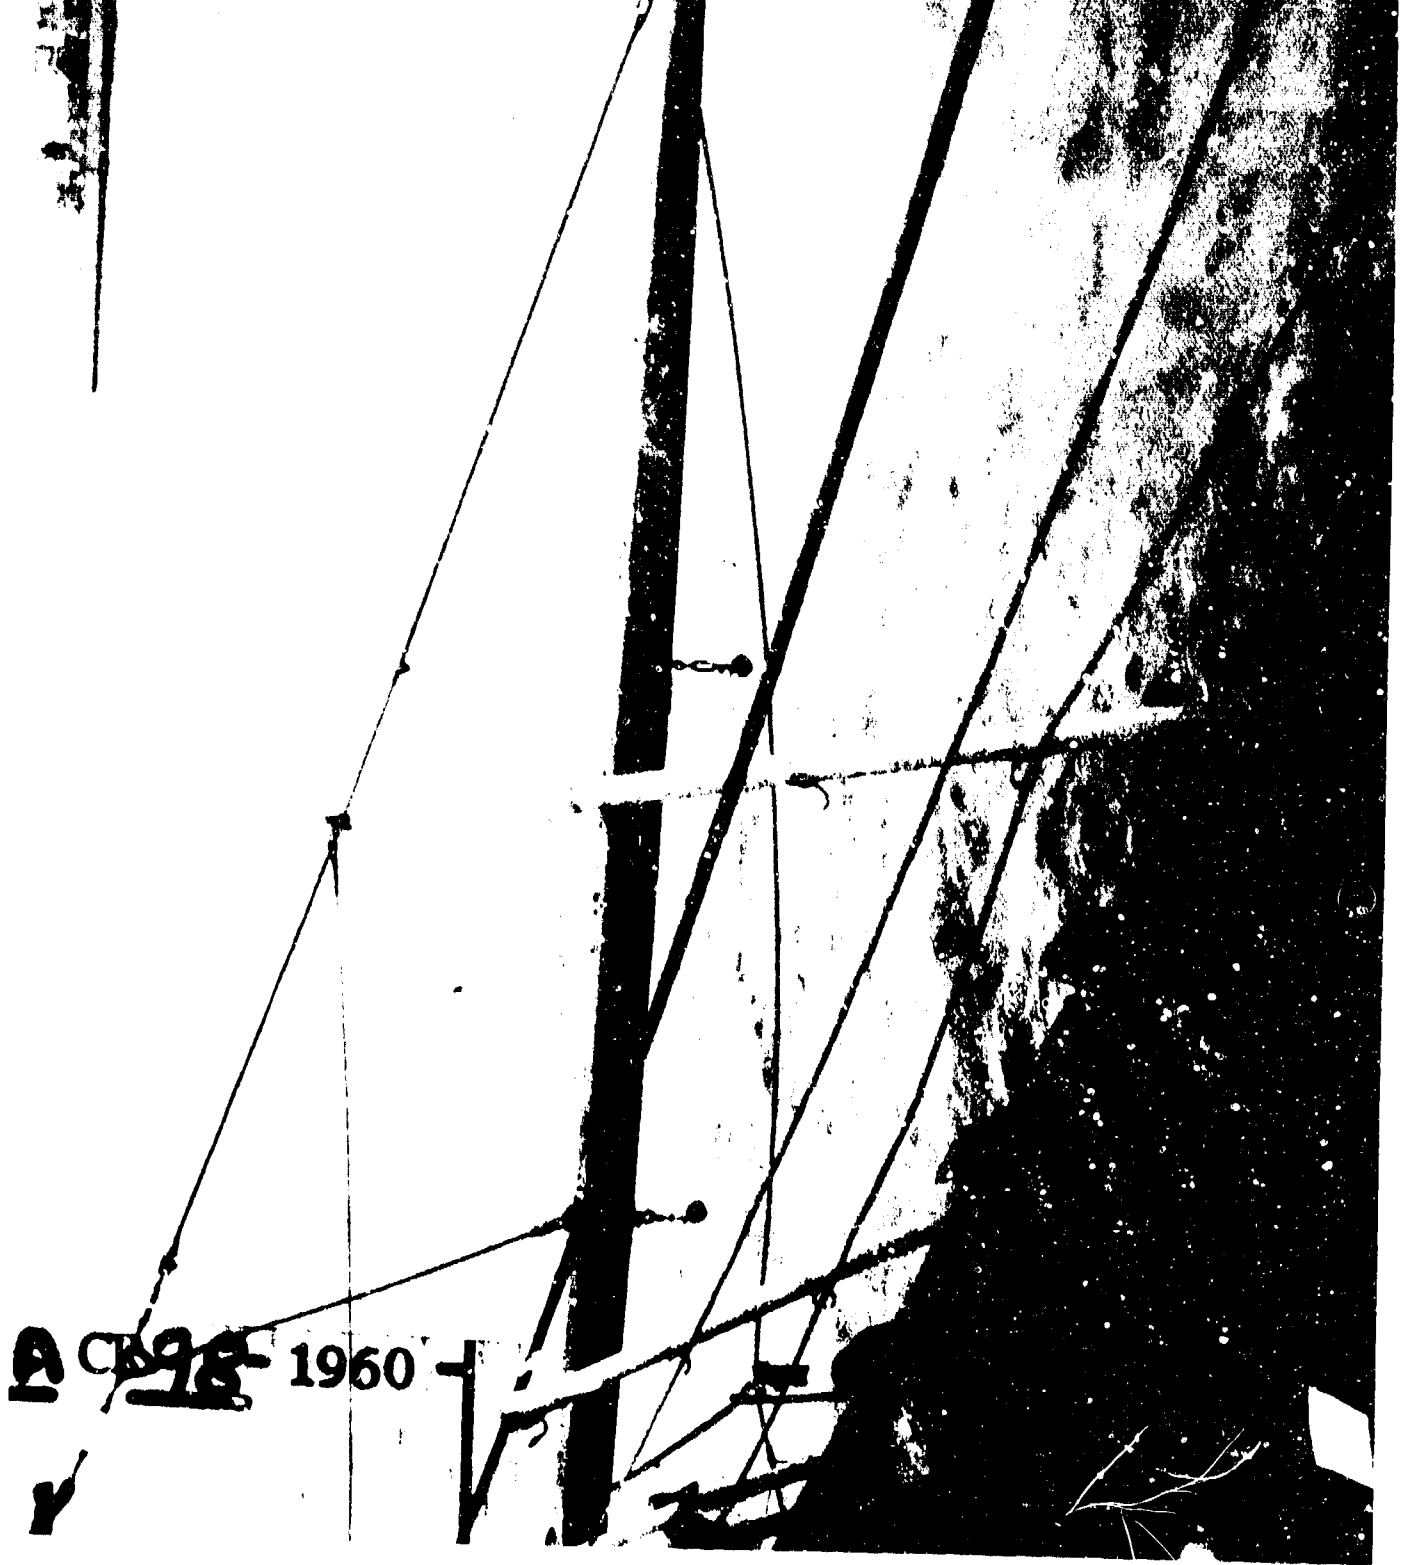
5. Photo 1960-12, page 43 shows the port boat boom, frame 59, swinging free. This boat was clamped in place before the test. The starboard boat booms remained in place. The pipe life rails on the port side are generally damaged, and on the upper deck forward, port side, there are large gaps in the rail. The rails on the upper deck suffered more severely than did those on other levels.

AA-CR-98-1960-12. USS CRITTENDEN (APA77). Port boat boom knocked out of clamp.

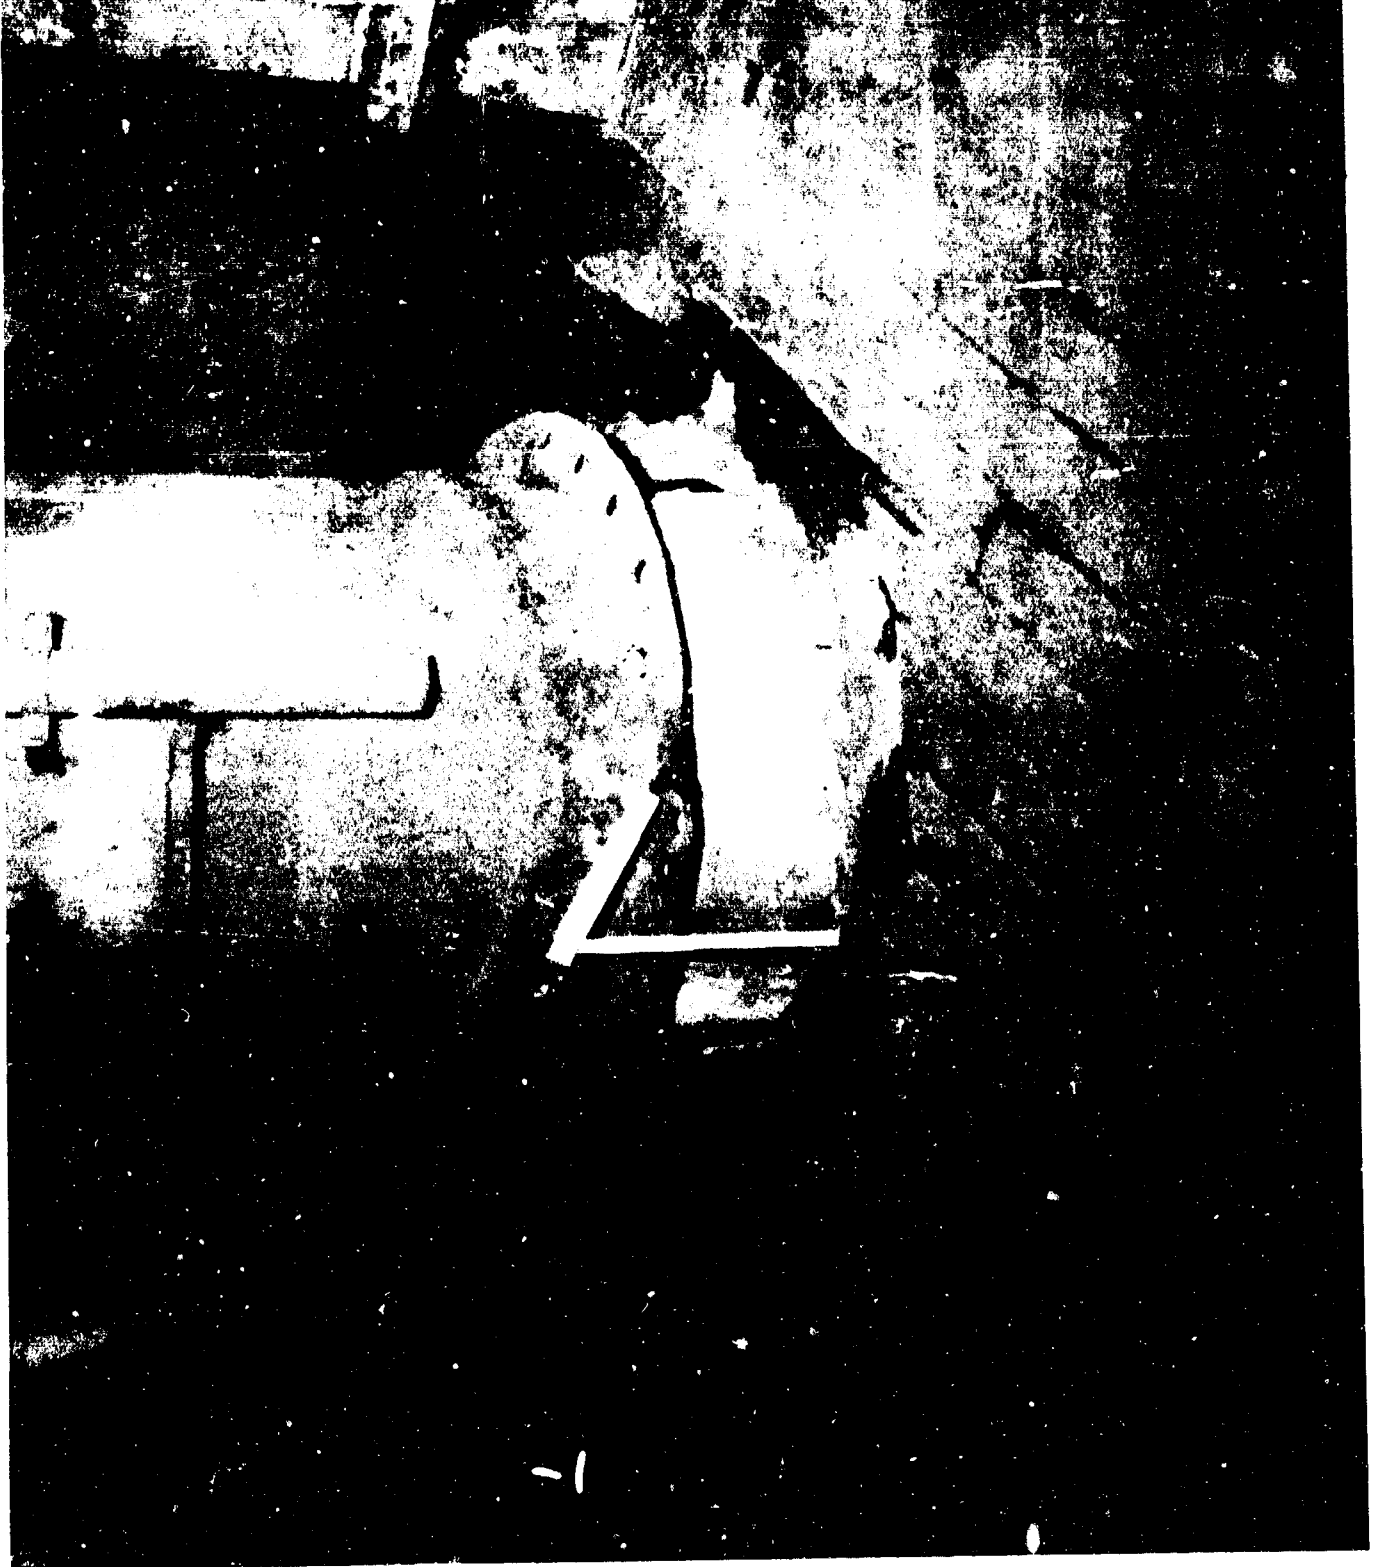
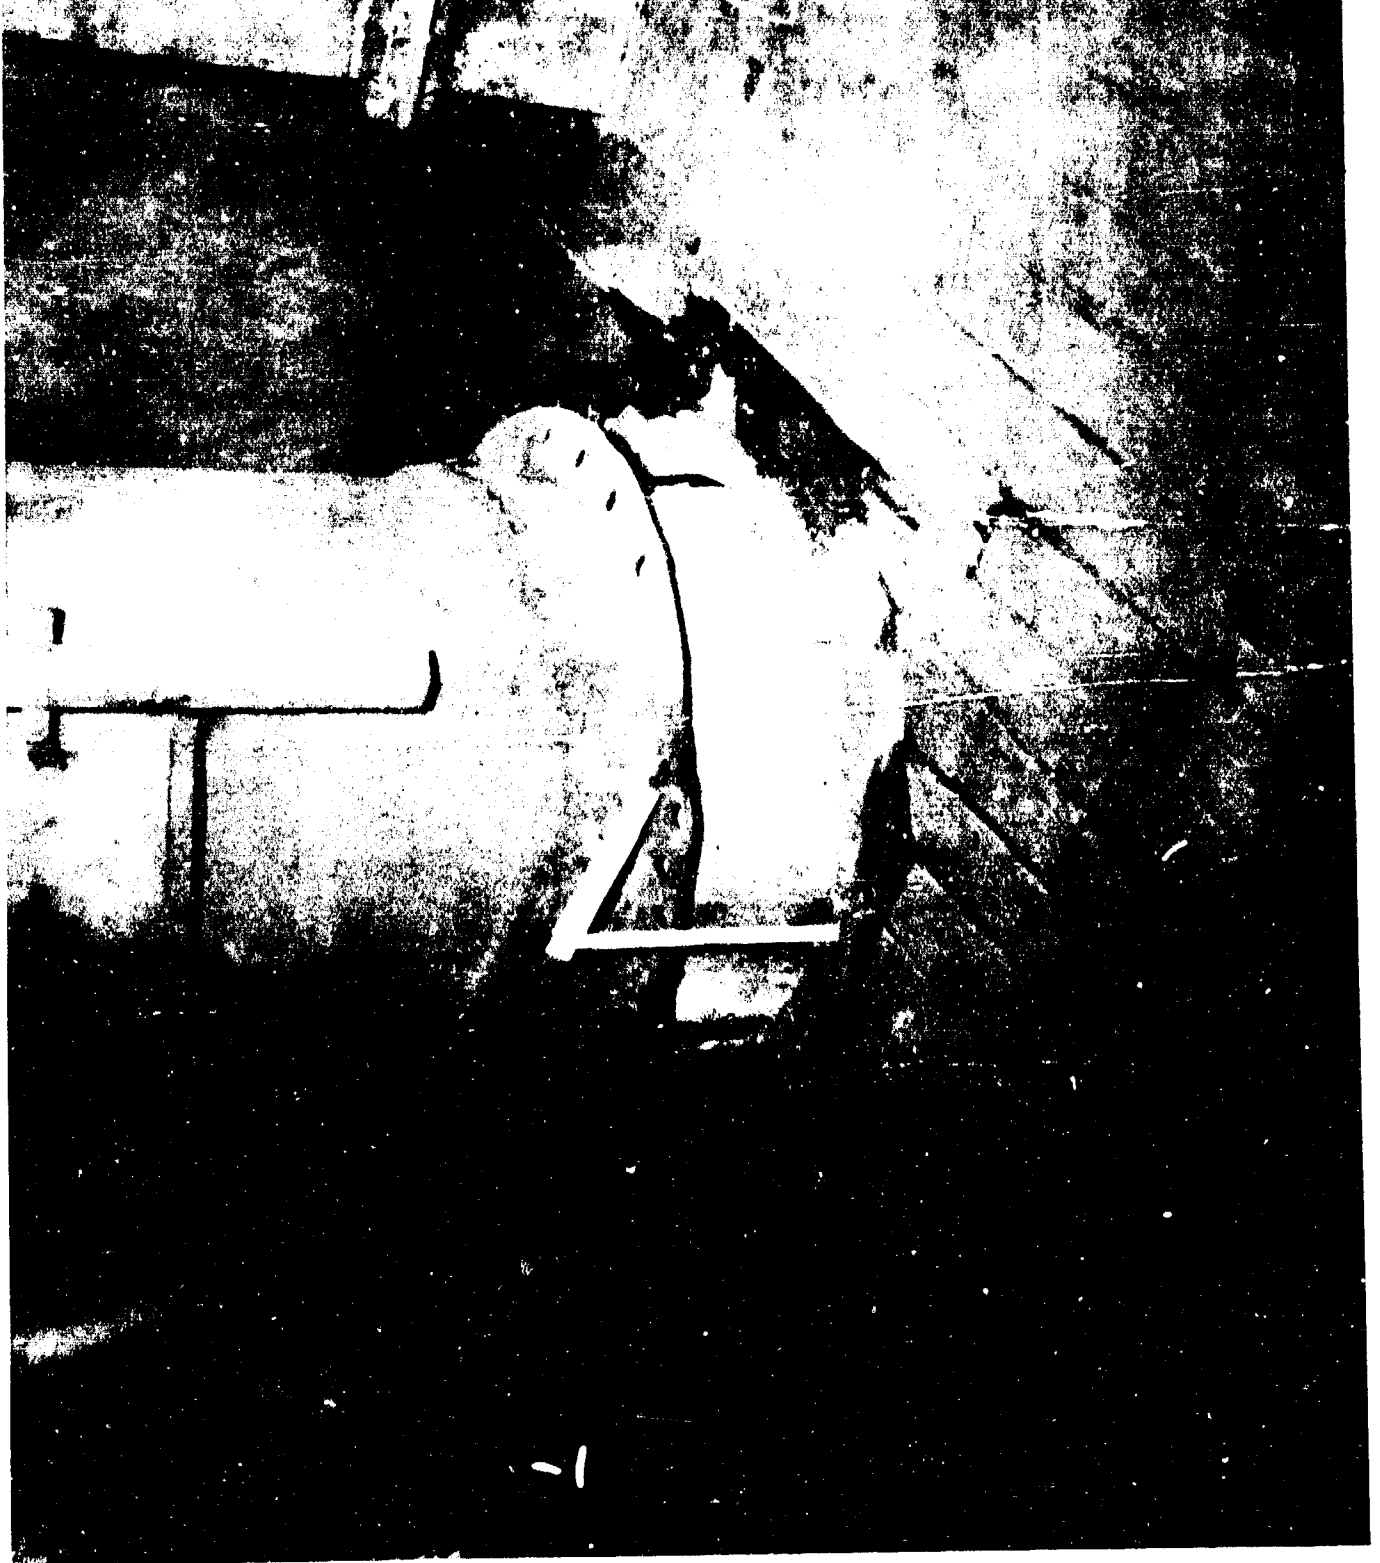
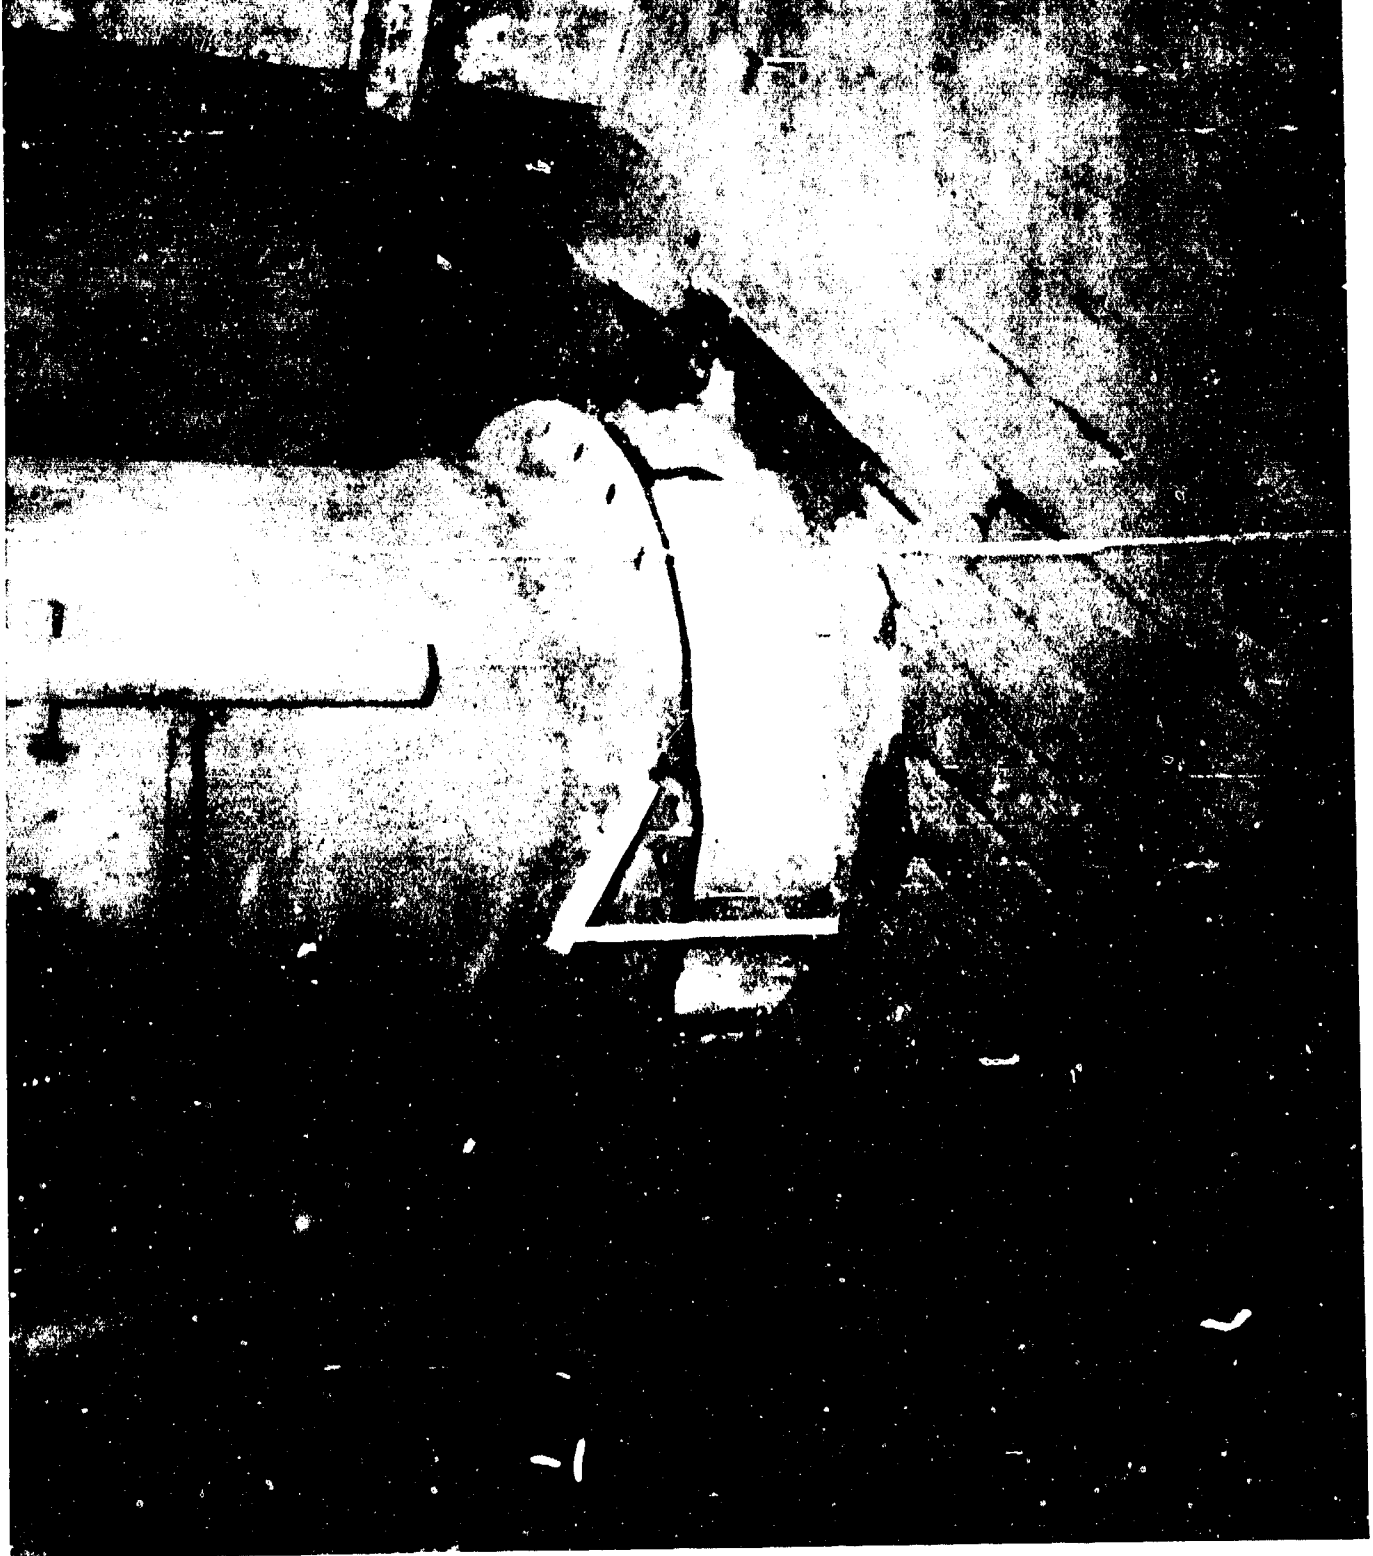
AA-CR-68-2146-1. USS ARKANSAS (BB33). Mainmast, starboard aft leg, showing lift from deck, main deck.

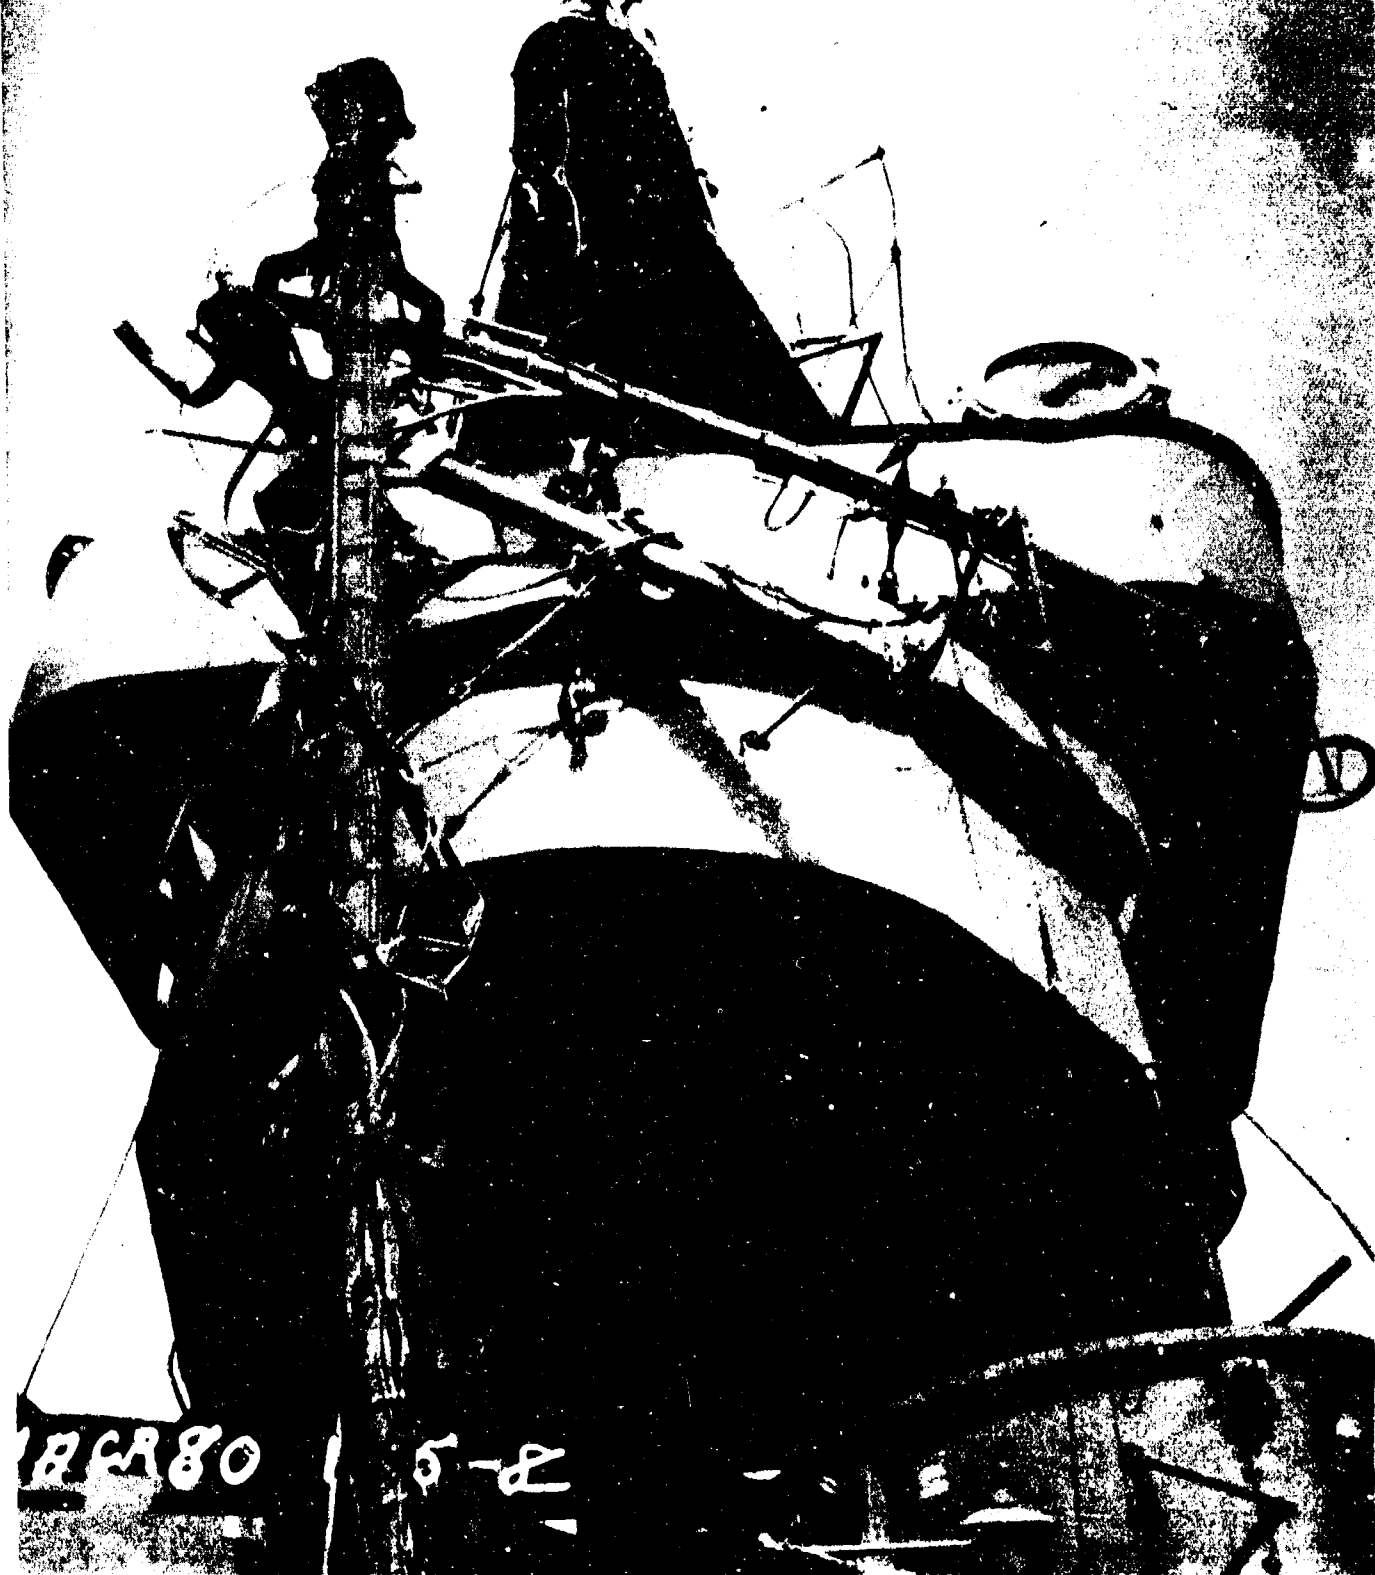
4. The main topmast fell forward and hung top down by cables. The topmast was supported on an extension of the director platform as shown in photos 1895-7 and 2135-7, pages 83 and 84. The foot of the mast was welded to a 10 inch base plate which was welded to the platform. The weld between the base plate and platform fractured. The forestay parted about 8 feet above the main deck, the starboard after stay about 12 feet above the deck, and the port after stay near the top of the mast. The starboard yardarm bent sharply about 3 feet from the mast due to the restraining influence of a guy. The bend in the mast was caused by the head of the mast striking the deck, not by the blast. See photos 1895-9, 1895-6, 1895-10, and 1775-12; and 1895-8; page 86, 88, 89, 85, and 87.

AA-CR-80-1895-8. USS ARKANSAS (BB33). Detail of lower end of mainmast and yardarm.

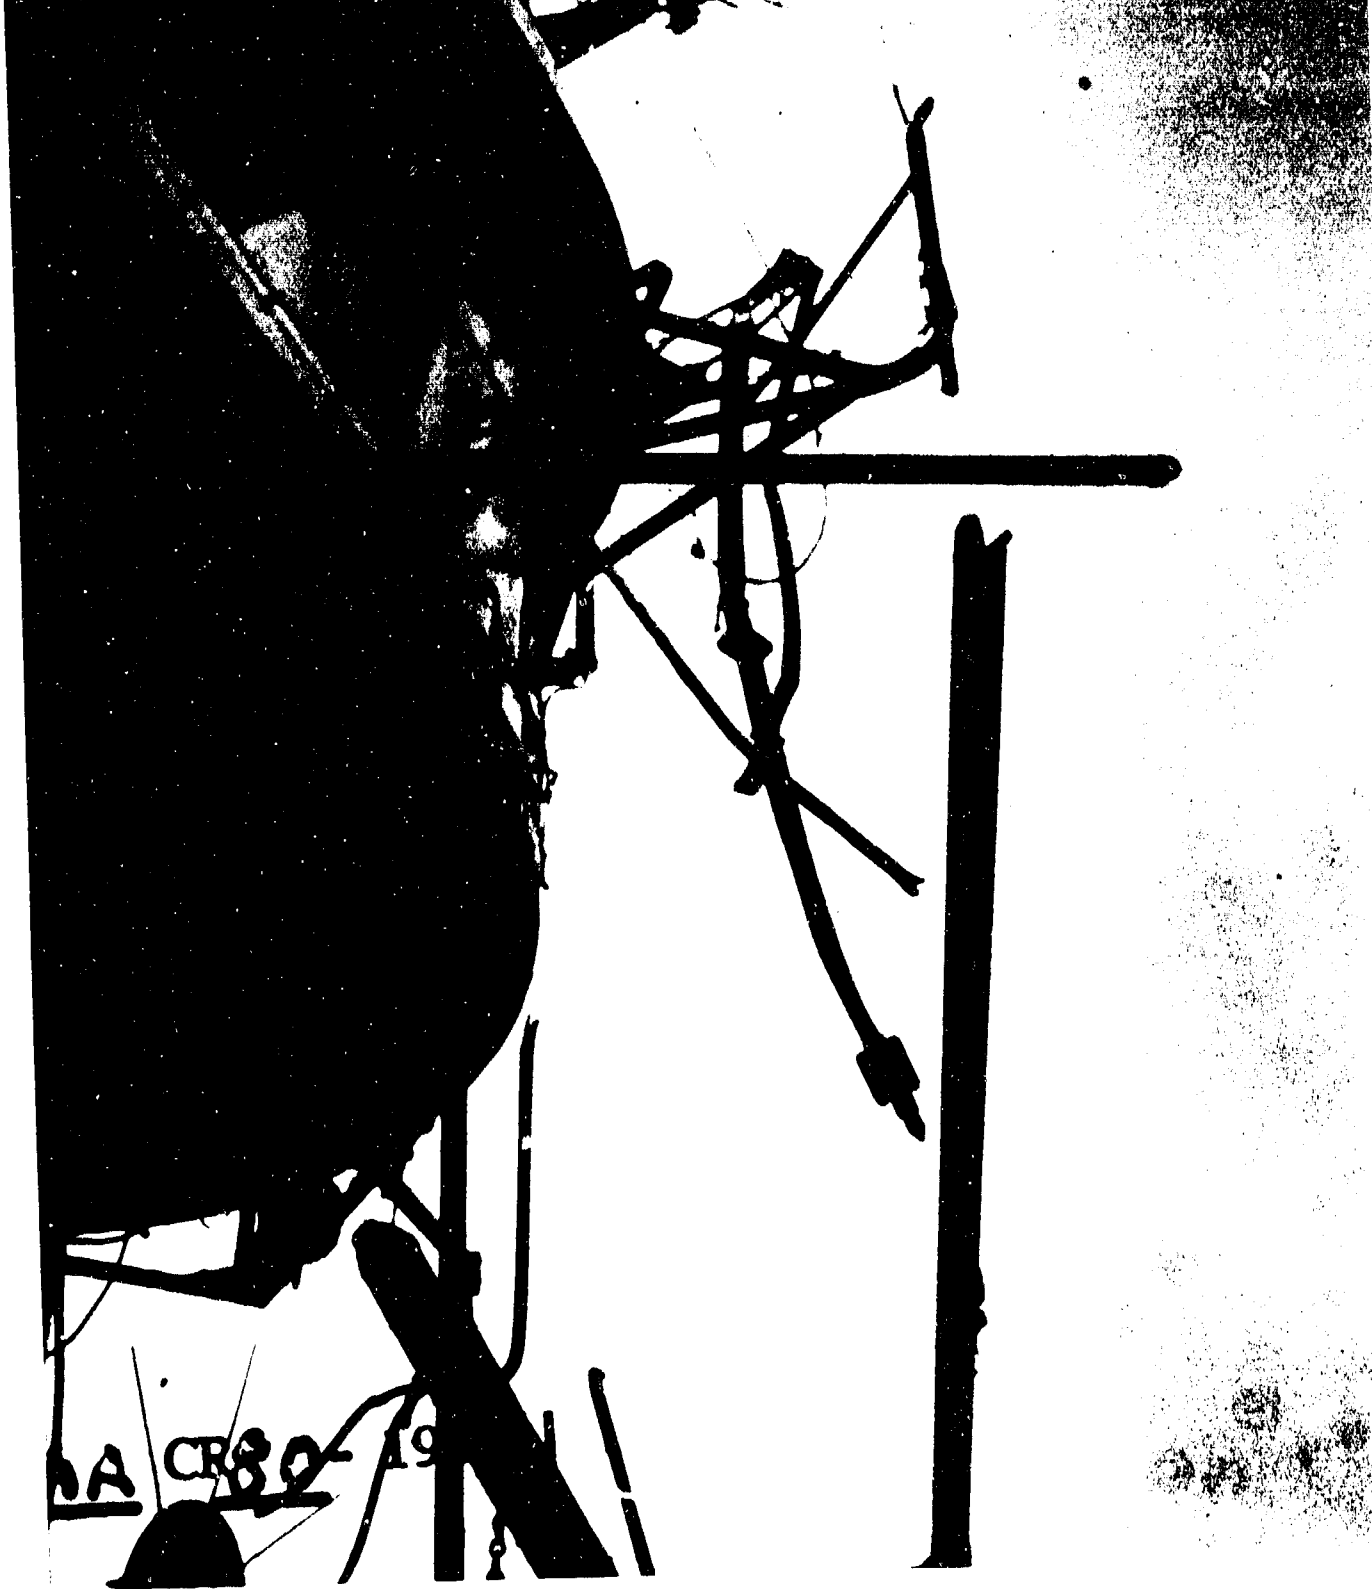
AA-CR-80-1900-3. USS NEVADA (BB36). Forward tripod, remains of starboard yardarm.

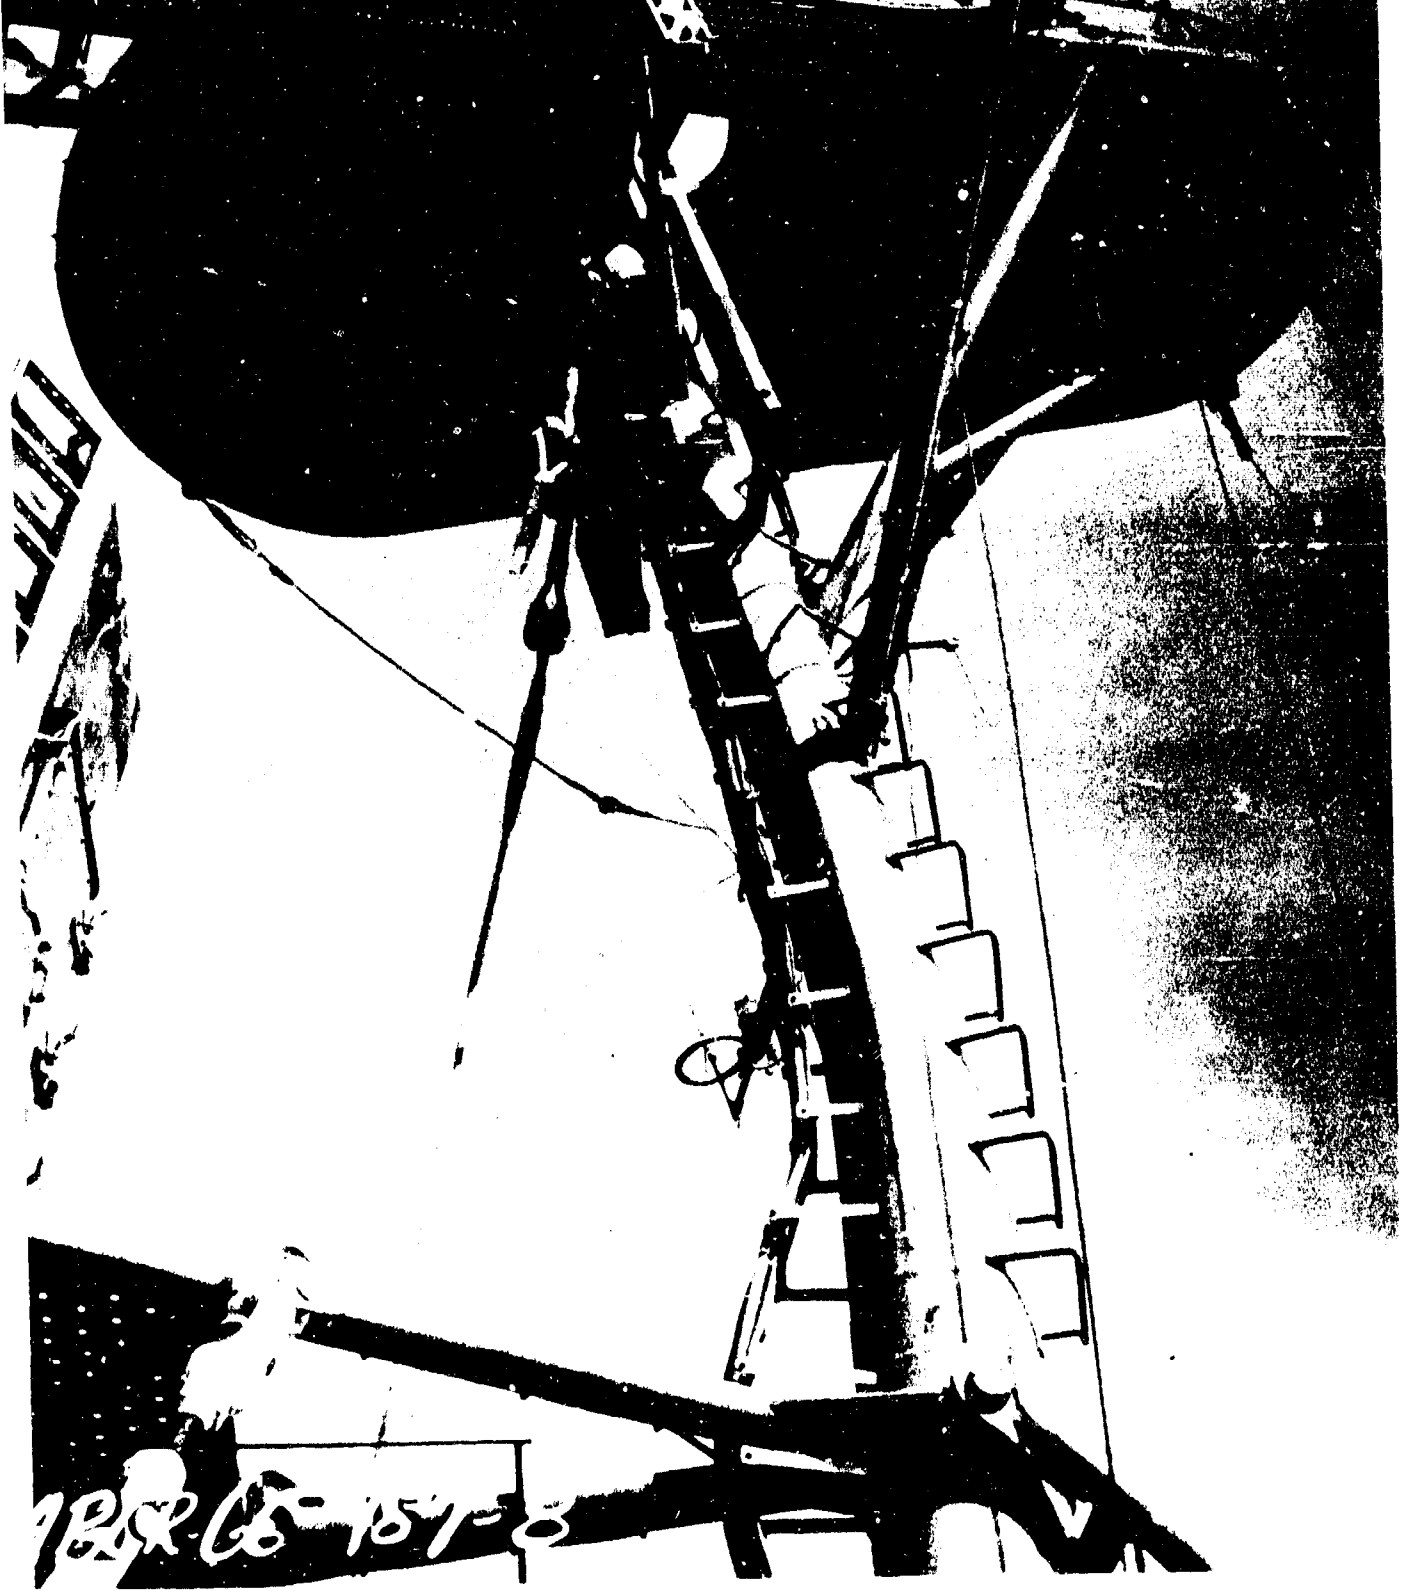
2. Photos 1757-1, 2; 1761-12; 157-8; and 1759-8 pages 130, 131, 132, 133 and 134 are views of the foremast. Photos 157-8 and 1759-8, pages 133 and 134 show that the pole which supports the radar platform is bent in a smooth curve starting about 12 feet above the fire control platform at a point just above the 4 inch pipe braces. There is no failure in these braces or in those between the pole and the radar platform. Failure of these poles is the result of bending under load without evidence of local weakness.

AB-CR-66-157-8. U.S.S. PENSACOLA (CA24). Forward radar pole-mast after test Baker showing platform and riggings.

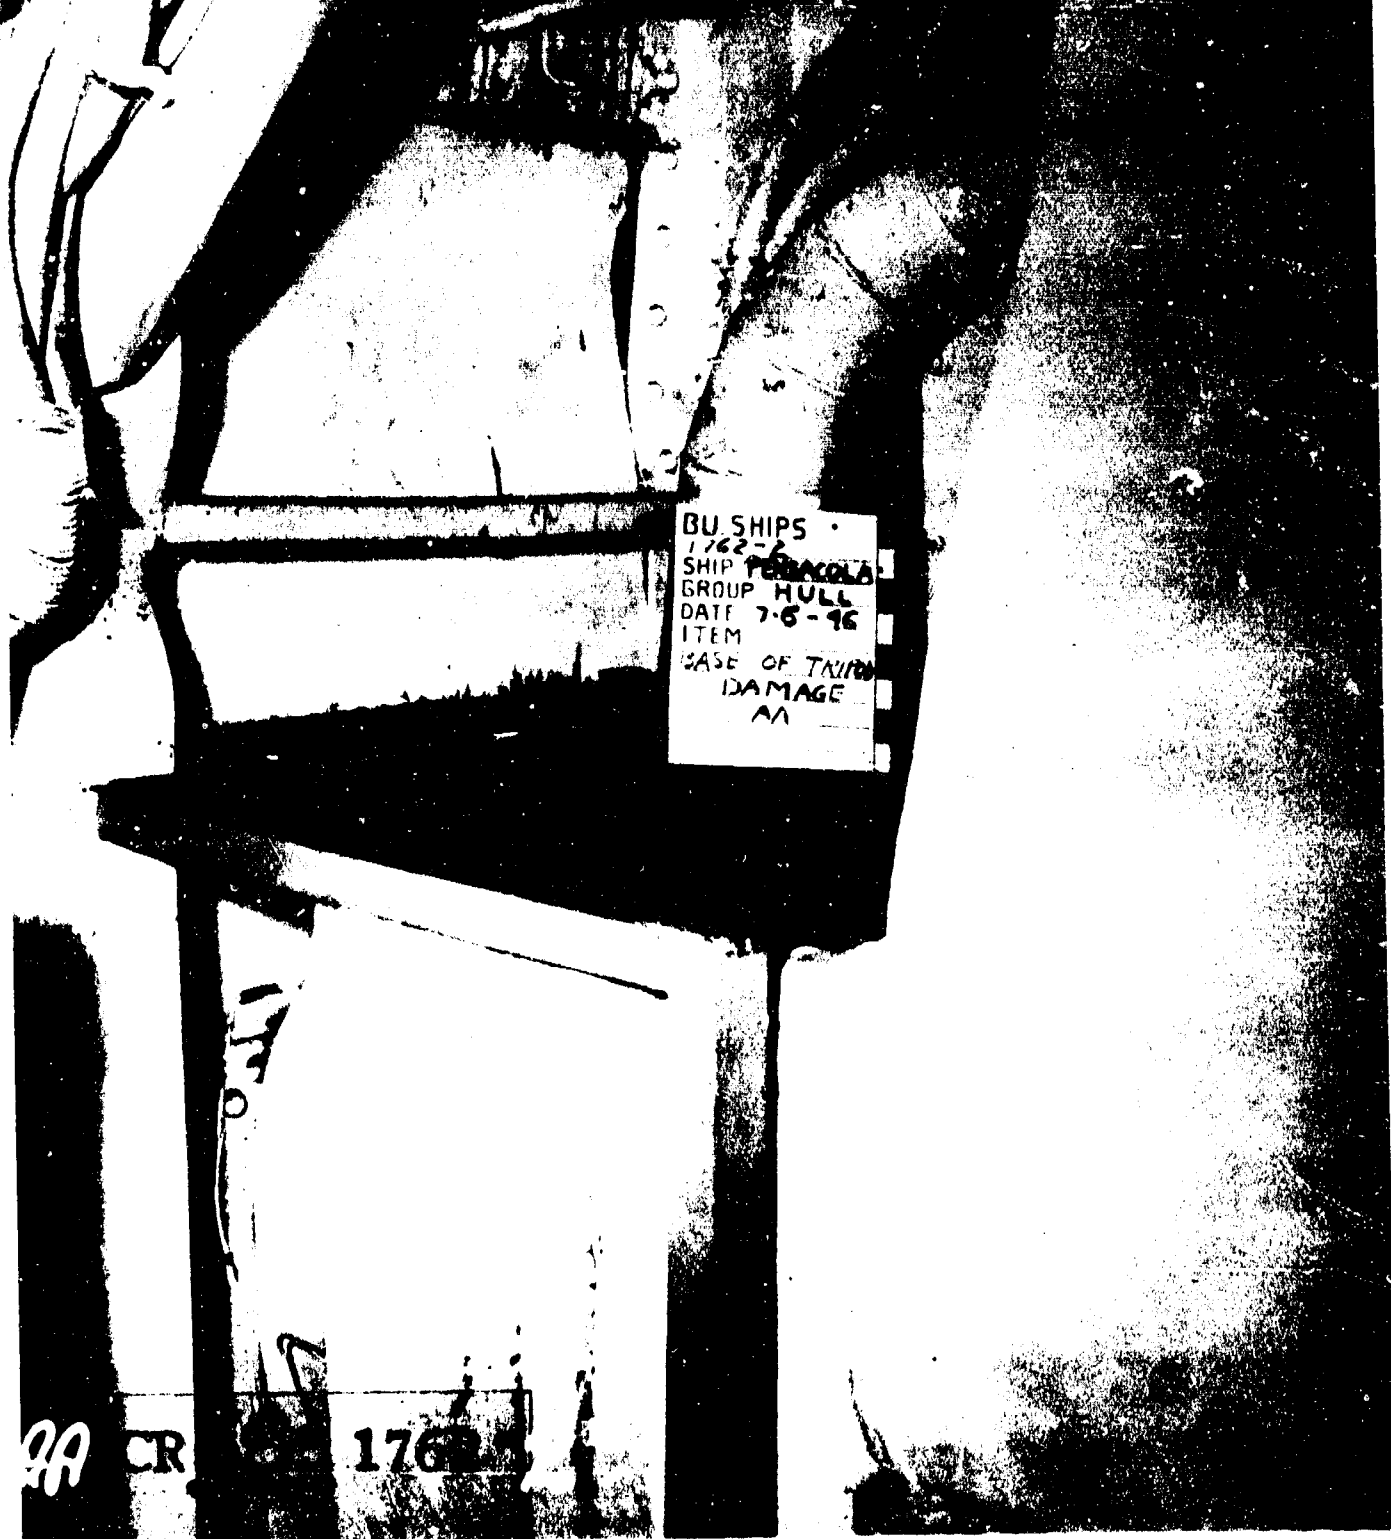
AA-CR-68-1762-2. U.S.S. PENSACOLA (CA24). bulkhead No. 42, showing crushing at centerline under forward leg of forward tripod. Looking aft from starboard side.
