⑨ BUREAU OF SHIPS GROUP
TECHNICAL INSPECTION REPORT

⑥ OPERATION CROSERoad.
FAILURES OF MASTS, YARDARMS,
BOOMS AND RIGGING E.U.J.

JOINT TASK FORCE ONE

FAILURES OF MASTS, YARDARMS, BOOMS, AND RIGGING

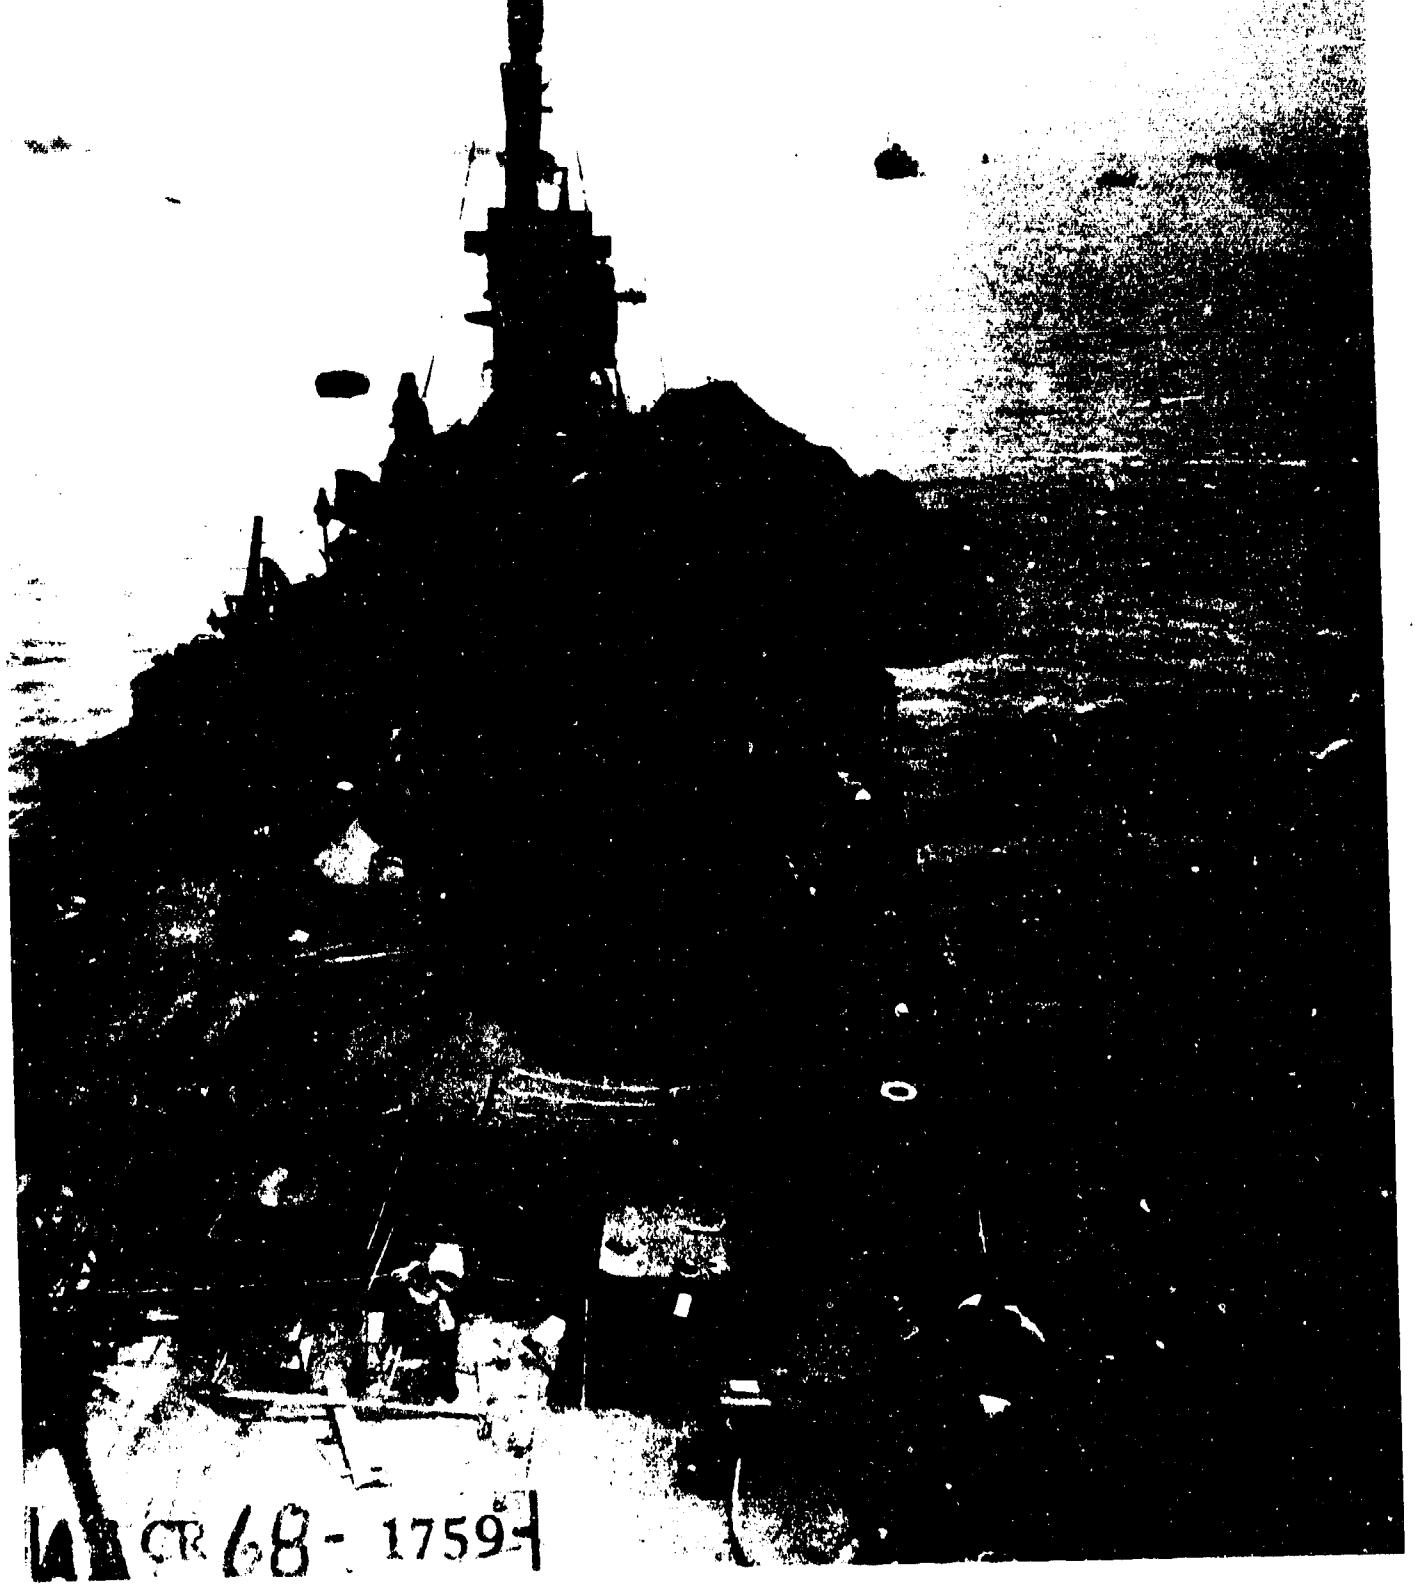
4. Lifeline stanchions and guard rails are distorted or broken where located in direct path of the blast. See photo 1761-12, 1759-4, 1968-7, 1755-10 and 1759-7; pages 132, 139, 140, 141, and 142. Where they are protected the stanchions and lines are generally carried away or burned. Wire stays generally remained intact but loose. Davits are operable. The starboard stack stays parted. Those on the port side were intact but loose.

AA-CR-68-1759-4. U.S.S. PENSACOLA (CA24). Looking aft at main-
mast showing yardarm and stays.

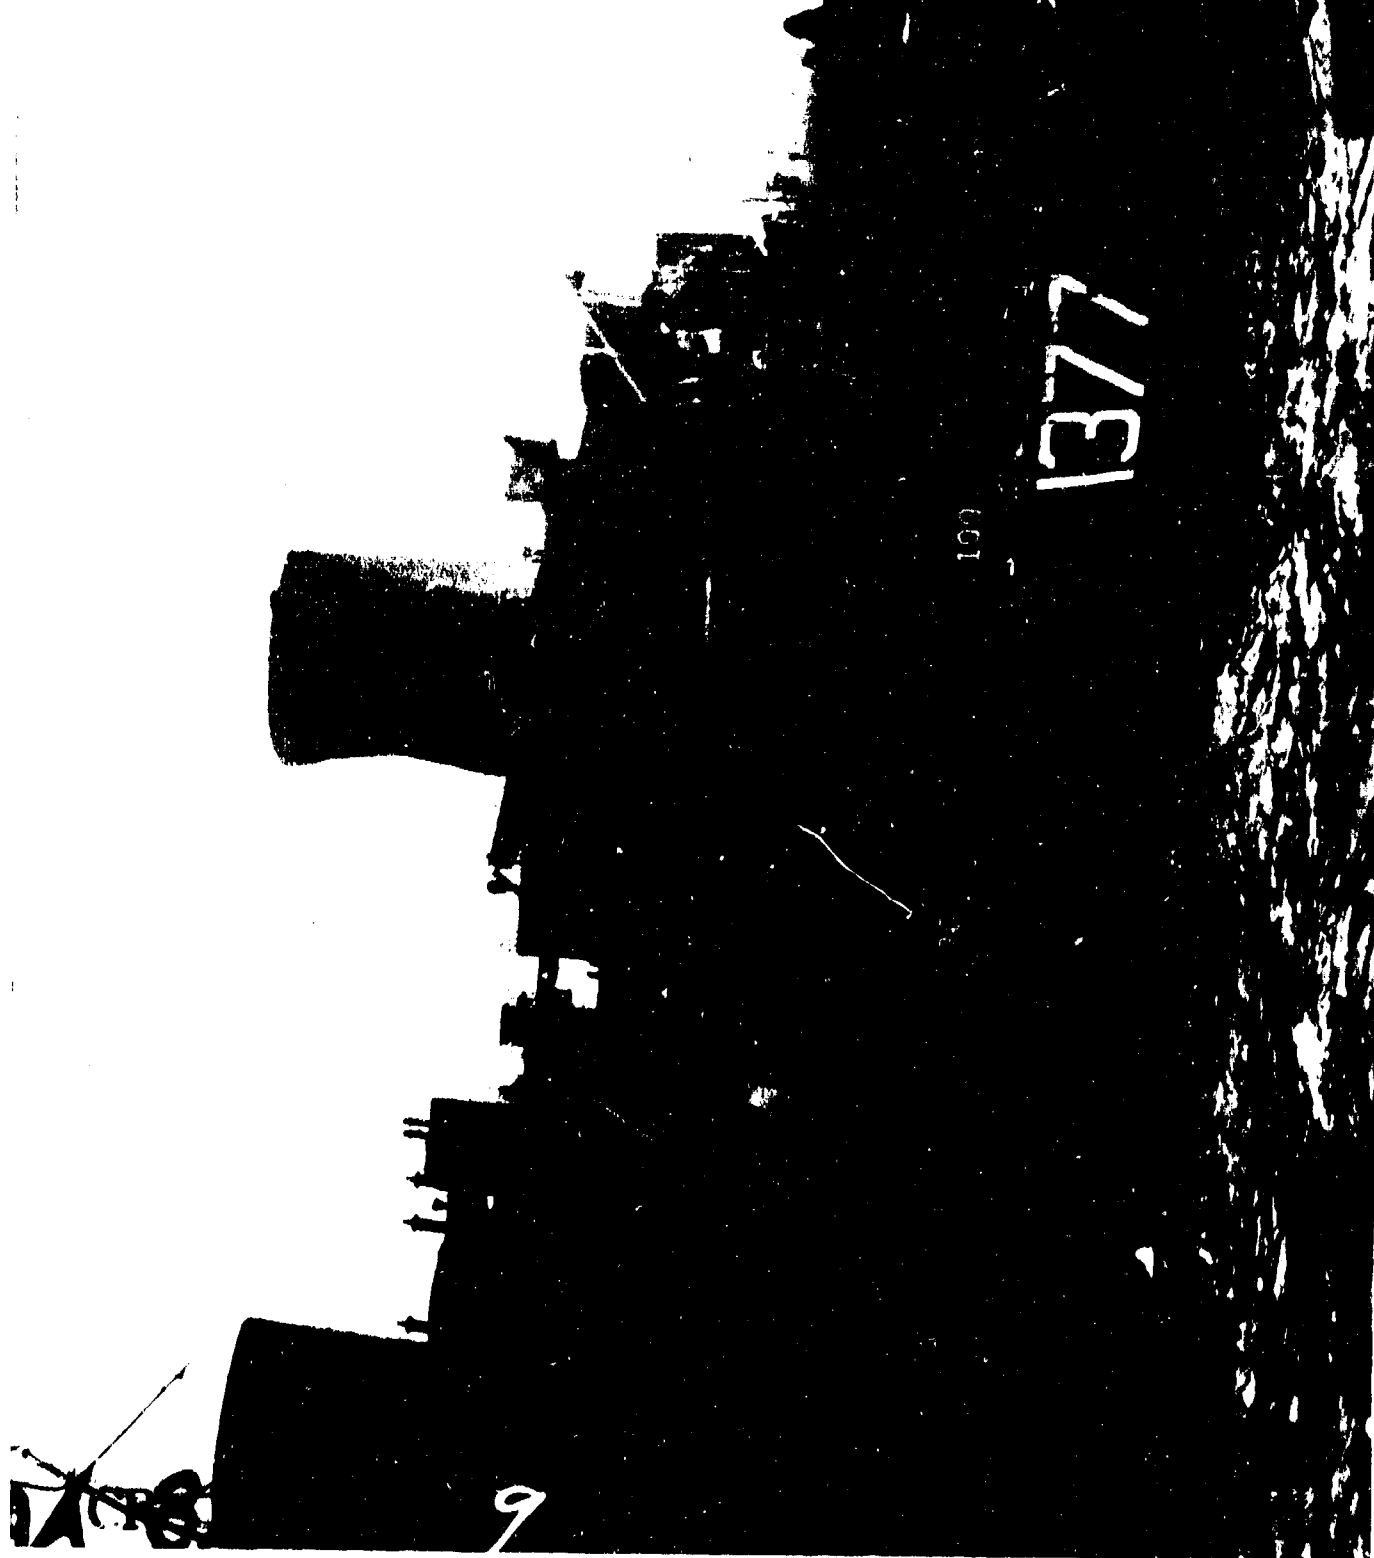
4. The starboard davits show no damage and are operable. The forward port davit shows evidence of overloading. The after wire fall has about 1/2 of its strands torn between the fall block and the winch. Renewing this fall might restore the davit to service. The after port davit is partially wrecked and is out of service. The travelling arms are pushed about 60 degrees out of vertical and the strongback is out of its bearings. The wire falls are practically severed. See photo 1922-9, page 161.

AA-CR-82-1922-9. U.S.S. DAWSON (APA79). View of No. 4 davit.

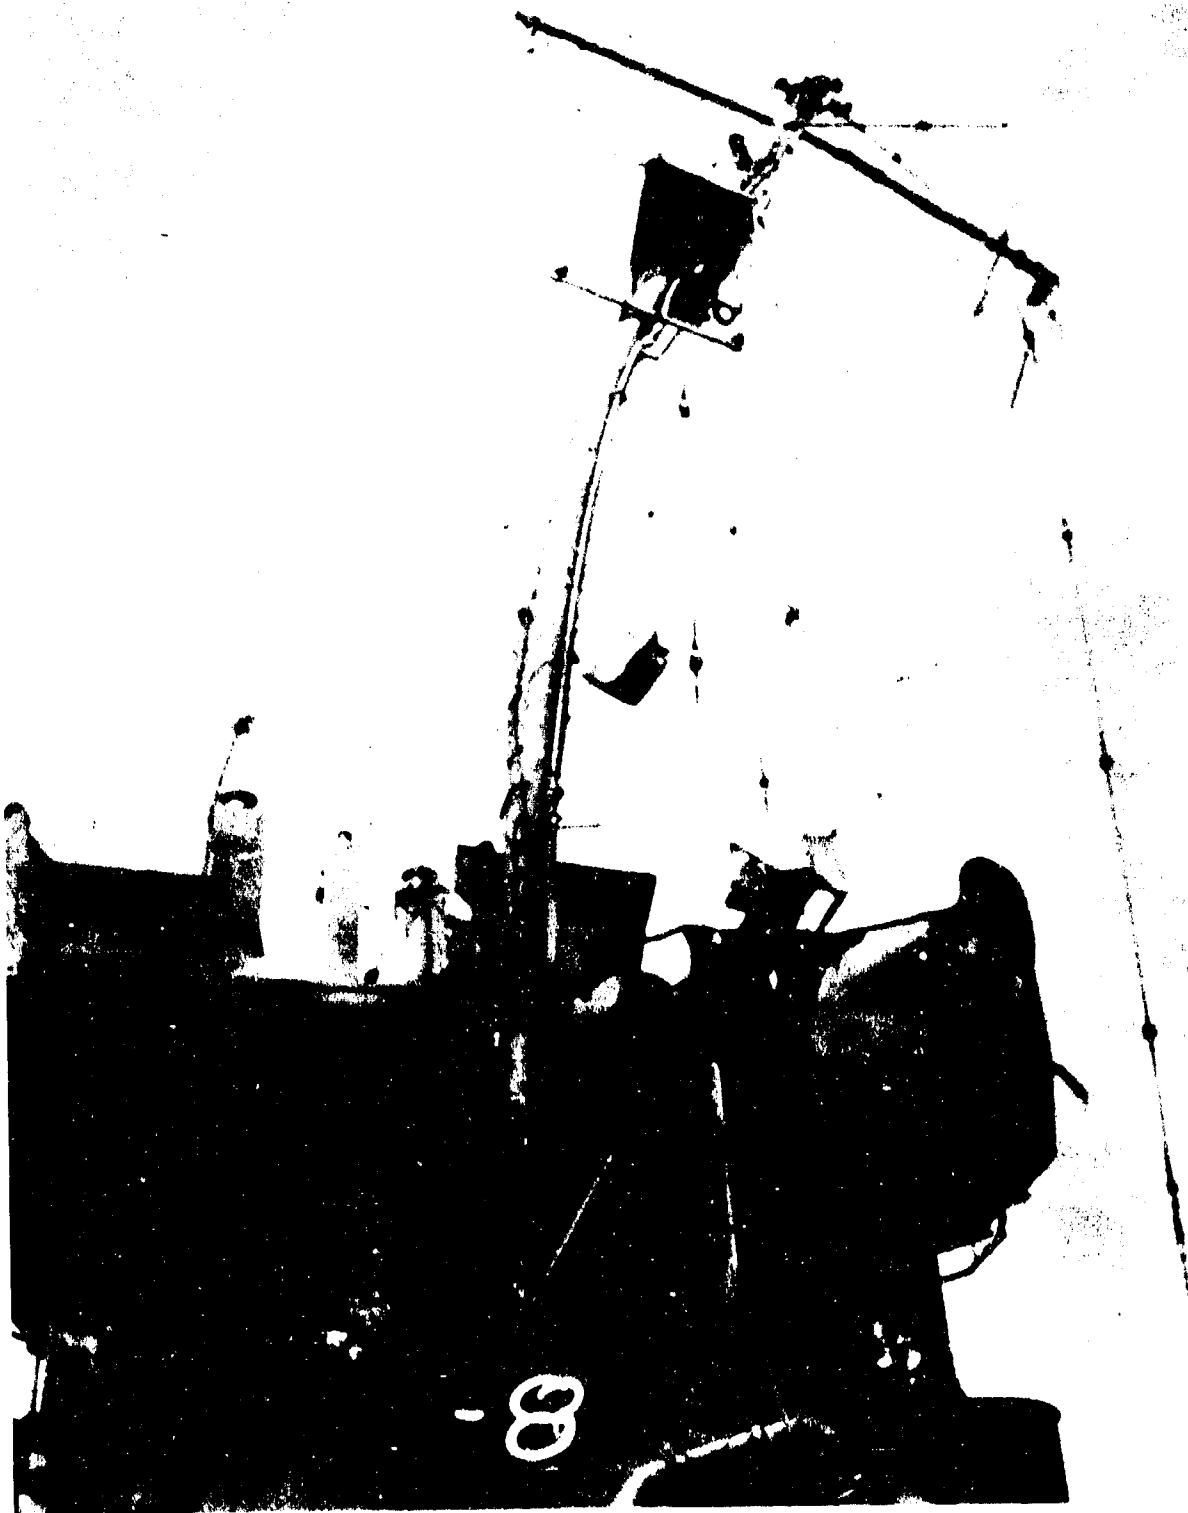
AA-CR-62-1868-8. U.S.S. SALT LAKE CITY (CA25). View looking forward at bulkhead 88 from frame 94 showing curve in mast and condition of rigging.

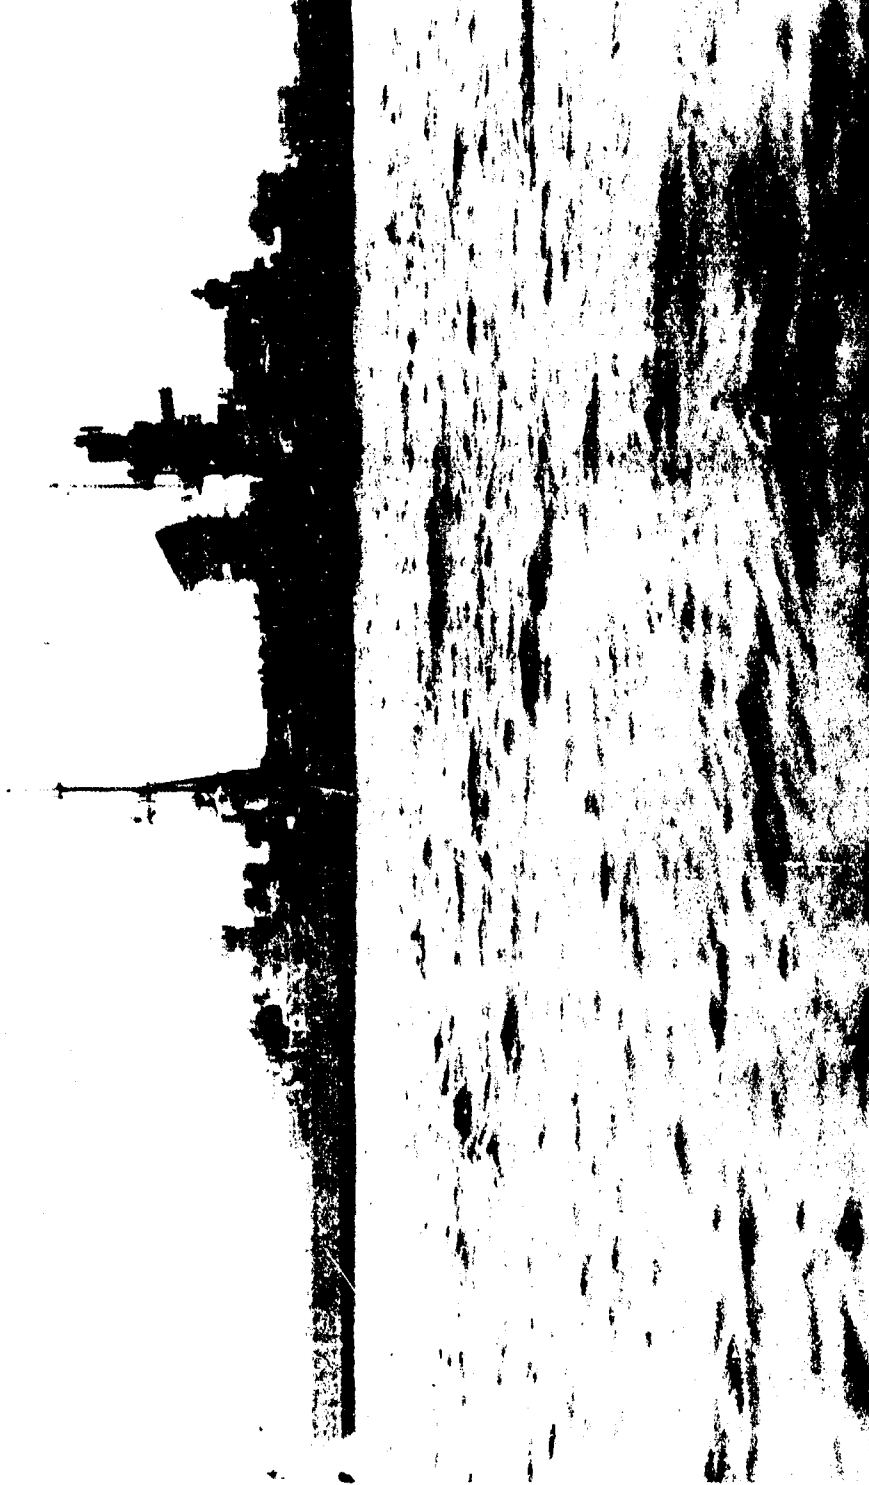
AA-CR-227-92-101. PRINZ EUGEN (IX300). View looking at starboard beam after Test Able. Note that main topmast has been broken off.

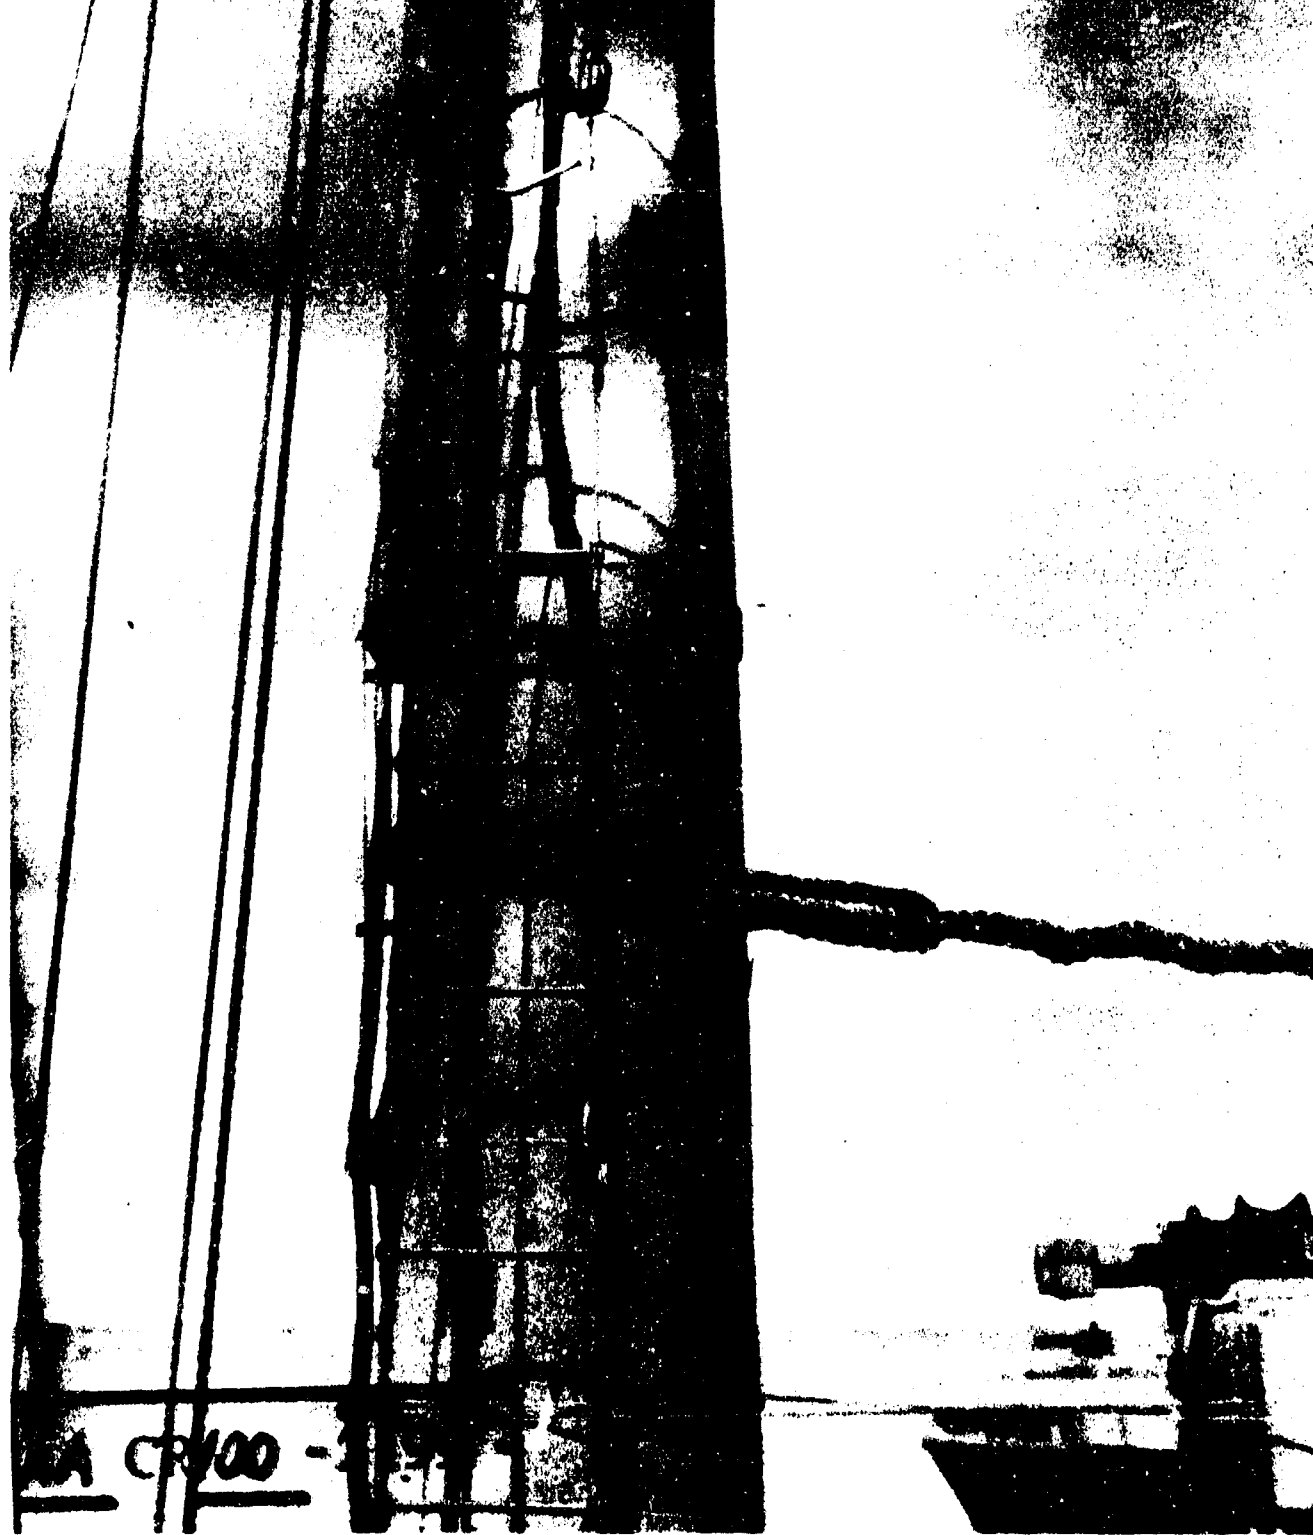
AA-CR-100-2199-1. PRINZ EUGEN (IX300). Continuation of crack shown in 2200-12.
