7 BUREAU OF SHIPS GROUP
TECHNICAL INSPECTION REPORT

6 OPERATION CROSSROADS.
U.S.S. INDEPENDENCE (CVL22)

TEST ABLE,

VOLUME 1 OF 4 [U].

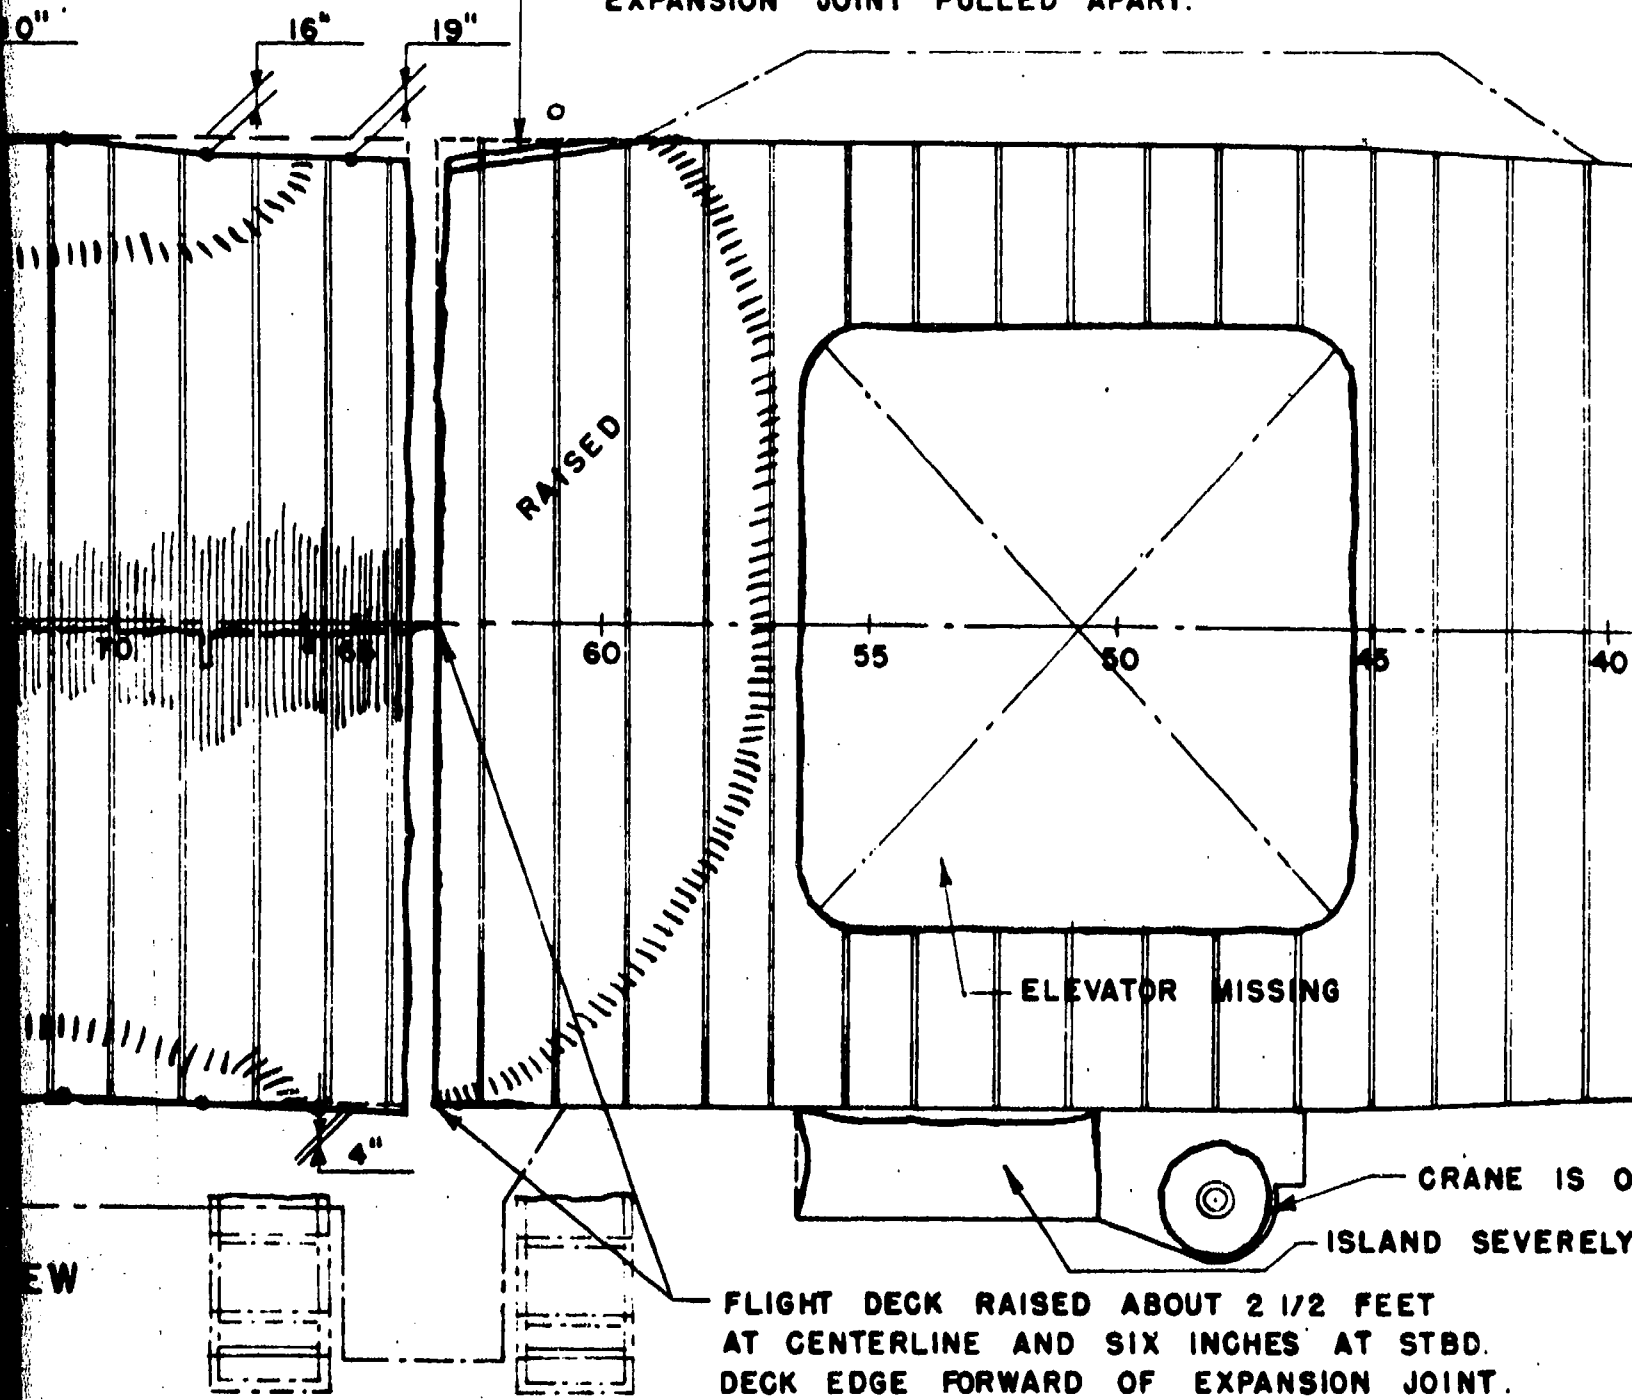
PORT EDGE OF FLIGHT DECK LIFTED FOUR FEET
IN WAY OF EXPANSION JOINT.
EXPANSION JOINT PULLED APART.

65 65 1/2 62 59
FLIGHT DECK ABREAST AND FORWARD OF FORWARD ELEVATOR IS SLIGHTLY DISTORTED BUT ESSENTIALLY UNDAMAGED.

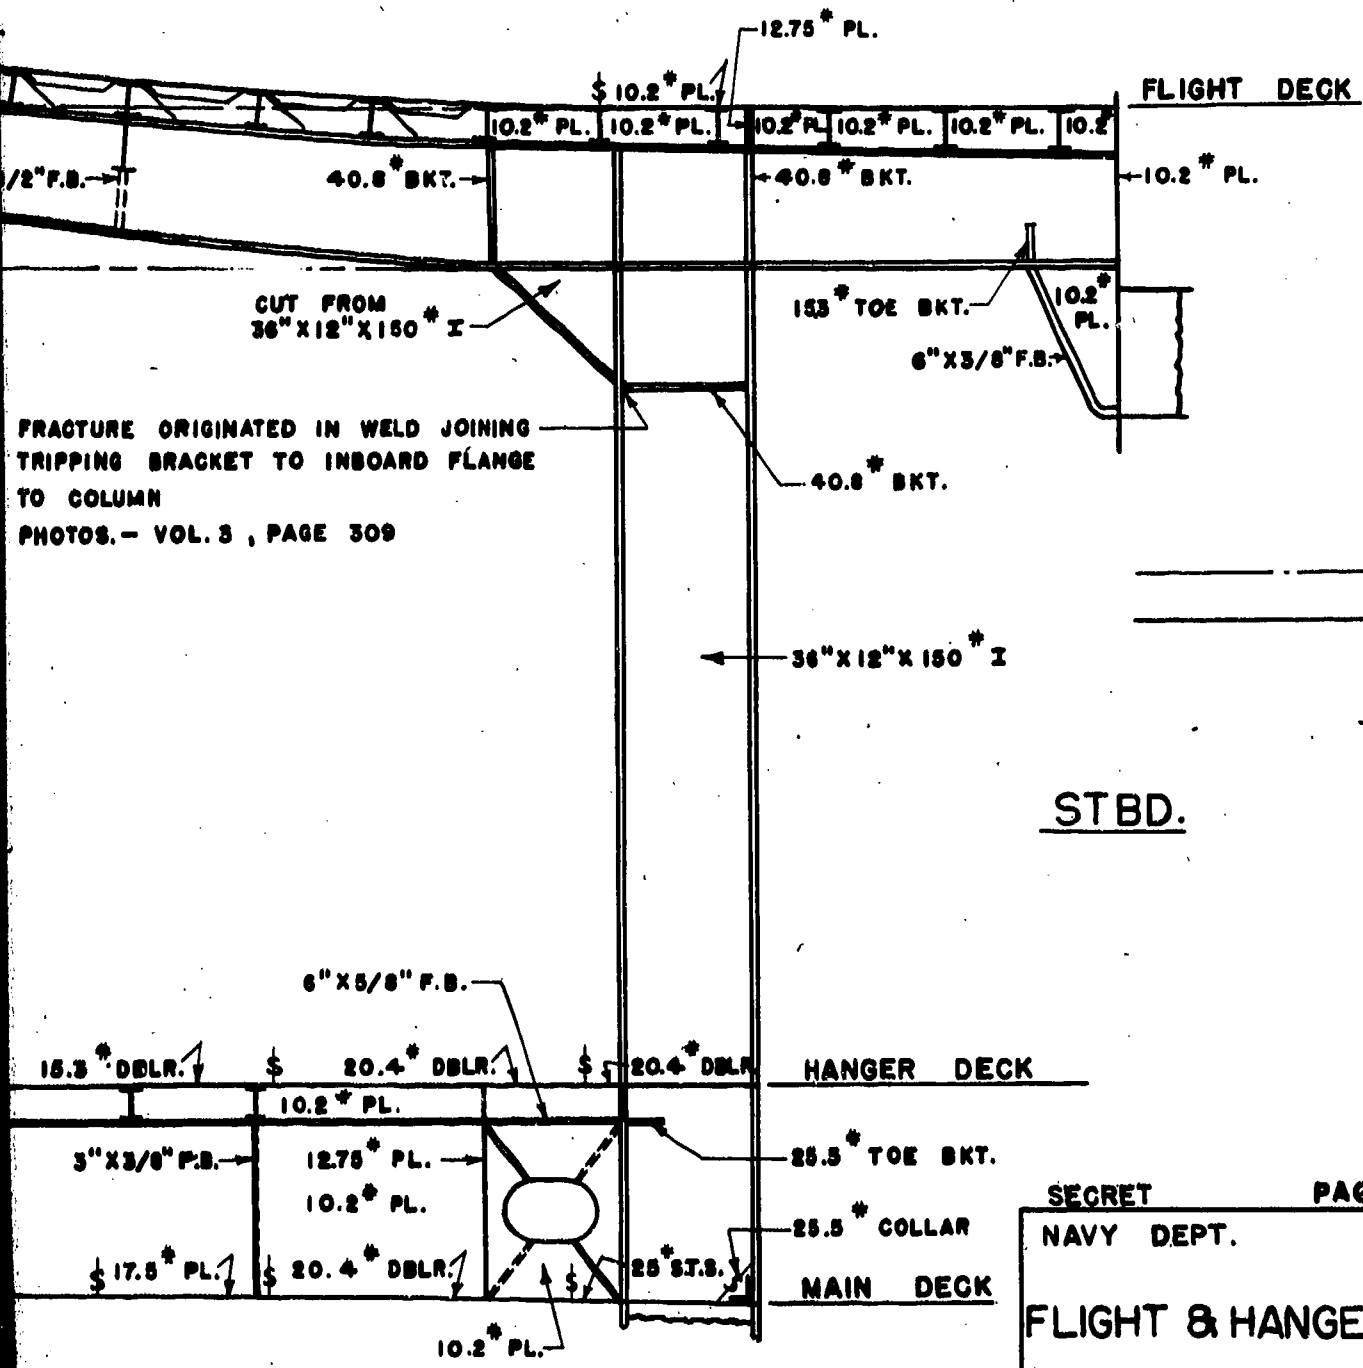
PLATE NO. 6

FRACTURE ORIGINATED IN WELD JOINING
TRIPPING BRACKET TO INBOARD FLANGE
TO COLUMN
PHOTOS. - VOL. 3 , PAGE 309

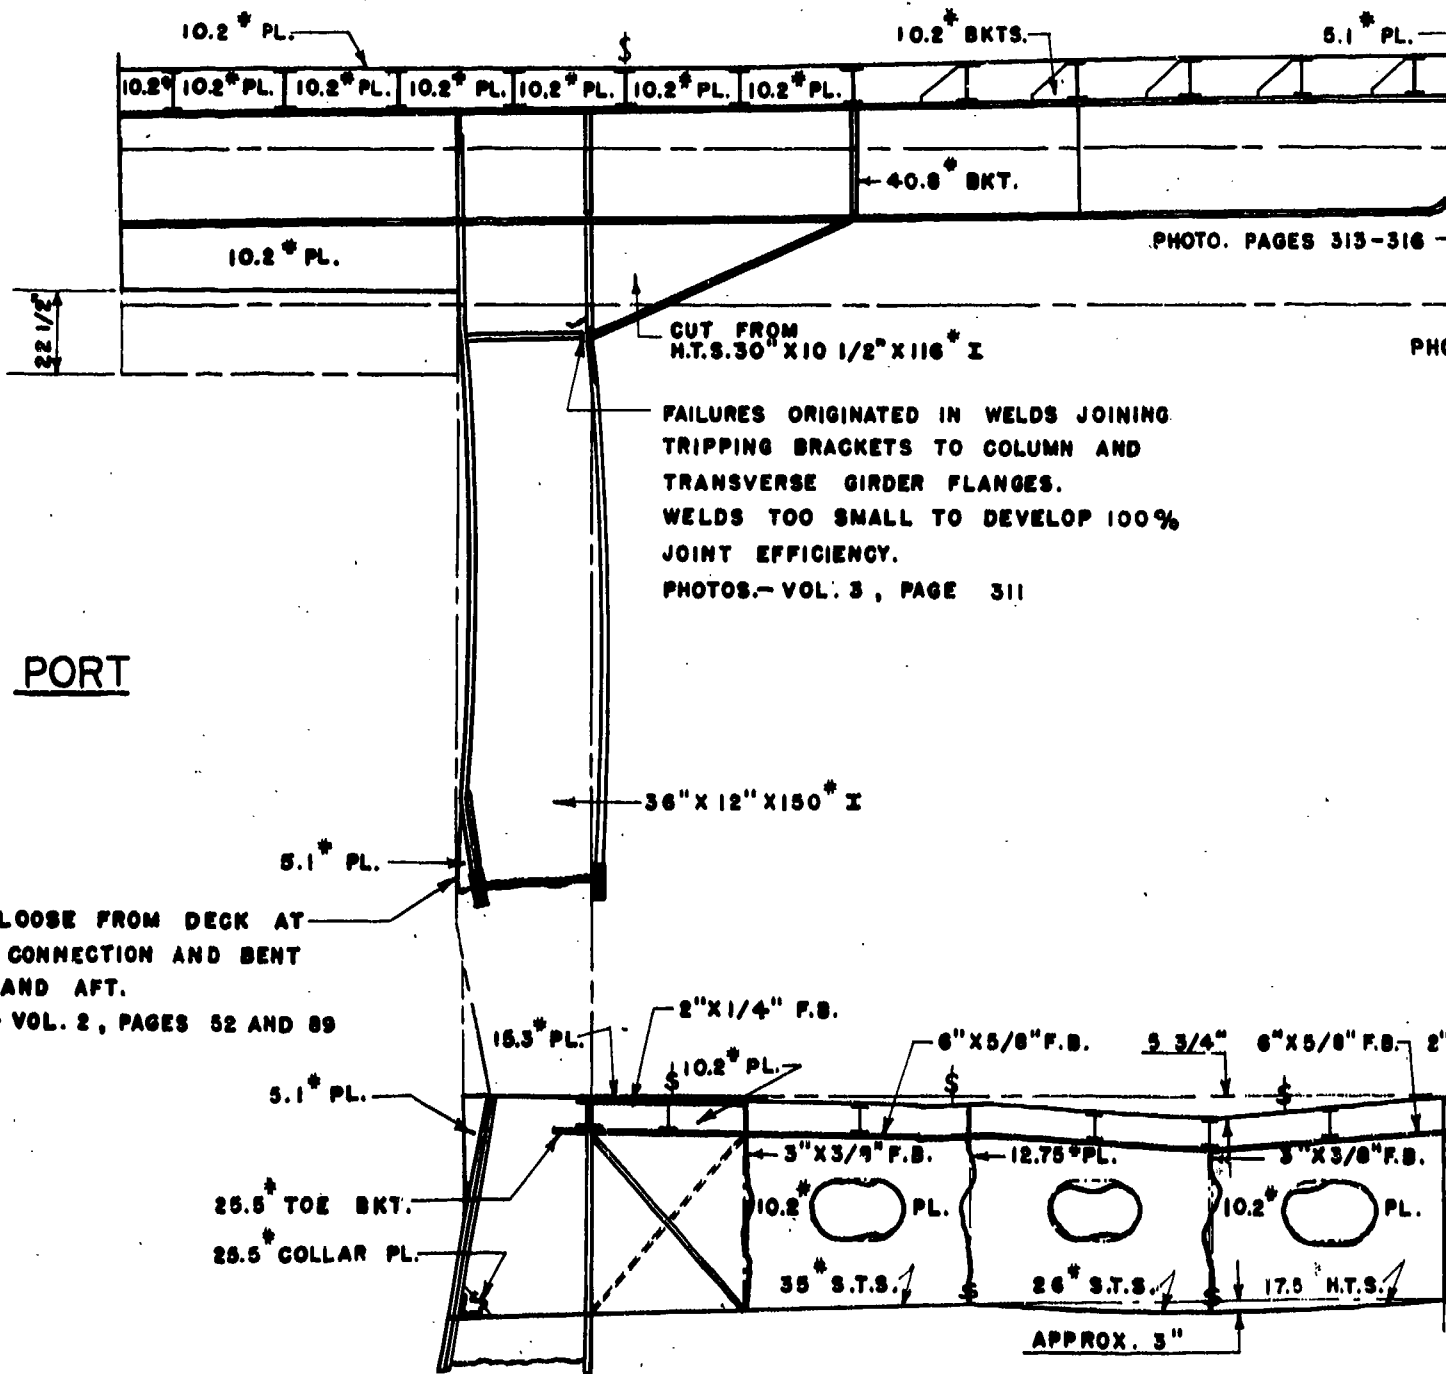
PULLED LOOSE FROM DECK AT RIVETED CONNECTION AND BENT UPWARD AND AFT.
 PHOTOS. - VOL. 2, PAGES 52 AND 59

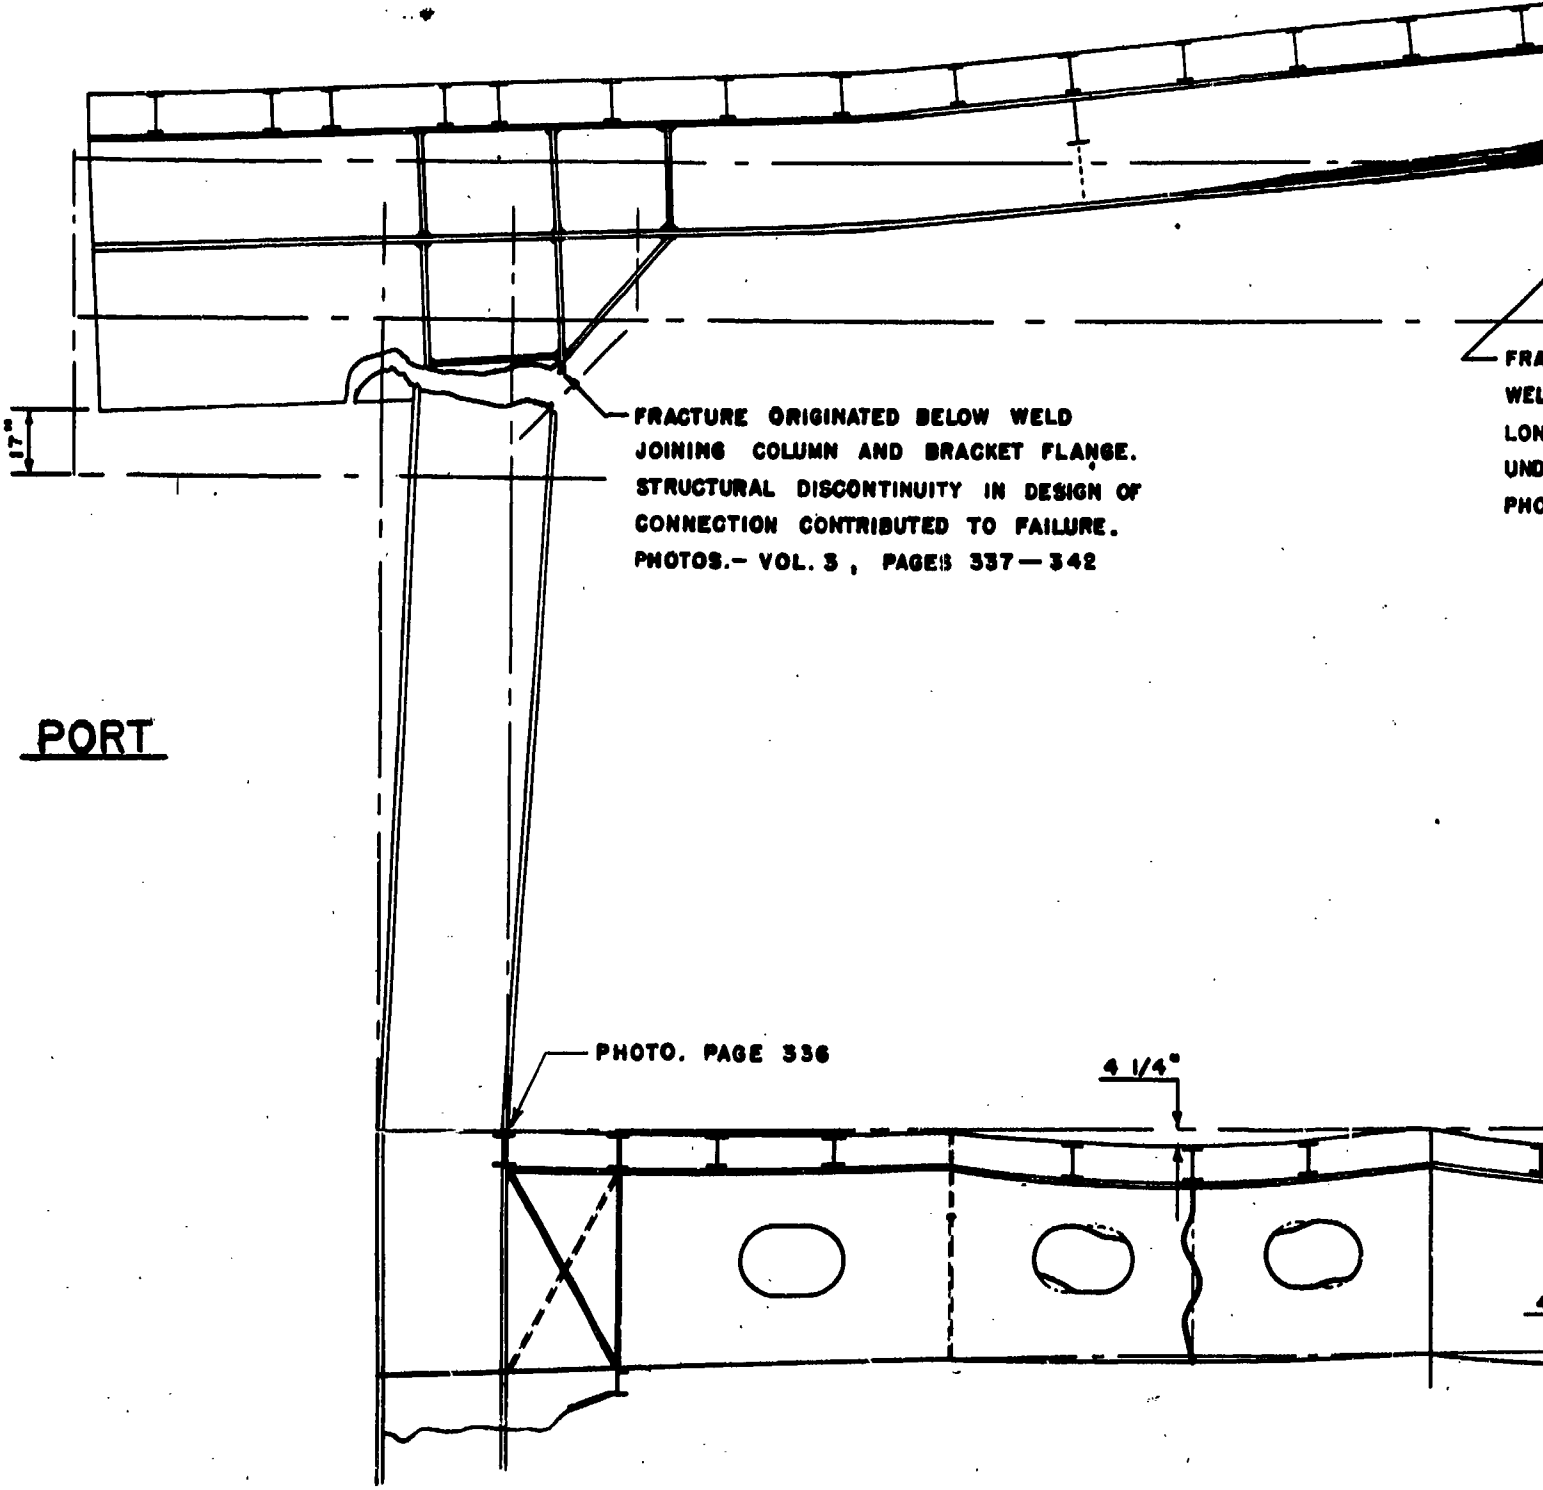
PLATE NO. 8

FRACTURE ORIGINATED BELOW WELD JOINING COLUMN AND BRACKET FLANGE. STRUCTURAL DISCONTINUITY IN DESIGN OF CONNECTION CONTRIBUTED TO FAILURE. PHOTOS.- VOL. 3 , PAGES 337-342

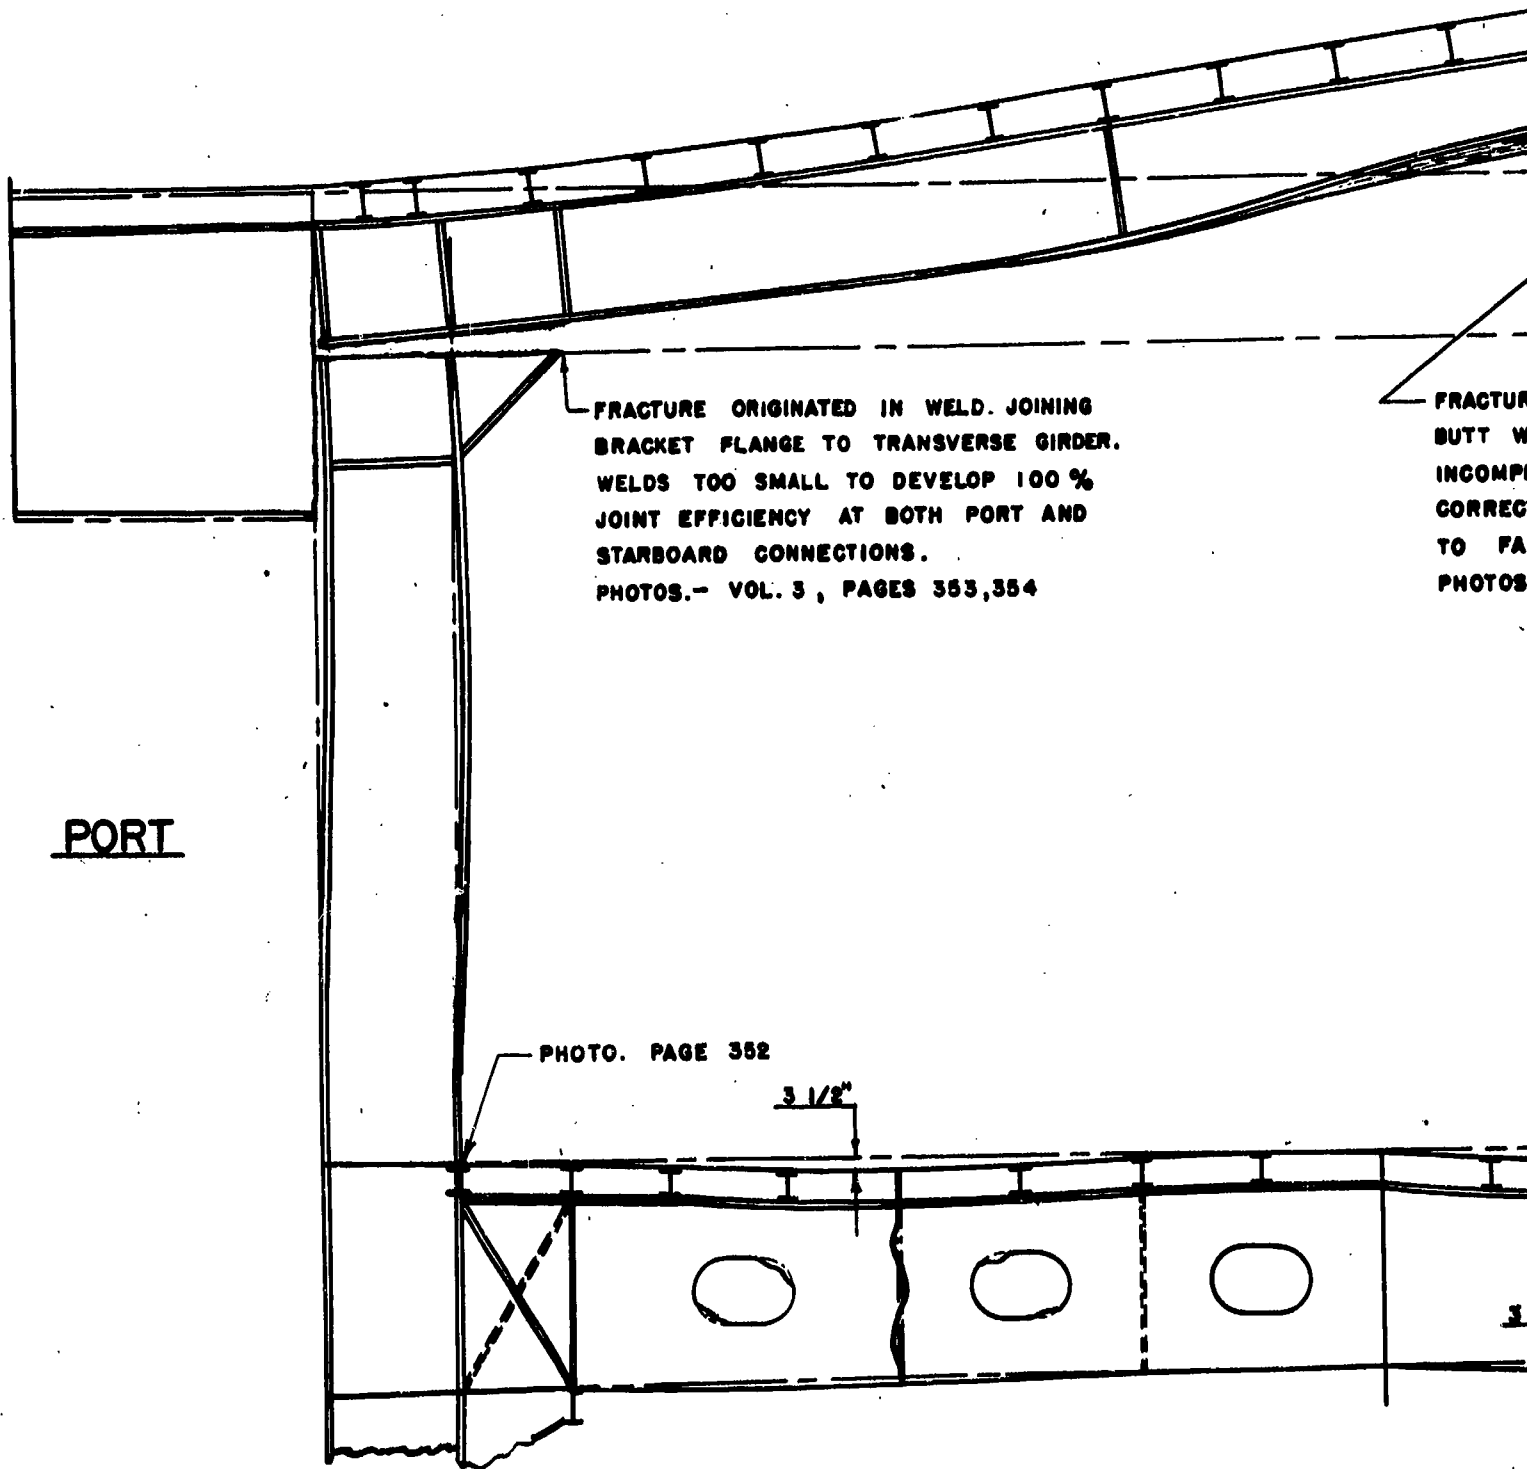
PLATE NO. 9

FRACTURE ORIGINATED IN WELD. JOINING
BRACKET FLANGE TO TRANSVERSE GIRDER.
WELDS TOO SMALL TO DEVELOP 100 %
JOINT EFFICIENCY AT BOTH PORT AND
STARBOARD CONNECTIONS.
PHOTOS.- VOL. 3 , PAGES 353,354

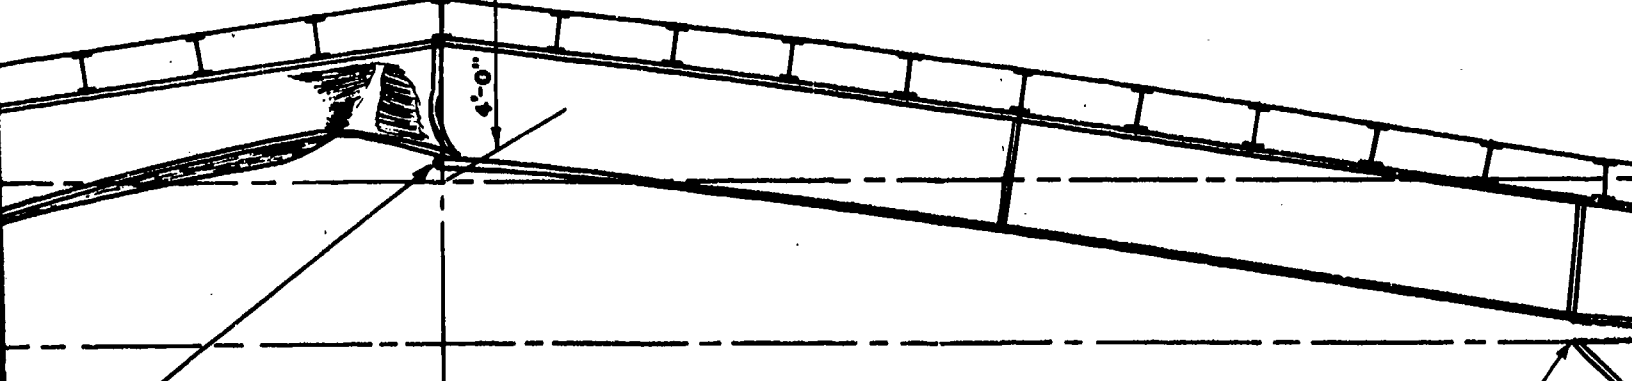
FRACTURE ORIGINATED IN AFTER END OF BUTT WELD IN LOWER FLANGE OF GIRDER. INCOMPLETE WELD PENETRATION AND INCORRECT EDGE PREPARATION CONTRIBUTED TO FAILURE.
PHOTOS.- VOL. 3 , PAGES 355 - 357

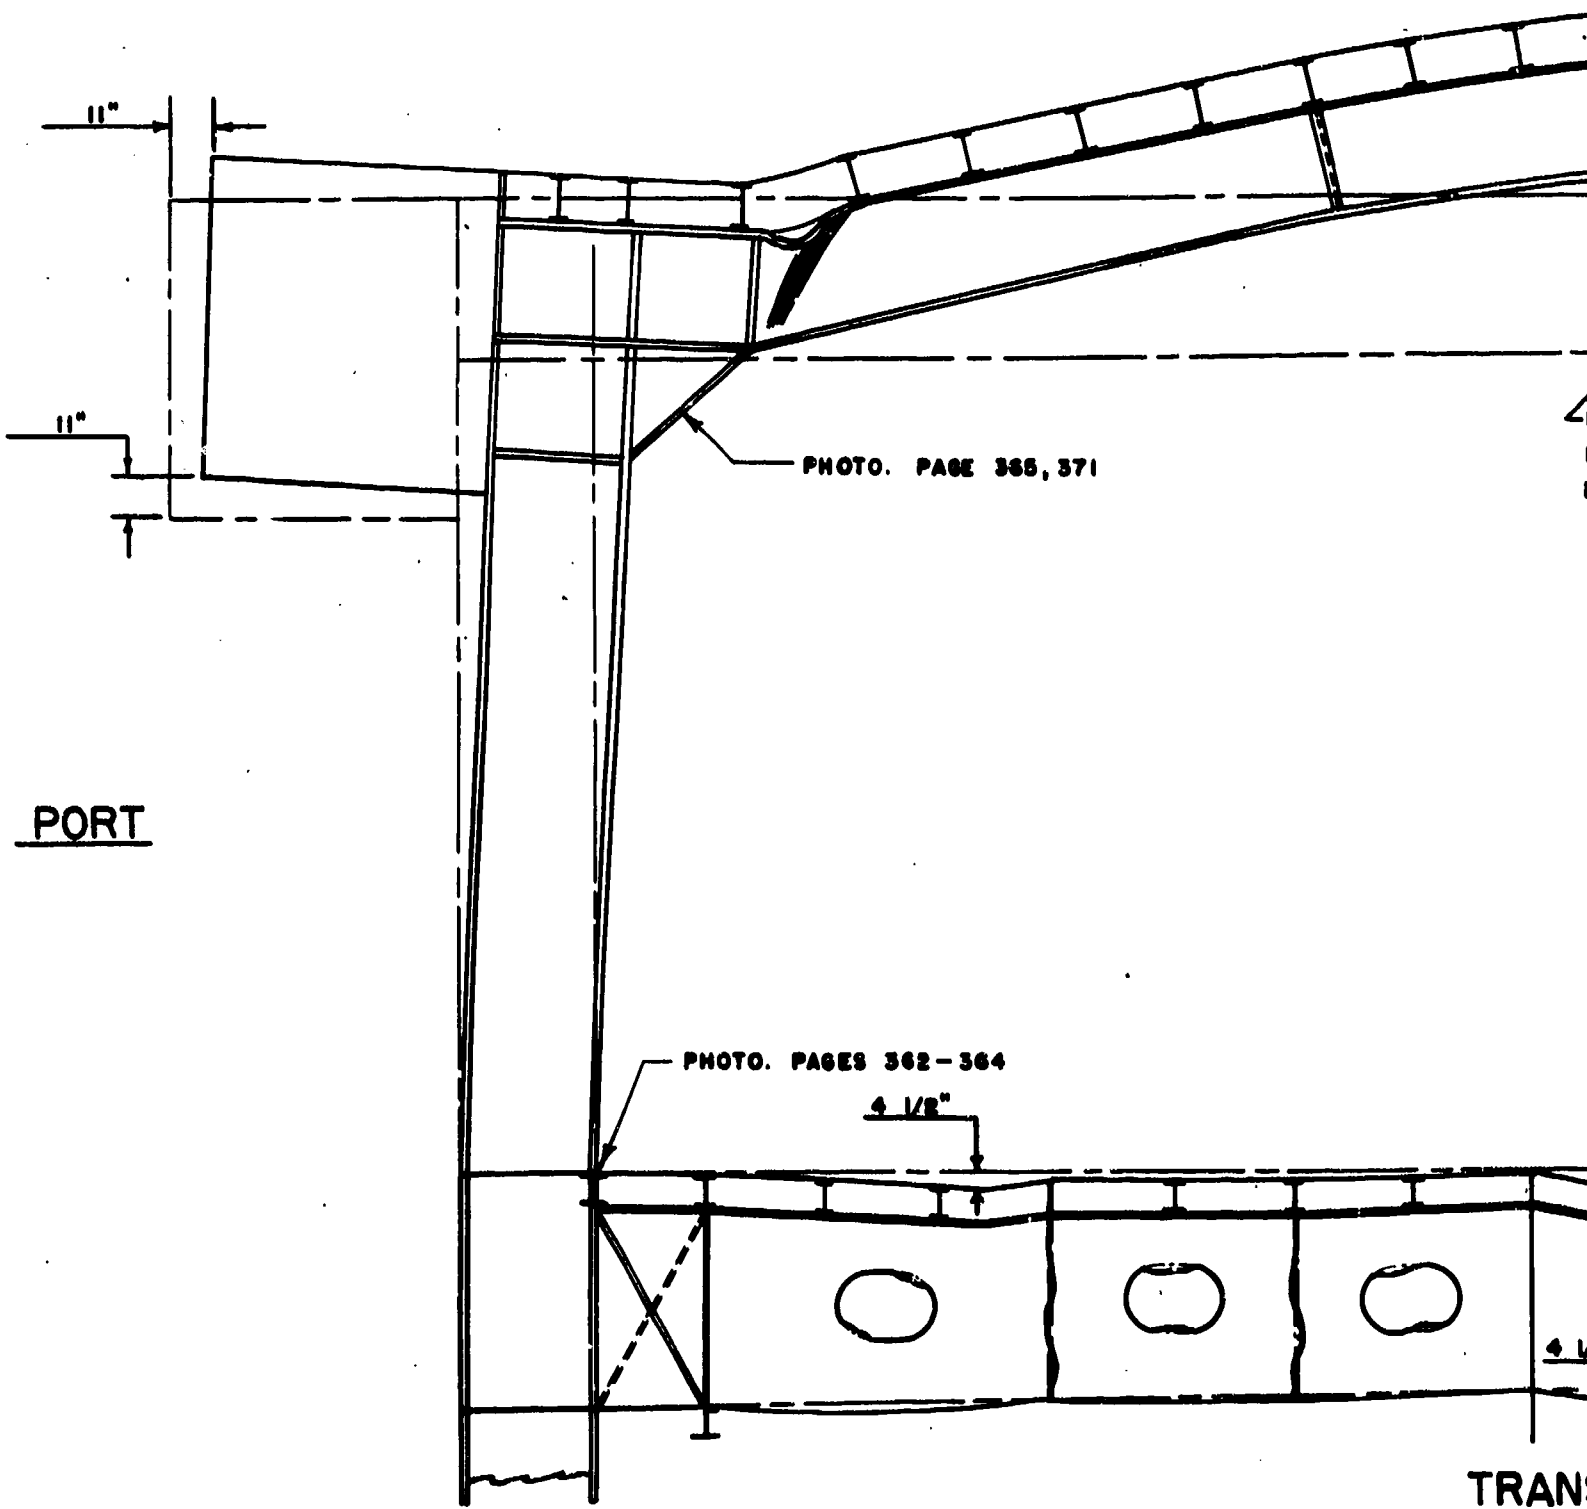
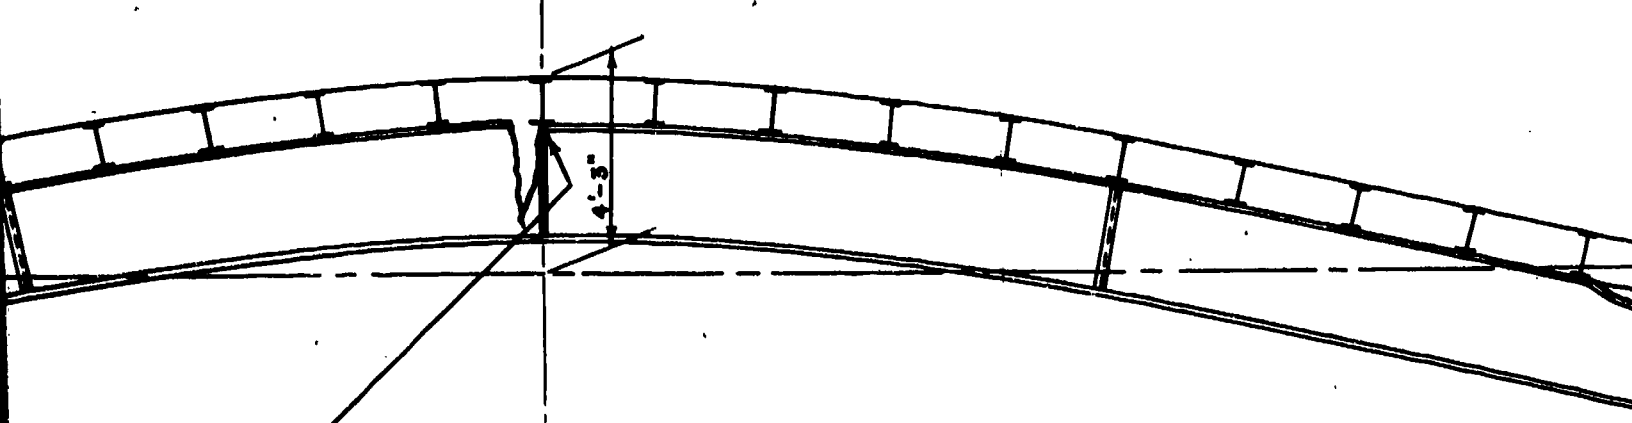
PLATE NO. 10

← FRACTURE ORIGINATED AT EDGE OF WELD
 IN TOP FLANGE OF GIRDER.
 PHOTOS.- VOL. 3, PAGES 366-369, 375, 376

FRACTURE ORIGINATED AT UPPER
 OF WELD JOINING GIRDER AND
 BRACKET FLANGES.
 DISCONTINUITY IN STRUCTURAL DES
 OF CONNECTION CONTRIBUTED TO
 PHOTOS.-VOL. 3, PAGES 370, 372

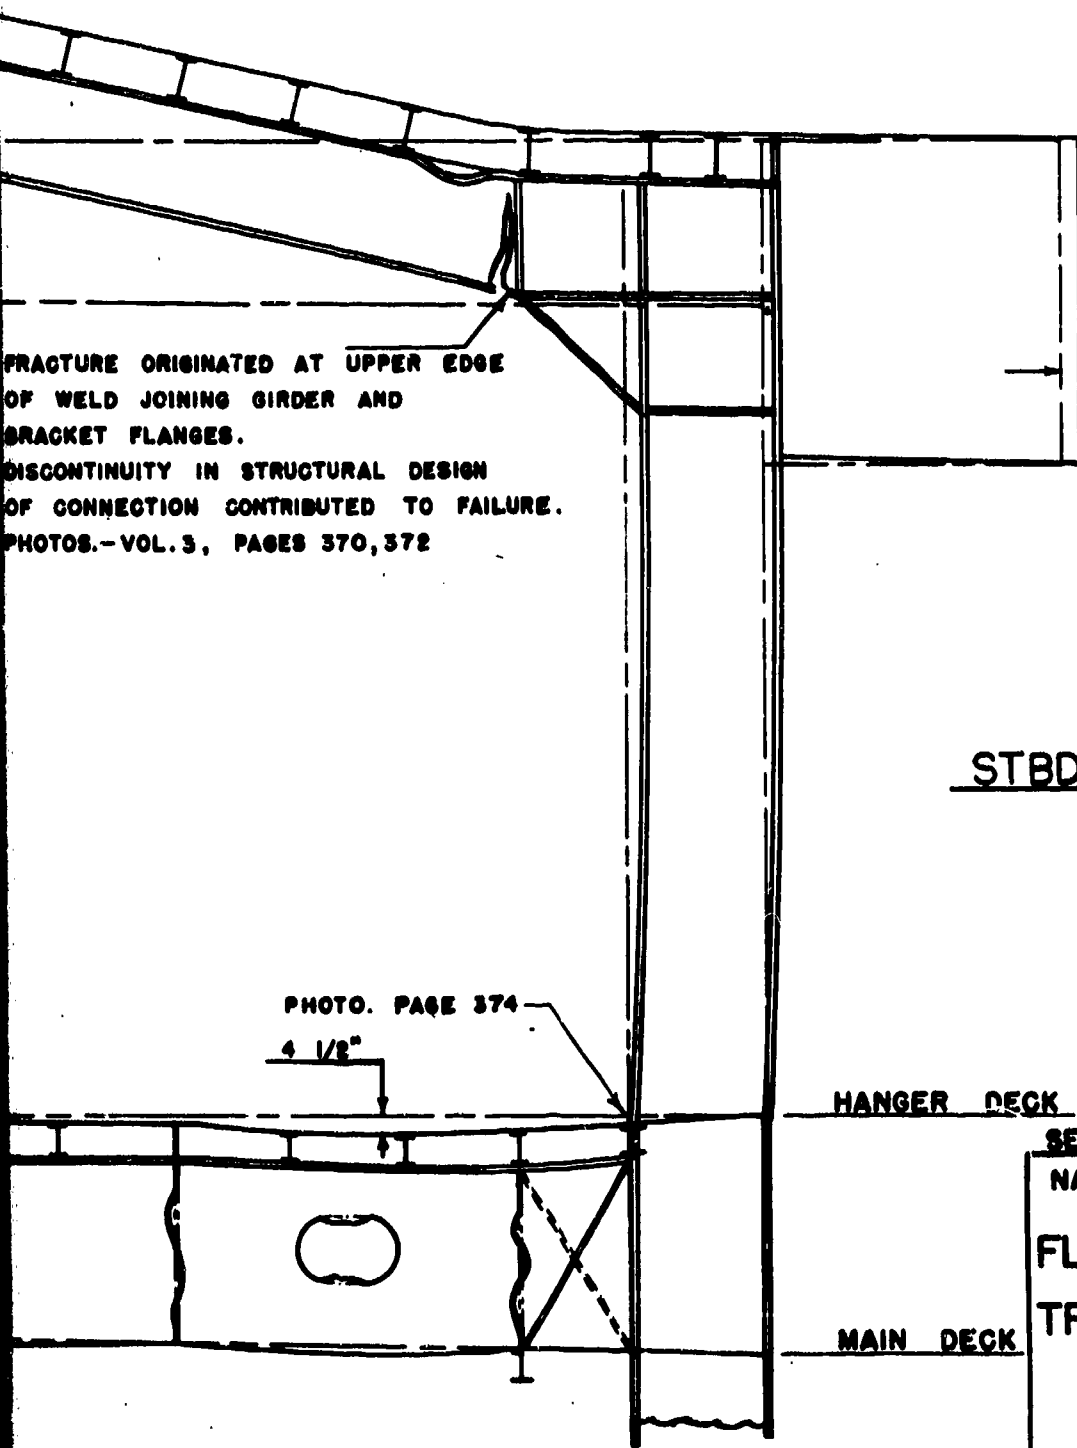
FRACTURE ORIGINATED AT UPPER EDGE
 OF WELD JOINING GIRDER AND
 BRACKET FLANGES.
 DISCONTINUITY IN STRUCTURAL DESIGN
 OF CONNECTION CONTRIBUTED TO FAILURE.
 PHOTOS.-VOL. 3, PAGES 370, 372

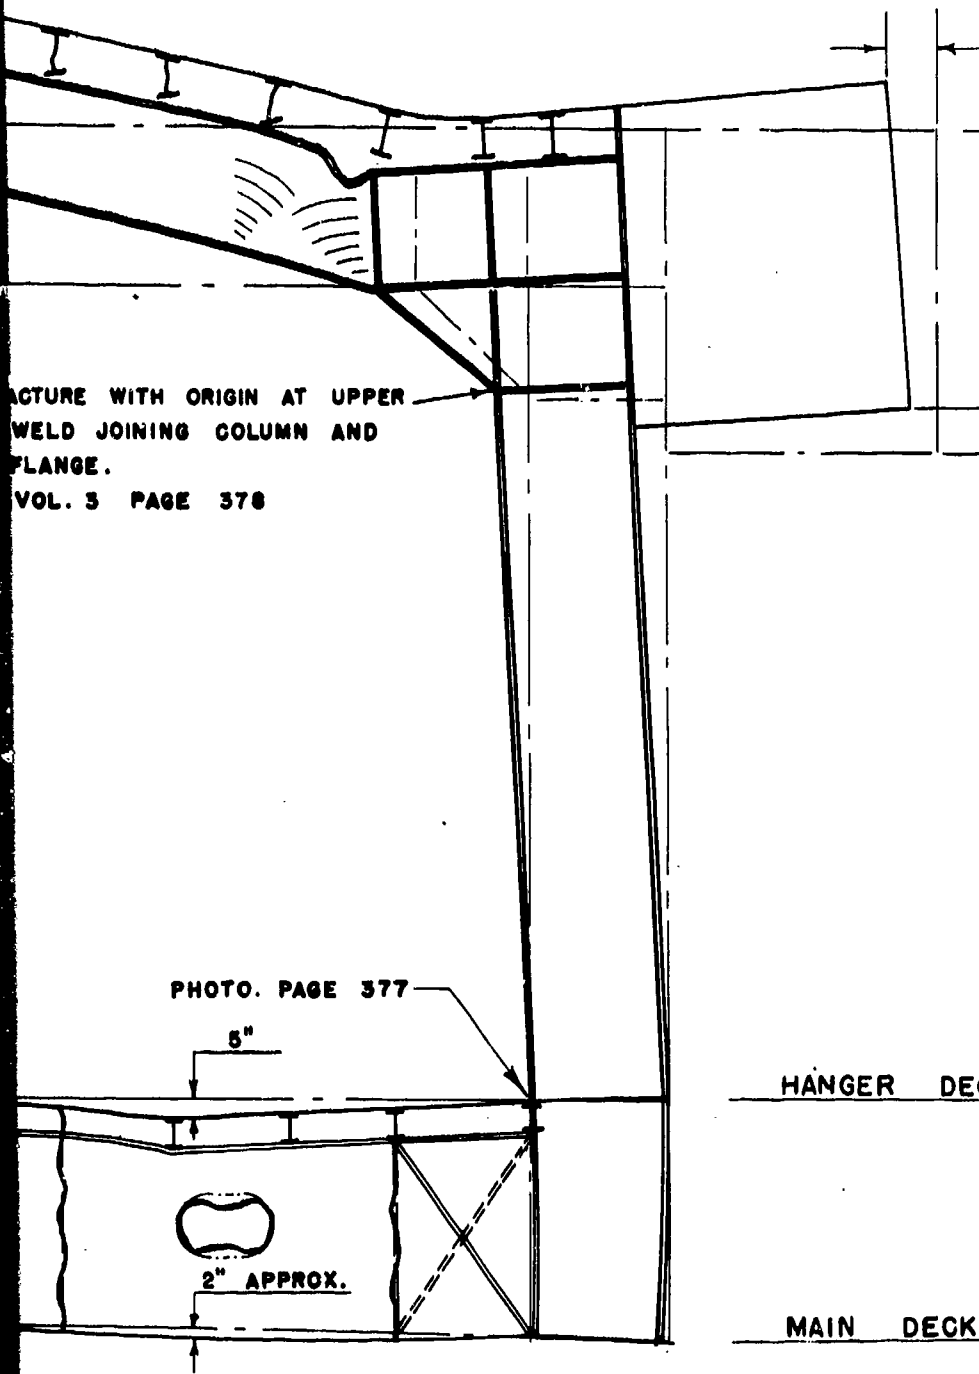
FRACTURE WITH ORIGIN AT UPPER
 WELD JOINING COLUMN AND
 FLANGE.
 VOL. 3 PAGE 378

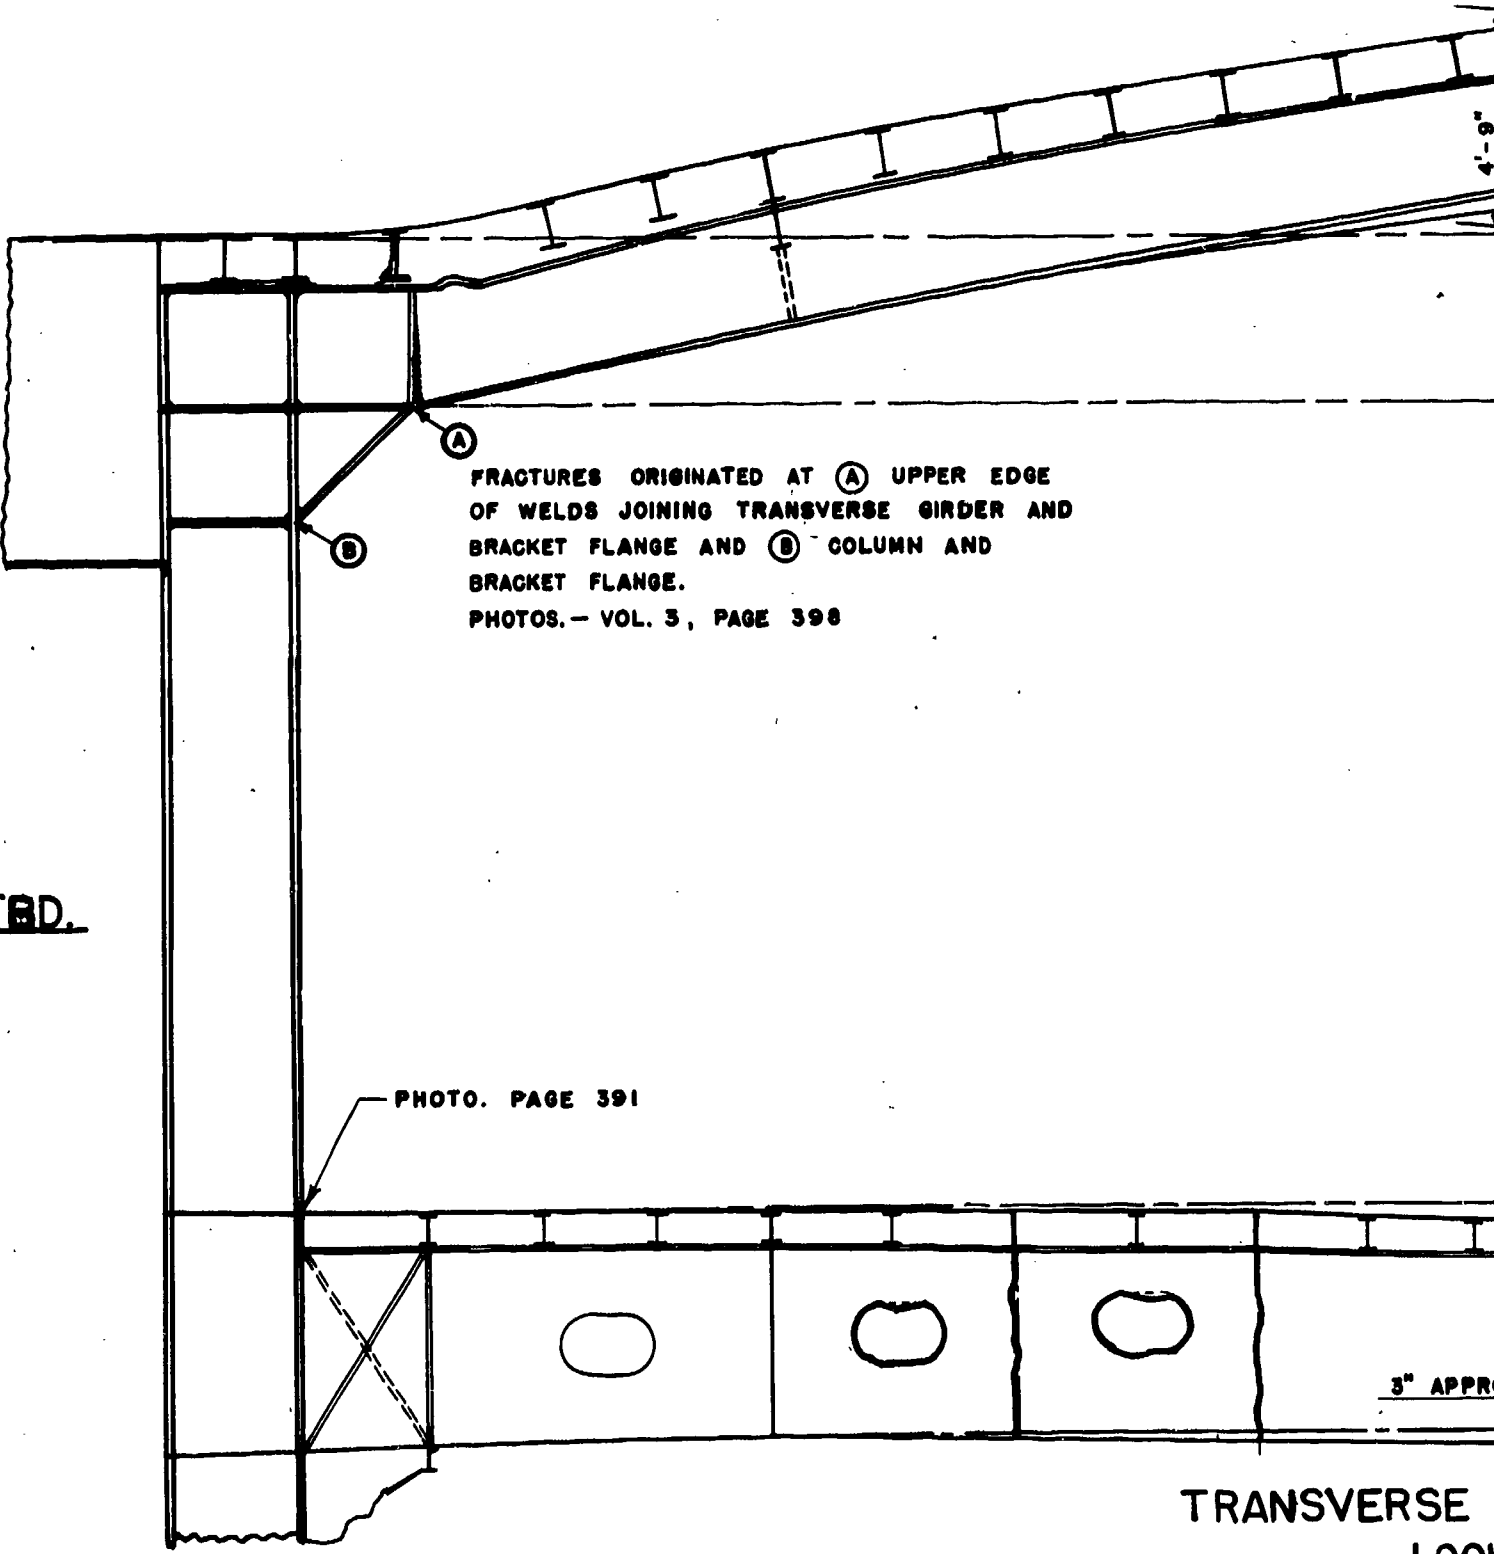
PLATE NO. 12

FRACTURES ORIGINATED AT (A) UPPER EDGE
OF WELDS JOINING TRANSVERSE GIRDER AND
BRACKET FLANGE AND (B) COLUMN AND
BRACKET FLANGE.
PHOTOS. - VOL. 3, PAGE 398

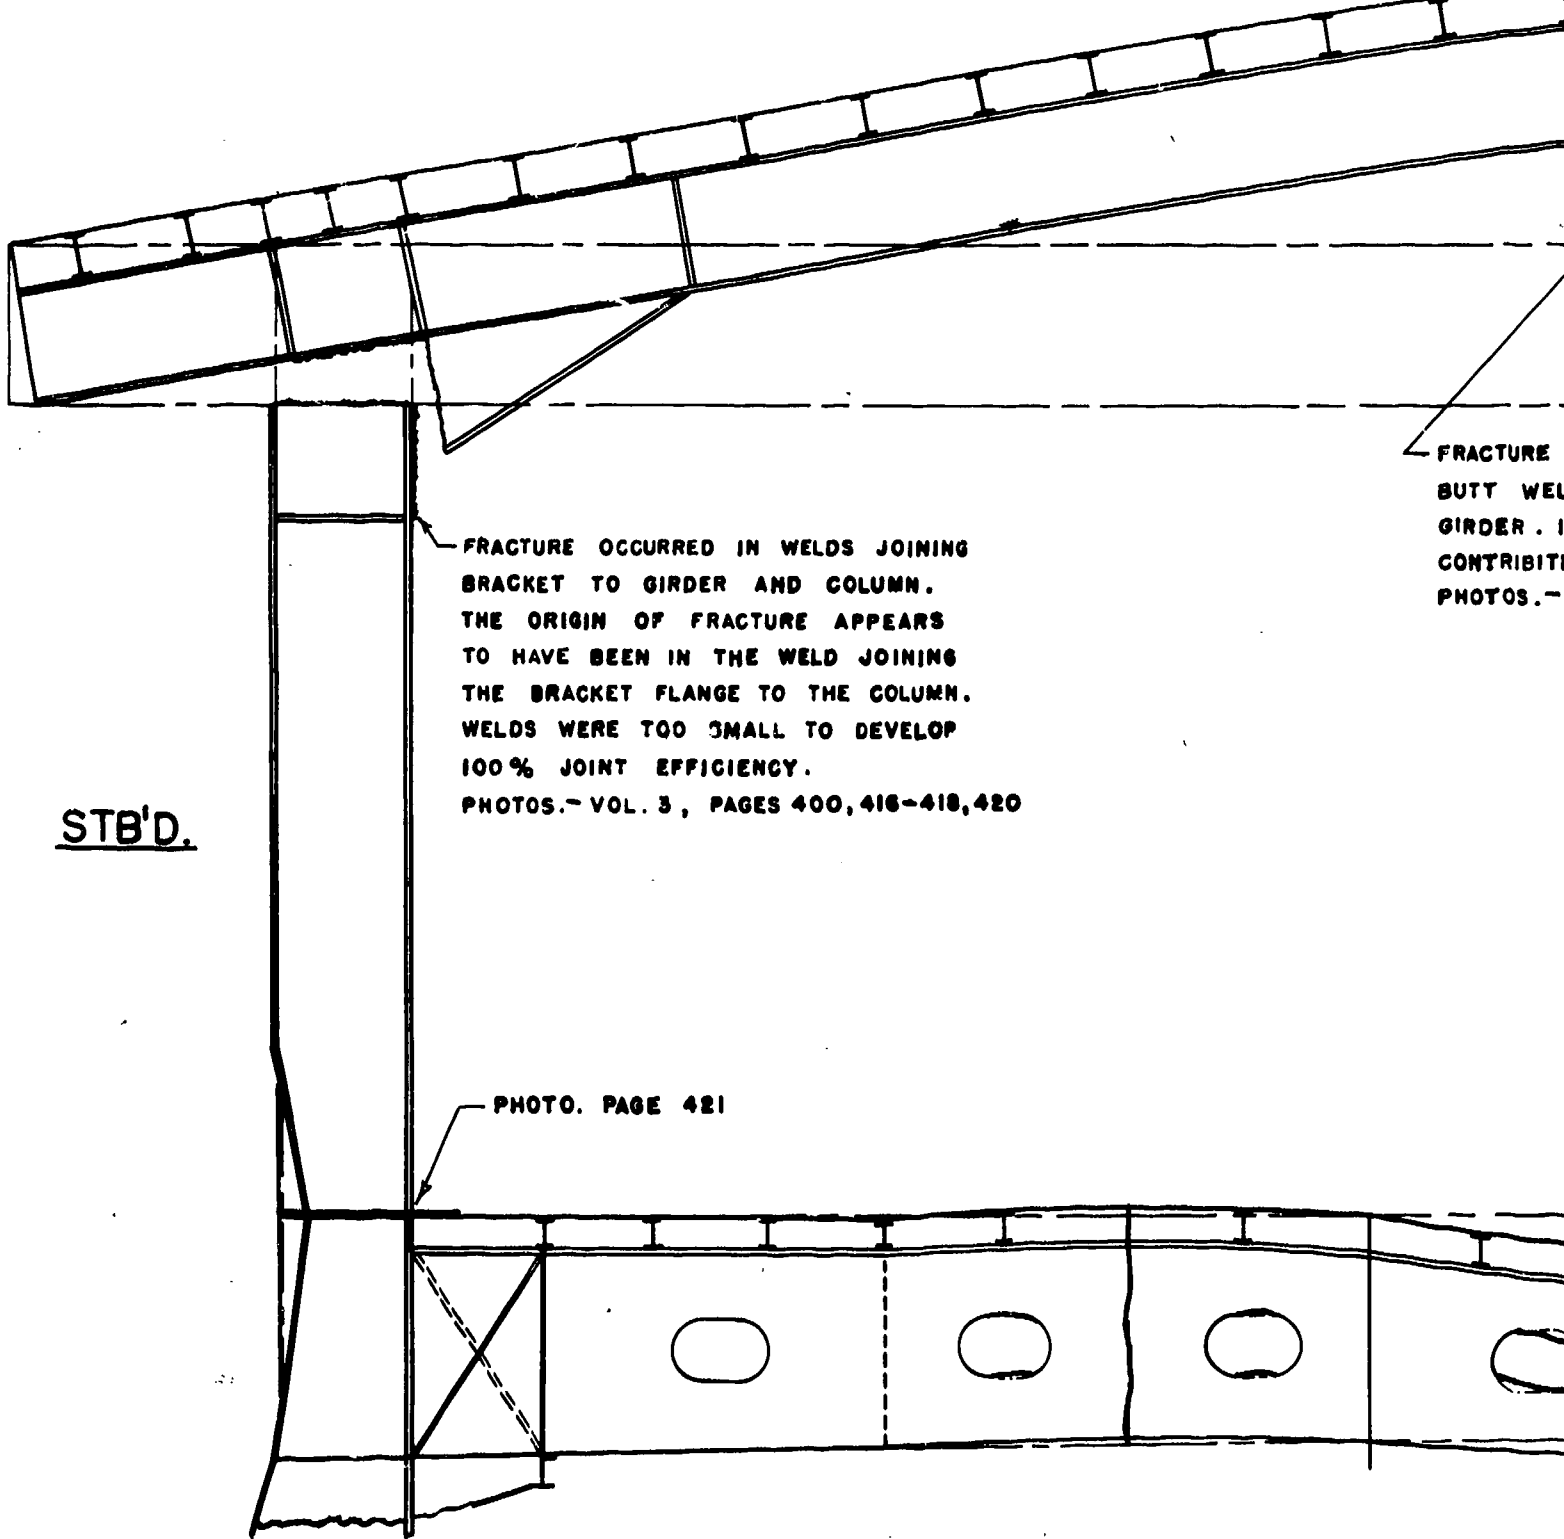
PLATE NO. 13

FRACTURE OCCURRED IN WELDS JOINING BRACKET TO GIRDER AND COLUMN. THE ORIGIN OF FRACTURE APPEARS TO HAVE BEEN IN THE WELD JOINING THE BRACKET FLANGE TO THE COLUMN. WELDS WERE TOO SMALL TO DEVELOP 100% JOINT EFFICIENCY. PHOTOS.- VOL. 3, PAGES 400, 416-418, 420
