7 BUREAU OF SHIPS GROUP
TECHNICAL INSPECTION REPORT

6 OPERATION CROSSROADS.
U.S.S. INDEPENDENCE (CVL22)

TEST ABLE,

VOLUME 1 OF 4 [U].

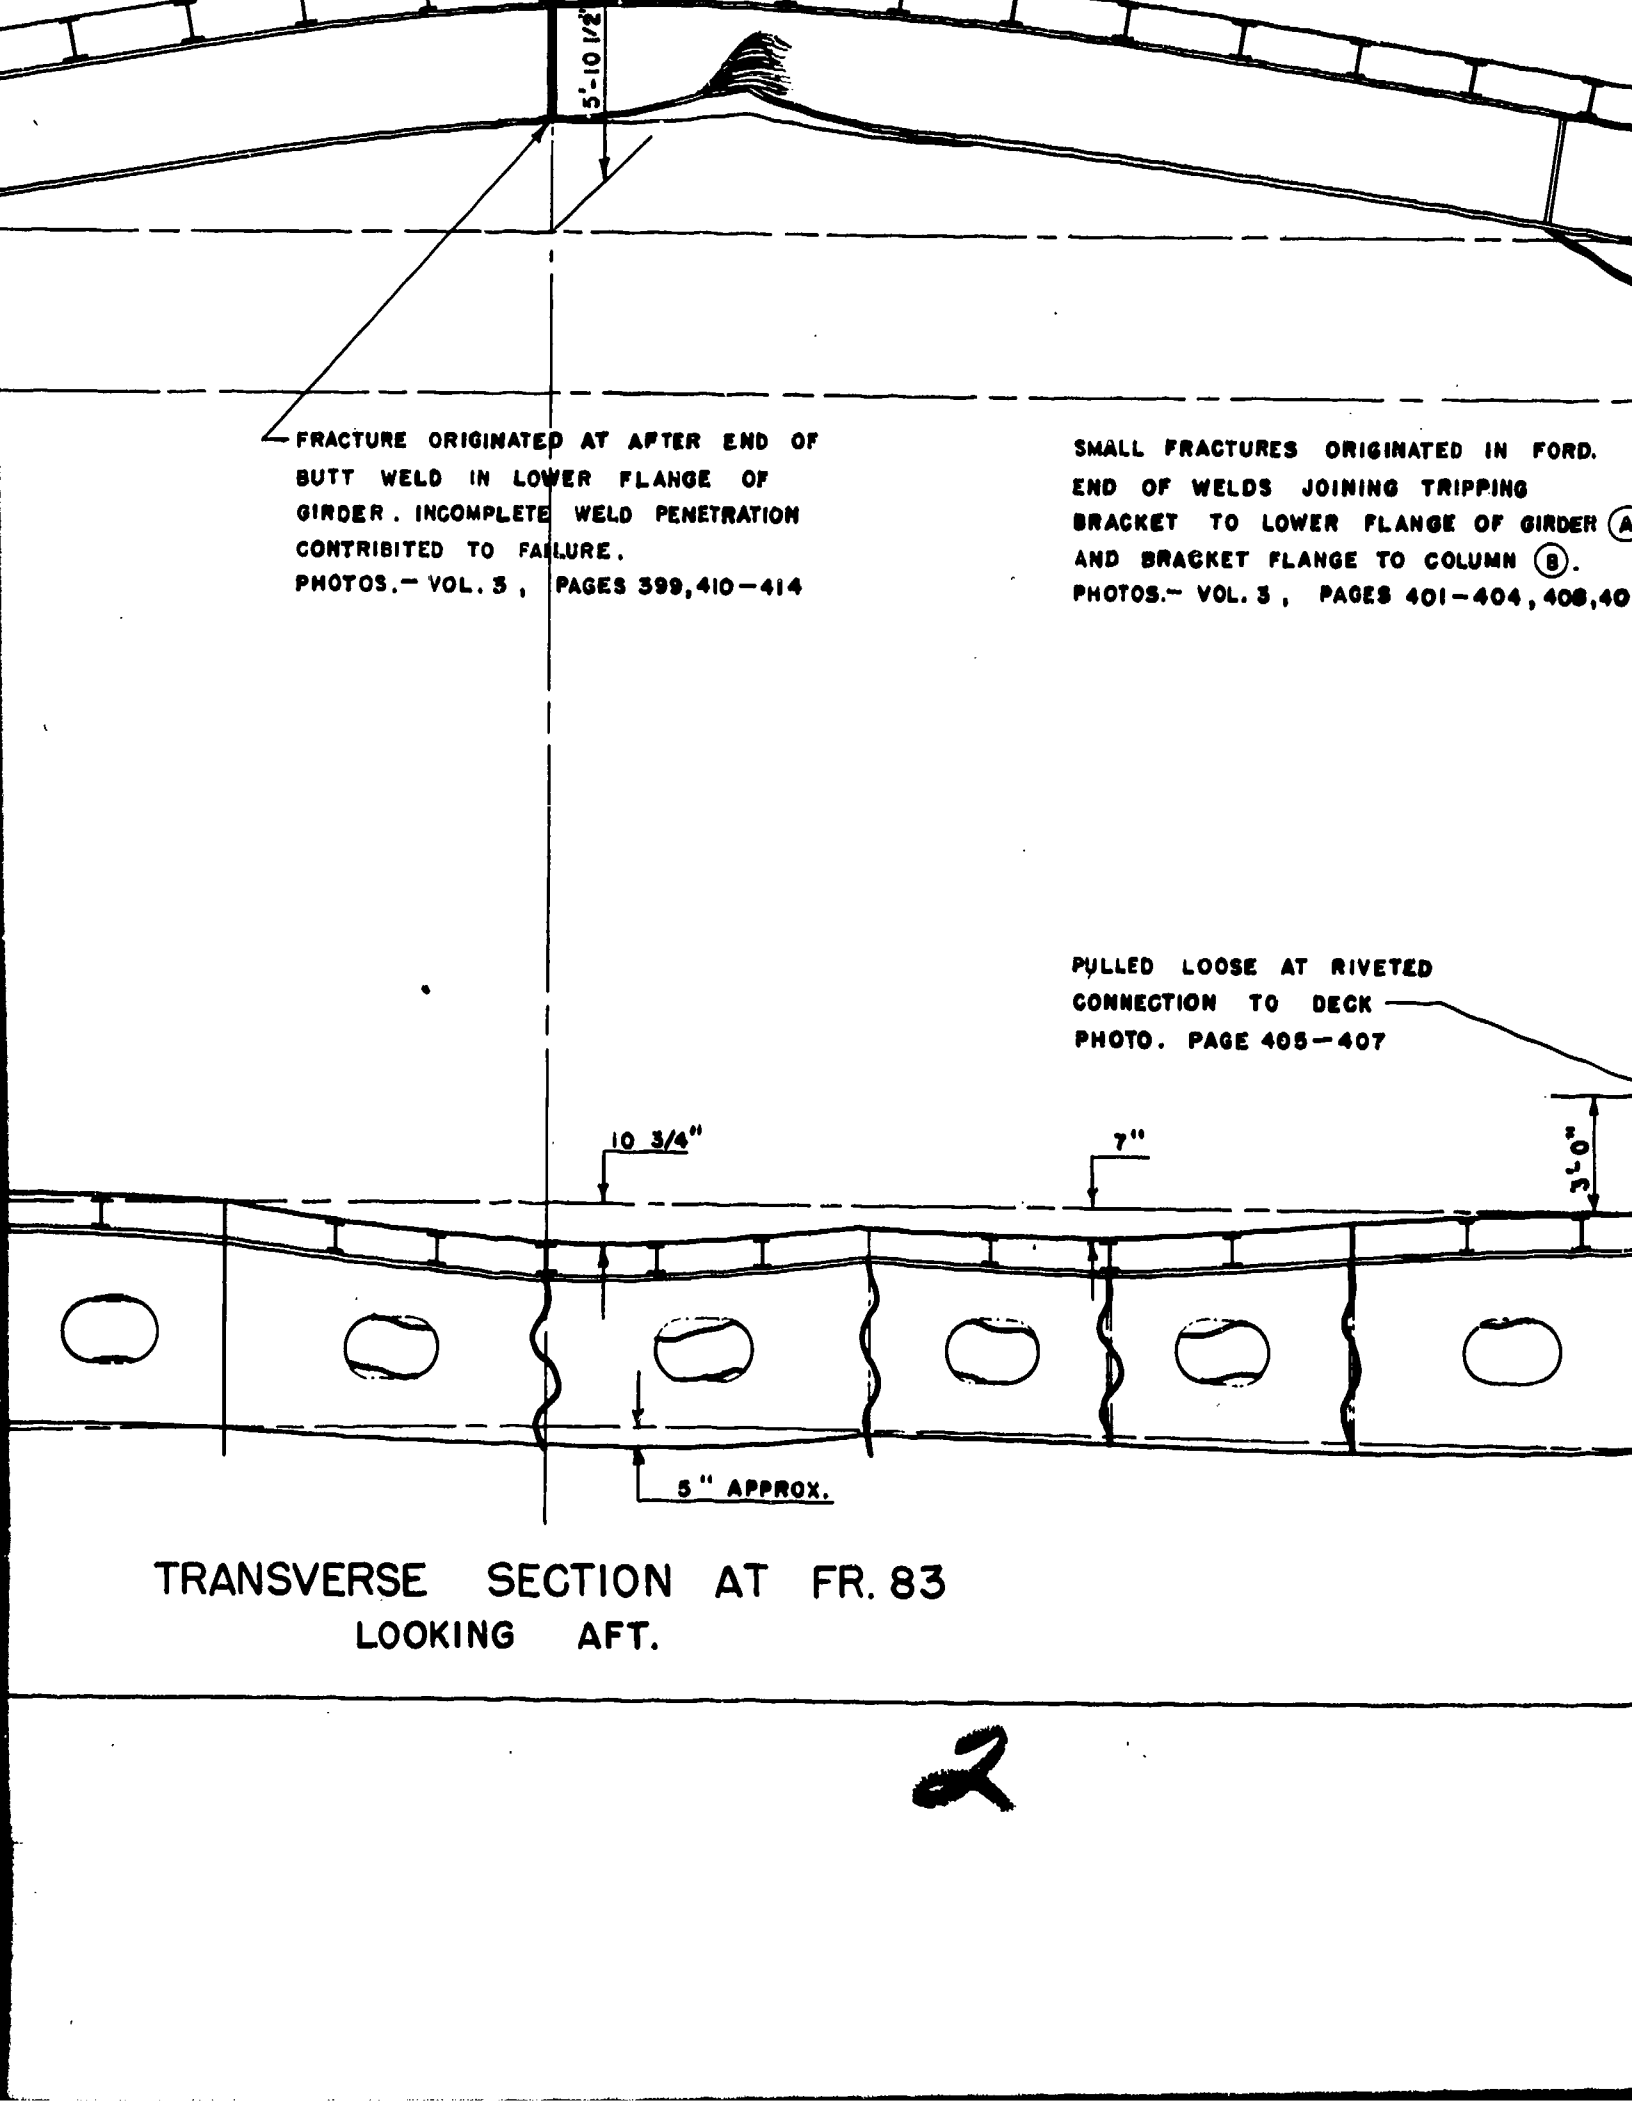
FRACTURE ORIGINATED AT AFTER END OF BUTT WELD IN LOWER FLANGE OF GIRDER. INCOMPLETE WELD PENETRATION CONTRIBUTED TO FAILURE.
PHOTOS.- VOL. 3 , PAGES 399,410-414

SMALL FRACTURES ORIGINATED IN FORD. END OF WELDS JOINING TRIPPING BRACKET TO LOWER FLANGE OF GIRDER (A) AND BRACKET FLANGE TO COLUMN (B).
PHOTOS.- VOL. 3 , PAGES 401-404, 408,40

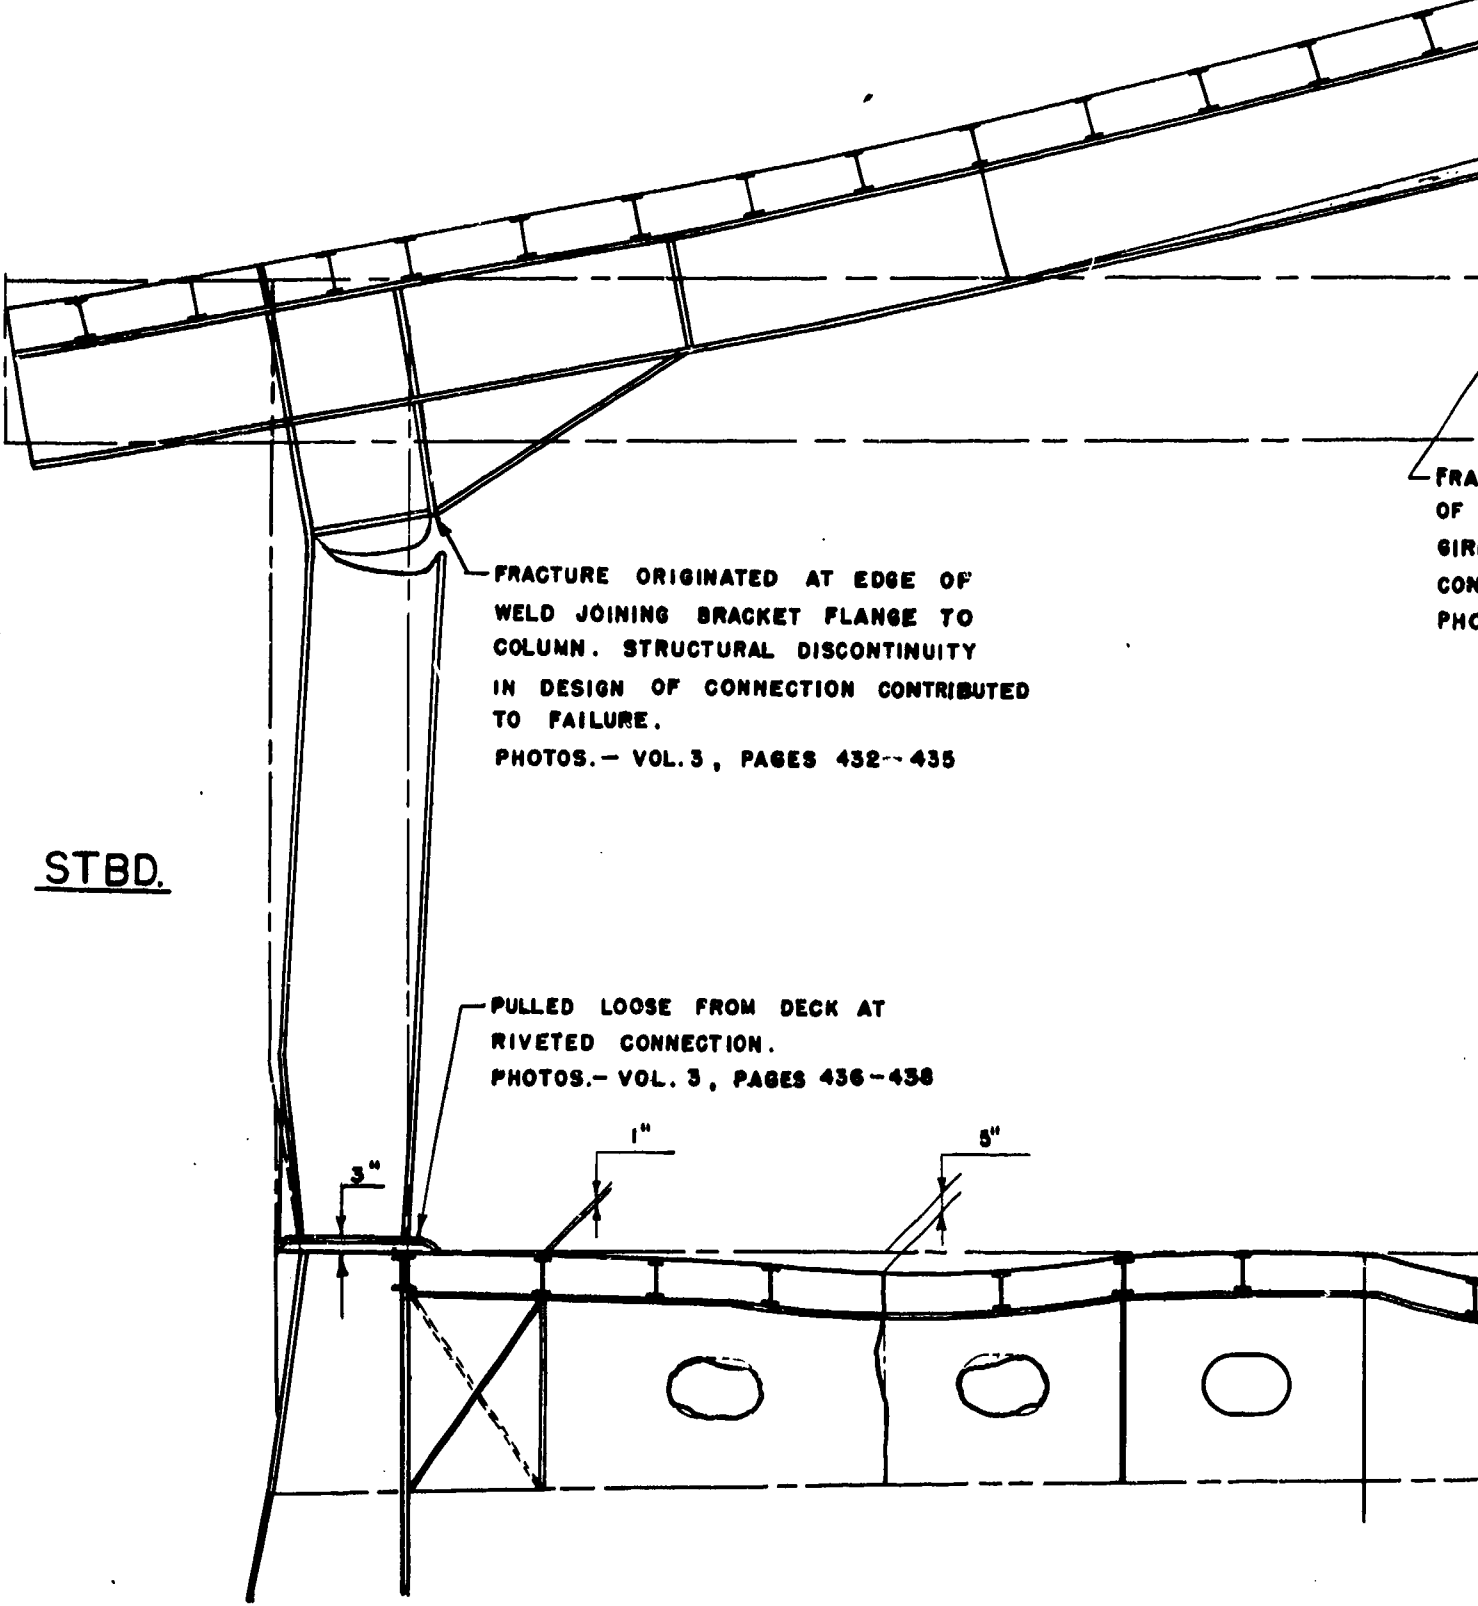
PLATE NO.14

FRACTURE ORIGINATED AT EDGE OF
WELD JOINING BRACKET FLANGE TO
COLUMN. STRUCTURAL DISCONTINUITY
IN DESIGN OF CONNECTION CONTRIBUTED
TO FAILURE.
PHOTOS.- VOL. 3 , PAGES 432--435

PULLED LOOSE FROM DECK AT
RIVETED CONNECTION.
PHOTOS.- VOL. 3 , PAGES 436-438

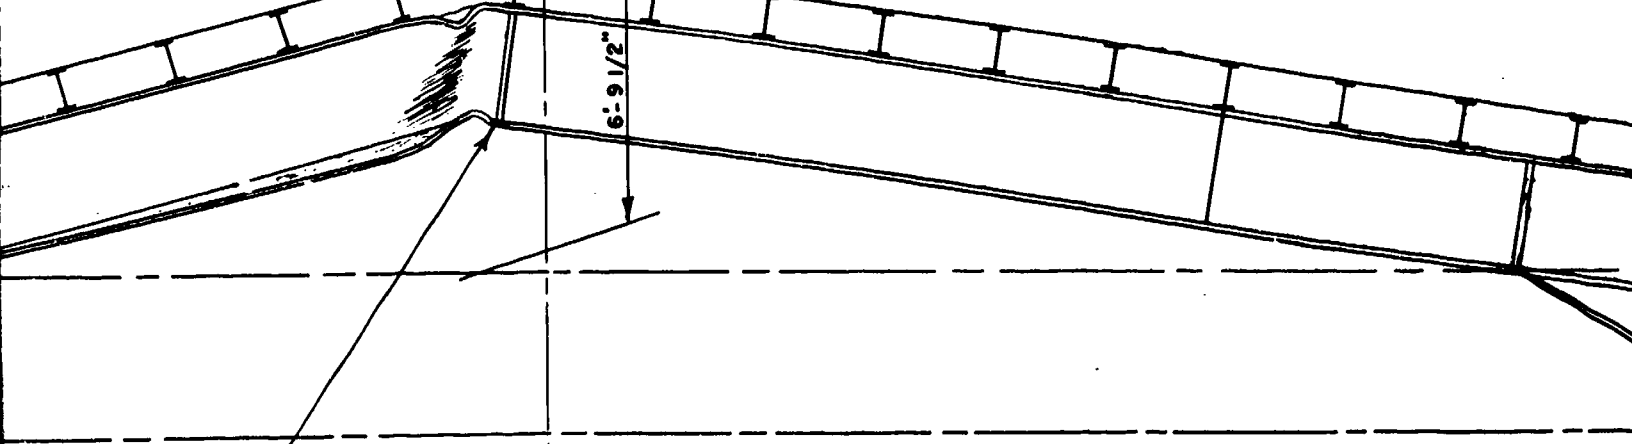
FRACTURE ORIGINATED AT FORWARD END OF BUTT WELD IN LOWER FLANGE OF GIRDER. INCOMPLETE WELD PENETRATION CONTRIBUTED TO FAILURE.

PULLED LOOSE FROM DECK AT RIVETED CONNECTION.
PHOTOS. - VOL. 3, PAGES 422-424

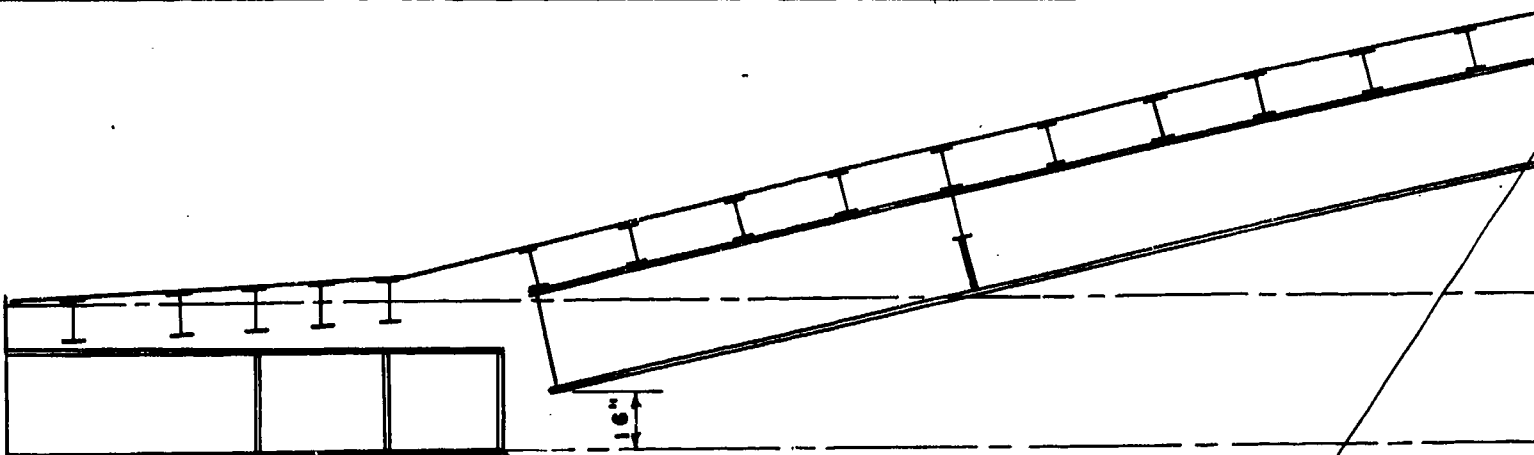
PLATE NO. 15

FRACTURE ORIGINATED AT UPPER EDGE OF WELD JOINING BRACKET FLANGE TO GIRDER. WELDS TOO SMALL TO DEVELOP 100% JOINT EFFICIENCY.
PHOTOS. - VOL. 3, PAGES 451-453

FRACTURE ORIGINATED AT UPPER EDGE OF WELD BETWEEN GIRDER AND LONGITUDINAL BRACKET.
PHOTOS. - VOL. 3, PAGES 451-453

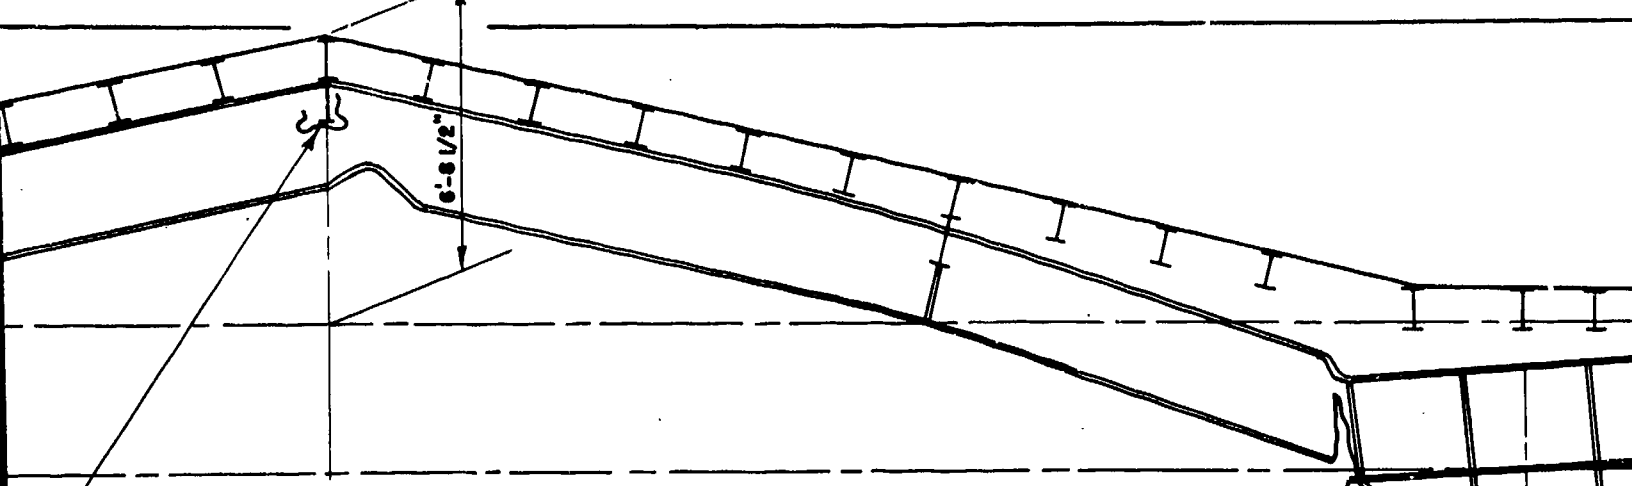
FRACTURE ORIGINATED AT FORWARD END OF WELD BETWEEN TRIPPING BRACKET AND LONGITUDINAL BRACKET.
 PHOTOS.— VOL. 3, PAGES 448—450

FRACTURE ORIGINATED AT UPPER EDGE OF WELD JOINING BRACKET FLANGE TO GIRDER. STRUCTURAL DISCONTINUITY IN DESIGN OF CONNECTION CONTRIBUTED TO FAILURE.
 PHOTOS.— VOL. 3, PAGES 445—447

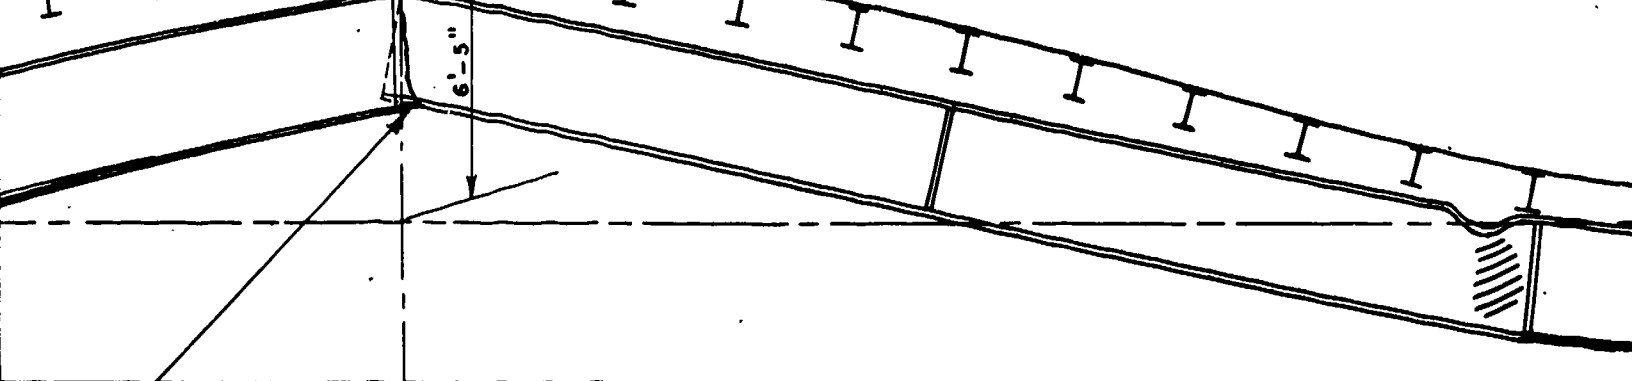
FRACTURE ORIGINATED IN BUTT WELD IN
 LOWER FLANGE OF GIRDER.
 PHOTOS.- VOL. 3, PAGES 475-483

FRACTURE ORIGINATED IN WELD JOINING
 BRACKET FLANGE TO TRANSVERSE GIRDER.
 WELDS TOO SMALL TO DEVELOP 100%
 JOINT EFFICIENCY.
 PHOTOS.- VOL. 3, PAGES 473, 474

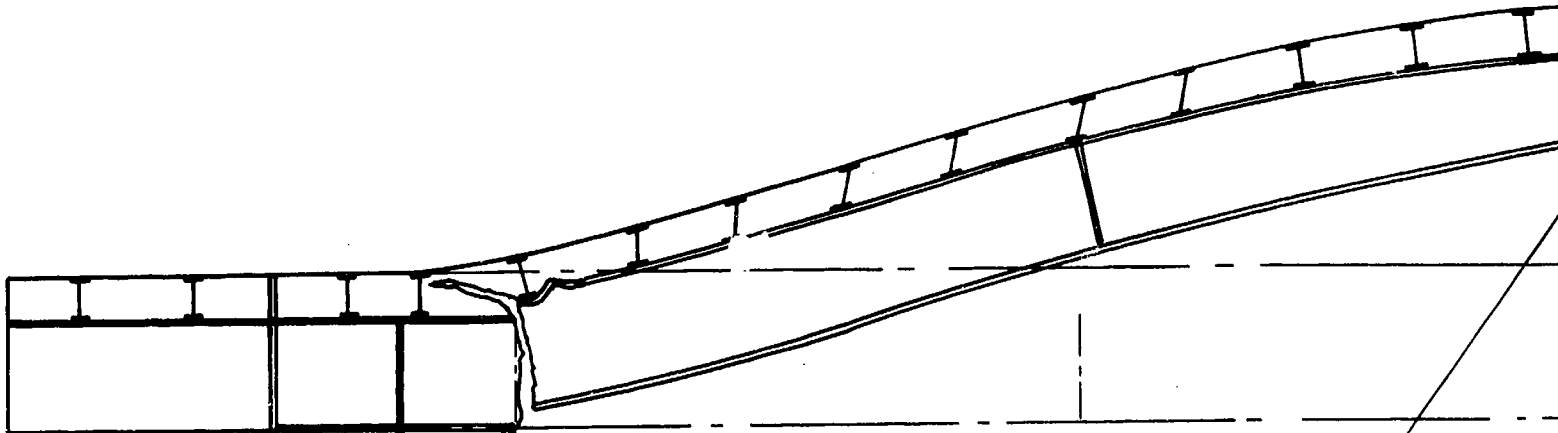
PLATE NO. 18

FRACTURE ORIGINATED AT UPPER EDGE OF WELD JOINING BRACKET FLANGE TO GIRDER. STRUCTURAL DISCONTINUITY IN DESIGN OF CONNECTION CONTRIBUTED TO FAILURE.

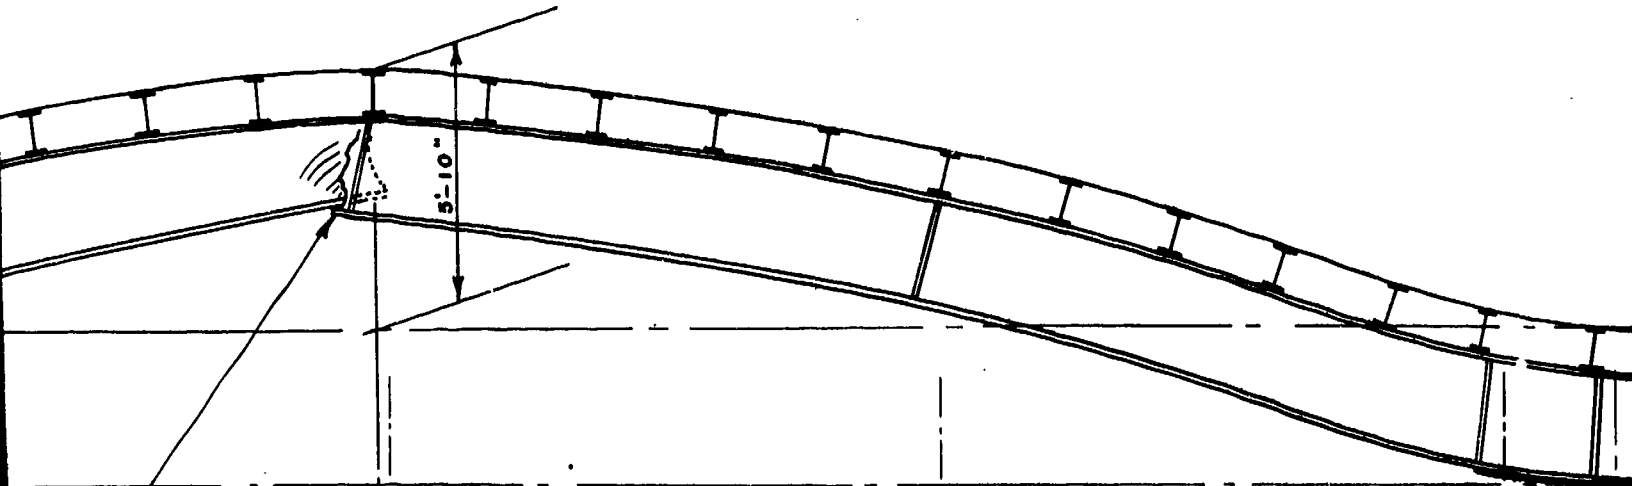
FRACTURE ORIGINATED AT BUTT WELD
 IN LOWER FLANGE OF GIRDER.
 PHOTOS.— VOL. 3, PAGES 492-495

FRACTURE ORIGINATED IN WELD JOINING
 BRACKET FLANGE AND GIRDER.
 WELDS TOO SMALL TO DEVELOP 100%
 JOINT EFFICIENCY.
 PHOTOS.— VOL. 3, PAGES 489-491

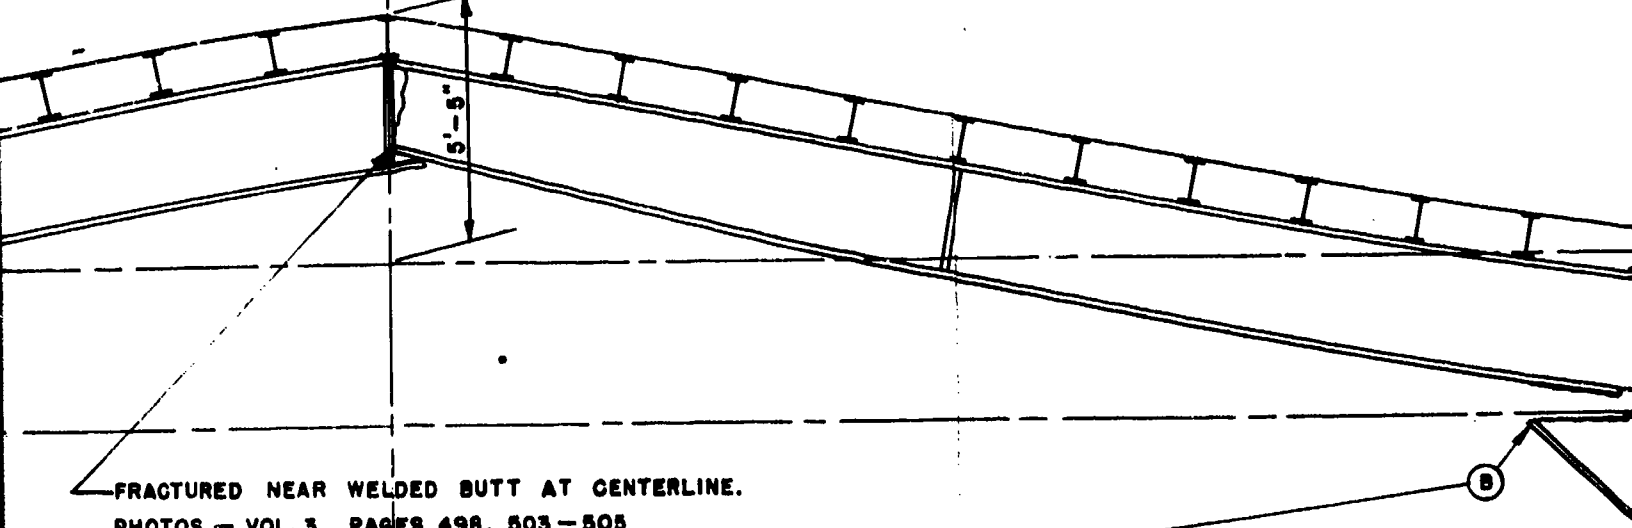
FRACTURED NEAR WELDED BUTT AT CENTERLINE.
 PHOTOS.— VOL. 3 , PAGES 498, 503—505

FRACTURE ORIGINATED IN WELDS JOINING
 BRACKET FLANGE TO GIRDER IN THE CASE
 OF BOTH STBD. (A) AND PORT (B)
 CONNECTIONS. WELDS TOO SMALL TO
 DEVELOP 100% JOINT EFFICIENCY.
 PHOTOS.— VOL. 3 , PAGES (A) 506,507

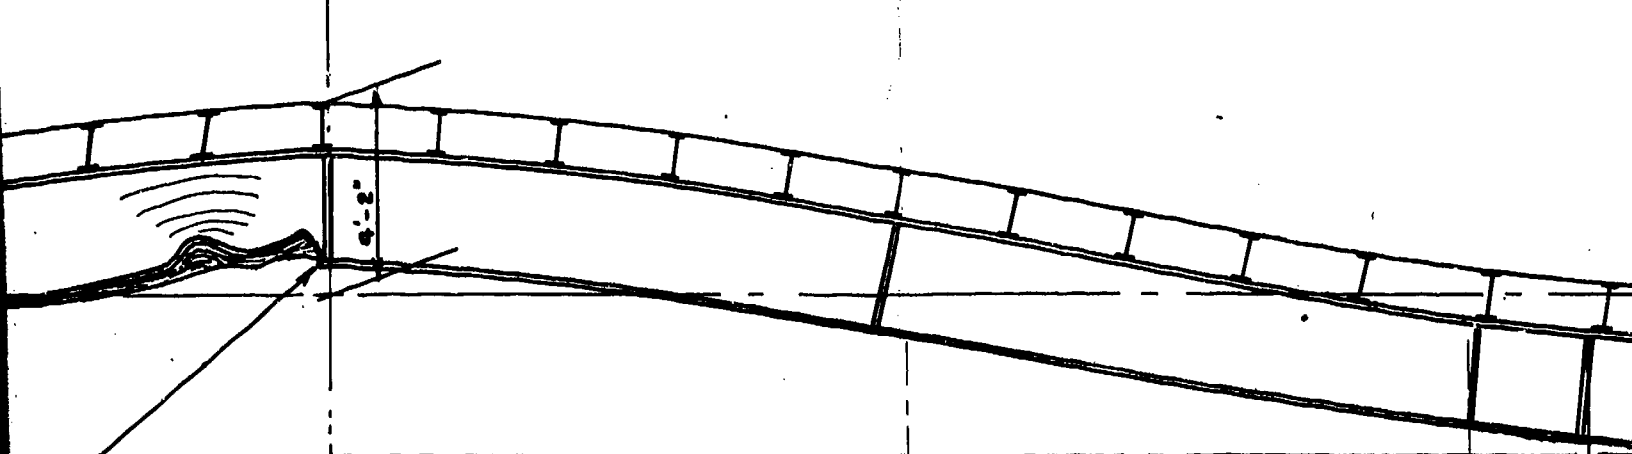
FRACTURE ORIGINATED IN FORWARD END OF BUTT WELD IN LOWER FLANGE OF GIRDER. INCOMPLETE WELD PENETRATION CONTRIBUTED TO FAILURE.

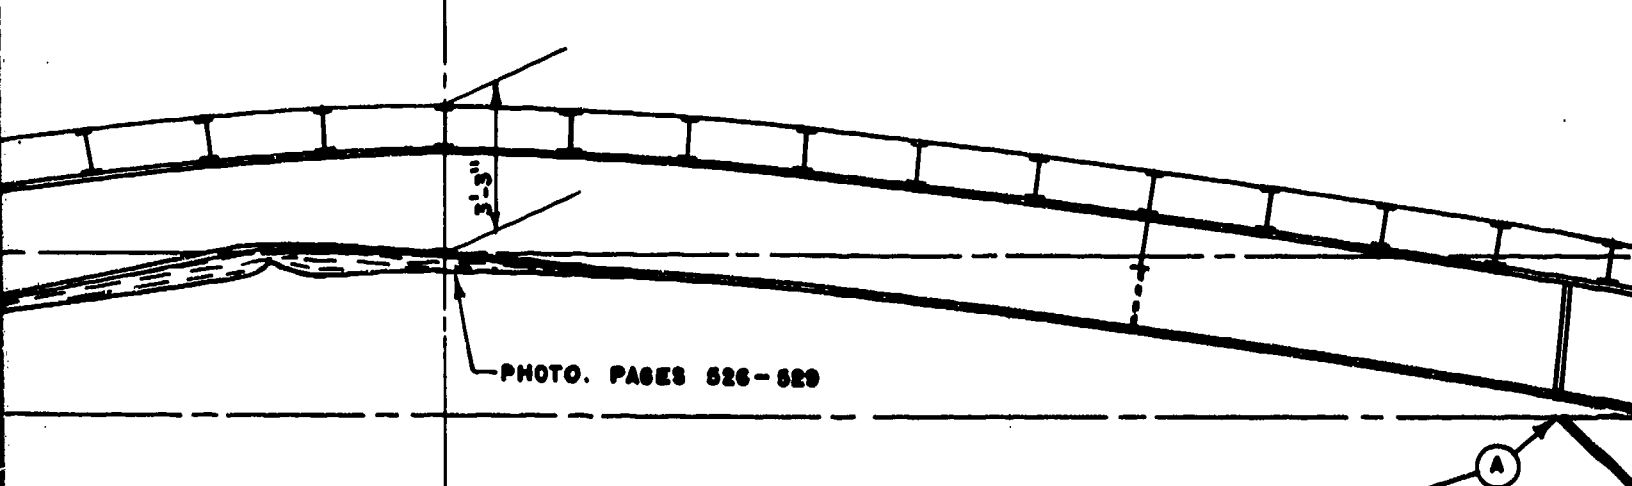
FRACTURE ORIGINATED IN WELDS JOINING
 BRACKET FLANGE AND GIRDER IN BOTH
 PORT (A) AND STARBOARD (B) CONNECTIONS.
 WELDS TOO SMALL TO DEVELOP 100 %
 JOINT EFFICIENCY.
 PHOTOS.- VOL. 4, PAGES
 (A) 520, 524, 525 (B) 523, 530

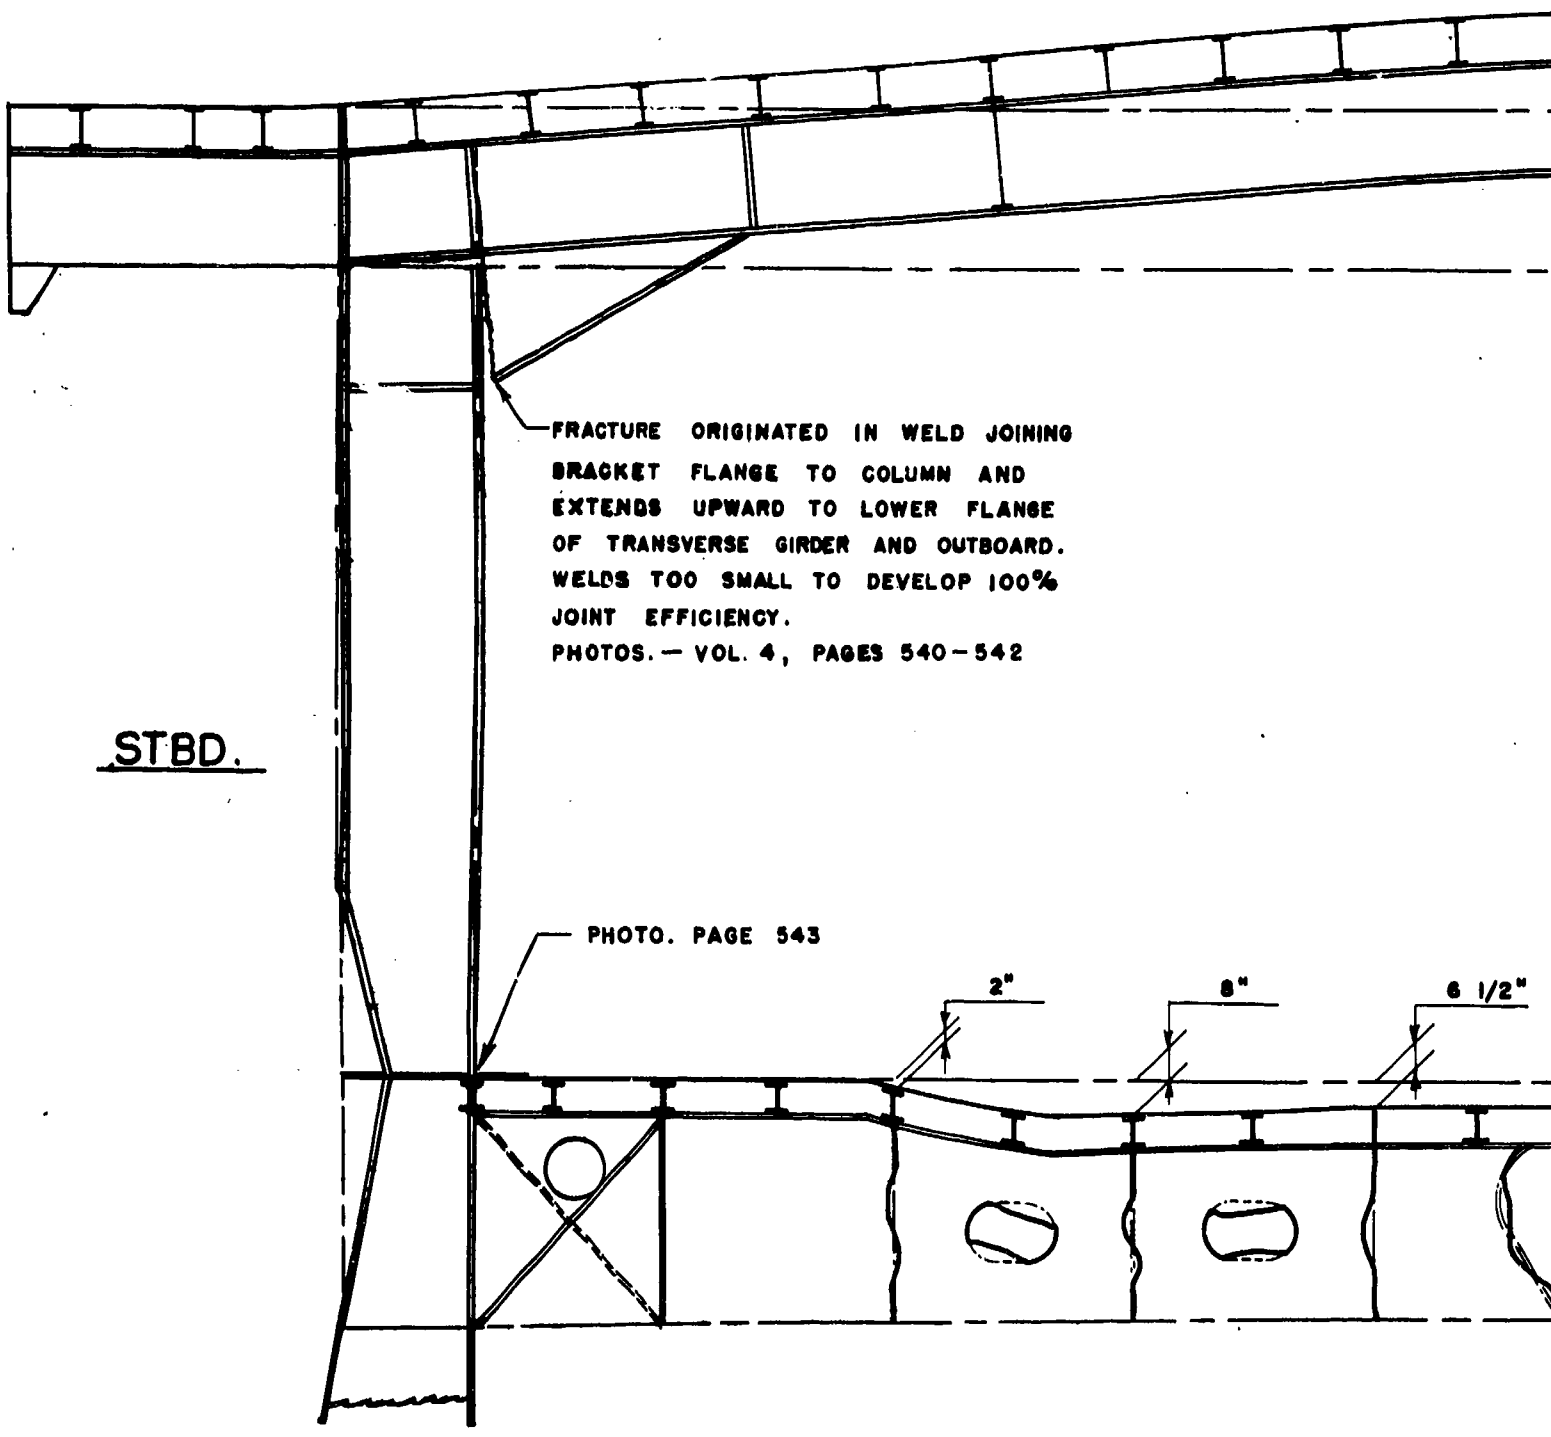
PLATE NO. 22

FRACTURE ORIGINATED IN WELD JOINING
BRACKET FLANGE TO COLUMN AND
EXTENDS UPWARD TO LOWER FLANGE
OF TRANSVERSE GIRDER AND OUTBOARD.
WELDS TOO SMALL TO DEVELOP 100%
JOINT EFFICIENCY.
PHOTOS. — VOL. 4, PAGES 540-542

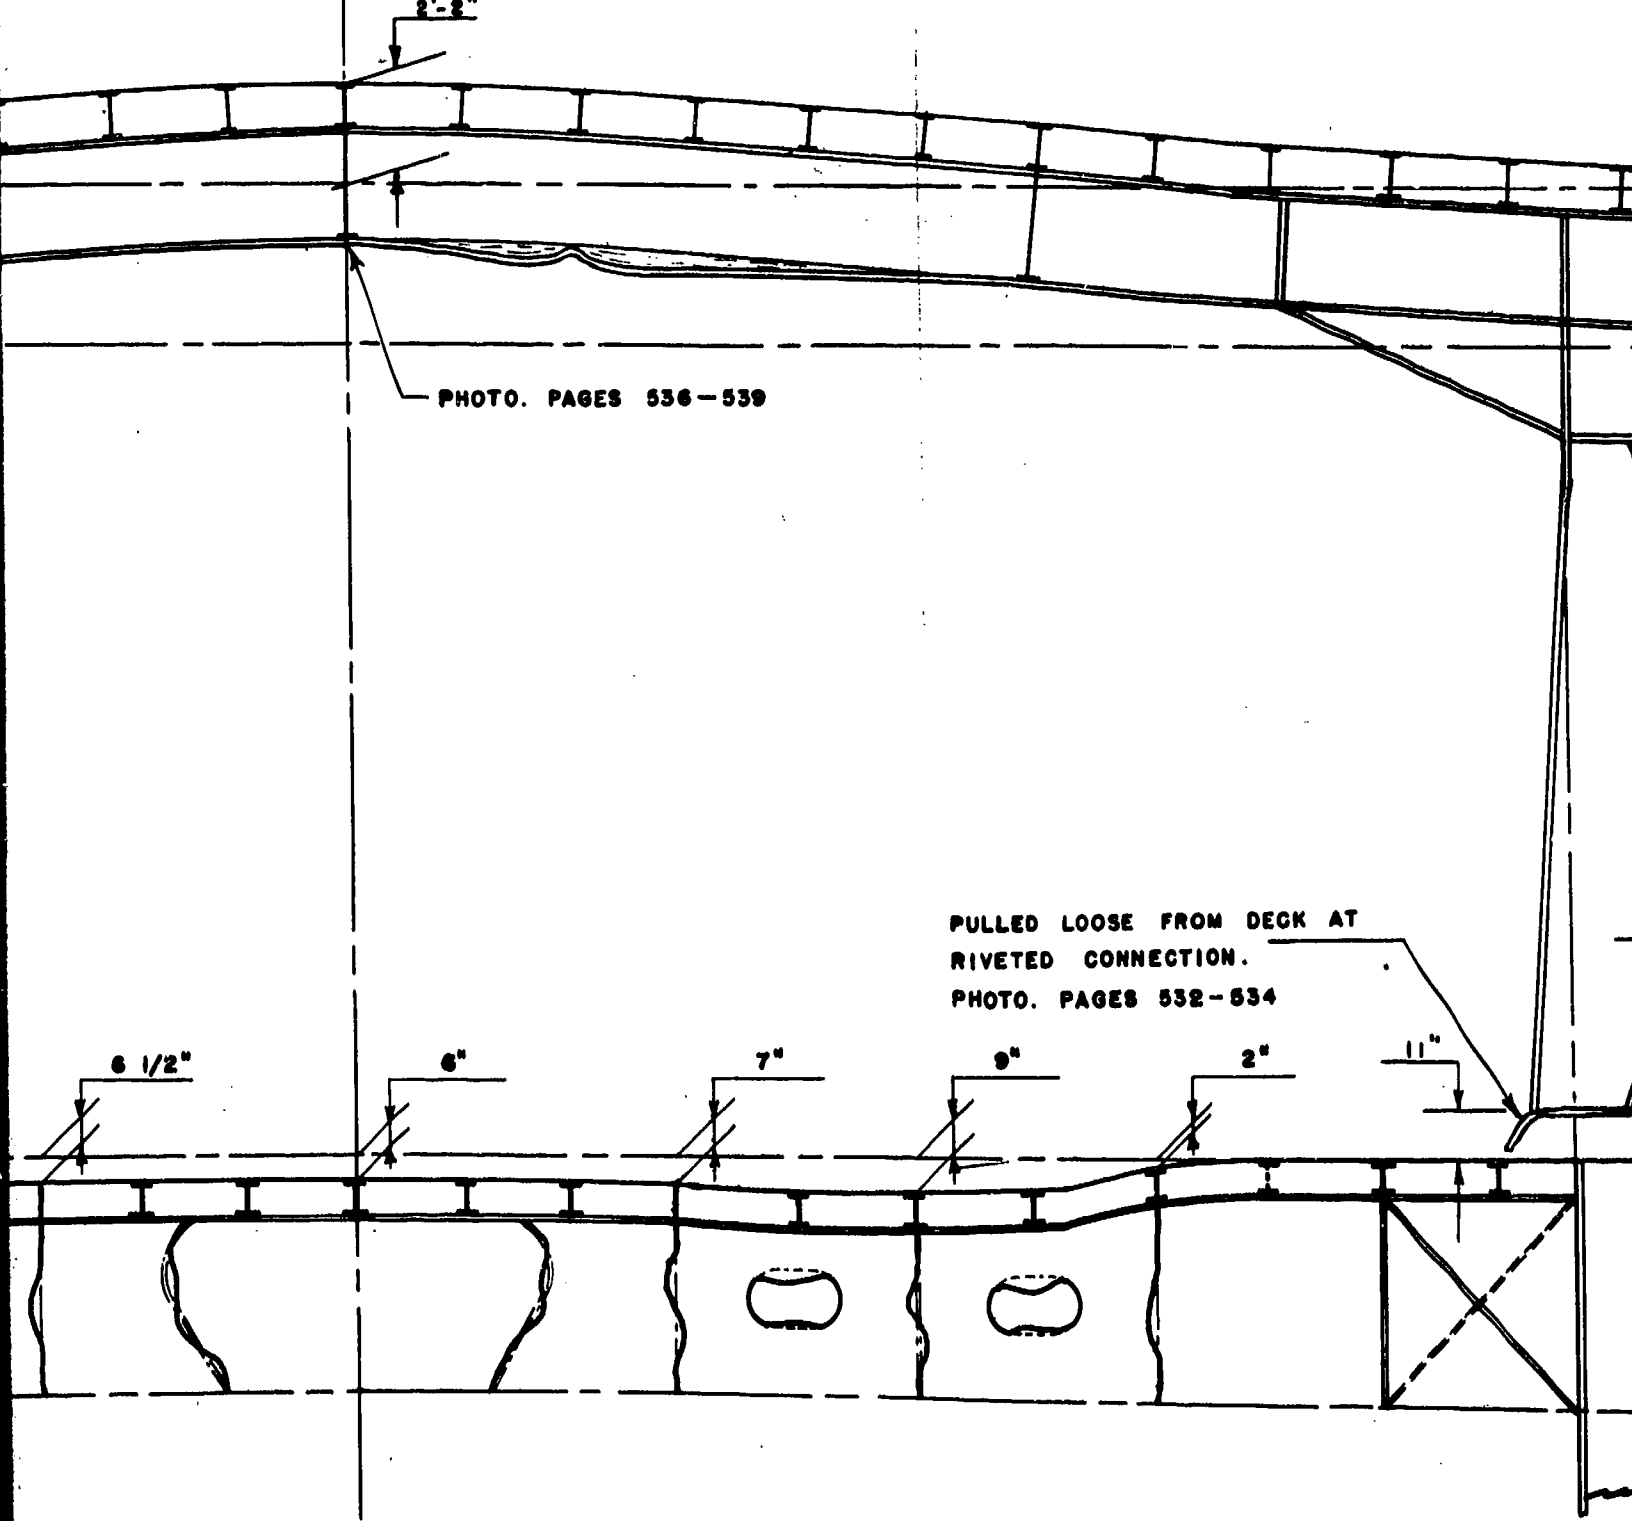
PULLED LOOSE FROM DECK AT
RIVETED CONNECTION.
PHOTO. PAGES 532-534

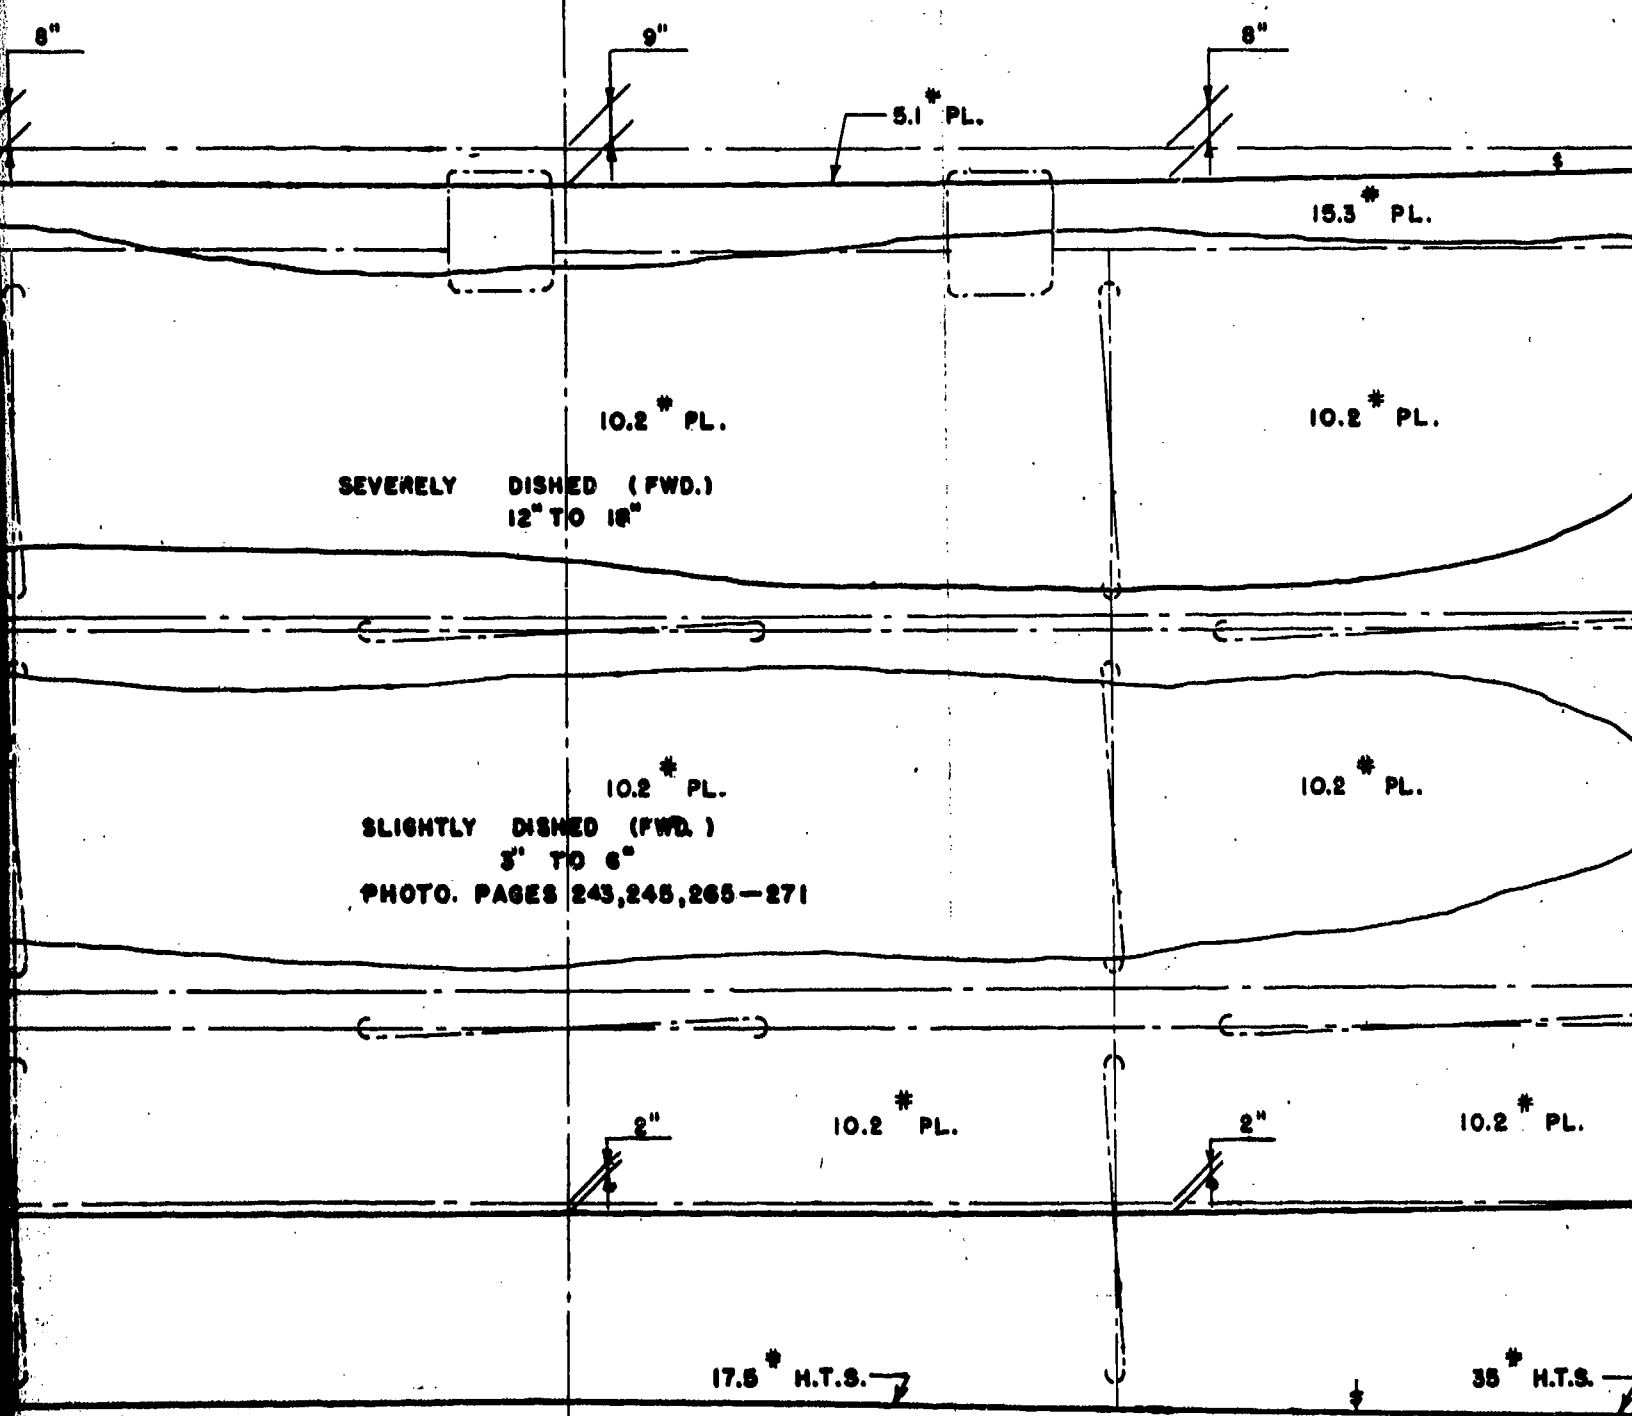
SEVERELY DISHED (FWD.)
12" TO 18"

SLIGHTLY DISHED (FWD.)
3" TO 6"
PHOTO. PAGES 243, 245, 265-271
