DIRECTOR OF SHIP MATERIAL

JOINT TASK FORCE ONE

FINAL REPORT

FOR TESTS ABLE AND BAKER

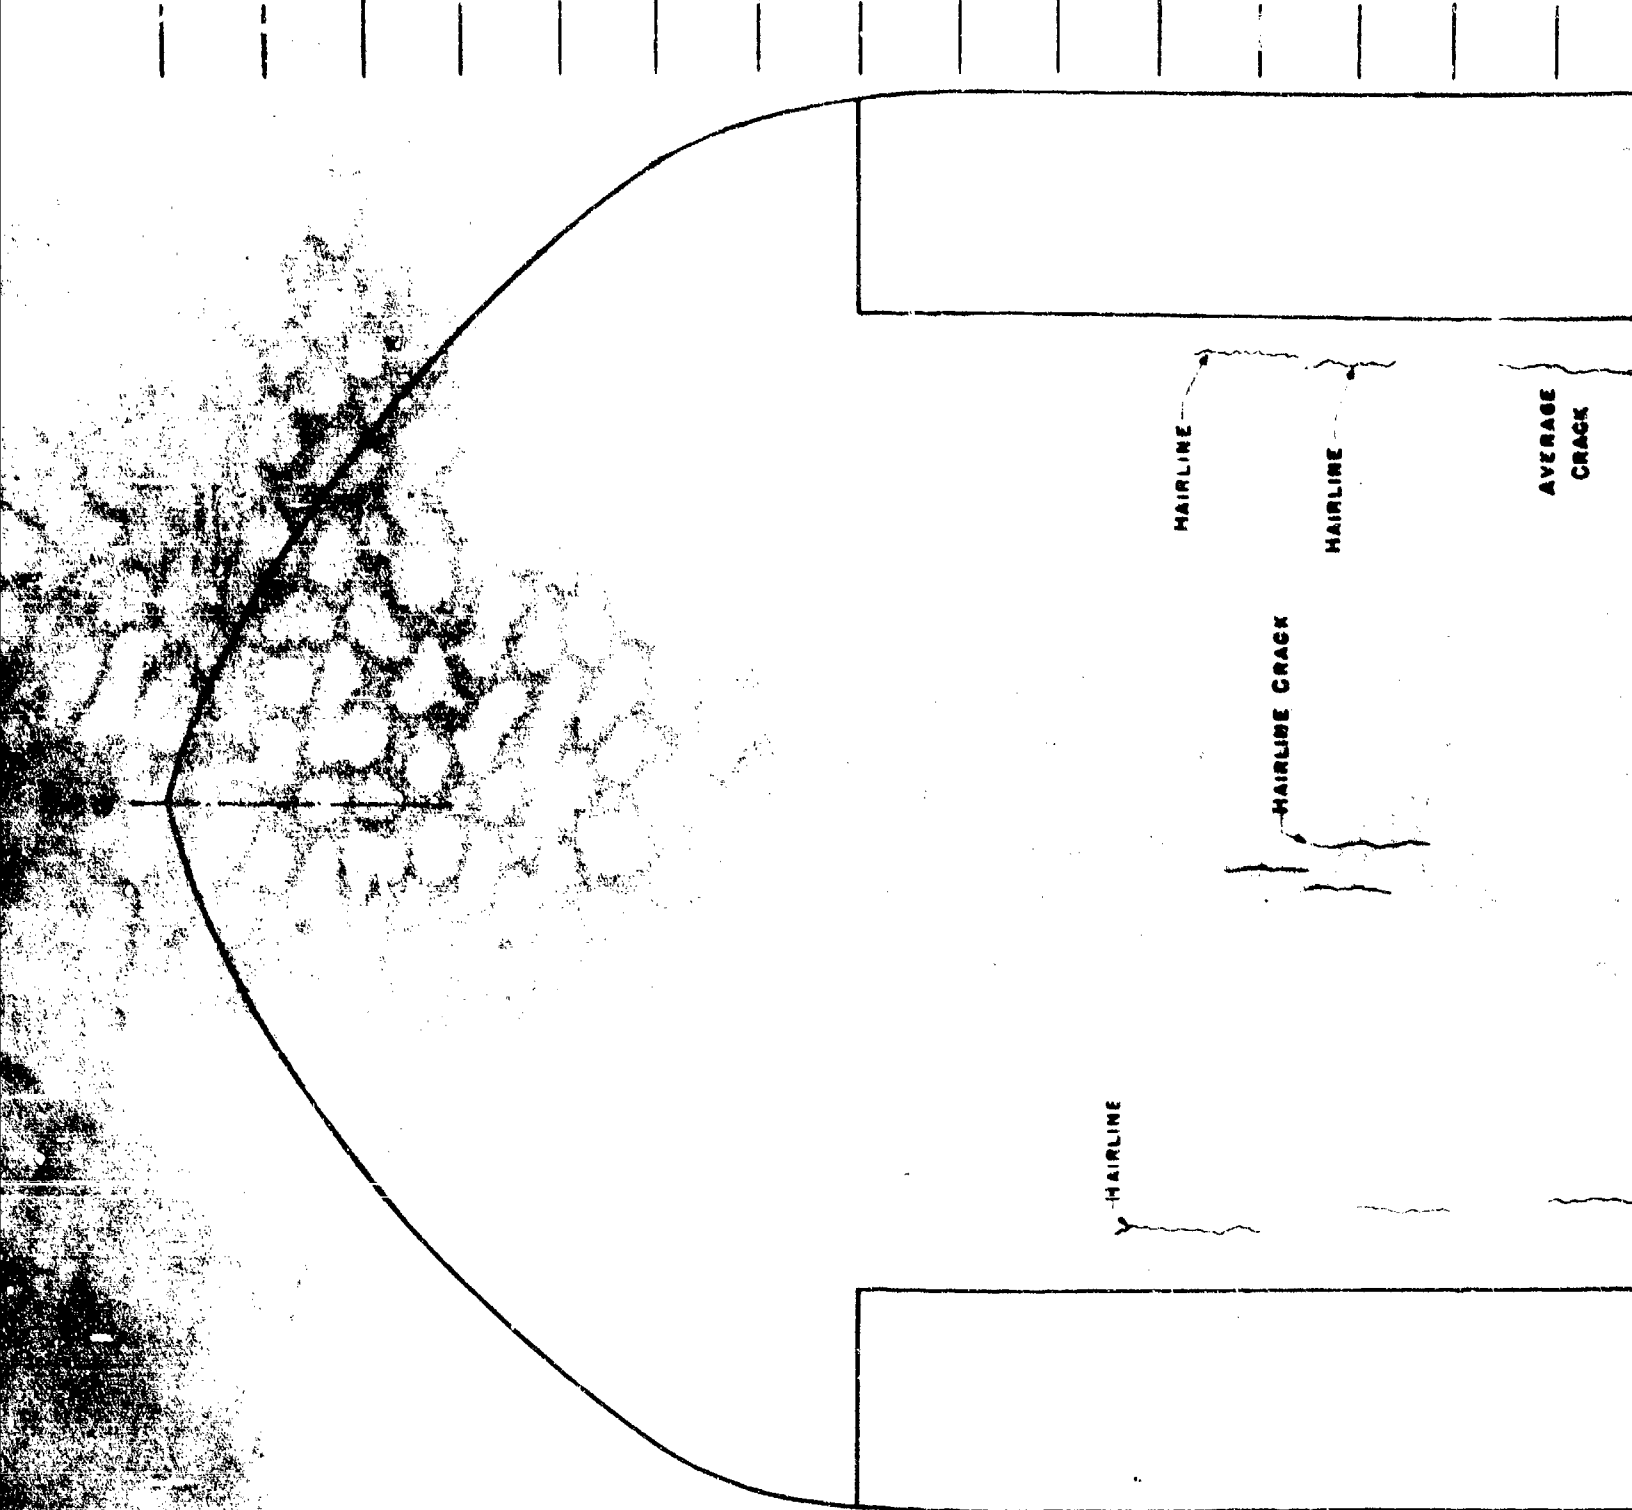
**ARDC - 13**  
**CRACK SURVEY AFTER TEST ABLE**

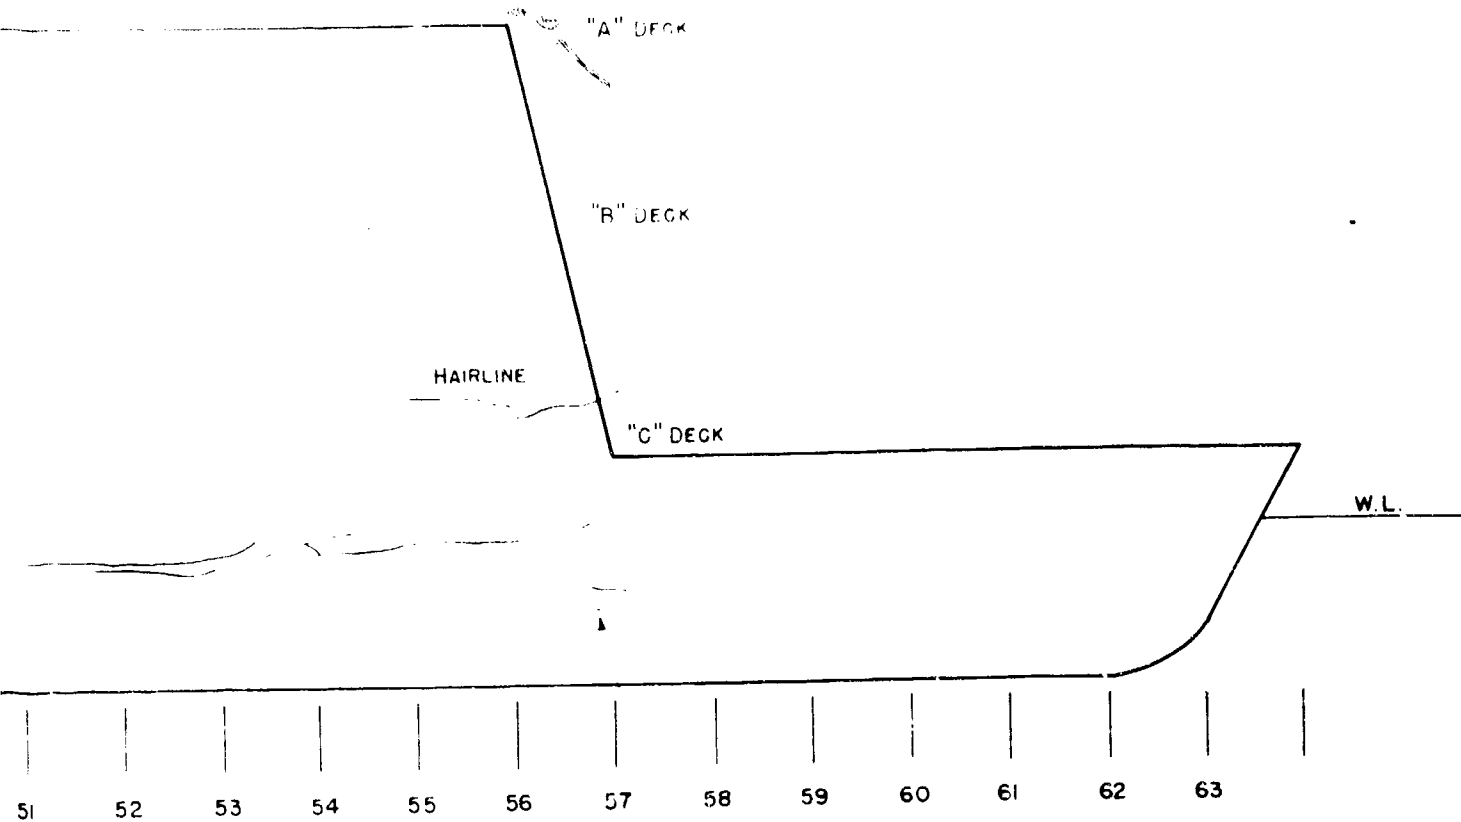
OUTSIDE FACE PORT WALL

SPALLING NOTED ON INSIDE OF DECK APPROX. 7' BELOW WATER LINE

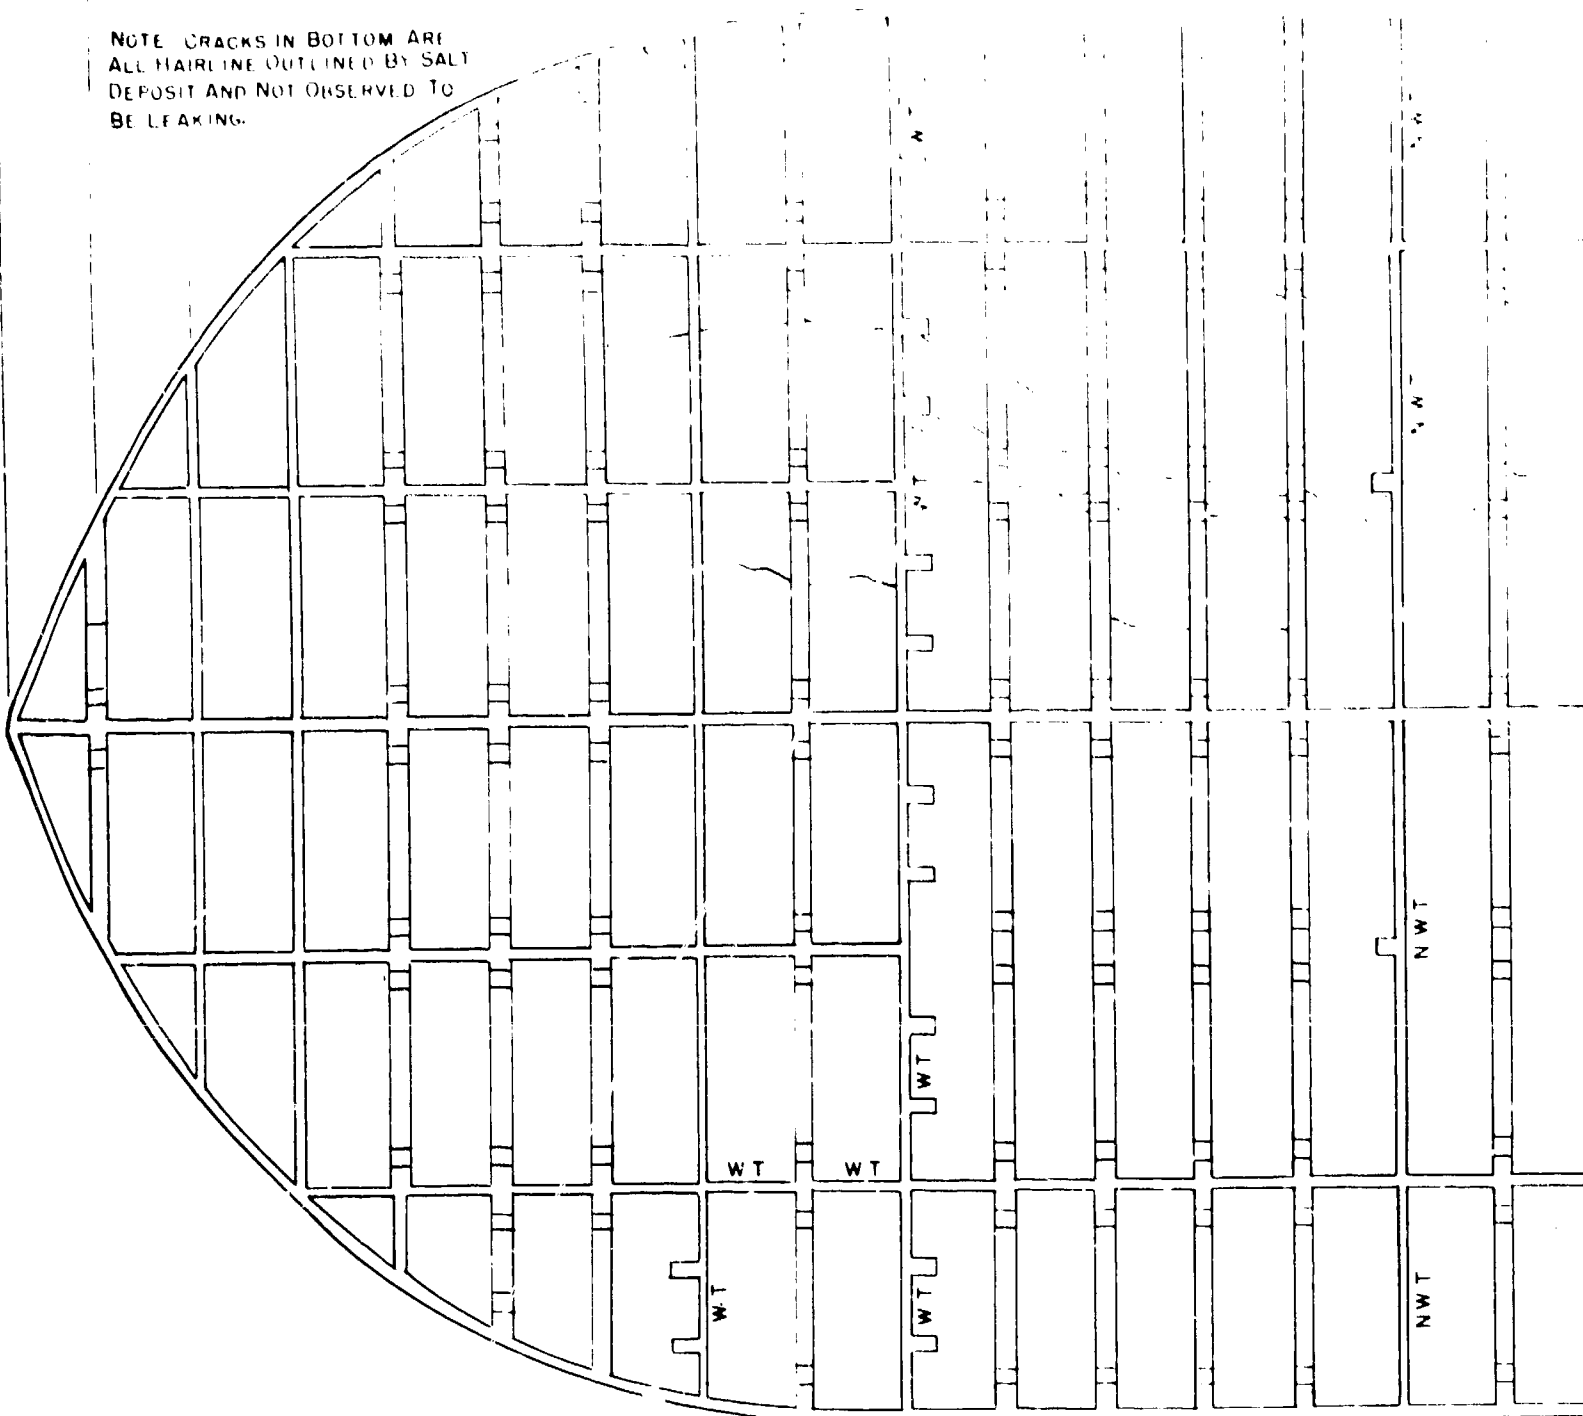
NOTE CRACKS IN BOTTOM ARE  
ALL HAIRLINE OUTLINED BY SALT  
DEPOSIT AND NOT OBSERVED TO  
BE LEAKING.

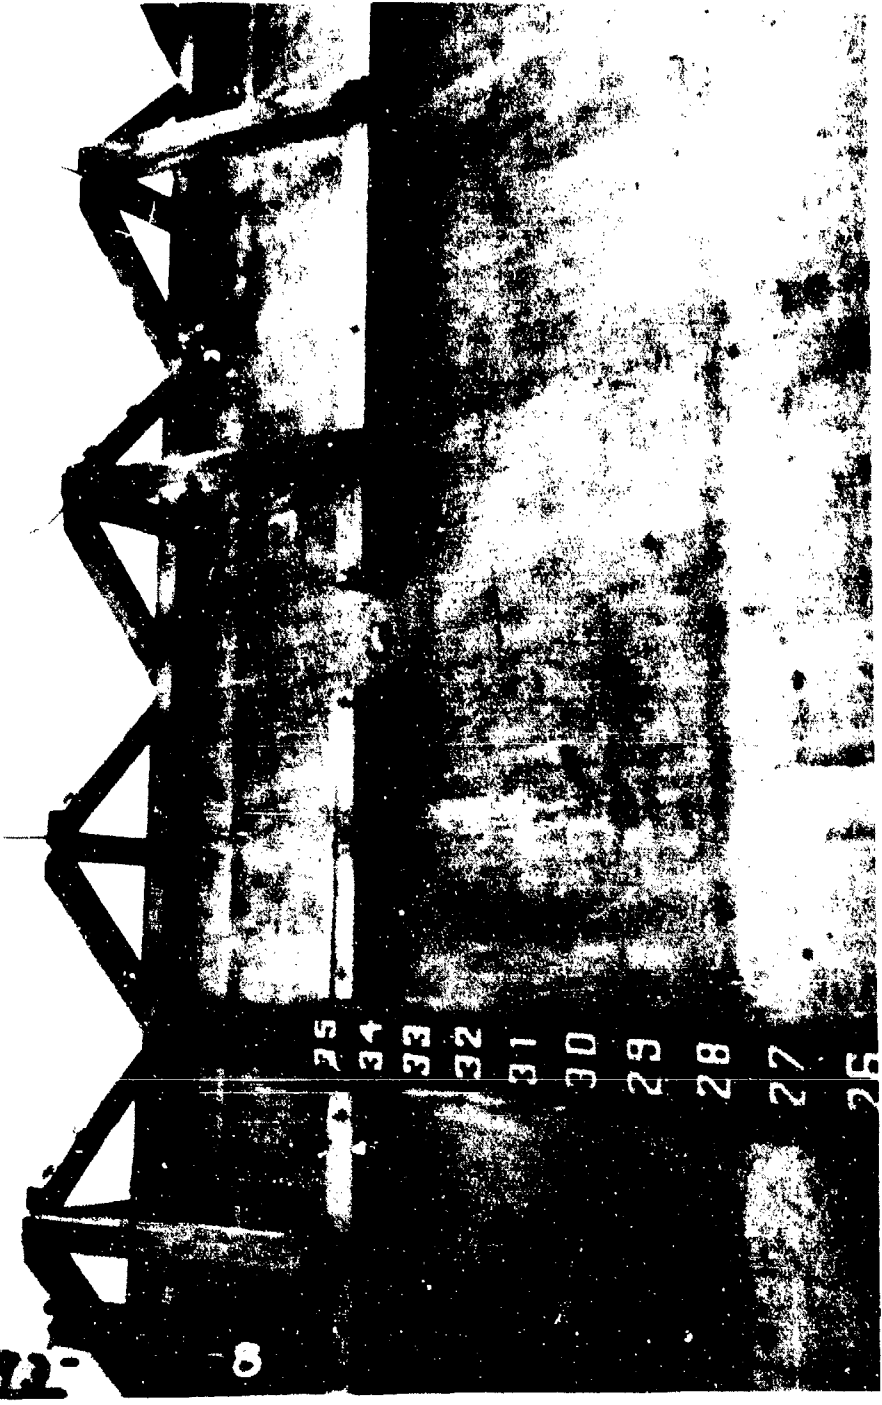
Crack - Inboard Face - Port Wing Wall - Frame 20 - 42 - 2' From Top

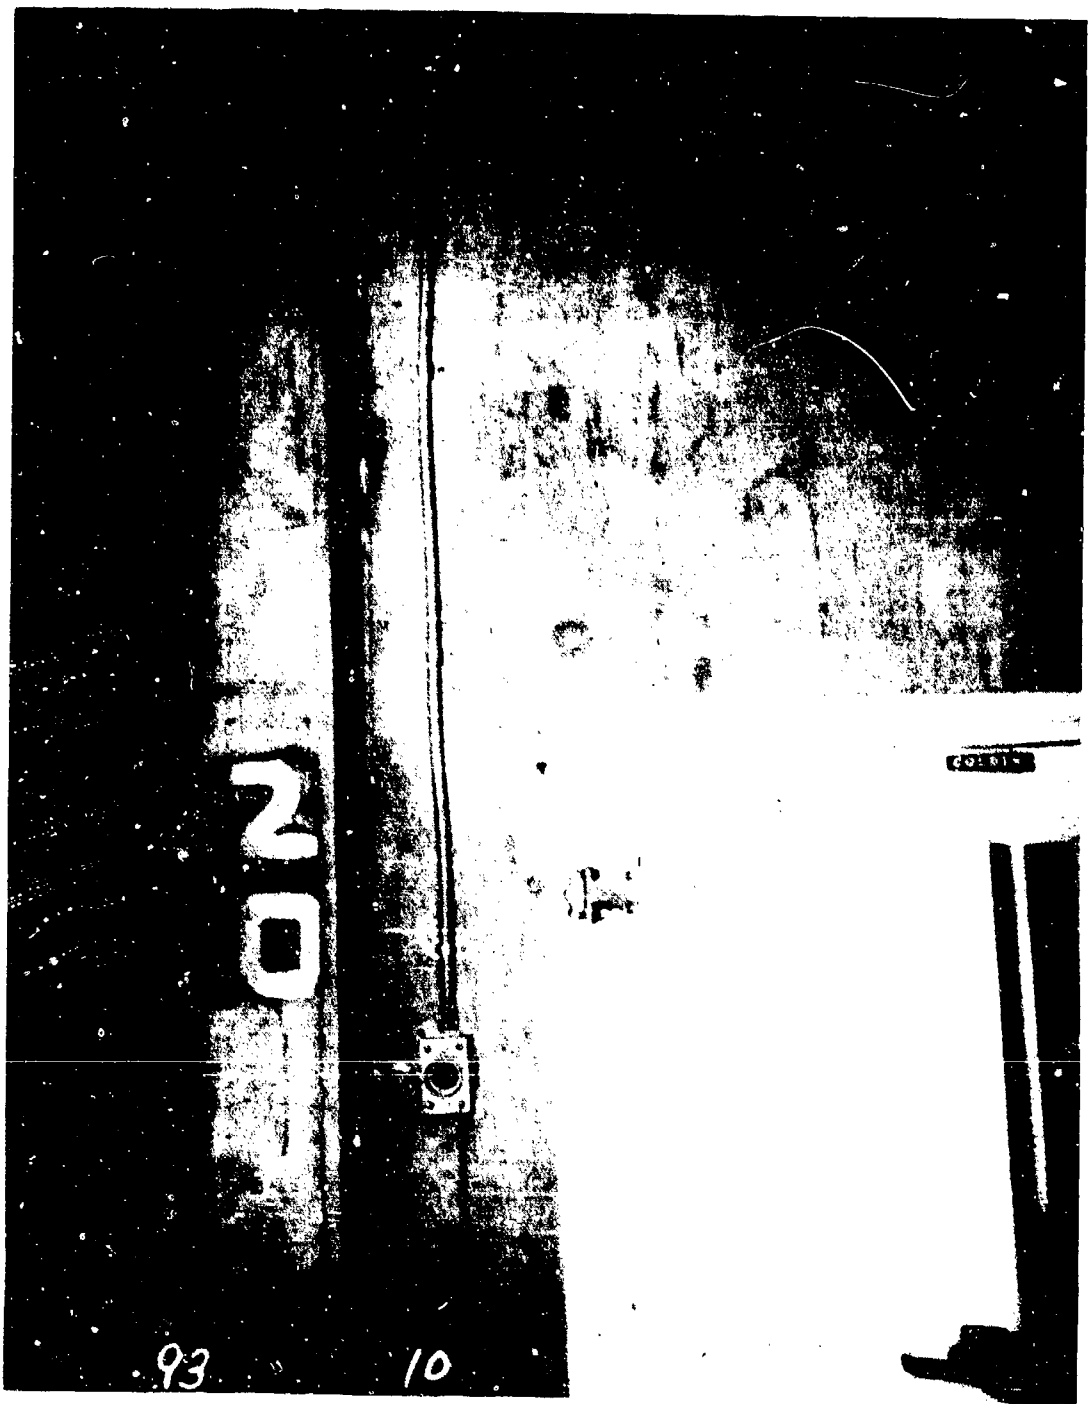
C  
Crack - "B" Level - Port Wing Wall - Frame 20 -  
Outboard Wall - Inside Face

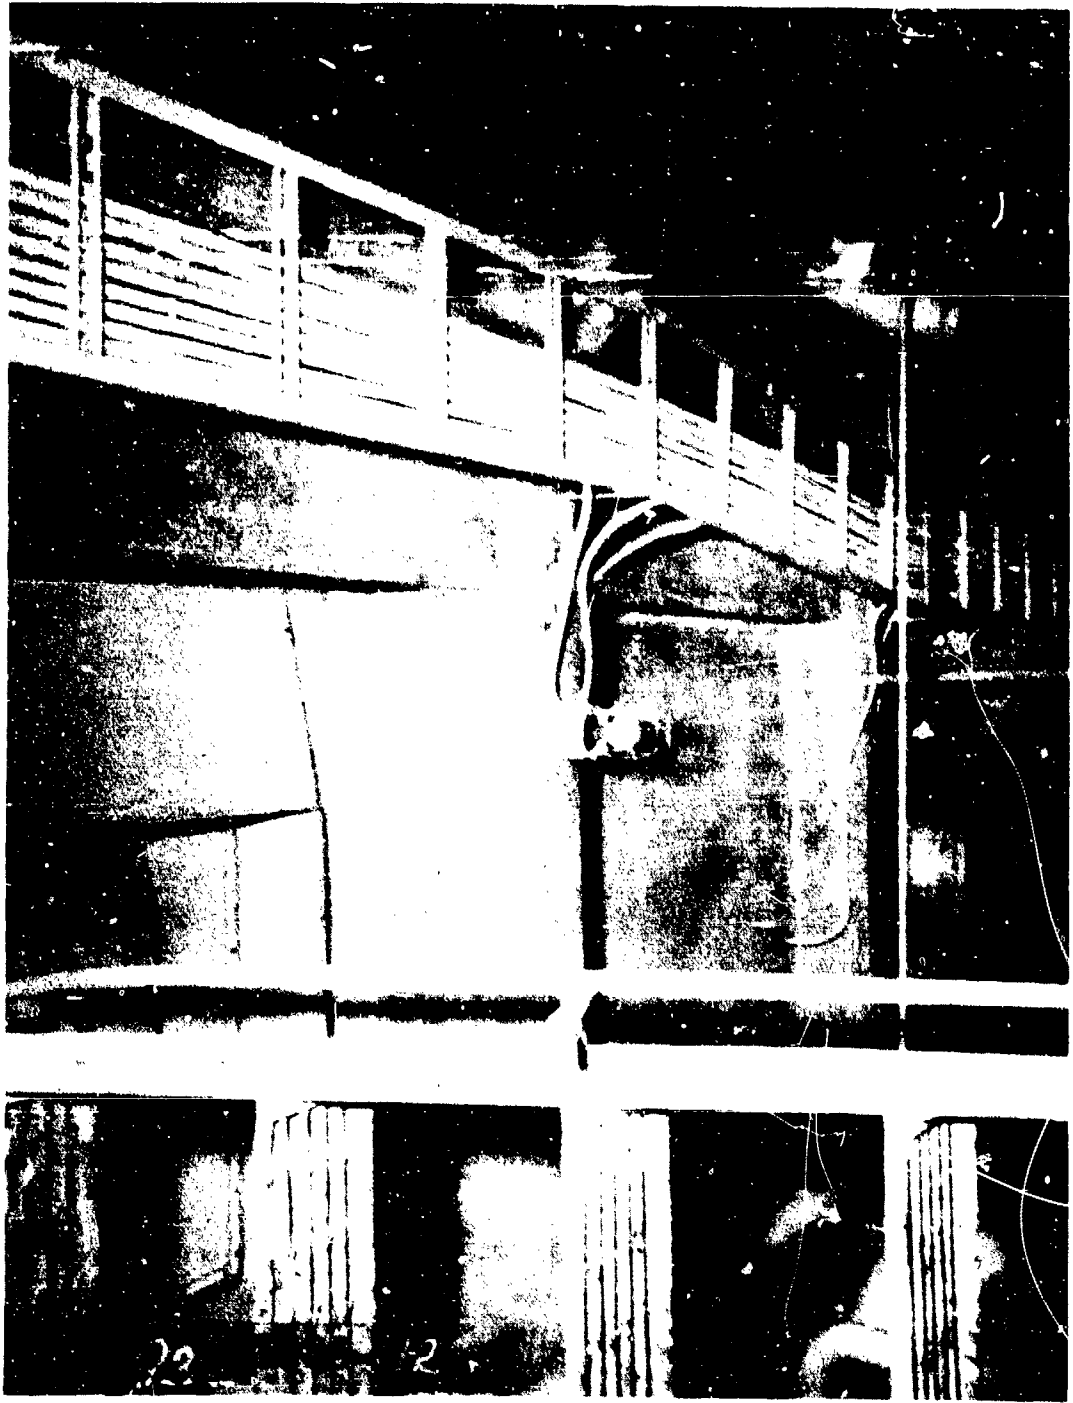
Crack - "B" Level - Port Wing Wall - Frame 24 - Top
