MSC-02680

APOLLO 13 MISSION REPORT

September 1970

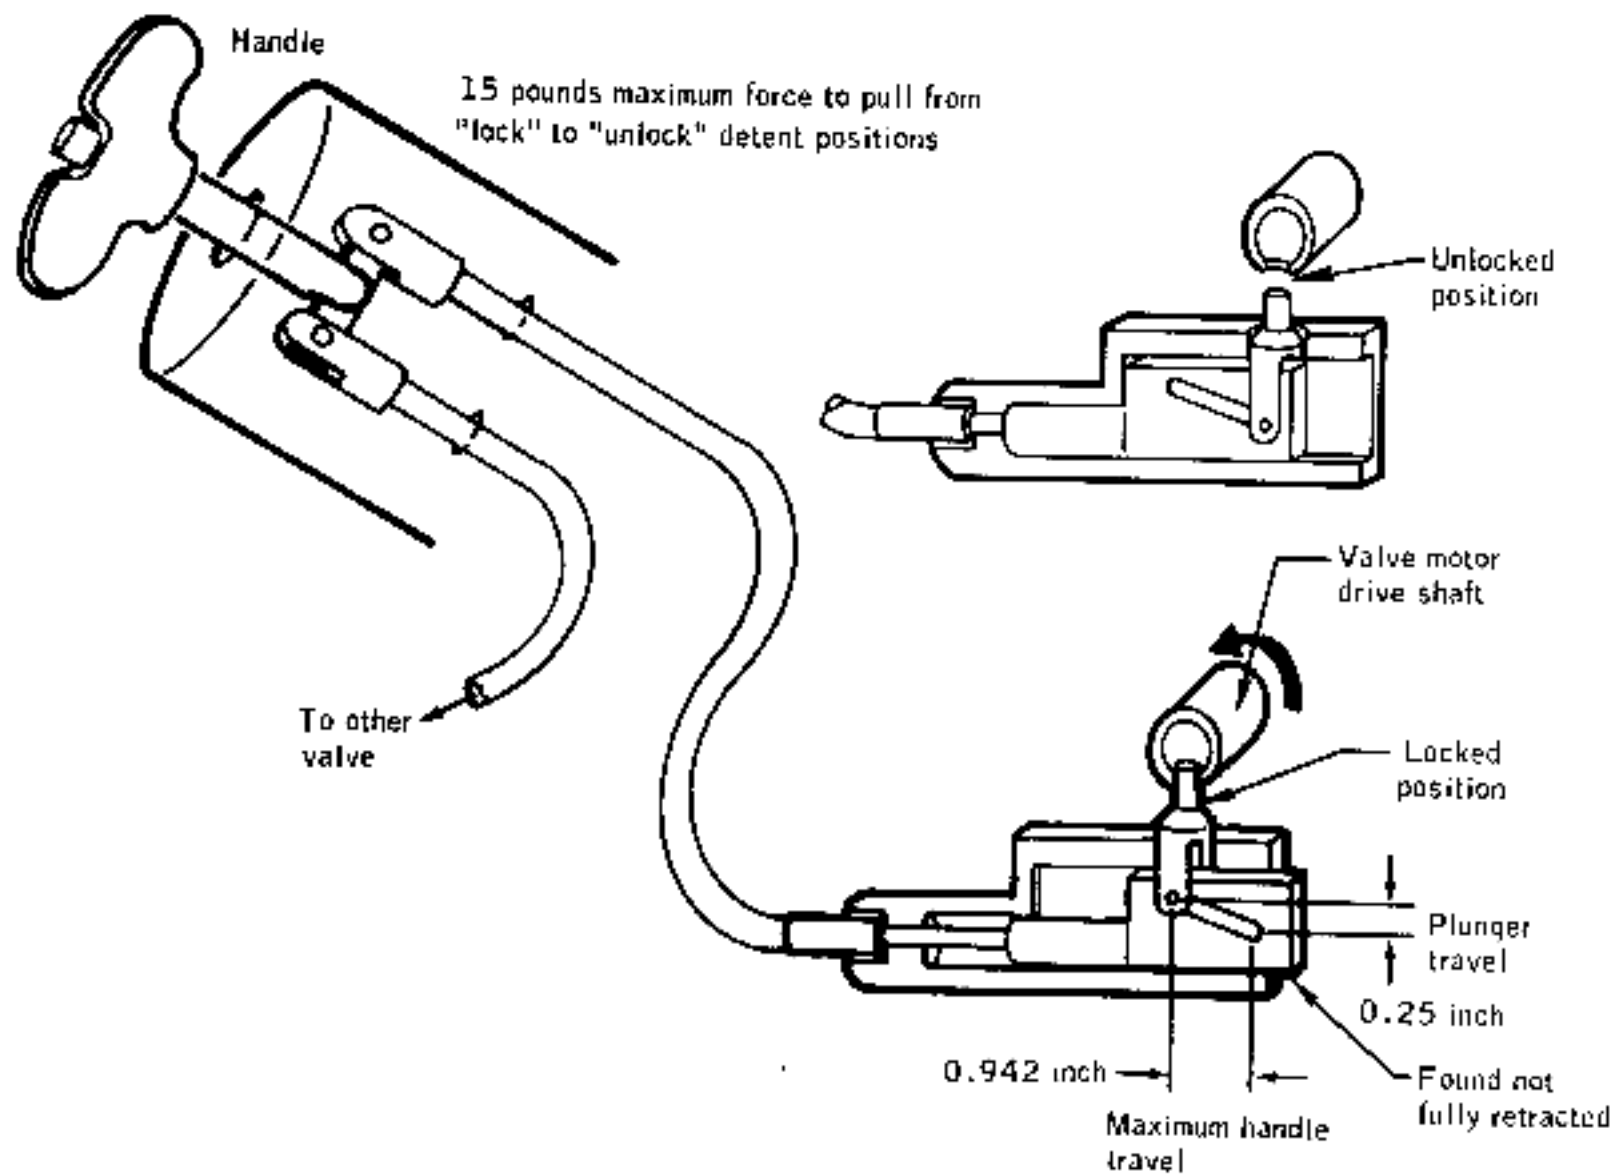
Figure 14-1.- Post-landing vent valve lock.

The valve-lock mechanism rigging tolerances were found to be within specifications. When reassembled in the spacecraft, the malfunction was duplicated with only partial travel of the handle.

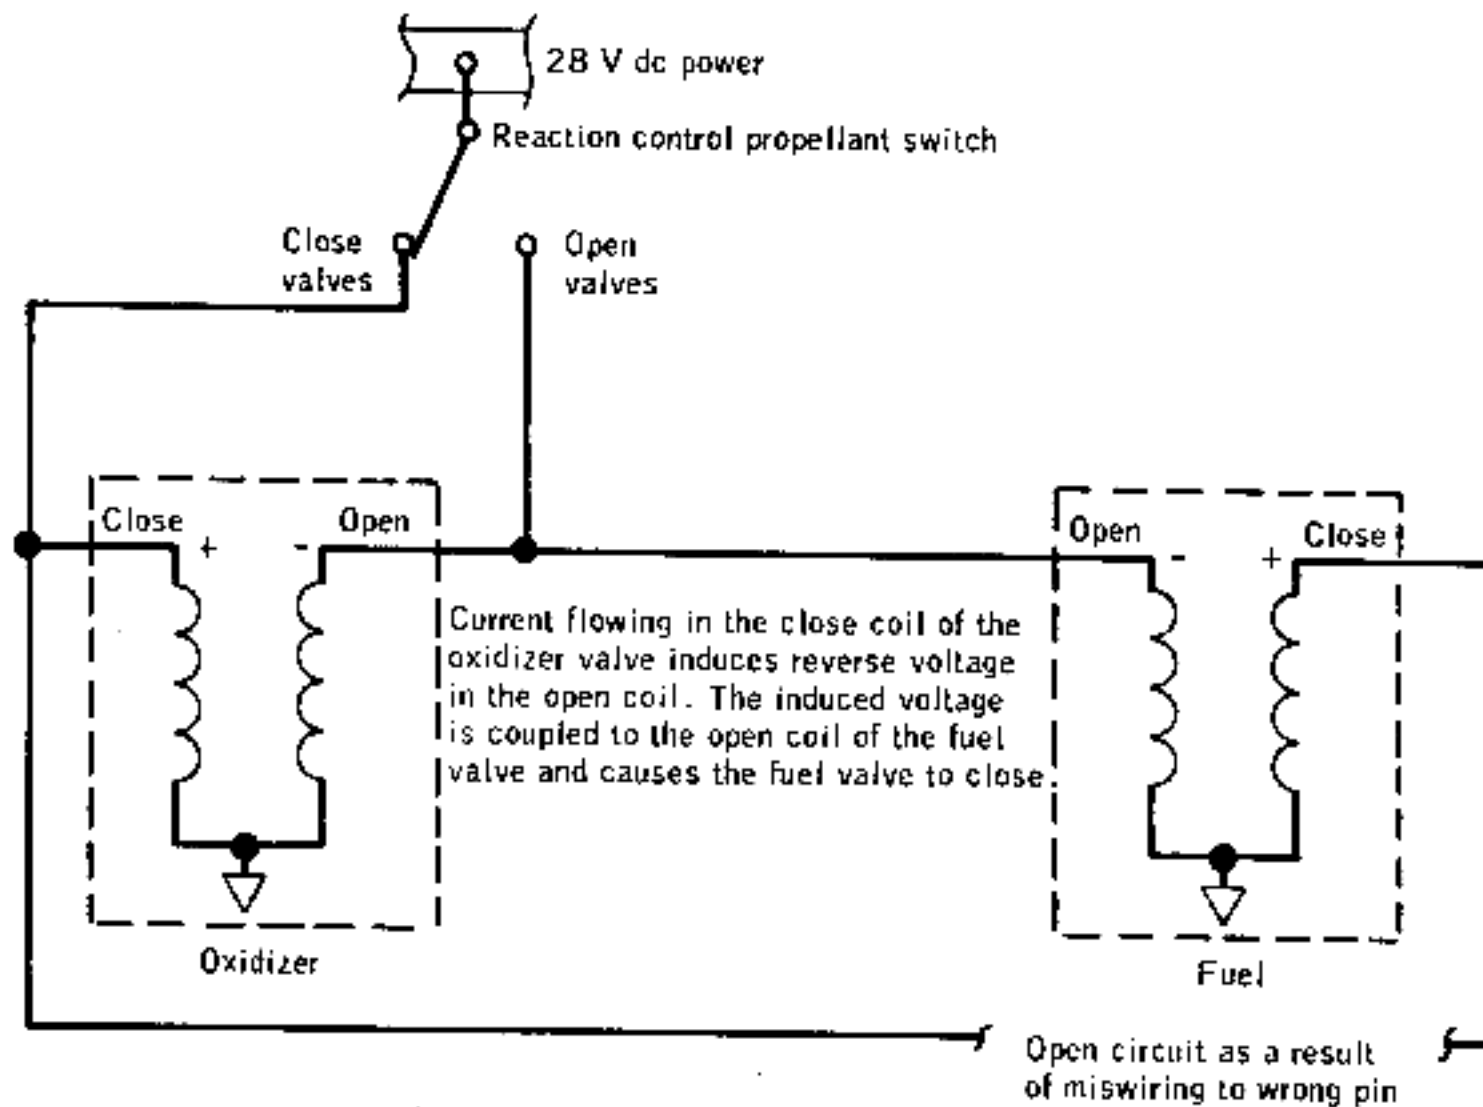
Figure 14-11.- Isolation valve circuit.

action. This voltage is applied to the fuel valve opening coil where it induces a magnetic field flux that closes the fuel valve. With 28 volts or more on the spacecraft bus, this phenomenon was consistently repeatable. With 24 to 28 volts on the bus, the valve would occasionally close, and with less than 24 volts, the valve would not close. Since preflight testing is accomplished at 28 volts, the functional tests did not disclose the miswiring. During the mission, the voltage was such that the valve did not close when commanded and therefore was found open after the flight.

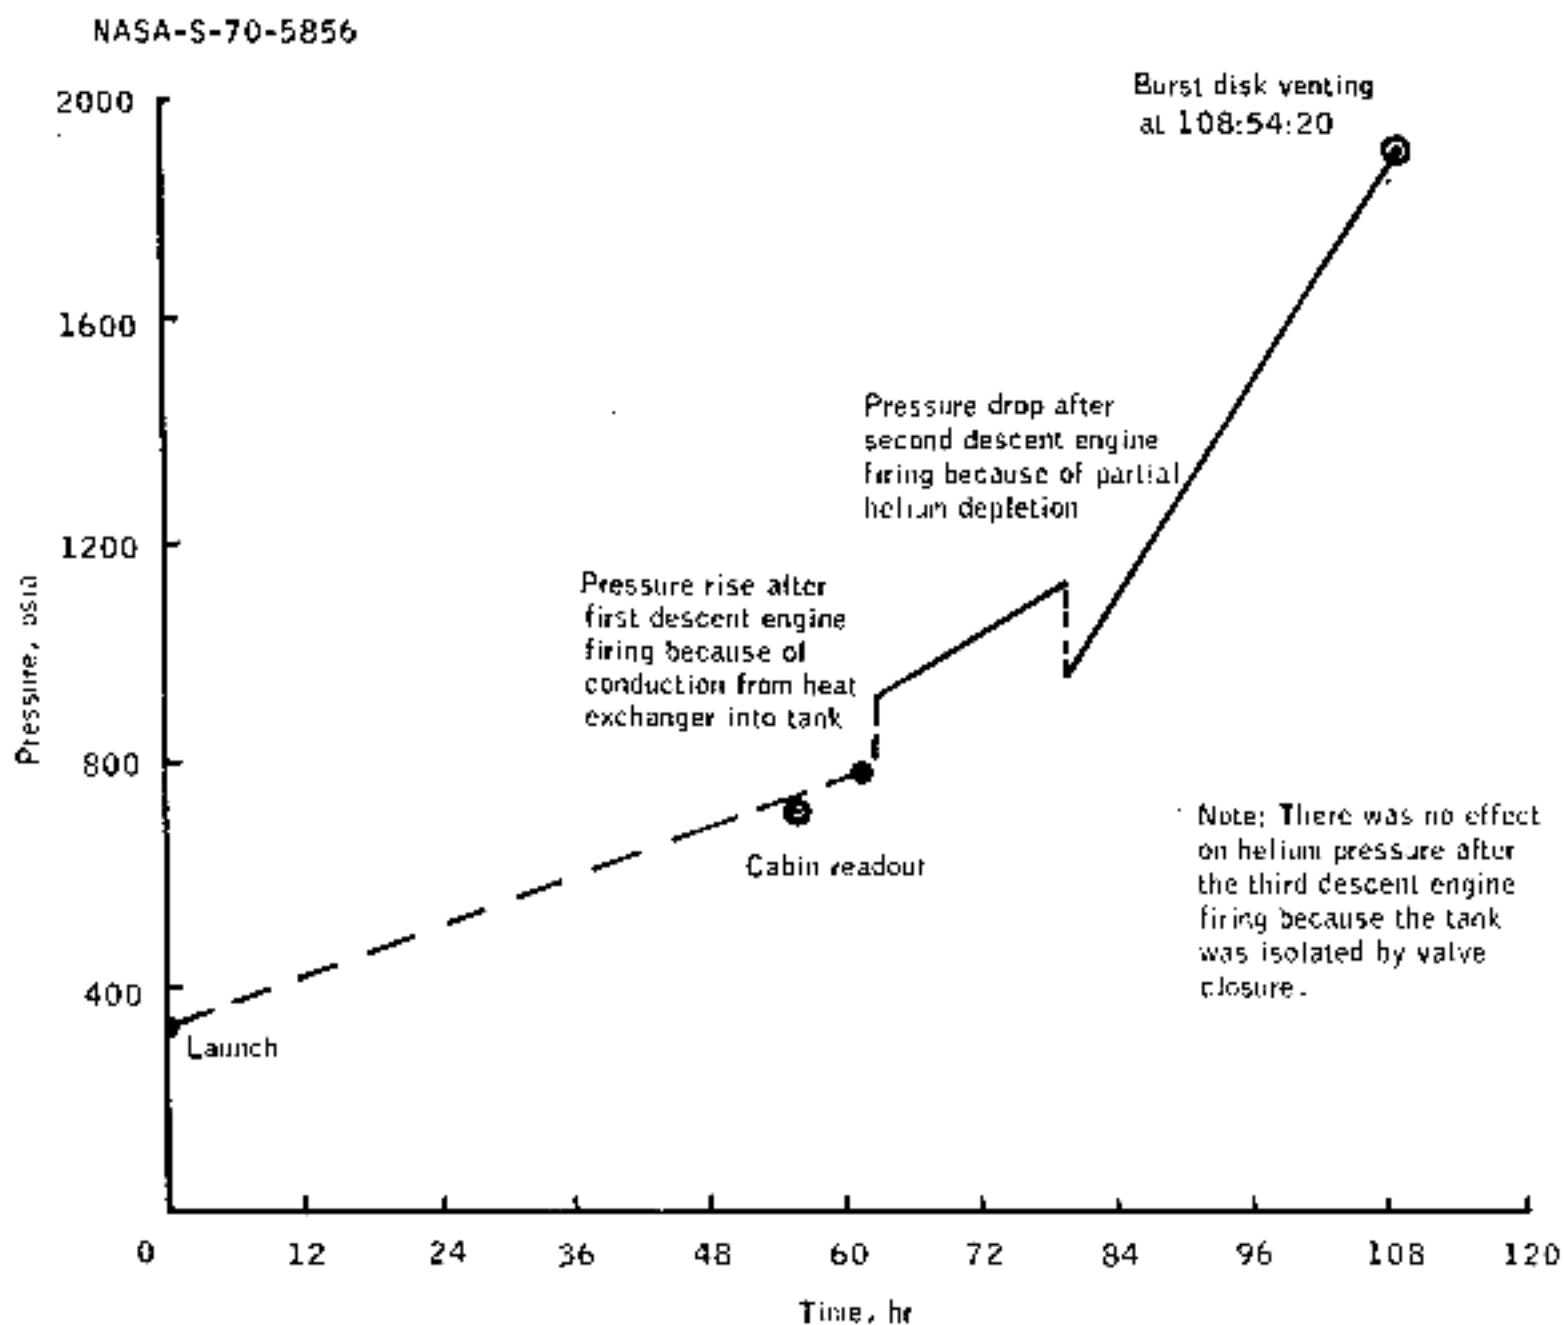
Figure 14-14.- Inflight profile of supercritical helium tank pressure.

The most likely cause of the anomaly is a tank-insulation degradation which would result in increased heat conduction to the helium. The insulating characteristics of the annular vacuum in tank was most likely degraded by the introduction of a contaminant (probably hydrogen) in extremely small concentrations (approximately 10^{-6} pounds). These contaminants when vaporized can exponentially increase the thermal conductivity in proportion to their vapor pressure, as indicated by special tests. While loading helium into the tank, the contaminants would freeze upon the inner shell. In the frozen state, the pressure of the contaminant is too low to significantly affect the thermal conductivity. However, the flow check which preceded the cold-soak operation would vaporize the contaminants in the vicinity of the heat exchanger lines which pass through the annulus. The subsequent increase in thermal conductivity could cause the abnormally high pressure-rise rate observed during the cold soak. These vapors would slowly condense on the cold (10° R) inner wall, resulting in the pressure rise rate dropping to the nominal level, as was observed. The rise rate would remain normal until the helium temperature increased above the vaporization temperature of the contaminant.

A screening test was devised for all future flight tanks to supplement normal helium tank testing. The purpose of this test is to determine the pressure rise rate for a wide range of helium temperatures from approximately 9° to 123° R. For a perfect tank, the steady-state rise rate should remain at approximately 8 psi/hour over the entire range of temperatures. The Apollo 14, 15, and 16 tanks have been subjected to the screening test, and each exhibit the same phenomena observed during Apollo 13, but to a lesser degree. For new tanks, the manufacturer will periodically analyze the gases removed from the vacuum jacket during pump down for possible contaminants. The pressure in the jacket will be measured 2 or 3 weeks after pumpdown to verify vacuum integrity.

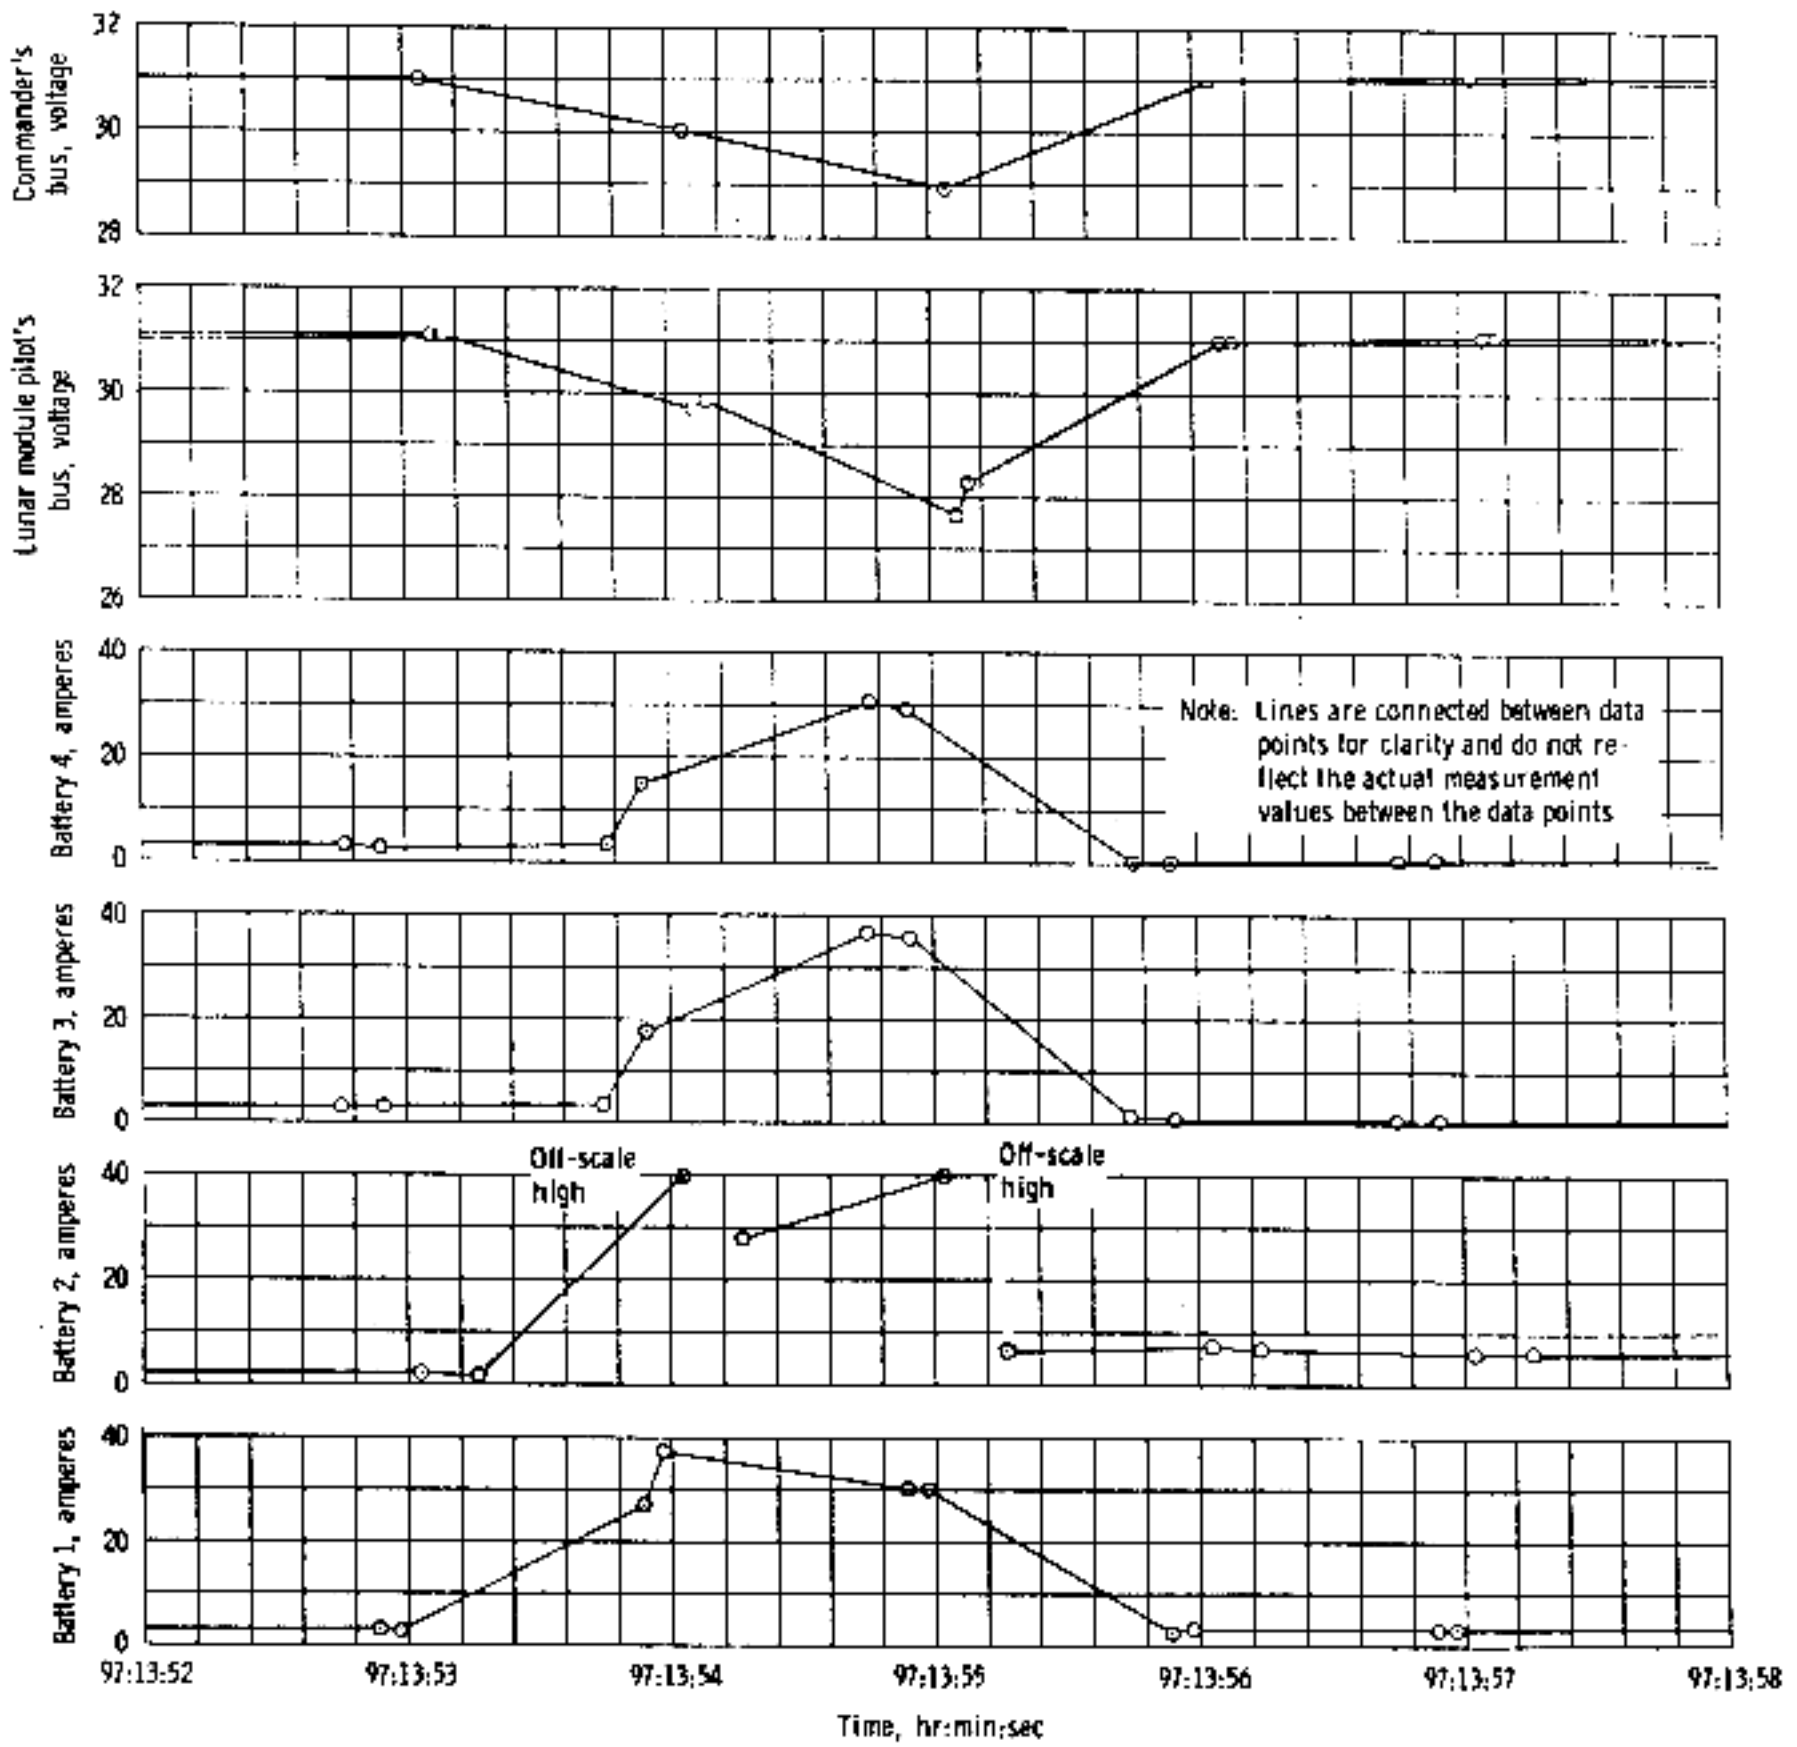
Figure 14-16.- Battery electrical transients.

The thumping noise occurred at about the same time as the current spikes. The current spikes show that a momentary short circuit existed in the Lunar-Module-Pilot side of the dc electrical system, which includes descent batteries 1 and 2 (fig. 14-16). The current surge was not of sufficient duration either to open the balance-load cross-tie circuit breakers, to display a reverse current indication, or to trip a battery-off relay as a result of an overcurrent condition.

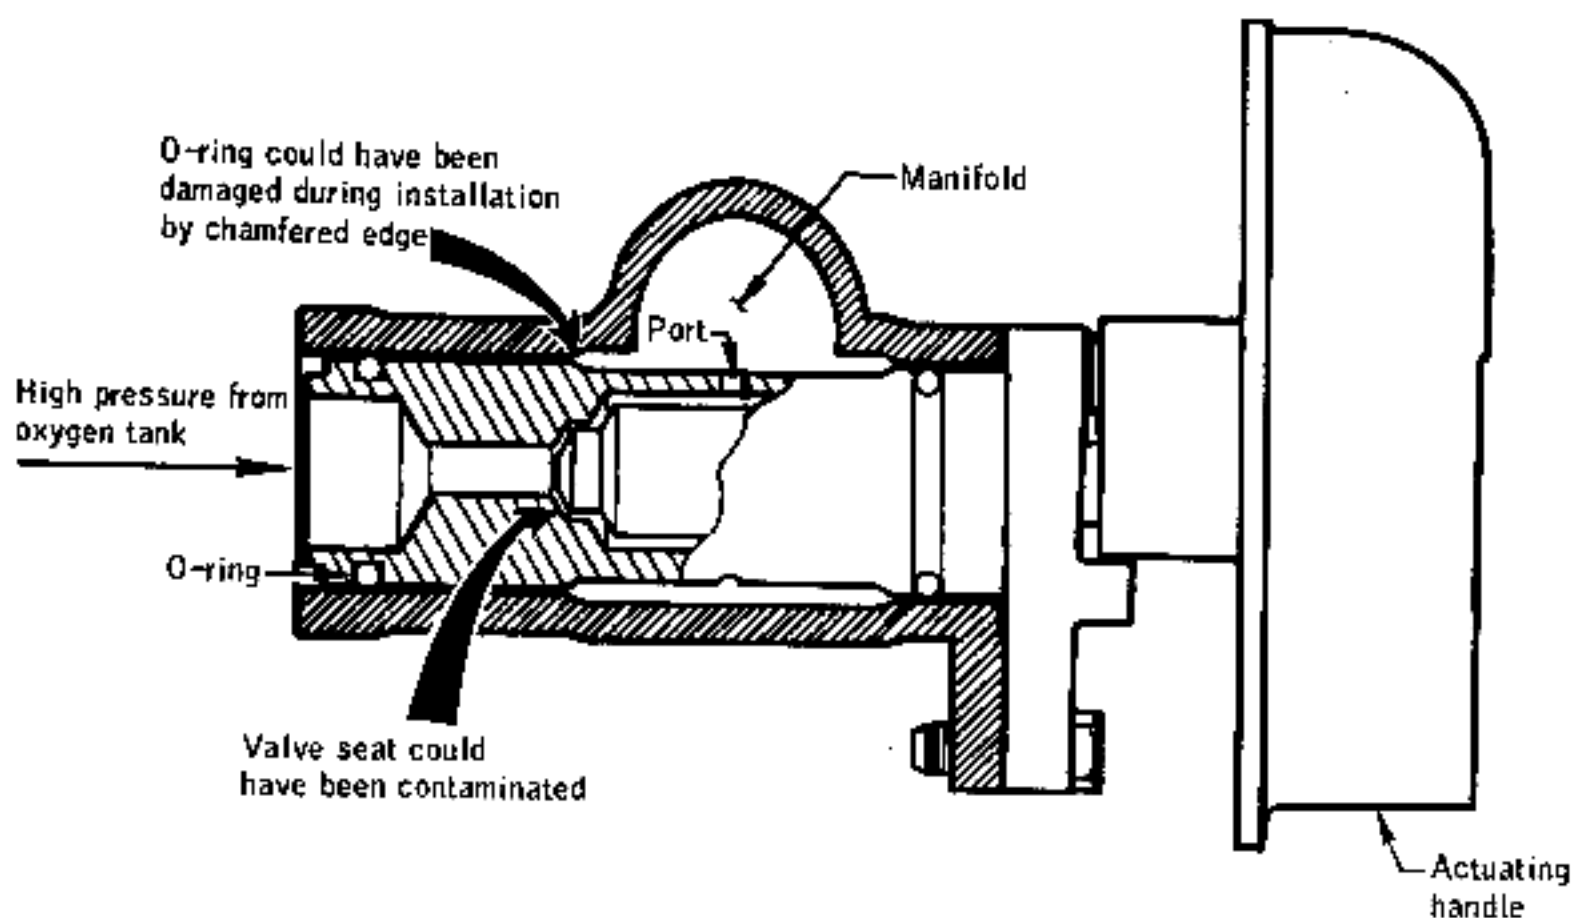
Figure 14-20.- Ascent stage tank shutoff valve.

(fig. 14-20) caused the leakage. When the valve is installed, the forward O-ring can be rolled and damaged when it passes the manifold port. In the other two valves, the cause was not identified and was assumed to be contamination.

compression allowed in the valve design would aggravate the tendency for the O-ring to roll during valve assembly.

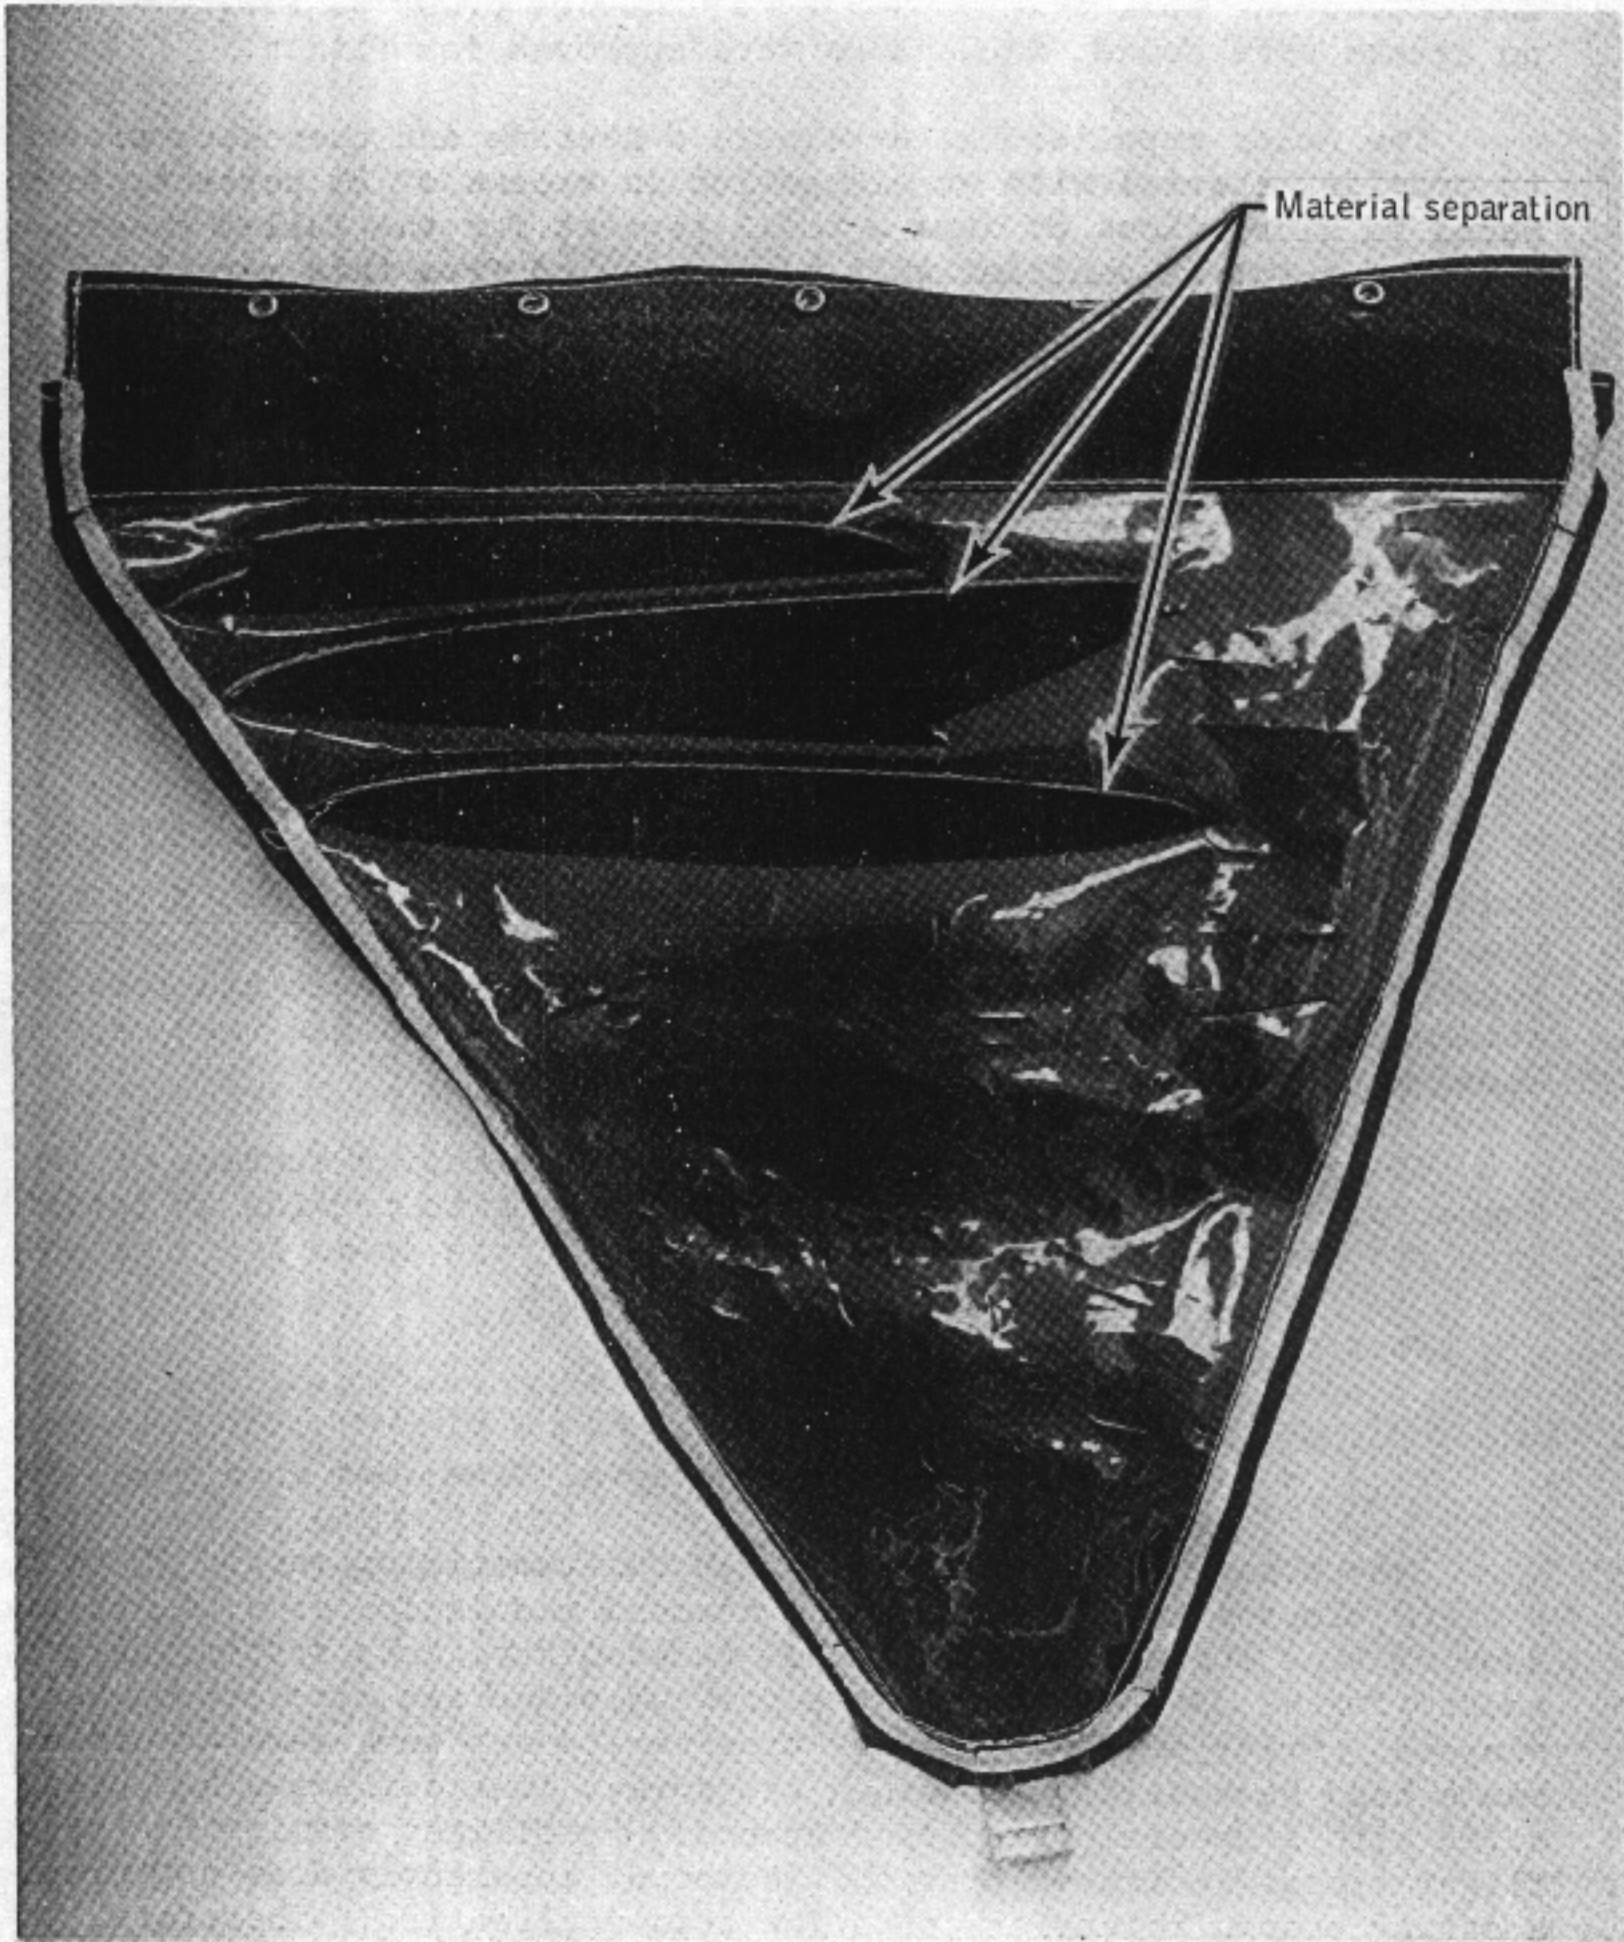
Figure 14-21.- Cracked left-hand window shade.

Cracking as a result of Aclar embrittlement has occurred before, therefore, the Apollo 13 shades were examined prior to flight. Since no cracks were found, the shades were approved for flight.
