⑨ BUREAU OF SHIPS GROUP
TECHNICAL INSPECTION REPORT

⑥ OPERATION CROSERoad.
FAILURES OF MASTS, YARDARMS,
BOOMS AND RIGGING E.U.J.

JOINT TASK FORCE ONE

FAILURES OF MASTS, YARDARMS, BOOMS, AND RIGGING

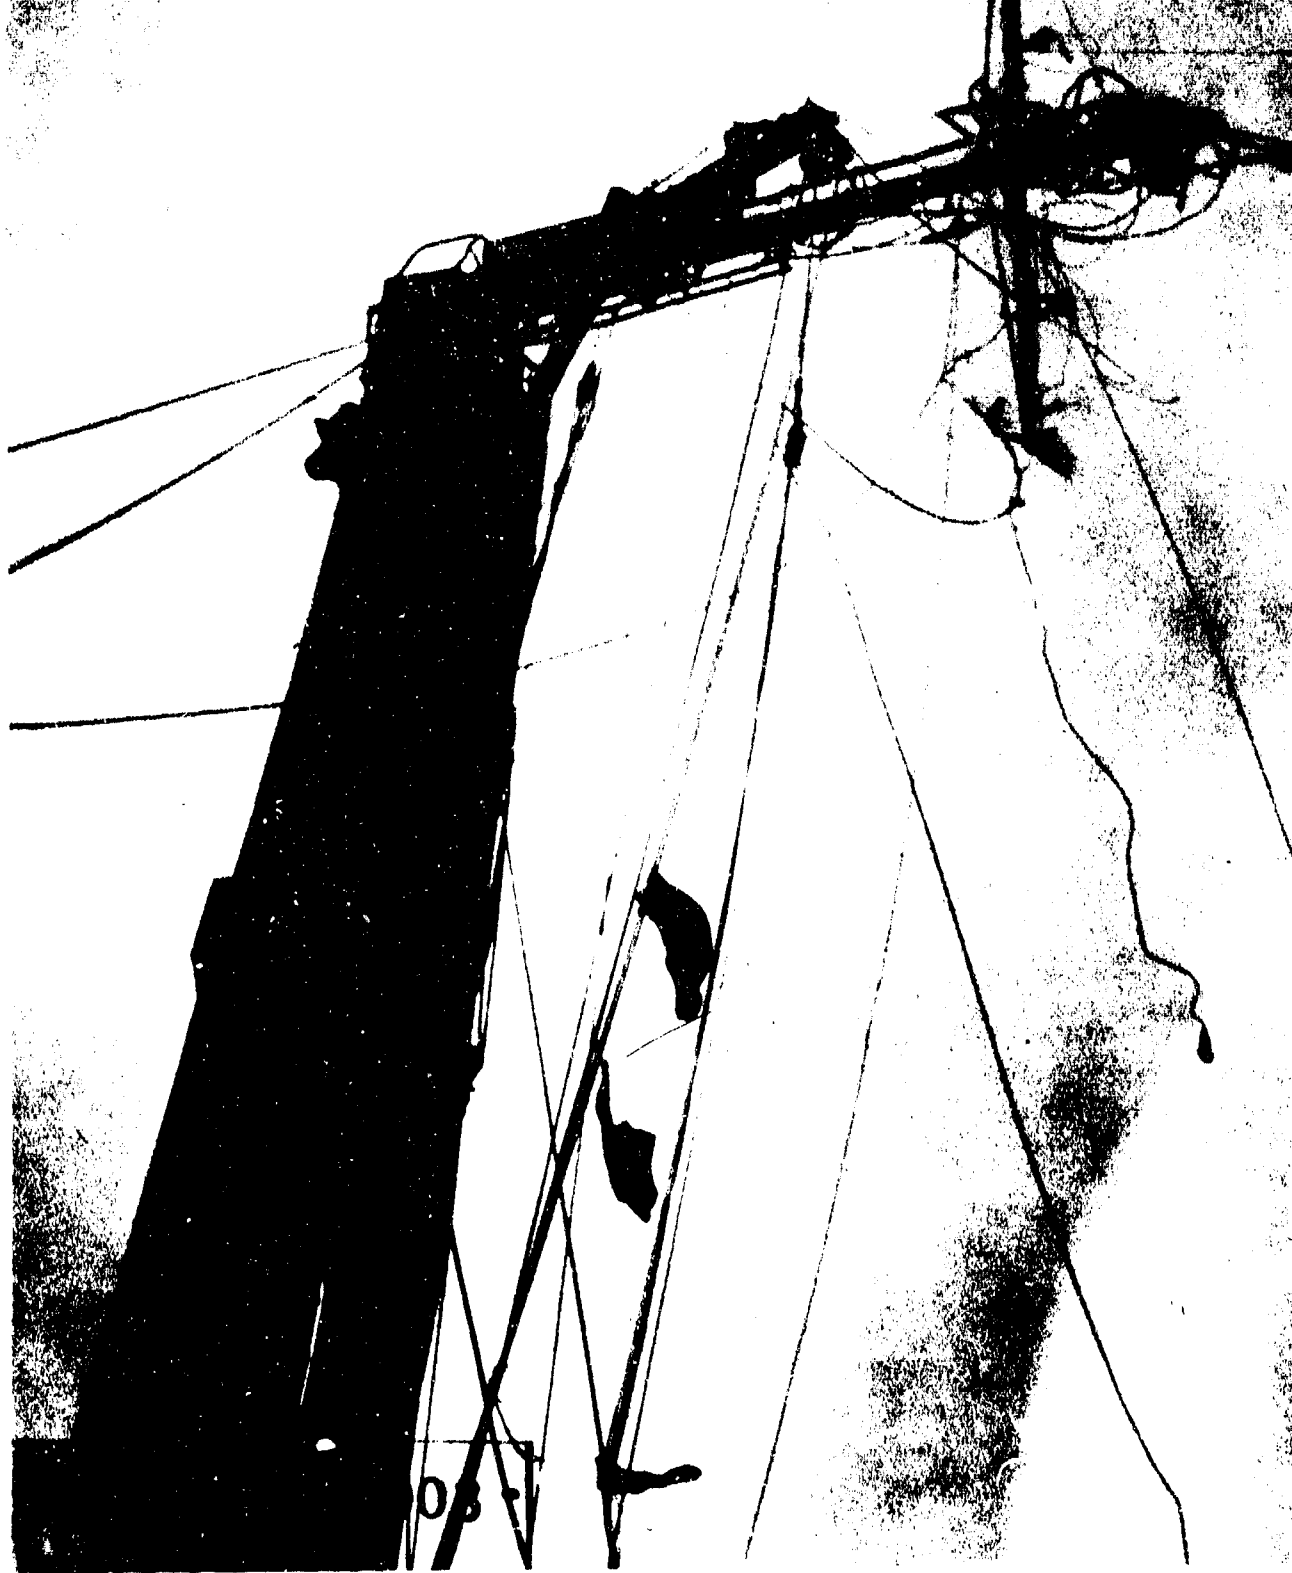
AA-CR-80-1903-7. USS CRITTENDEN (APA77). Foremast, looking to starboard. Note sharp bend in port and starboard cargo booms.

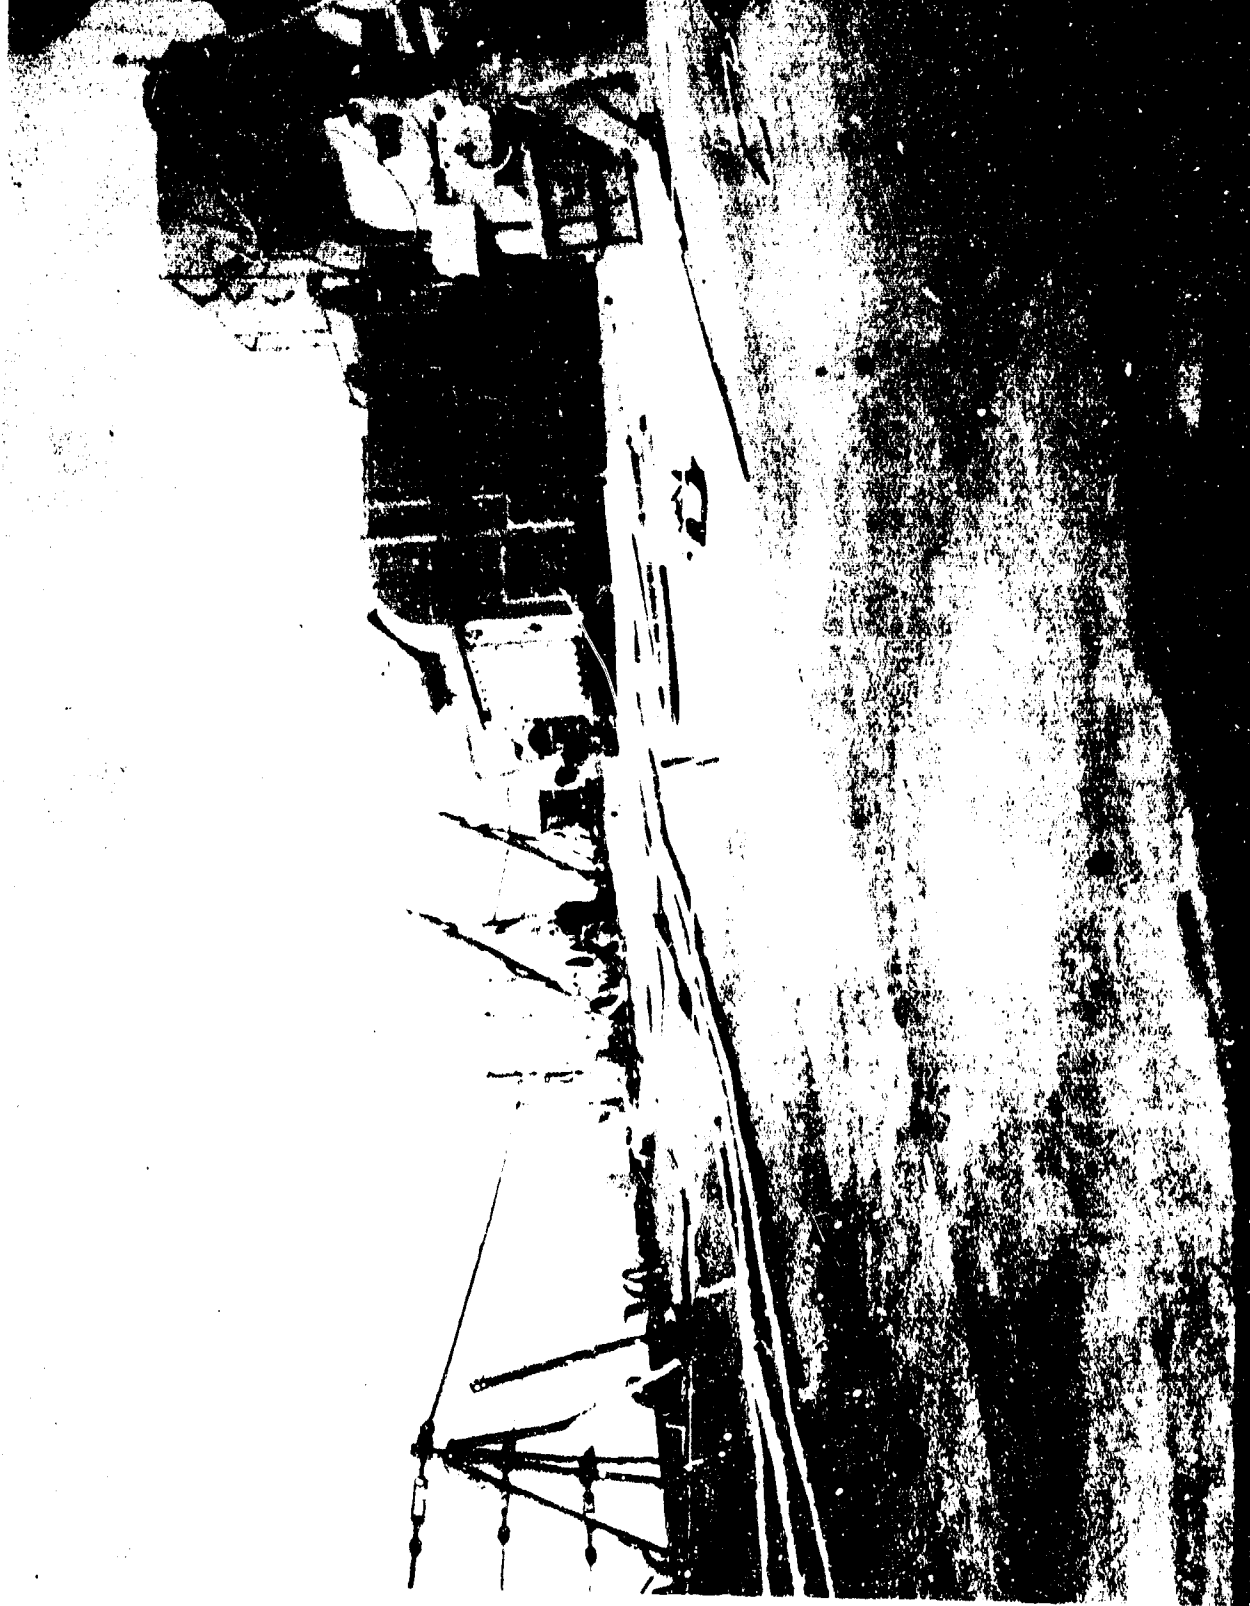
4. Standing rigging is in disarray from failure of the topmasts but is intact generally, although several of the stack stays failed in the turnbuckles. Photo 1906-8, page 42 shows several items of rigging with wires and end fittings intact.

AA-CR-88-2101-9. USS CRITTENDEN (APA77). Upper deck, port side, showing foremast stay turn-buckles.

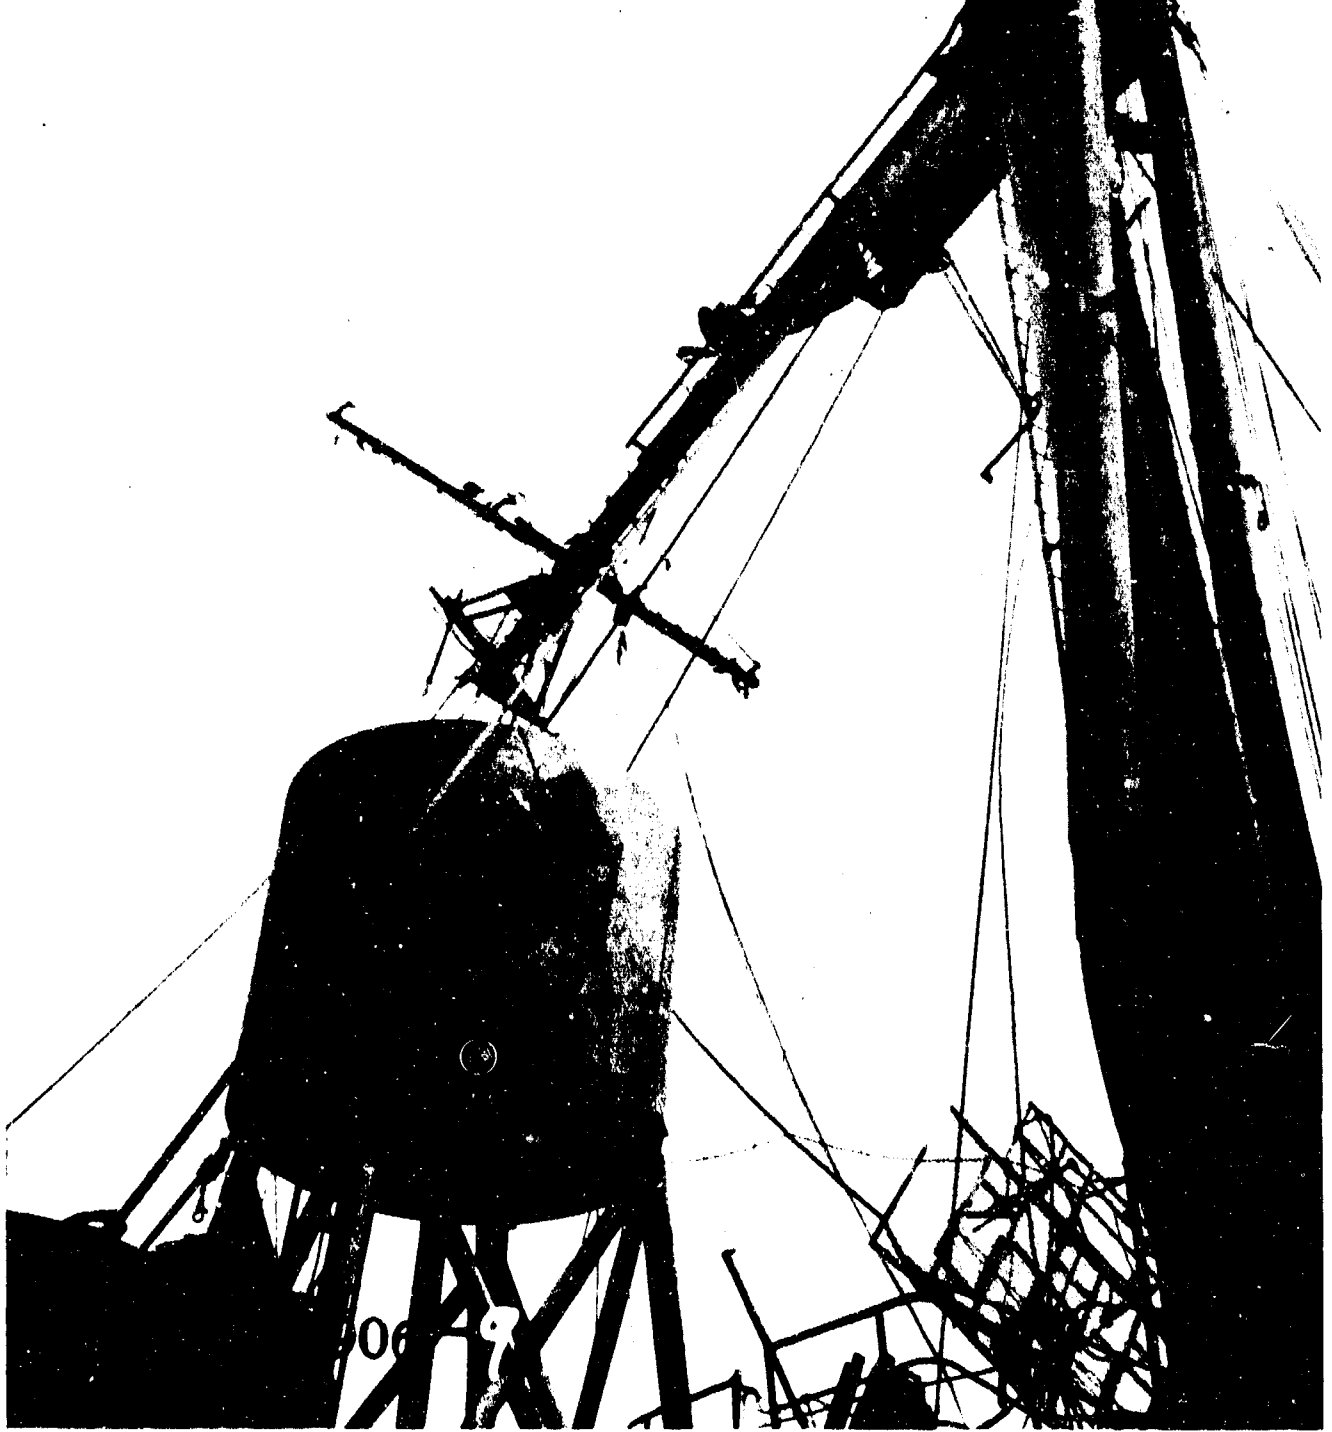
3. The maintopmast is bent about 110 degrees out of its normal vertical position and in the direction of the blast travel. See photos 227-49-116, 1906-9, 1906-12 and 1921-12; pages 26 , 37, 38 , and 39 . The bend occurs just above the crosstree level and, as in the case of the foremast, the mast is fractured at the bend. The mainmast cargo booms, which were stowed in clamps along the mast, are useless due to their severe deformation. Photos 1922-2 and 1905-11; pages 40 and 41 show severe kinking of the starboard boom about 10 feet above the hinge pin. The port boom is bent in an easy curve.

AA-CR-80-1906-9. U.S.S. CRITTENDEN (APA-77). Mainmast. Note relatively sharp bend of starboard cargo boom, and long easy curve of port cargo boom.

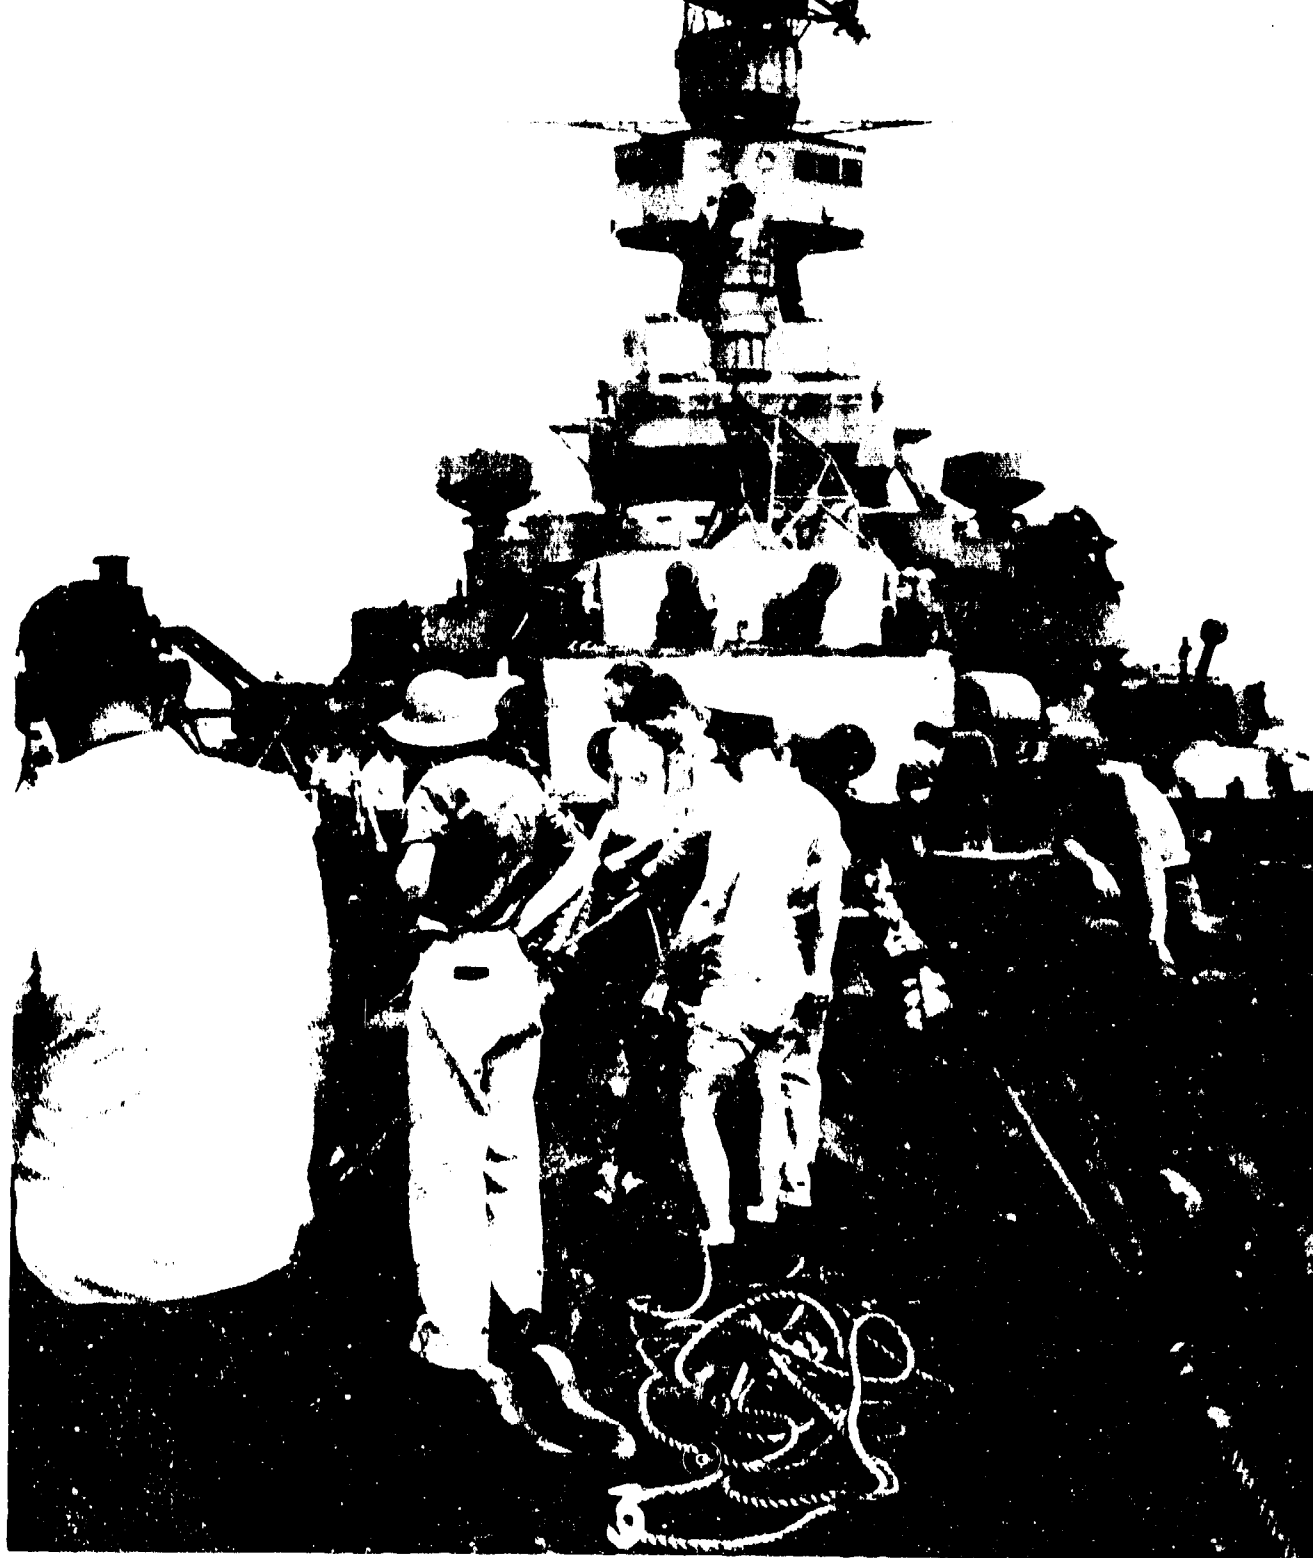
AA-CR-68-2091-3. USS ARKANSAS (BB33). View looking aft at forward superstructure showing SK radar mast and yardarms.

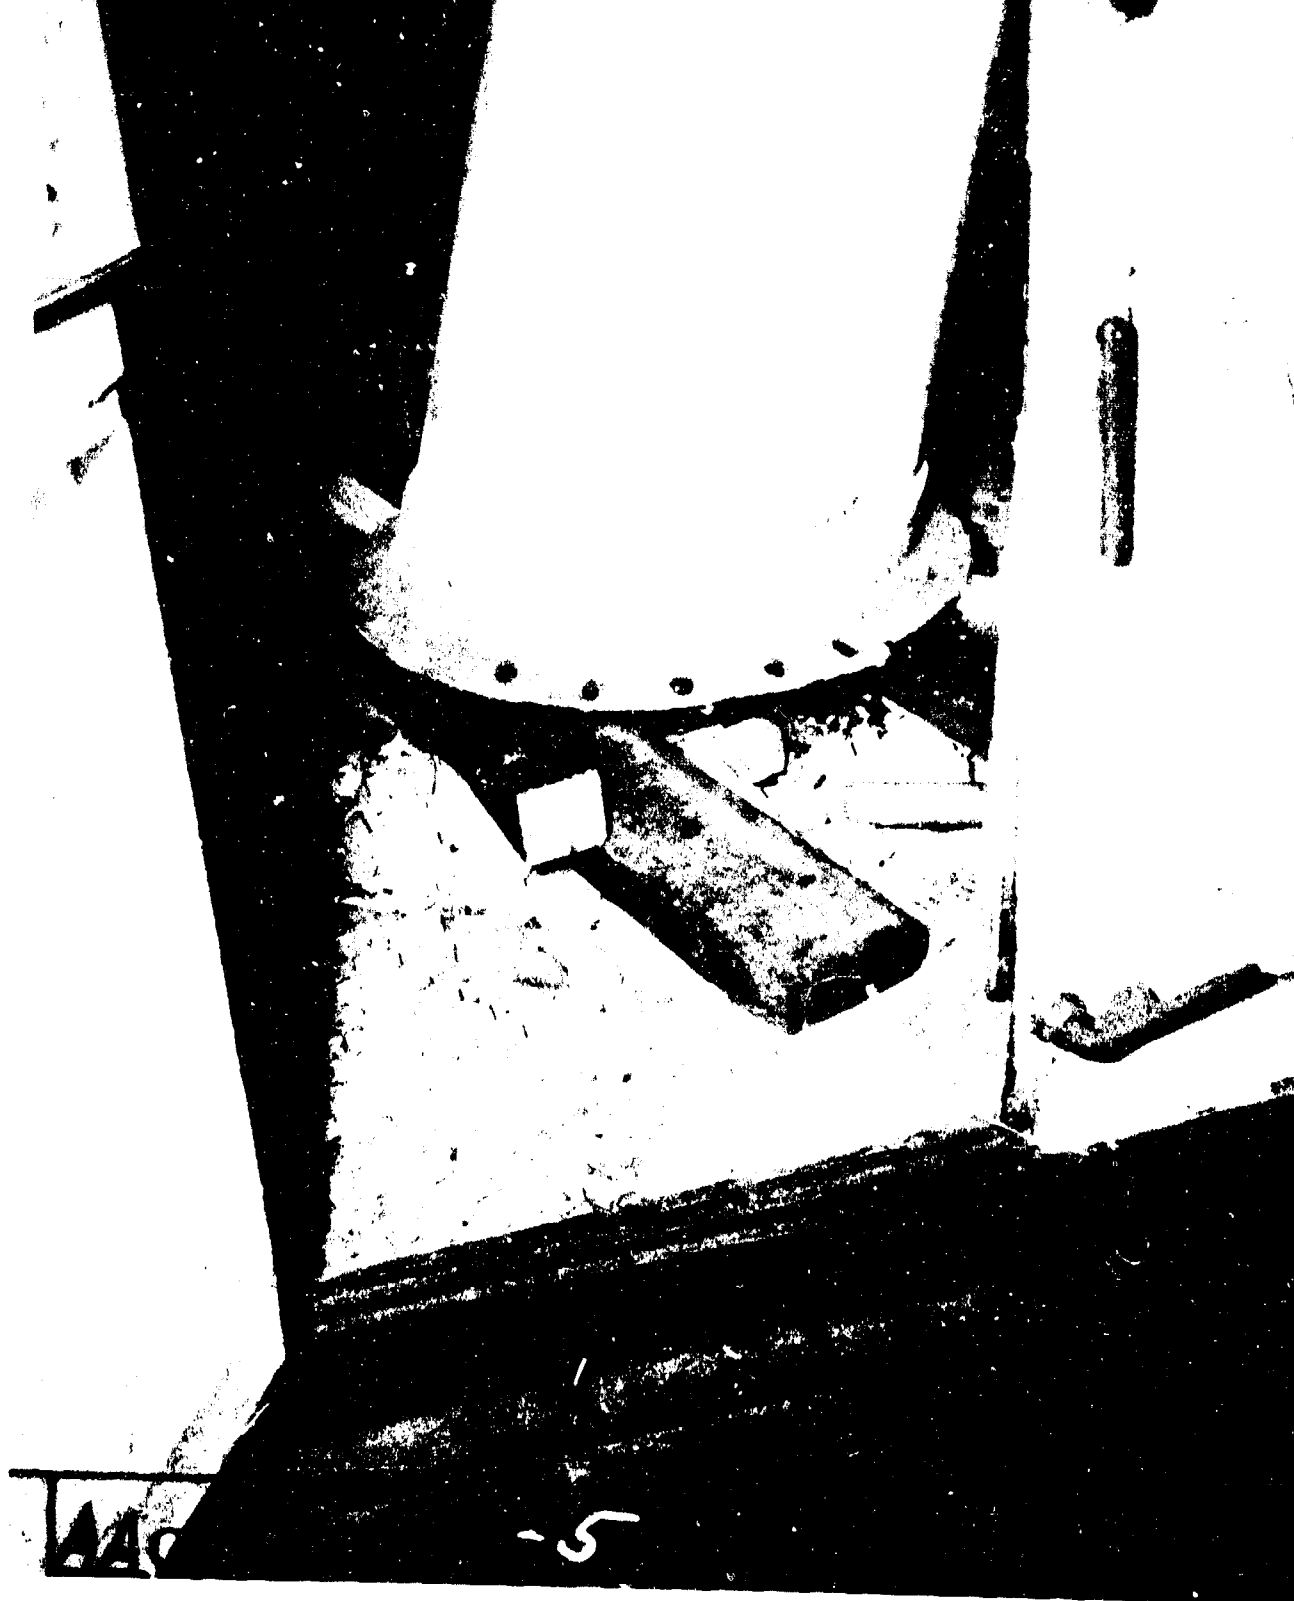
AA-CR-2146-5. USS ARKANSAS (BB33). 2nd deck, base of starboard aft leg, frame 103.

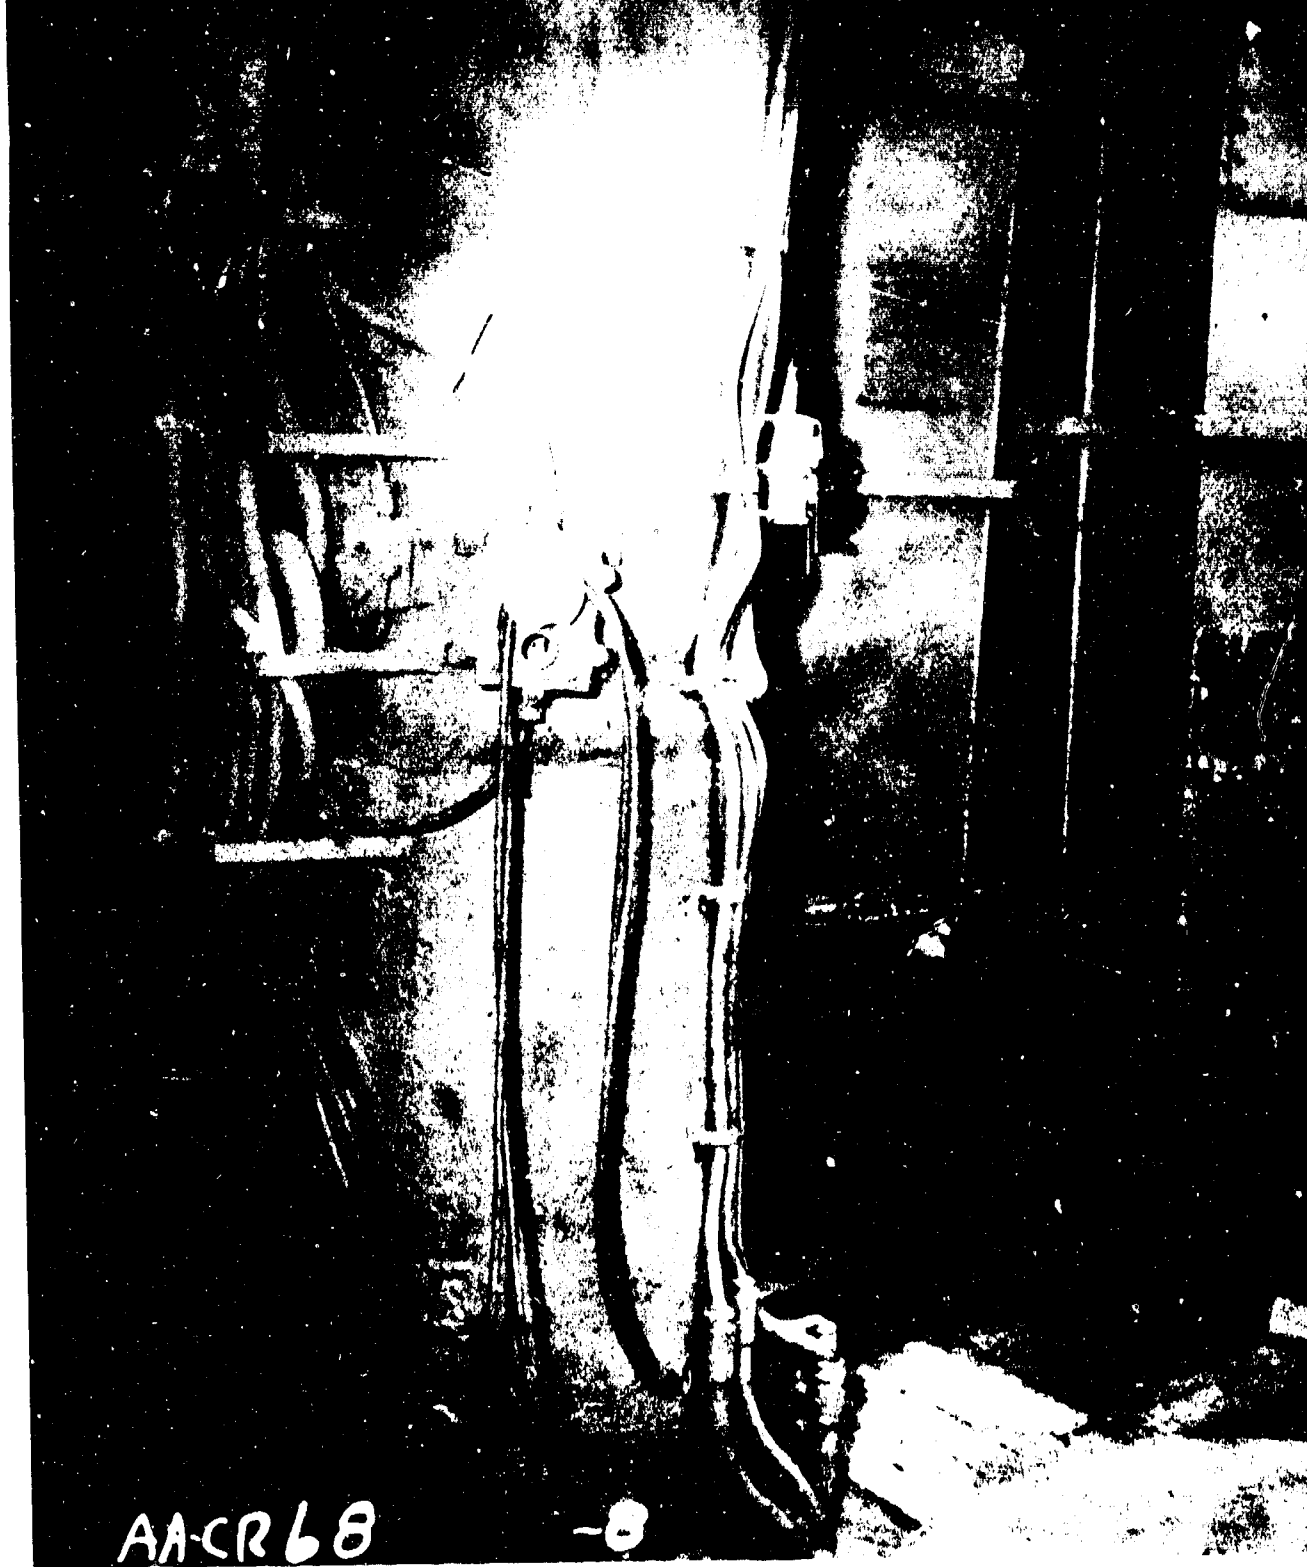
AA-CR-68-2111-8. USS ARKANSAS (BB33). Foreleg- mainmast tripod looking at wrinkle from starboard side.

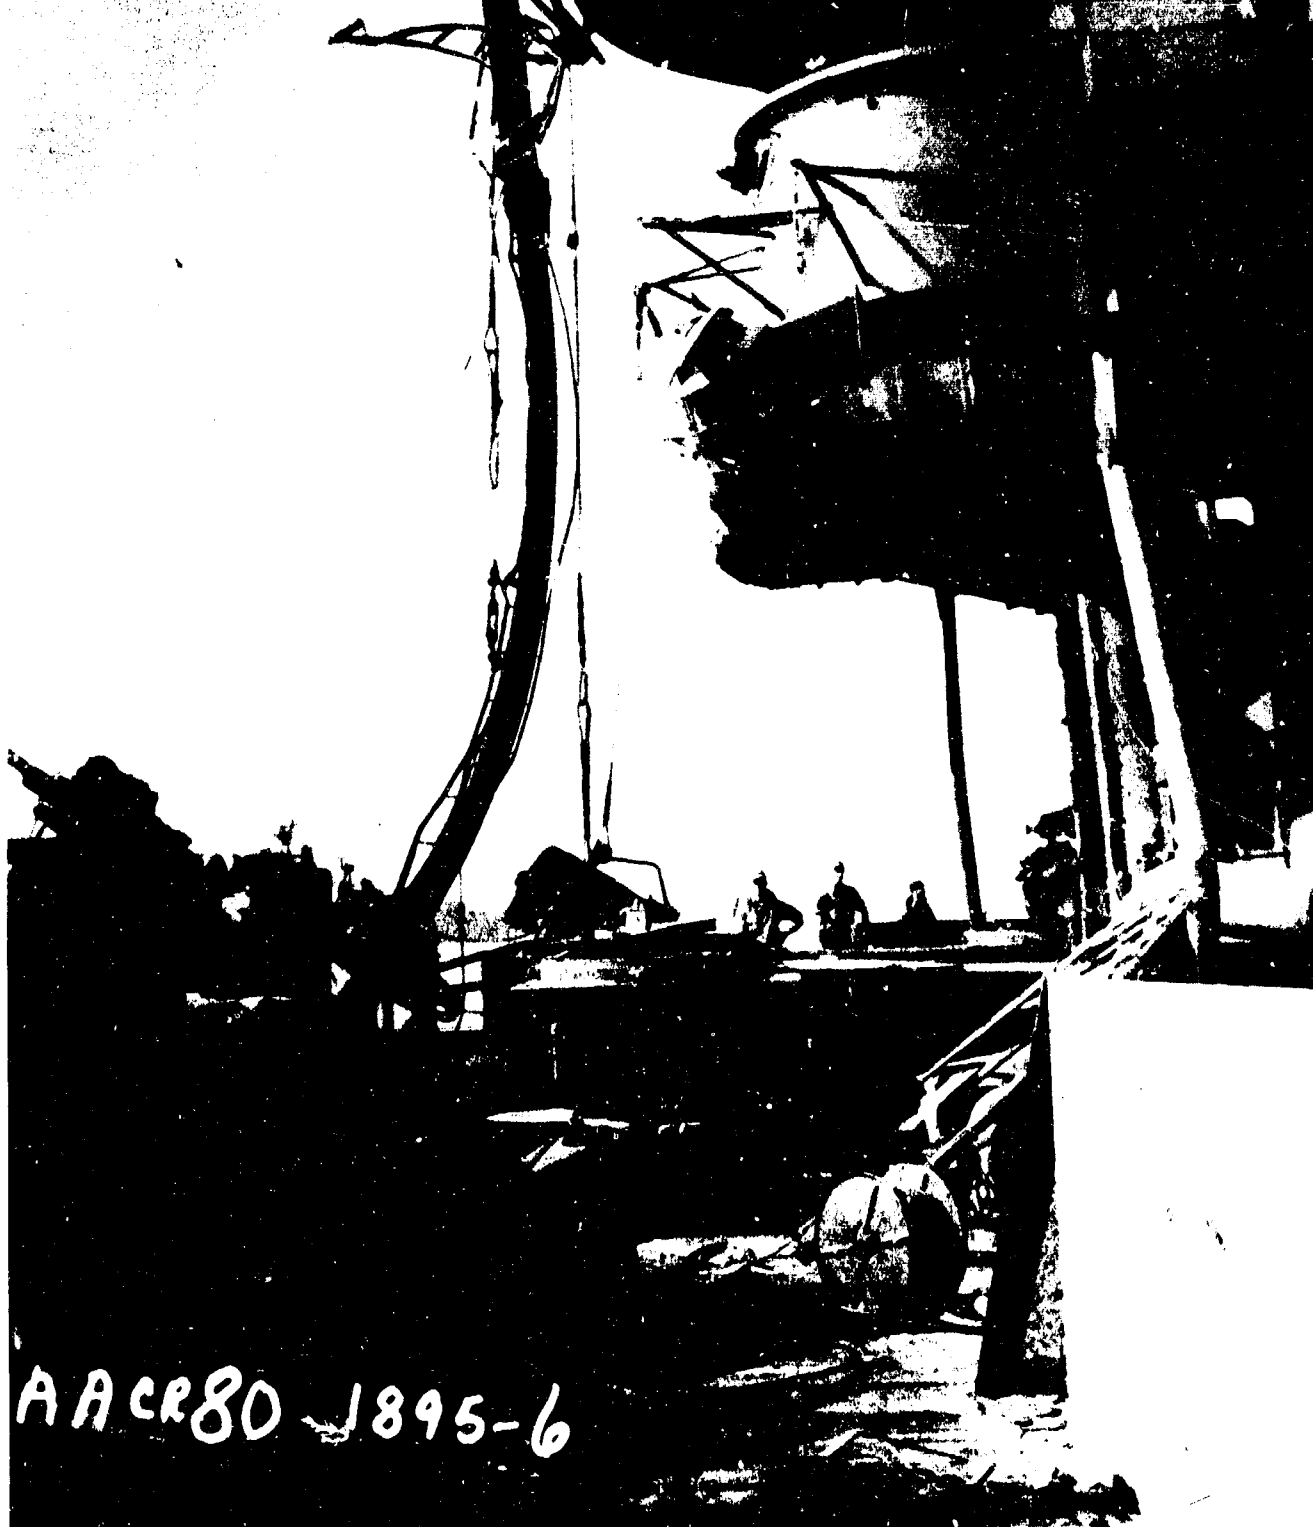
AA-CR-80-1895-6. USS ARKANSAS (BB33). General view of main deck and portion of main mast. Note that top of mast is in debris on deck.

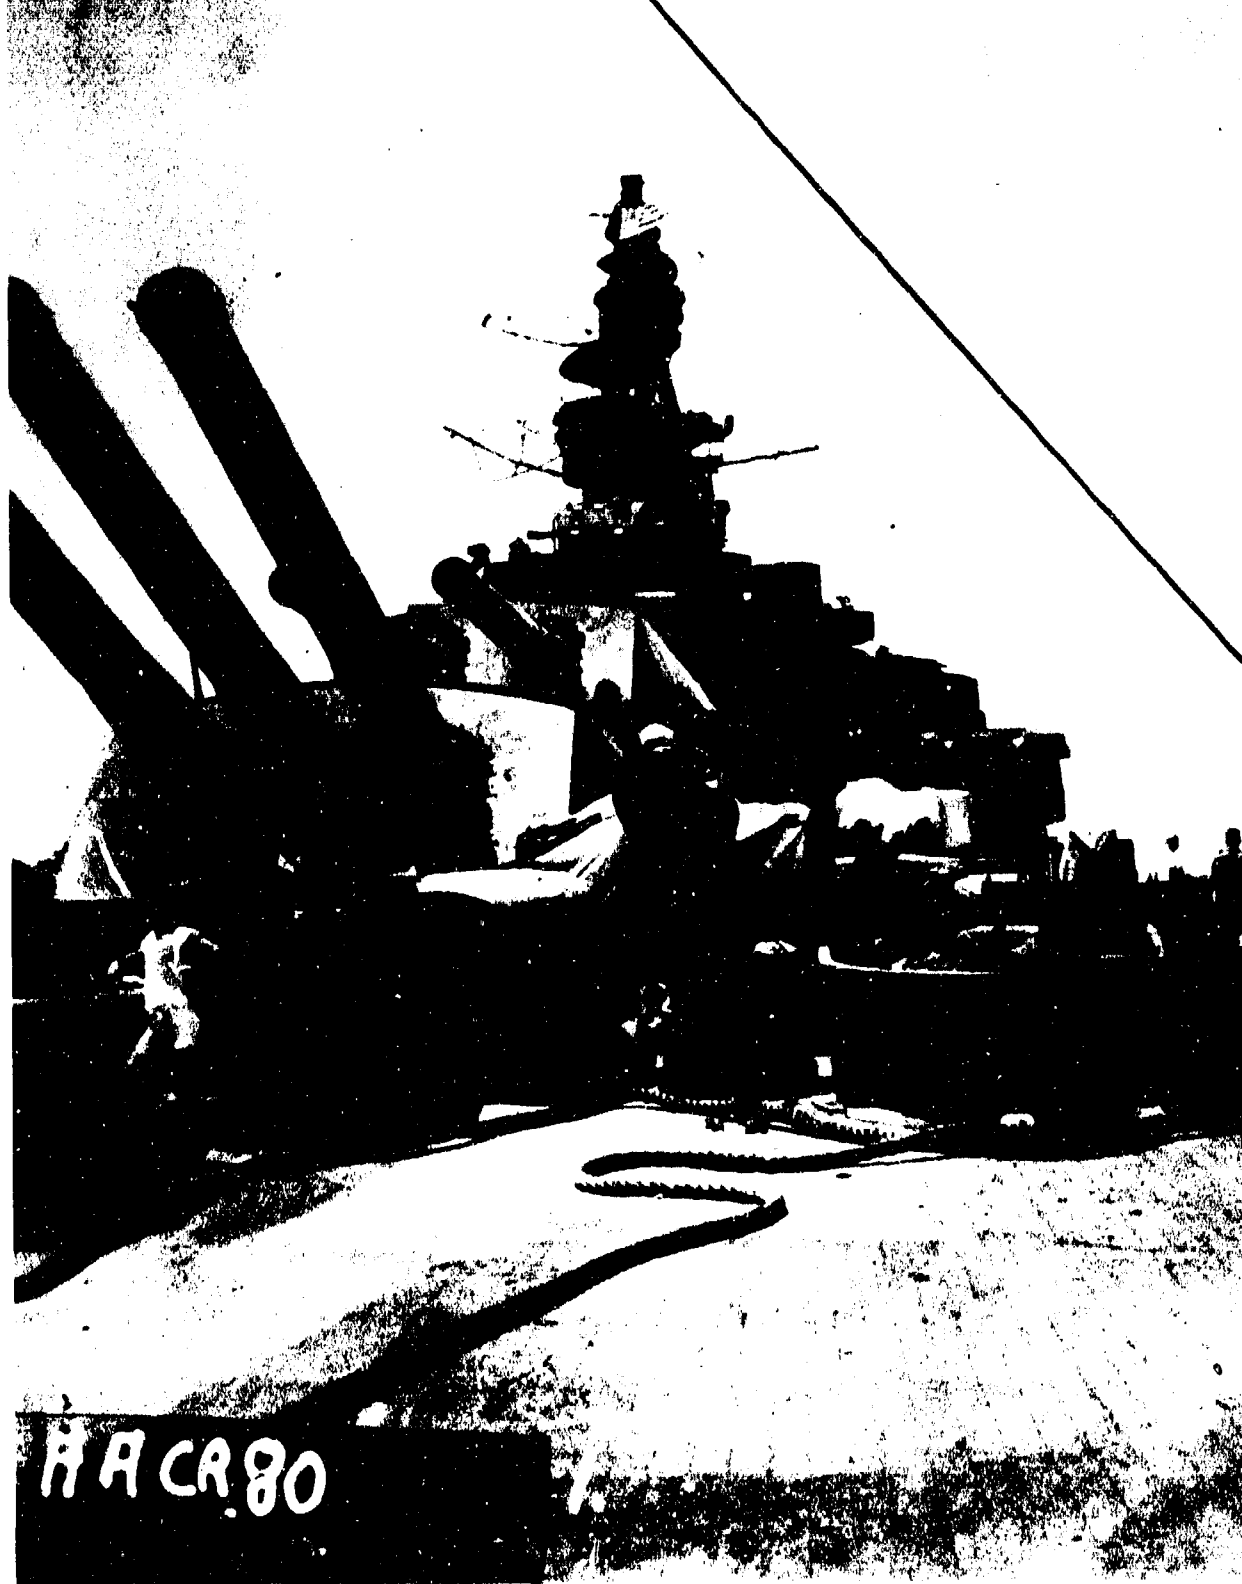
AA-CR-80-1909-1. USS NEVADA (BB36). Looking forward, showing after and forward tripod yardarms, and remains of forward starboard yardarms.

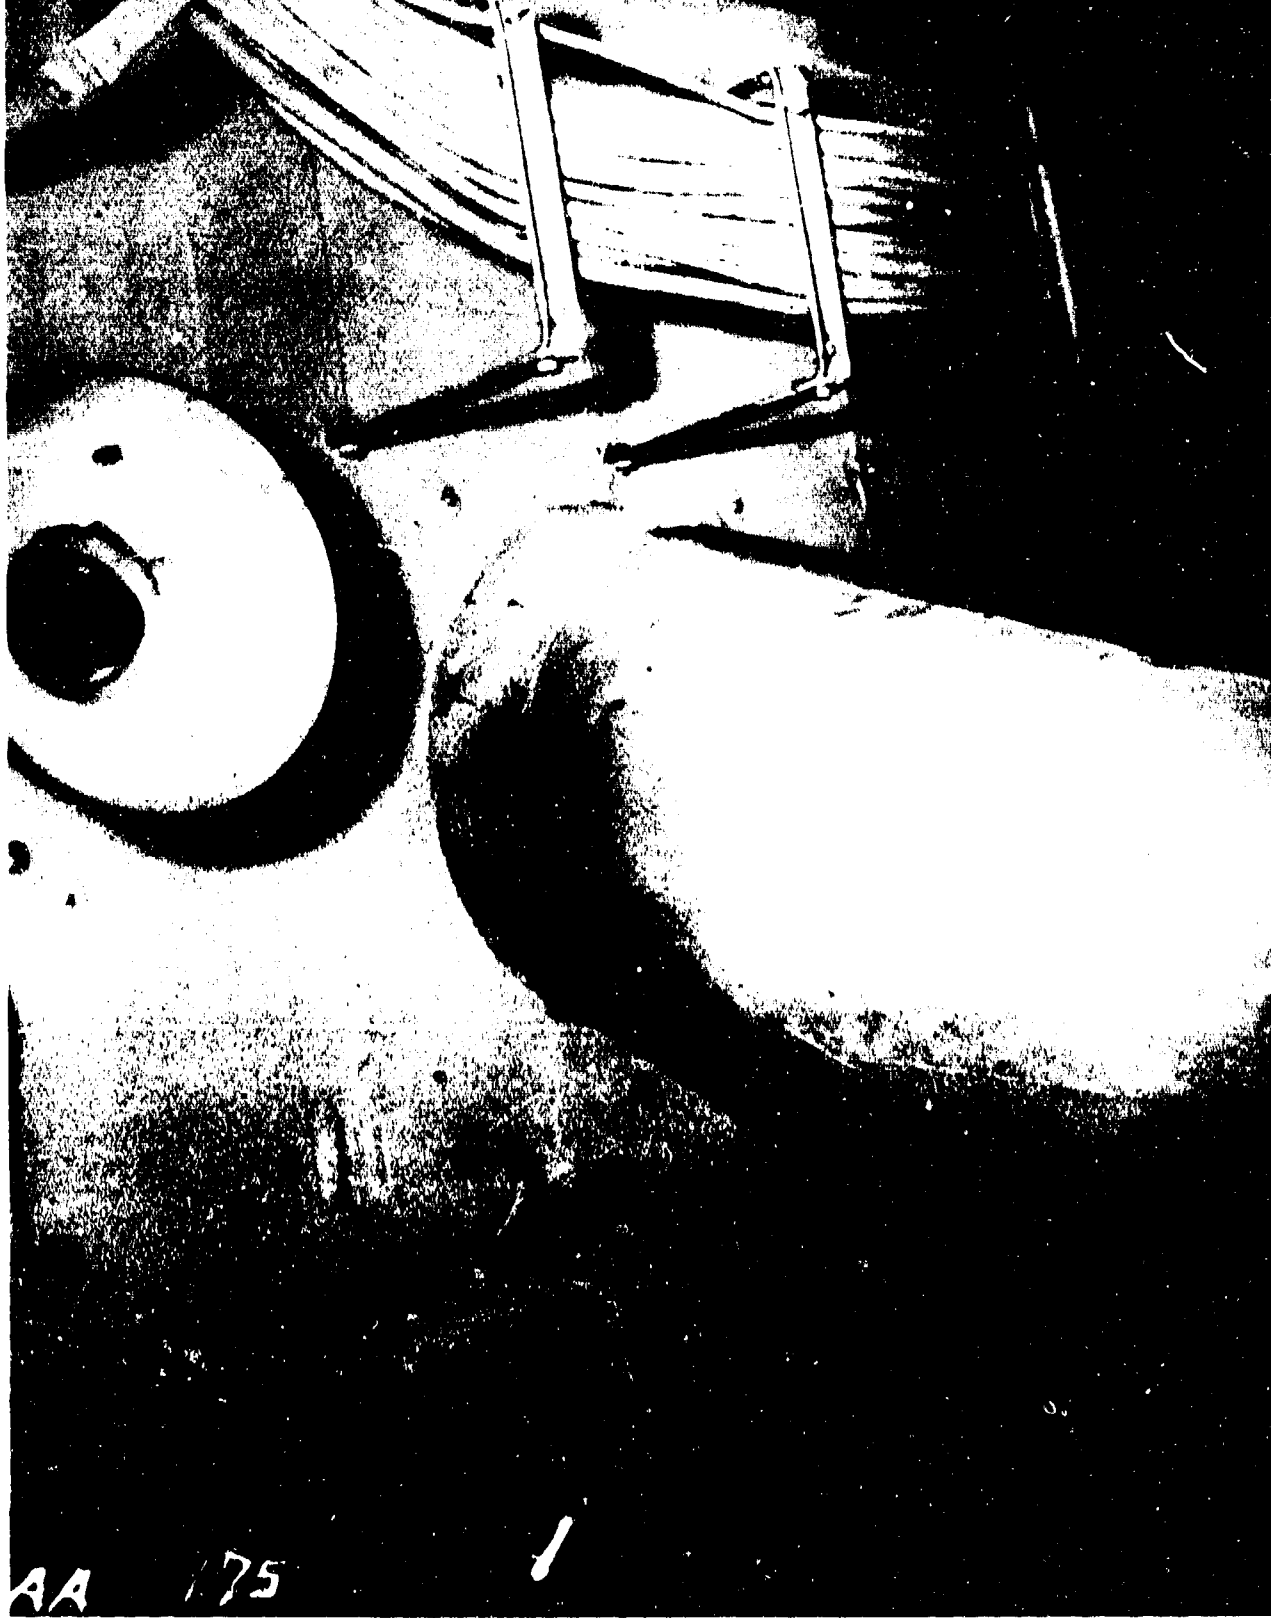
AA-CR-175-2154-1. USS NEVADA (BB36). Forward leg of port director tub, frame 68-69, looking inboard, showing compression evidence at top of leg under 02 level.

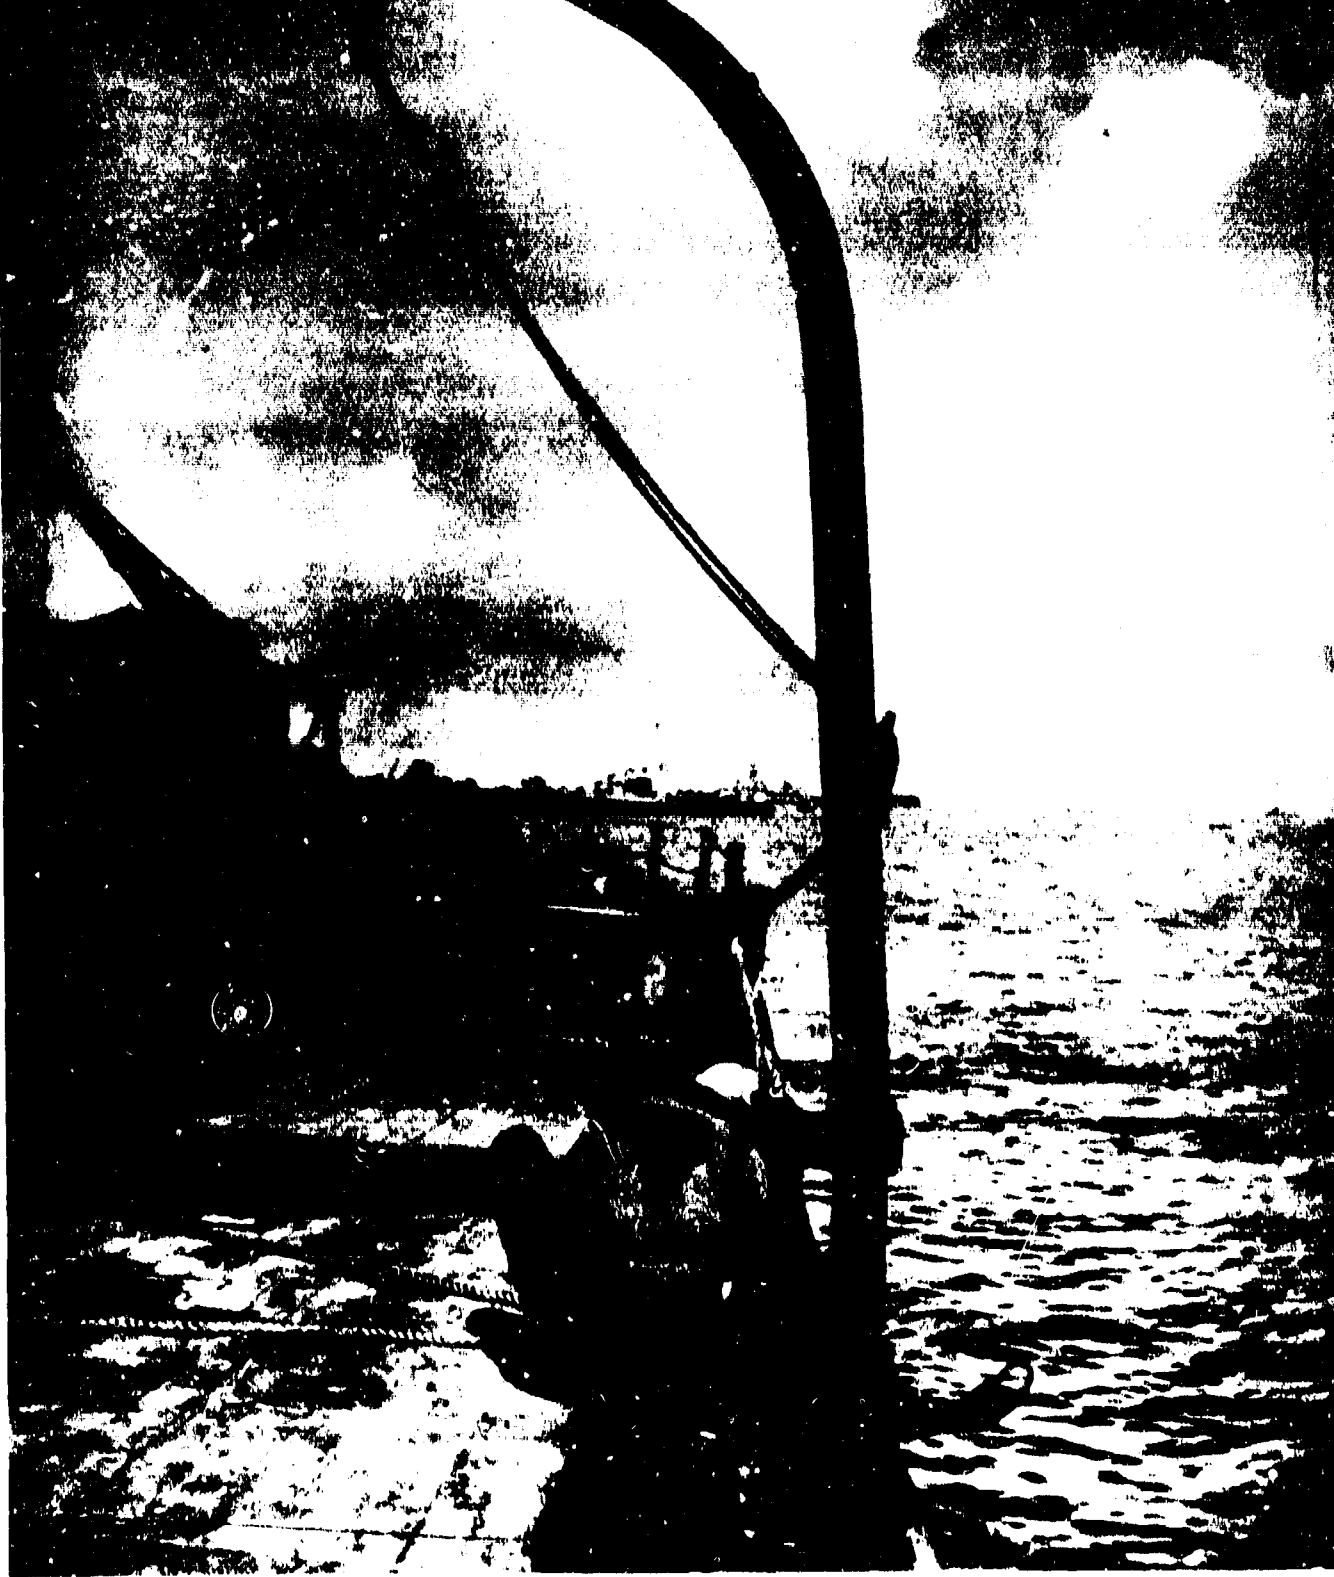
AA-CR-100-1889-8. USS NEVADA (BB36). Side ladder davit, frame 105, showing bend above deck edge fitting.

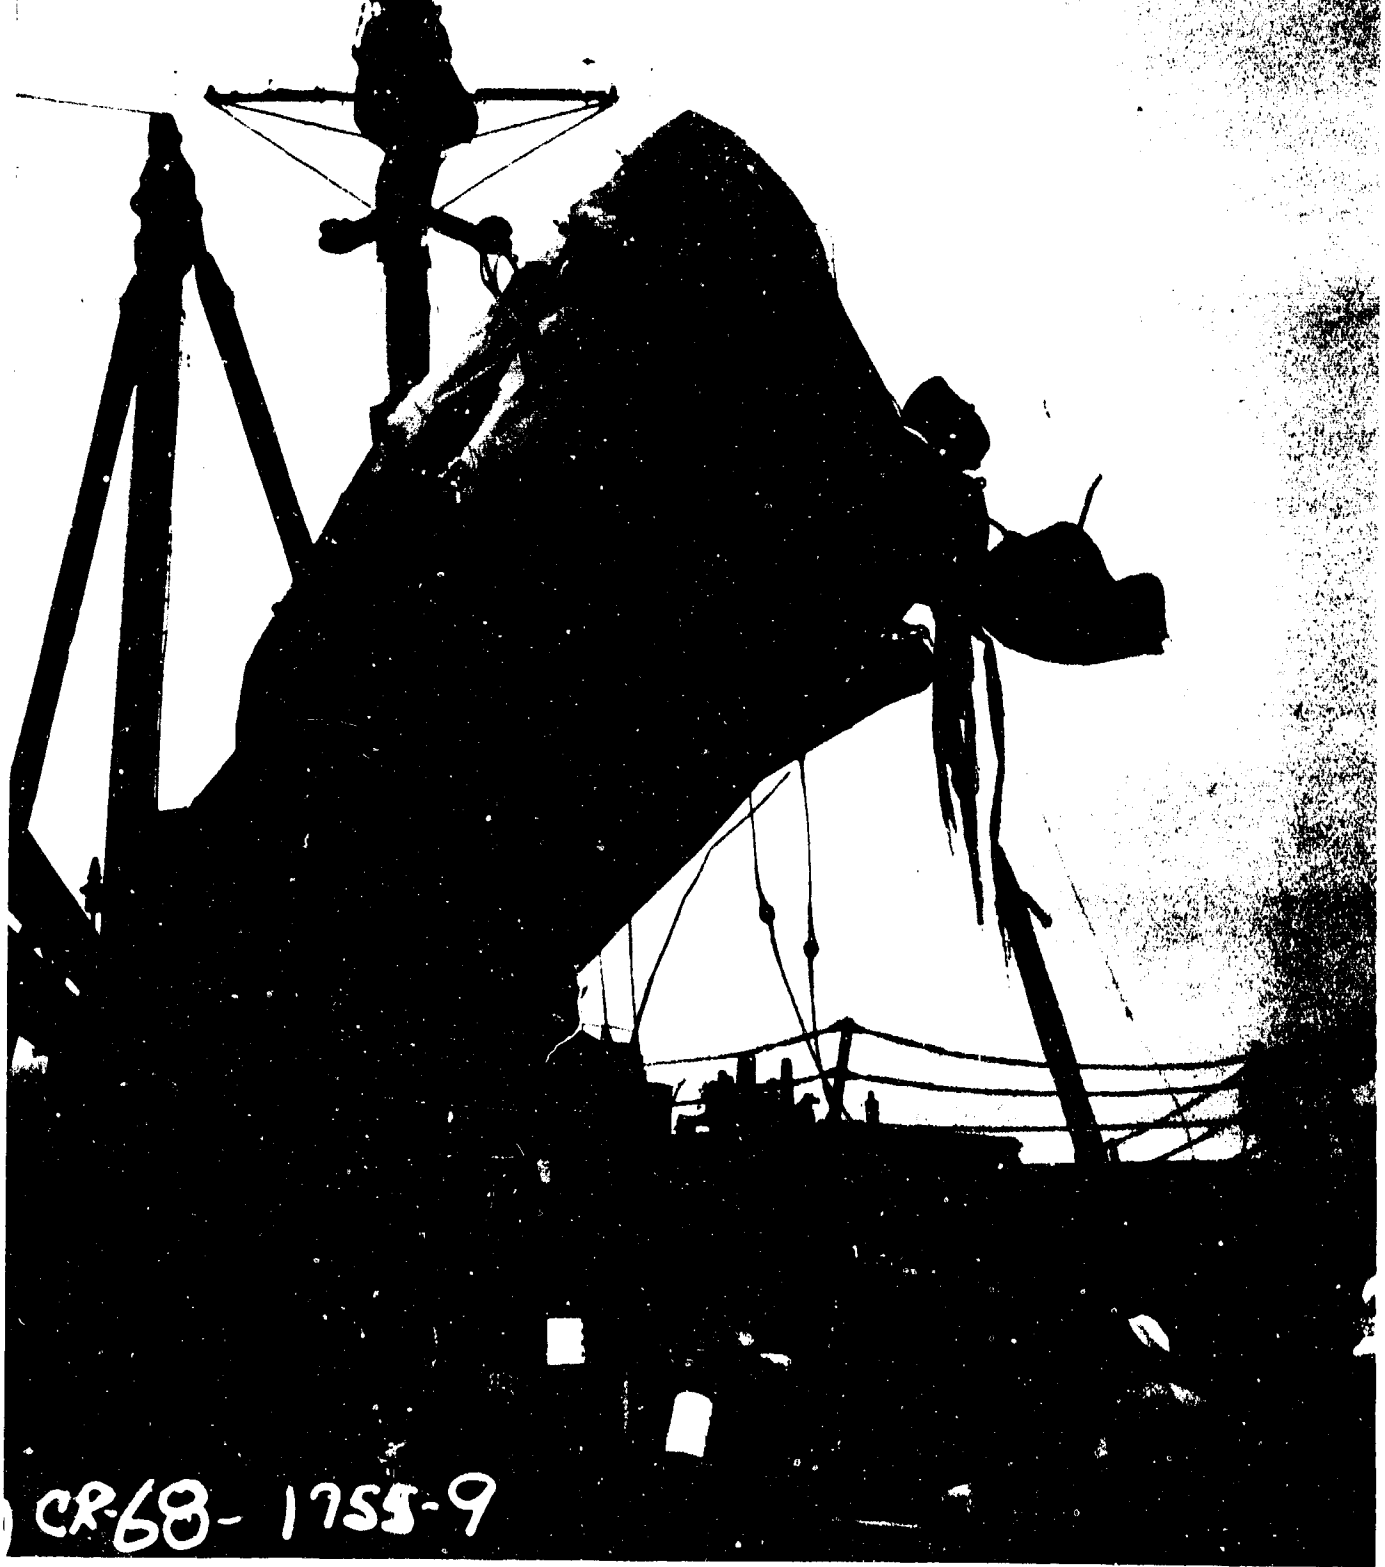
AA-CR-68-1755-9. U.S.S. PENSACOLA (CA24). View looking aft at mainmast and airplane boom tripod.
