⑨ BUREAU OF SHIPS GROUP
TECHNICAL INSPECTION REPORT

⑥ OPERATION CROSERoad.
FAILURES OF MASTS, YARDARMS,
BOOMS AND RIGGING E.U.J.

JOINT TASK FORCE ONE

FAILURES OF MASTS, YARDARMS, BOOMS, AND RIGGING

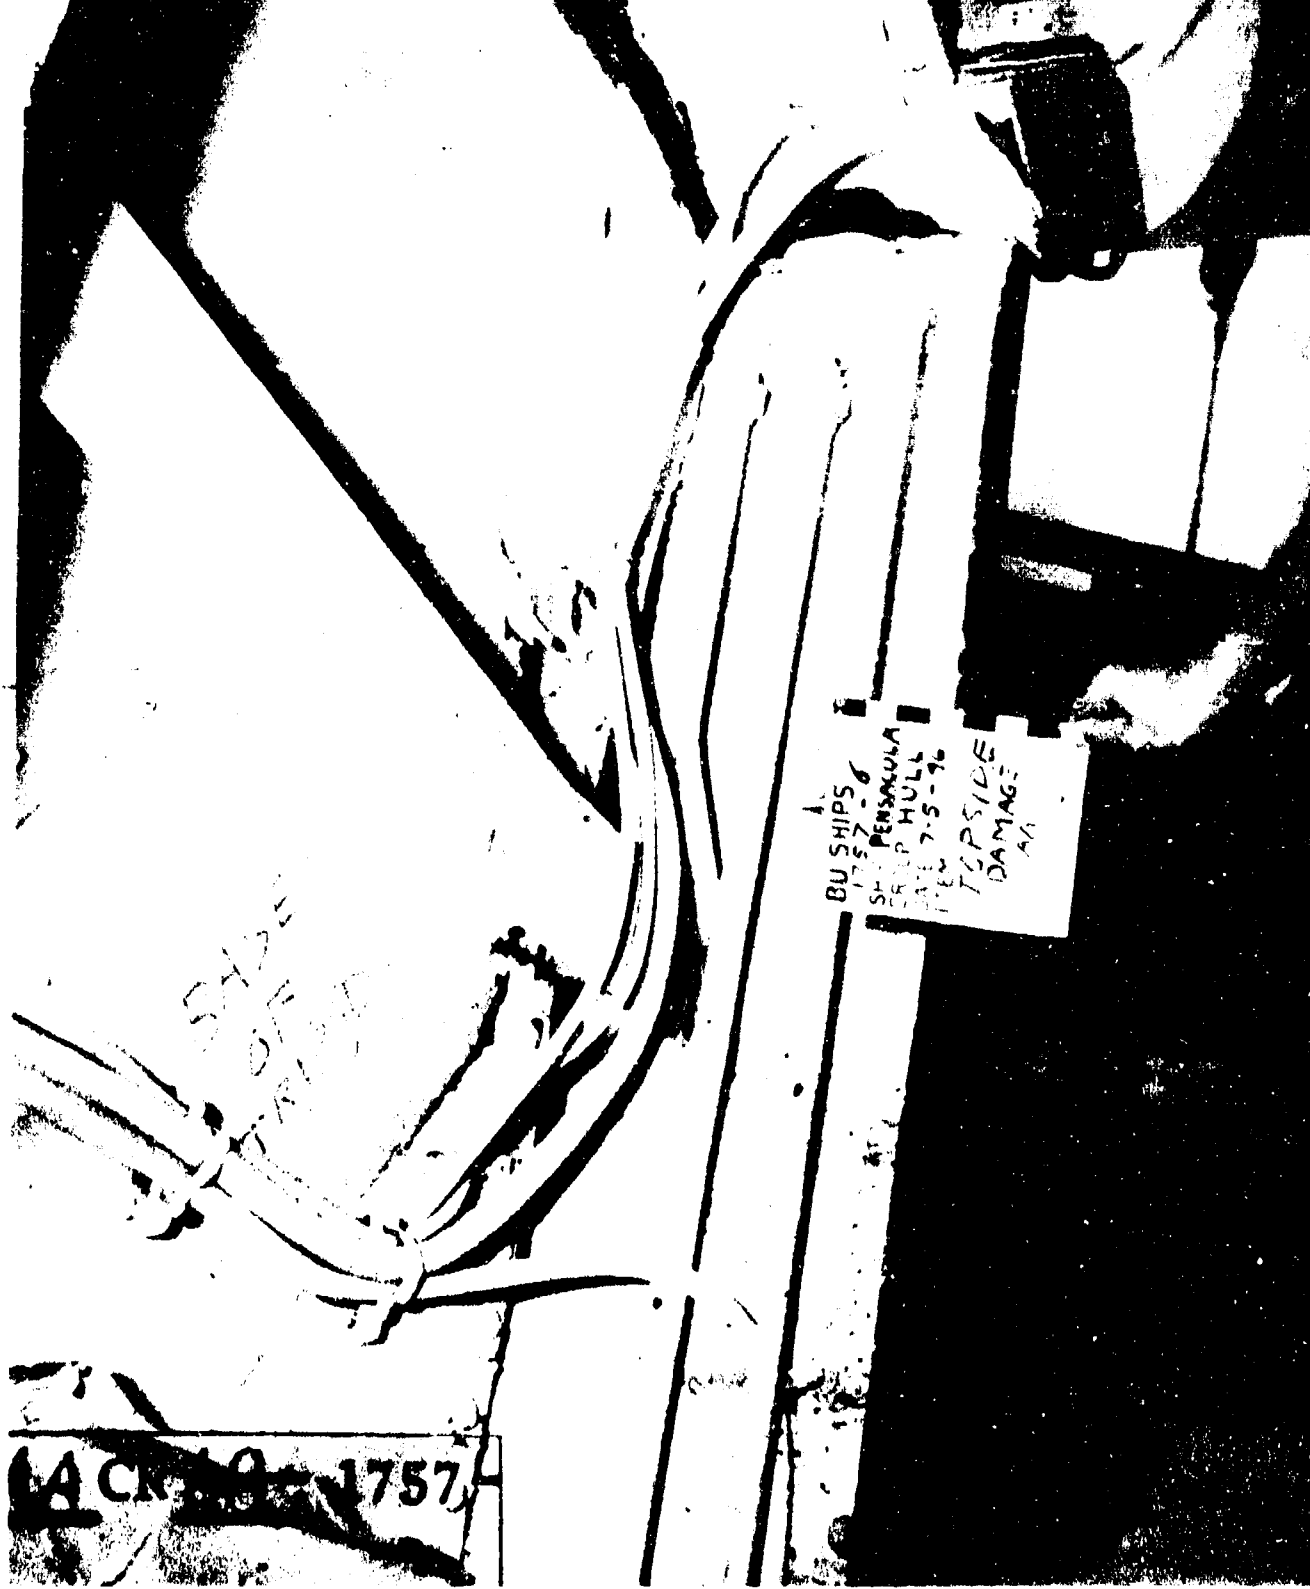
AA-CR-68-1757-6. U.S.S. PENSACOLA (CA24). Looking up at under side of 01 deck showing base of port after leg of mainmast strut - frame 92.

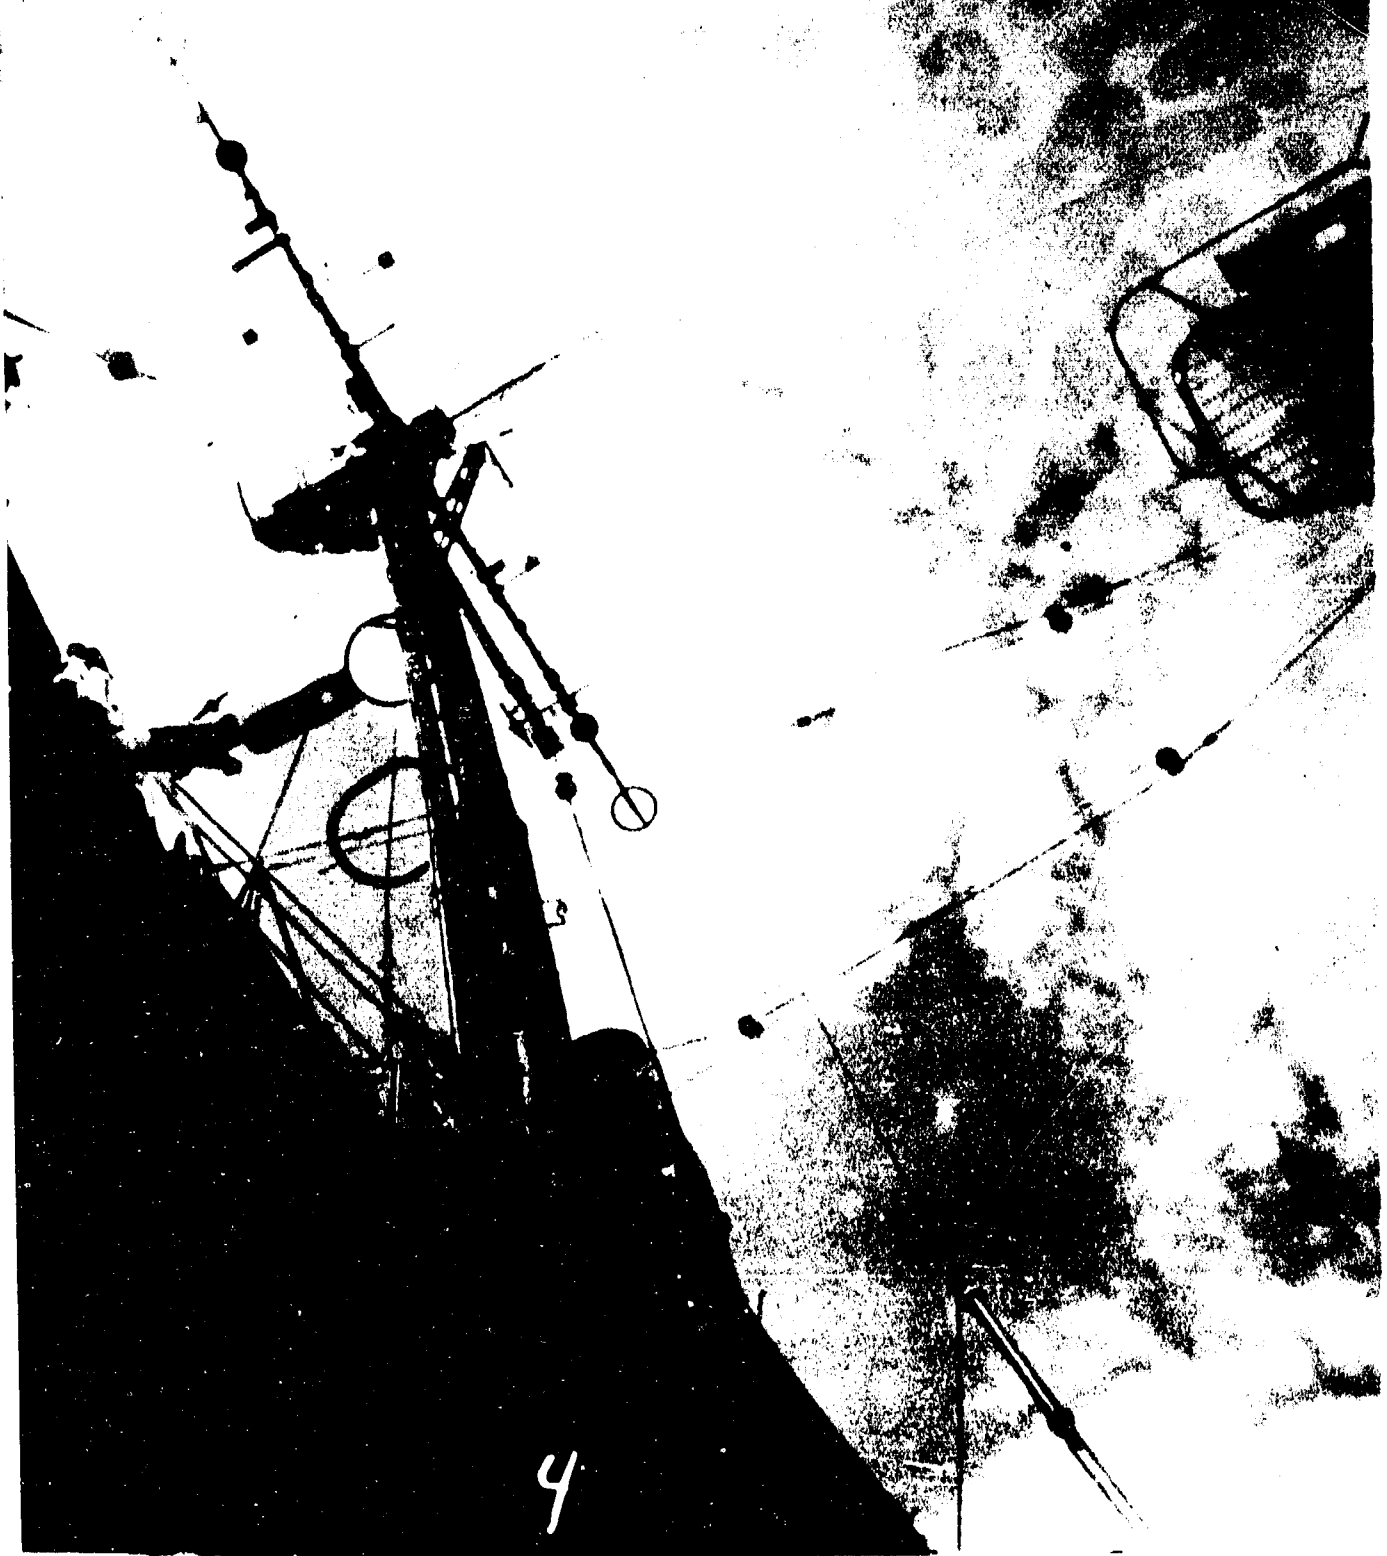
AA-CR-100-2198-4. U.S.S. HUGHES (DD410). View looking to starboard and up at foremast.

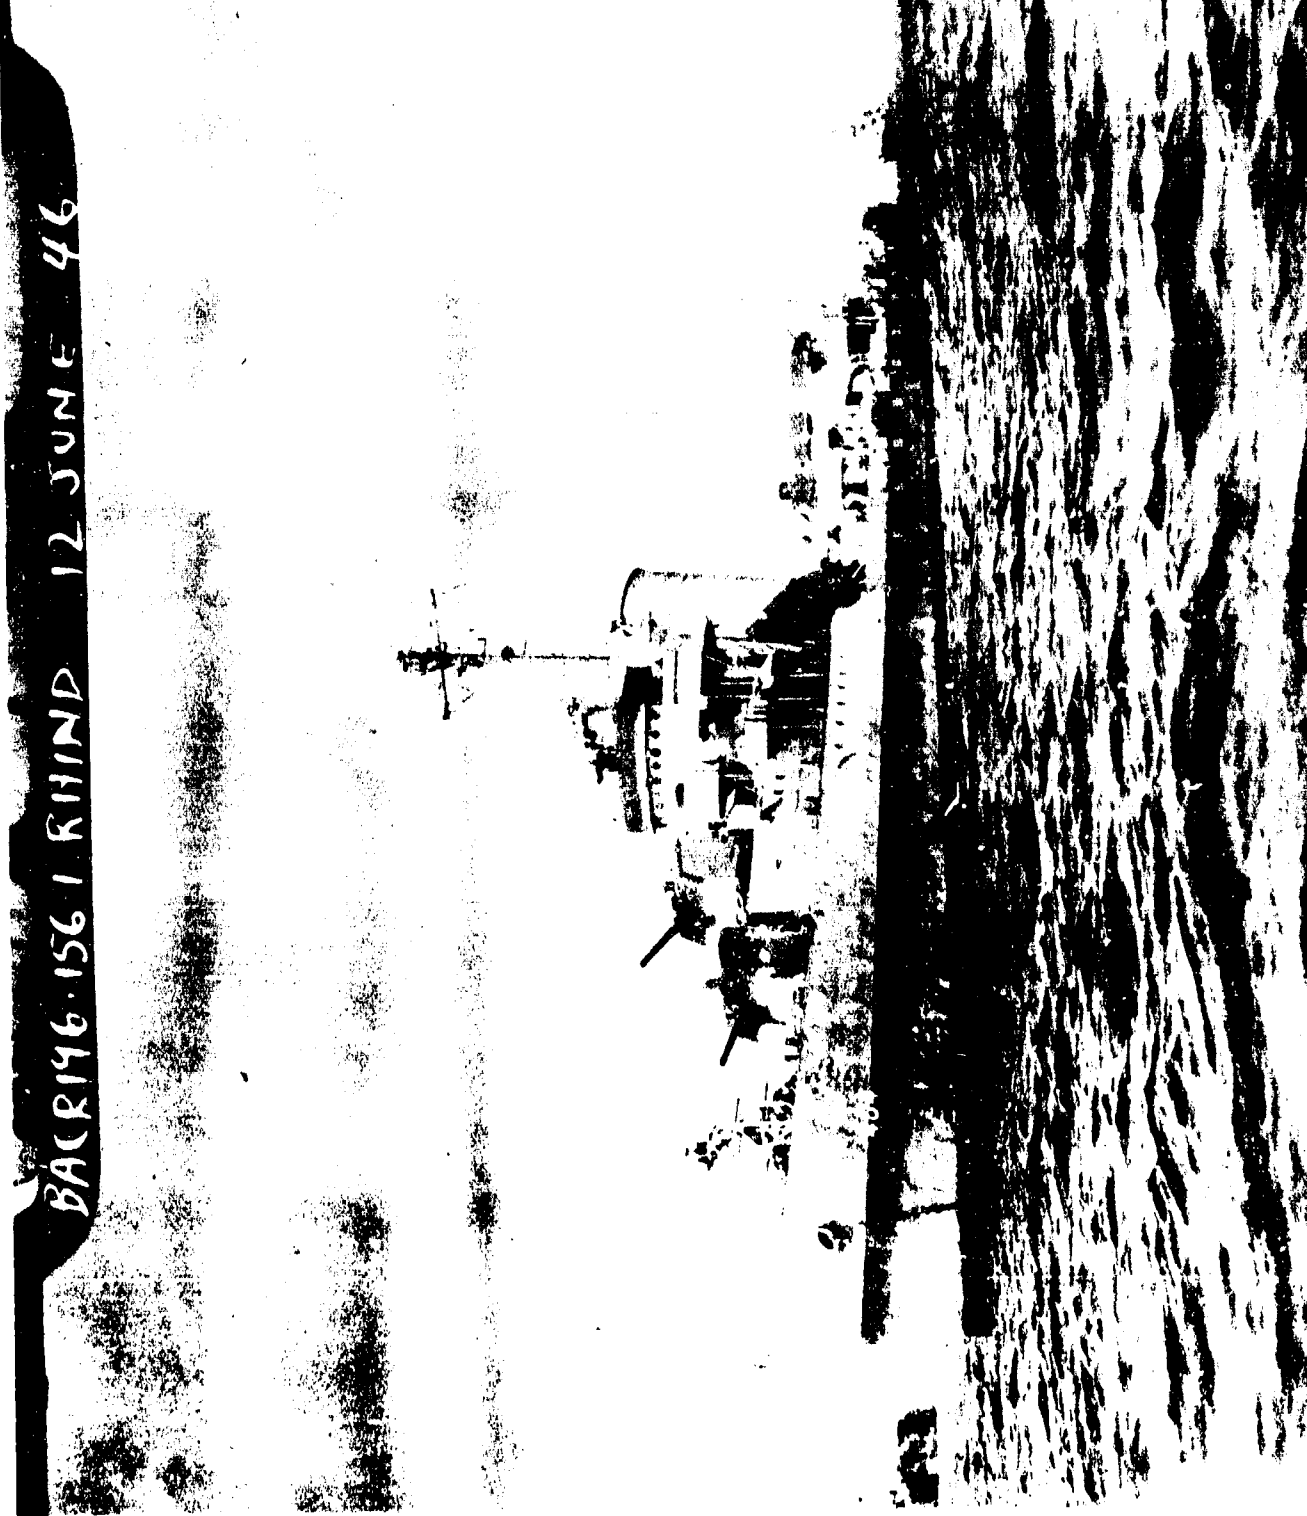
2. Photos 196-156-1, 227-49-137, 227-283-58 and 227-520-42; pages 184, 185, 186, and 187 are comparative views before and after Test A. In photos 227-283-58 and 227-520-42, pages 186 and 187, it appears that while the foremast and mainmast have been bent in the direction of the blast, the head of the foremast has been bent into the blast. Investigation showed that the foremast is cracked just below the yard. The position of the yardarm is relatively unchanged with respect to the upper portion of the mast which is askew to the main body of the mast. Radar on the starboard yardarm are gone but the upper stays are intact. All strand antennae are down and whip antennae are bent or broken. The main body of the foremast is about 10 degrees out of its normal position. The foremast is about 10 degrees out of its normal position. The foremast wave guide is twisted around the breakdown lights. There are bends, kinks nearly, in the foremast just above the padeyes to which the lower mast guys were secured about 12 feet above the brackets connecting the mast to the main deck. There are similar bends just at the tops of the brackets. The two 3/4 inch wire lower forward guys parted about 20 feet from the lower end. The remaining guys on this mast have approximately 14 inches slack. Photo 2200-9, page 188 shows the rigging and antennae still remaining and indicate that most of it is slack. Photo 2200-2, page 189 shows breaks in the cable guards at the navigating bridge level. Photo 2200-1, page 190 shows the frayed end in the lower portion of the starboard lower guy.

BA-CR-196-156-1. U.S.S. RHIND (DD404). View looking at port bow before Test Able.

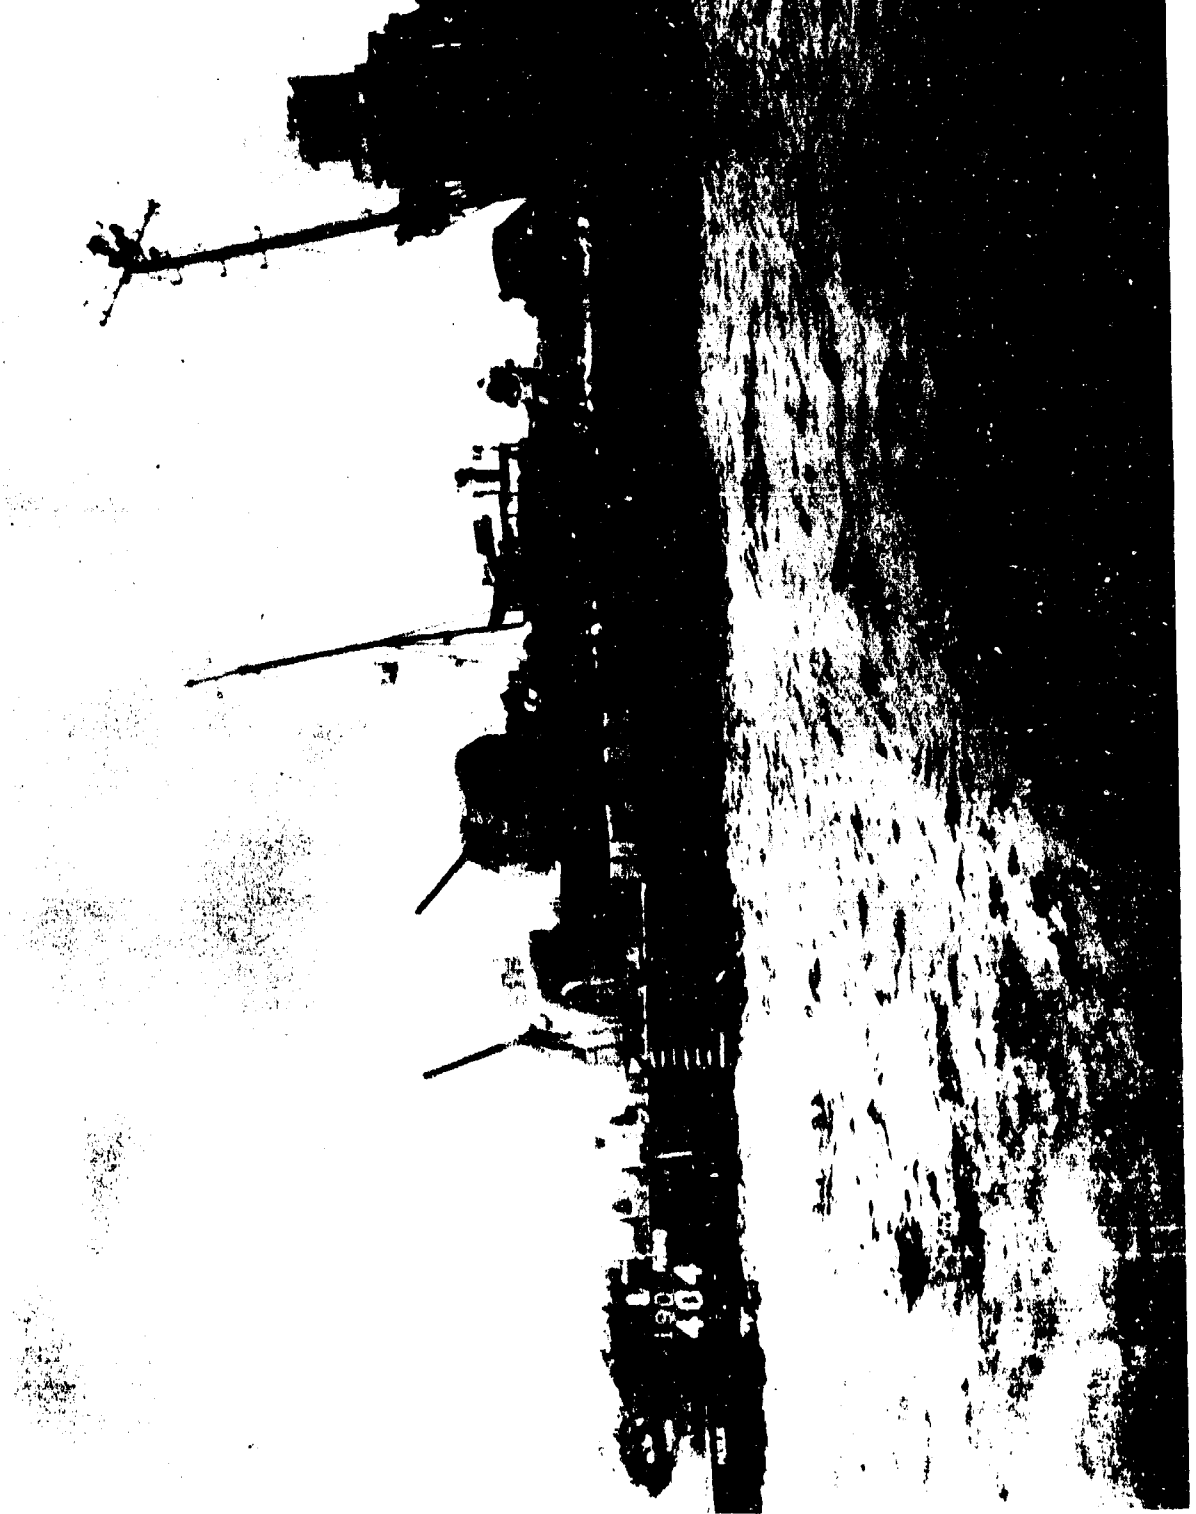
BB-CR-227-520-42. U.S.S. RHIND (DD404). View looking at starboard quarter, after Test A.
