7 BUREAU OF SHIPS GROUP
TECHNICAL INSPECTION REPORT

6 OPERATION CROSSROADS.
U.S.S. INDEPENDENCE (CVL22)

TEST ABLE,

VOLUME 1 OF 4 [U].

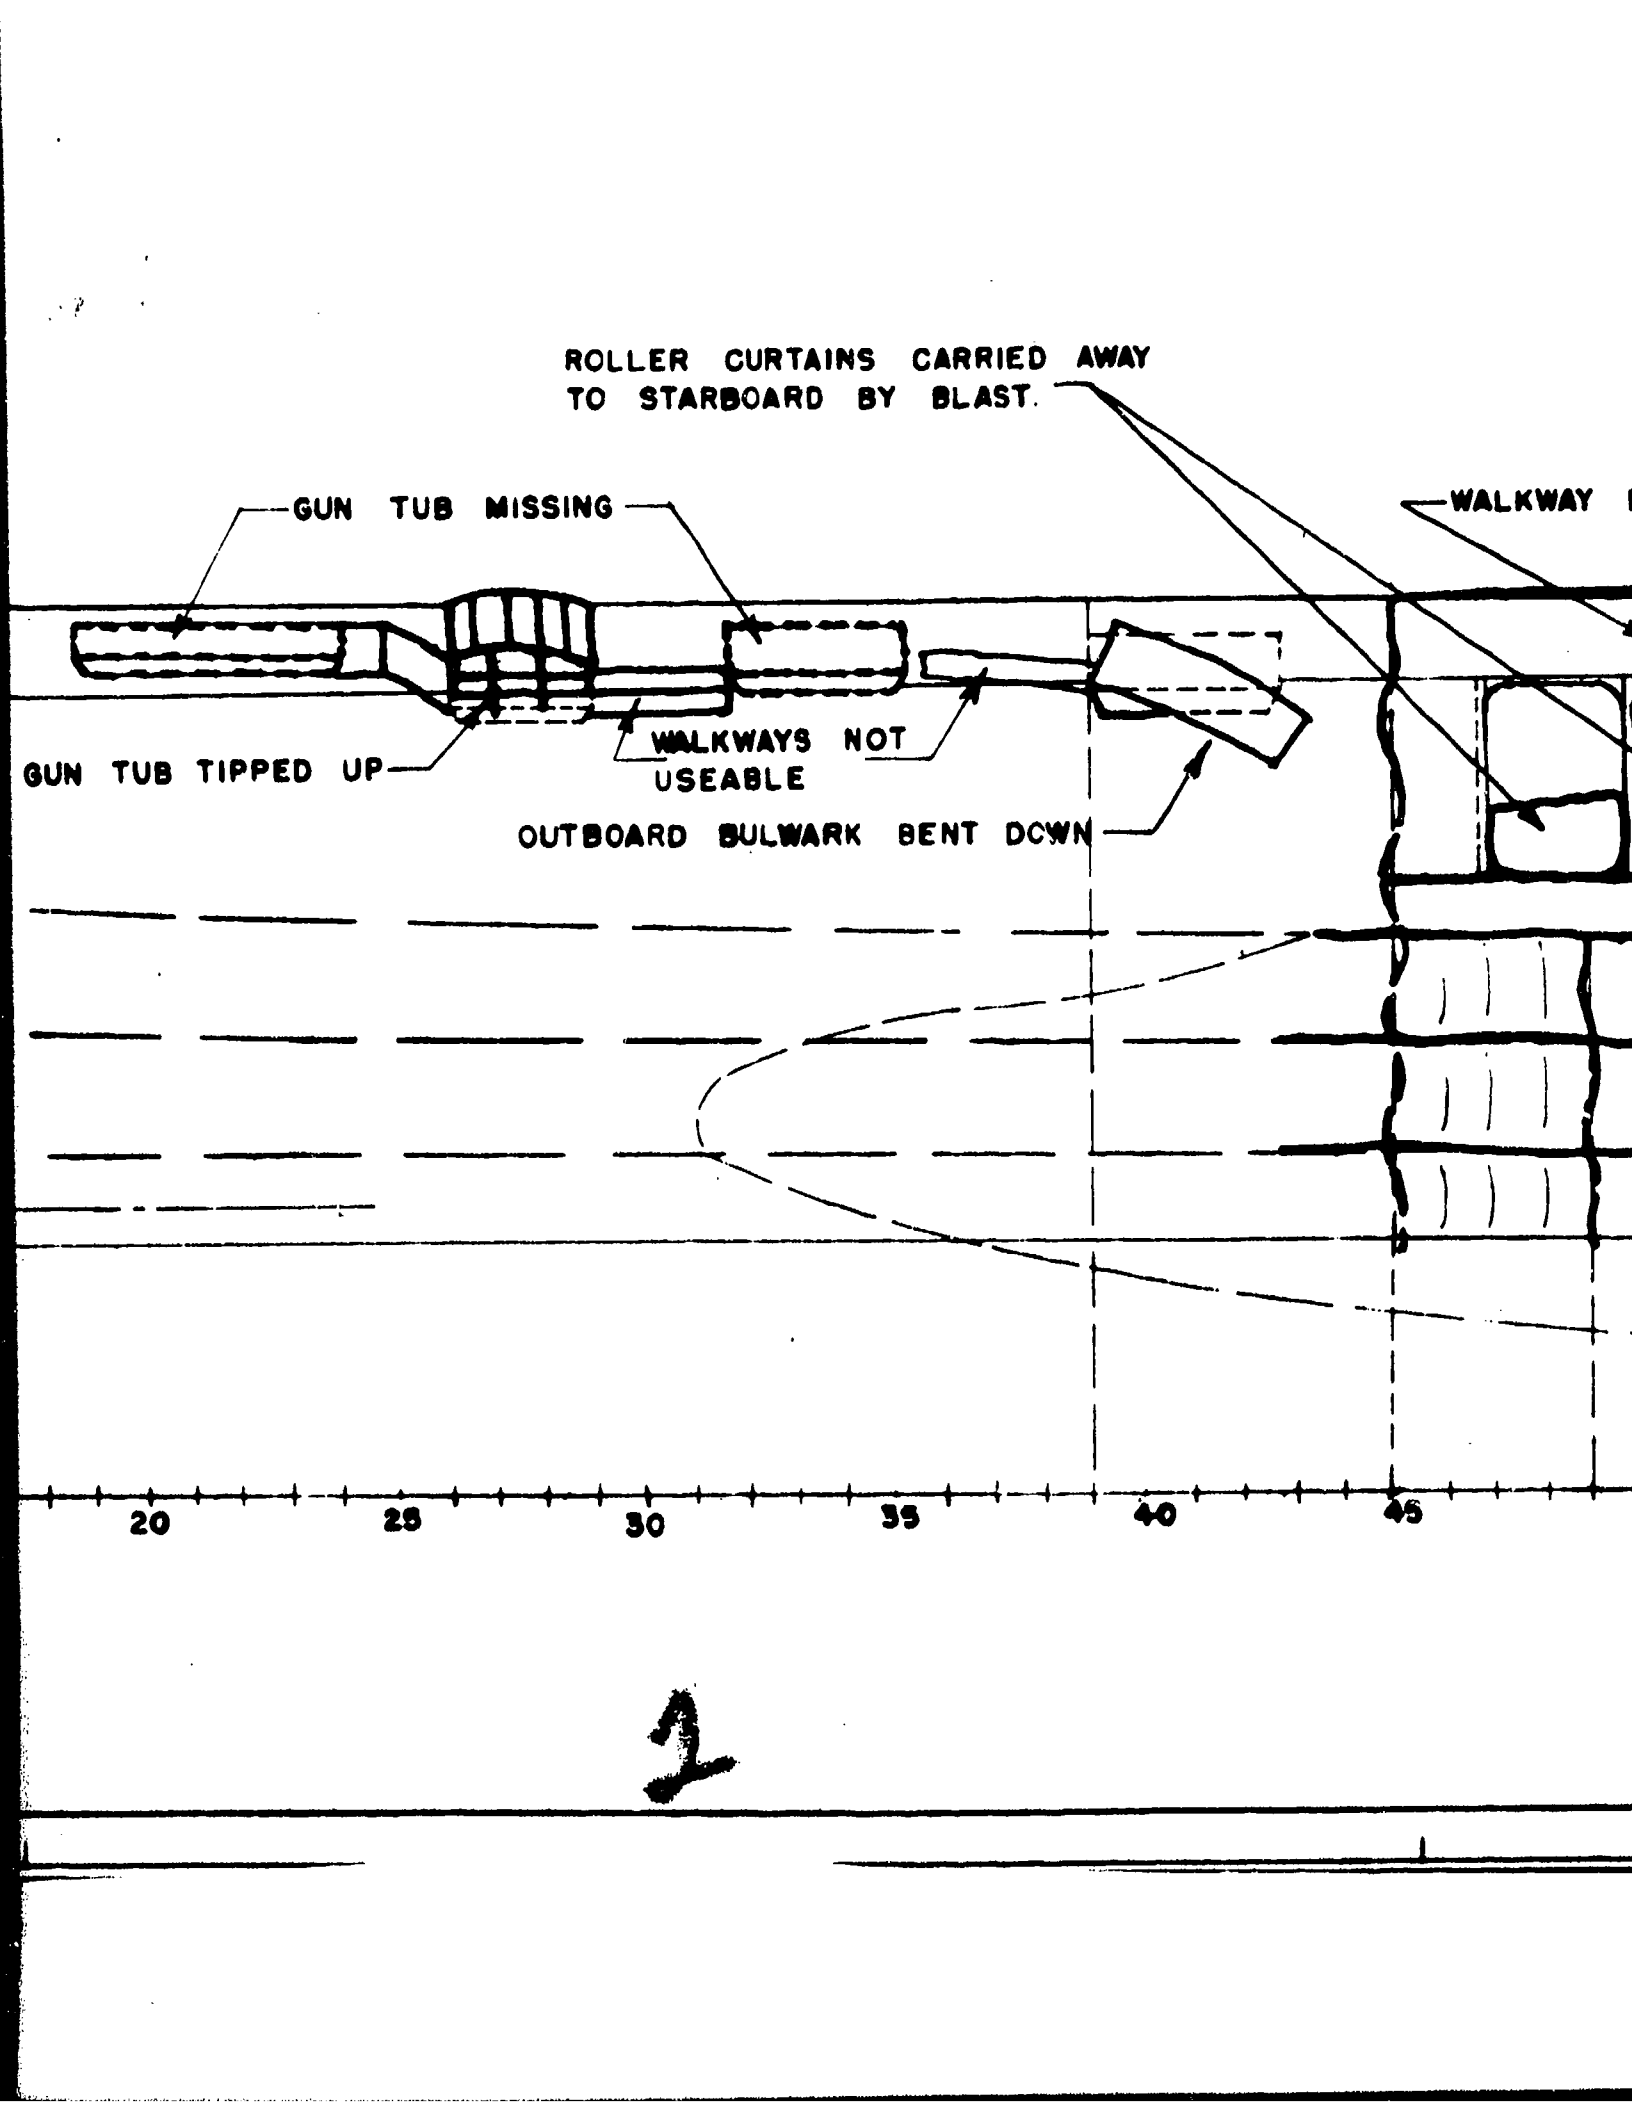
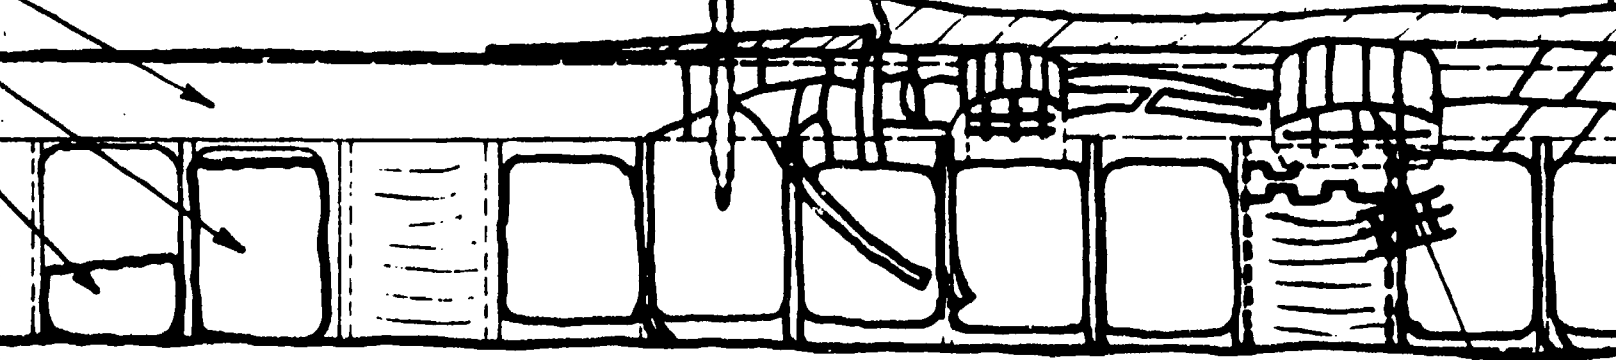
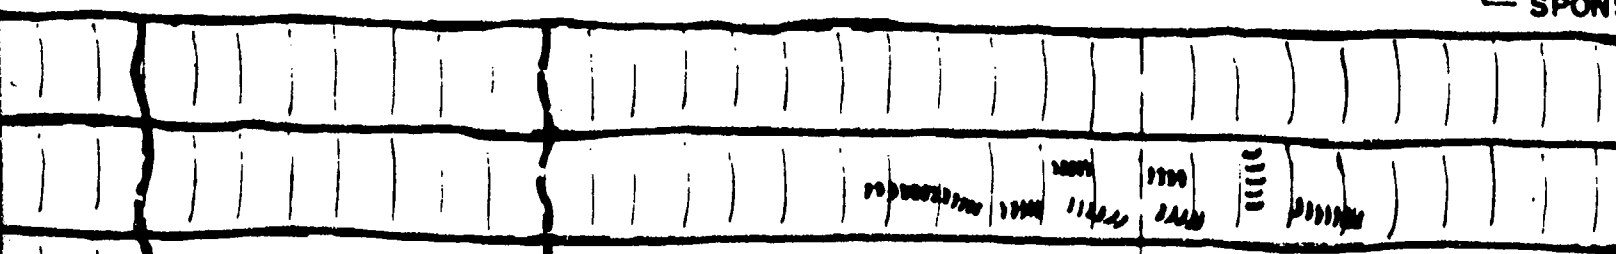
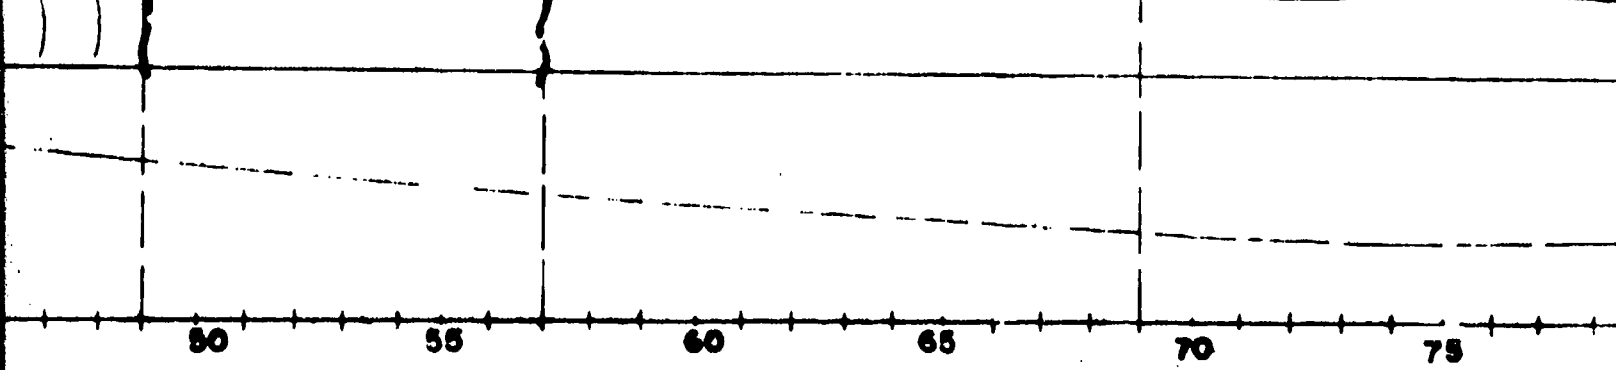
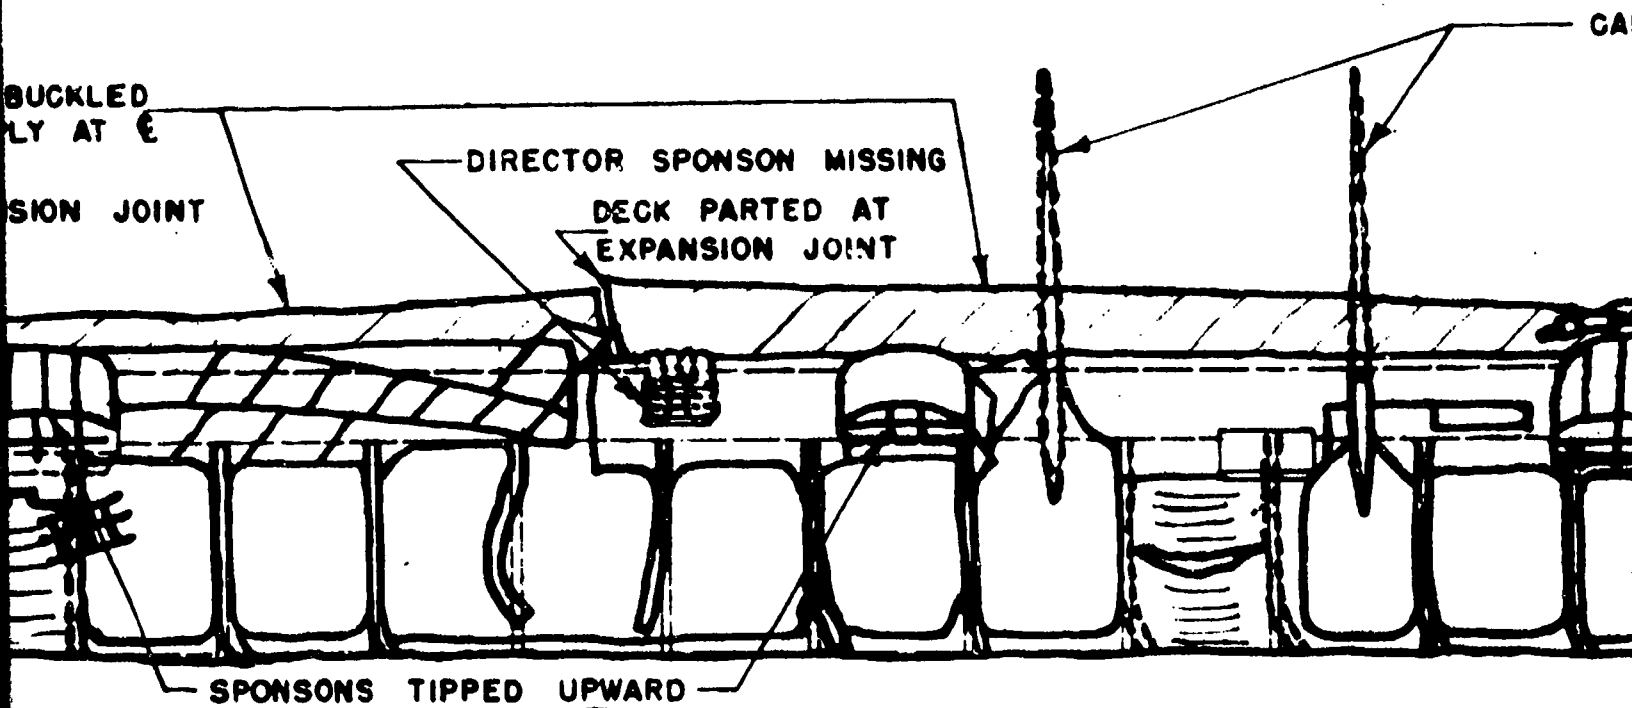
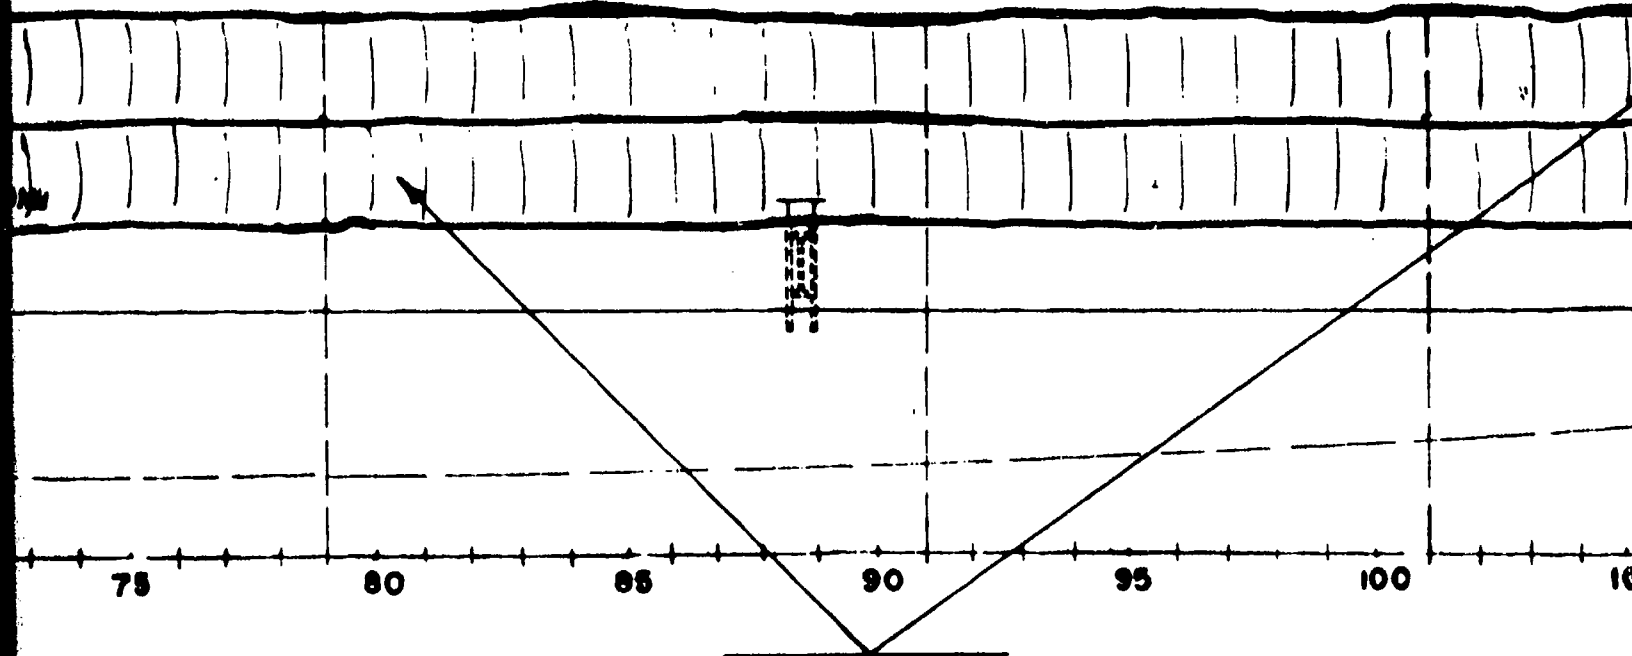
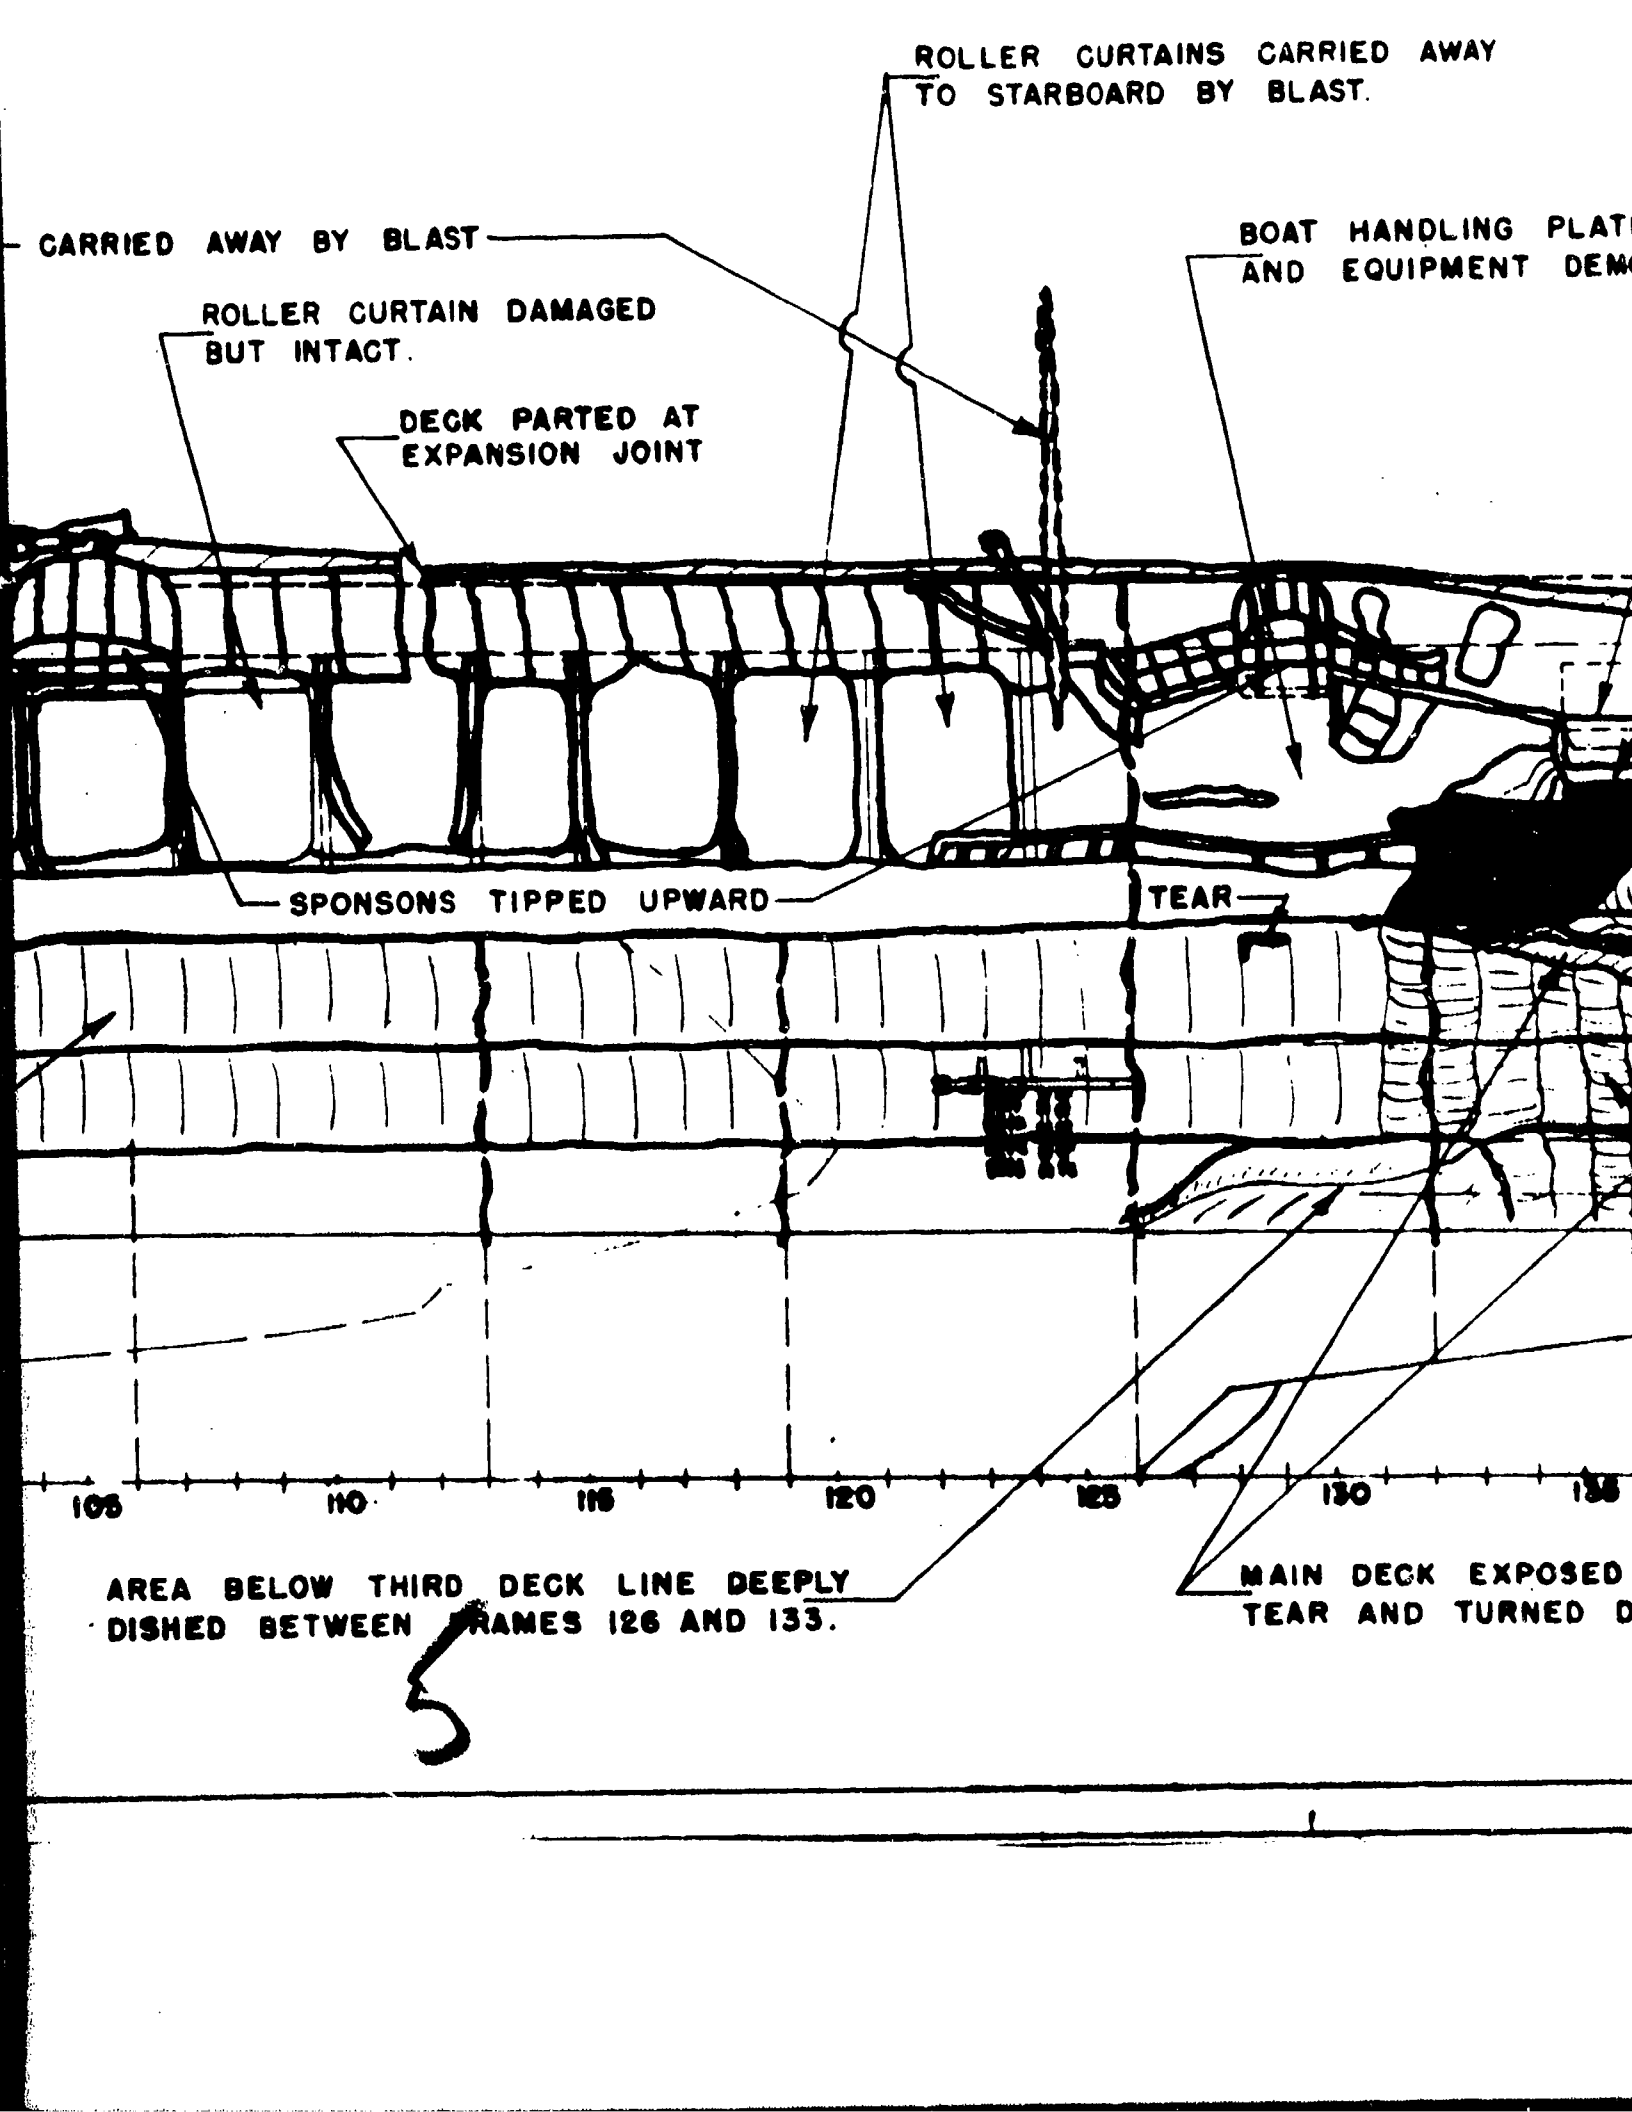
DAMAGE
PORT PROFILE
TEST A

CARRIED AWAY BY BLAST

FRAMES 56 TO 71, 74 TO 95, 98 TO 107,
AND 110 TO 118 CARRIED AWAY IN-
BOARD BY BLAST. WOBBLE BENTS
ADJACENT TO EXPANSION JOINTS TORN
AWAY FROM CONNECTION TO HANGAR DECK.
(FRAMES 62, 65, 83, 86, 110 AND 113).

BLISTER PLATING DISHED AFT OF FRAME 45
BETWEEN LONGITUDINAL FLATS AT MAIN,
SECOND AND THIRD DECKS LEVELS.

ROLLER CURTAIN DAMAGED BUT INTACT.

BOAT HANDLING PLATFORM
AND EQUIPMENT DEMOLISHED

40MM GUN PLATFORM
TIPPED DOWN WITH
OUTBOARD BULWARK MISSING.

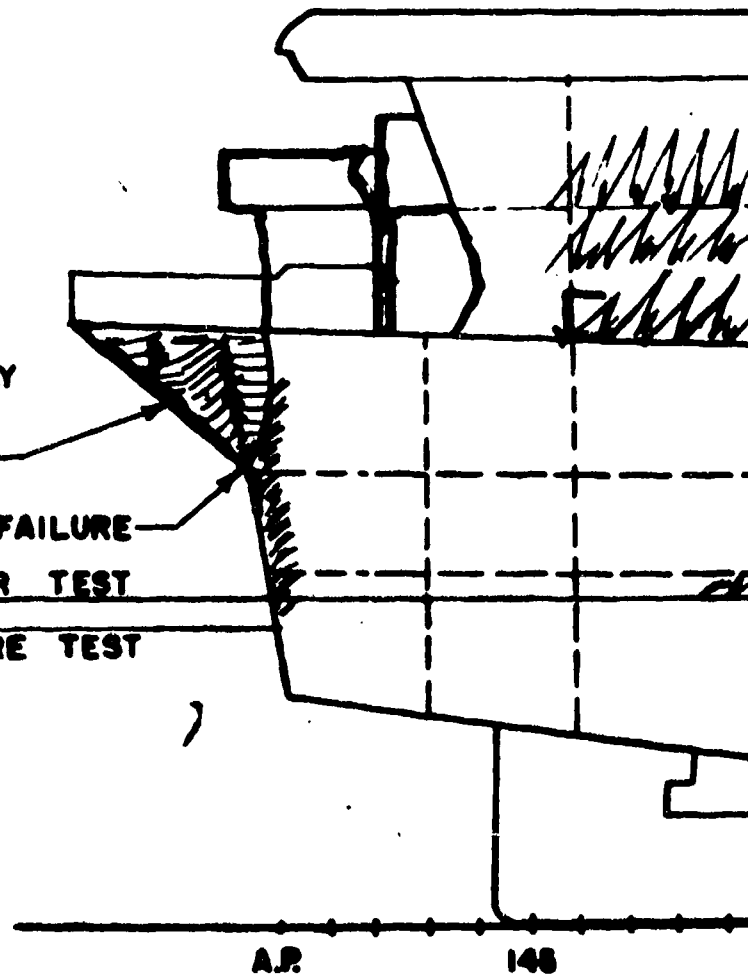
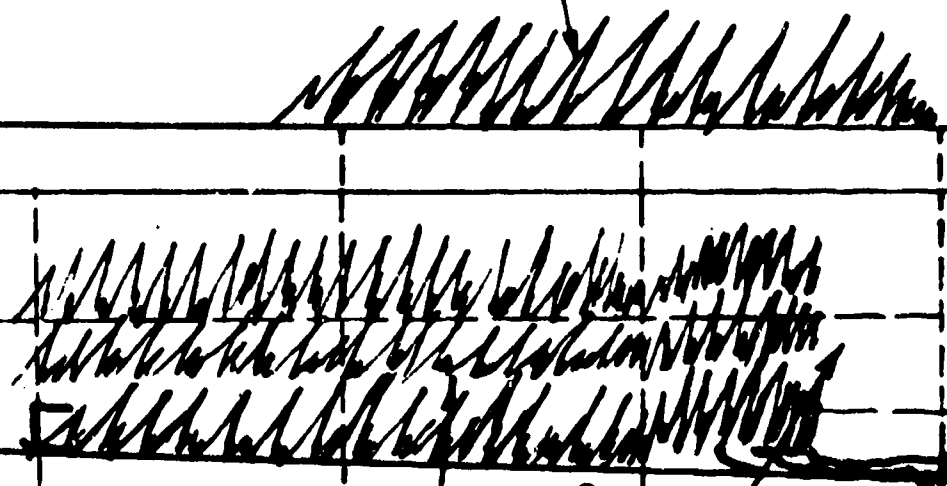
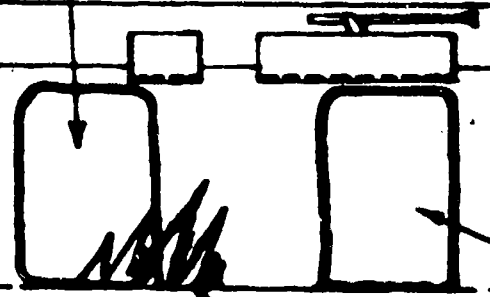
UPWARD DEFLECTION APPARENTLY
CAUSED BY REFLECTION OF
BLAST FROM WATER.

SEAM FAILURE

MAIN DECK COVERING IGNITED BY
FROM FIRE BELOW.

TEAR IN PLATING

SHEAR WRINKLES ALONG WATERLINE

ABOVE MAIN DK. AFT OF BHD. 126 ARE
BY FIRE. 12 TORPEDOES BURNED OR
WITH LOW ORDER DETONATIONS.

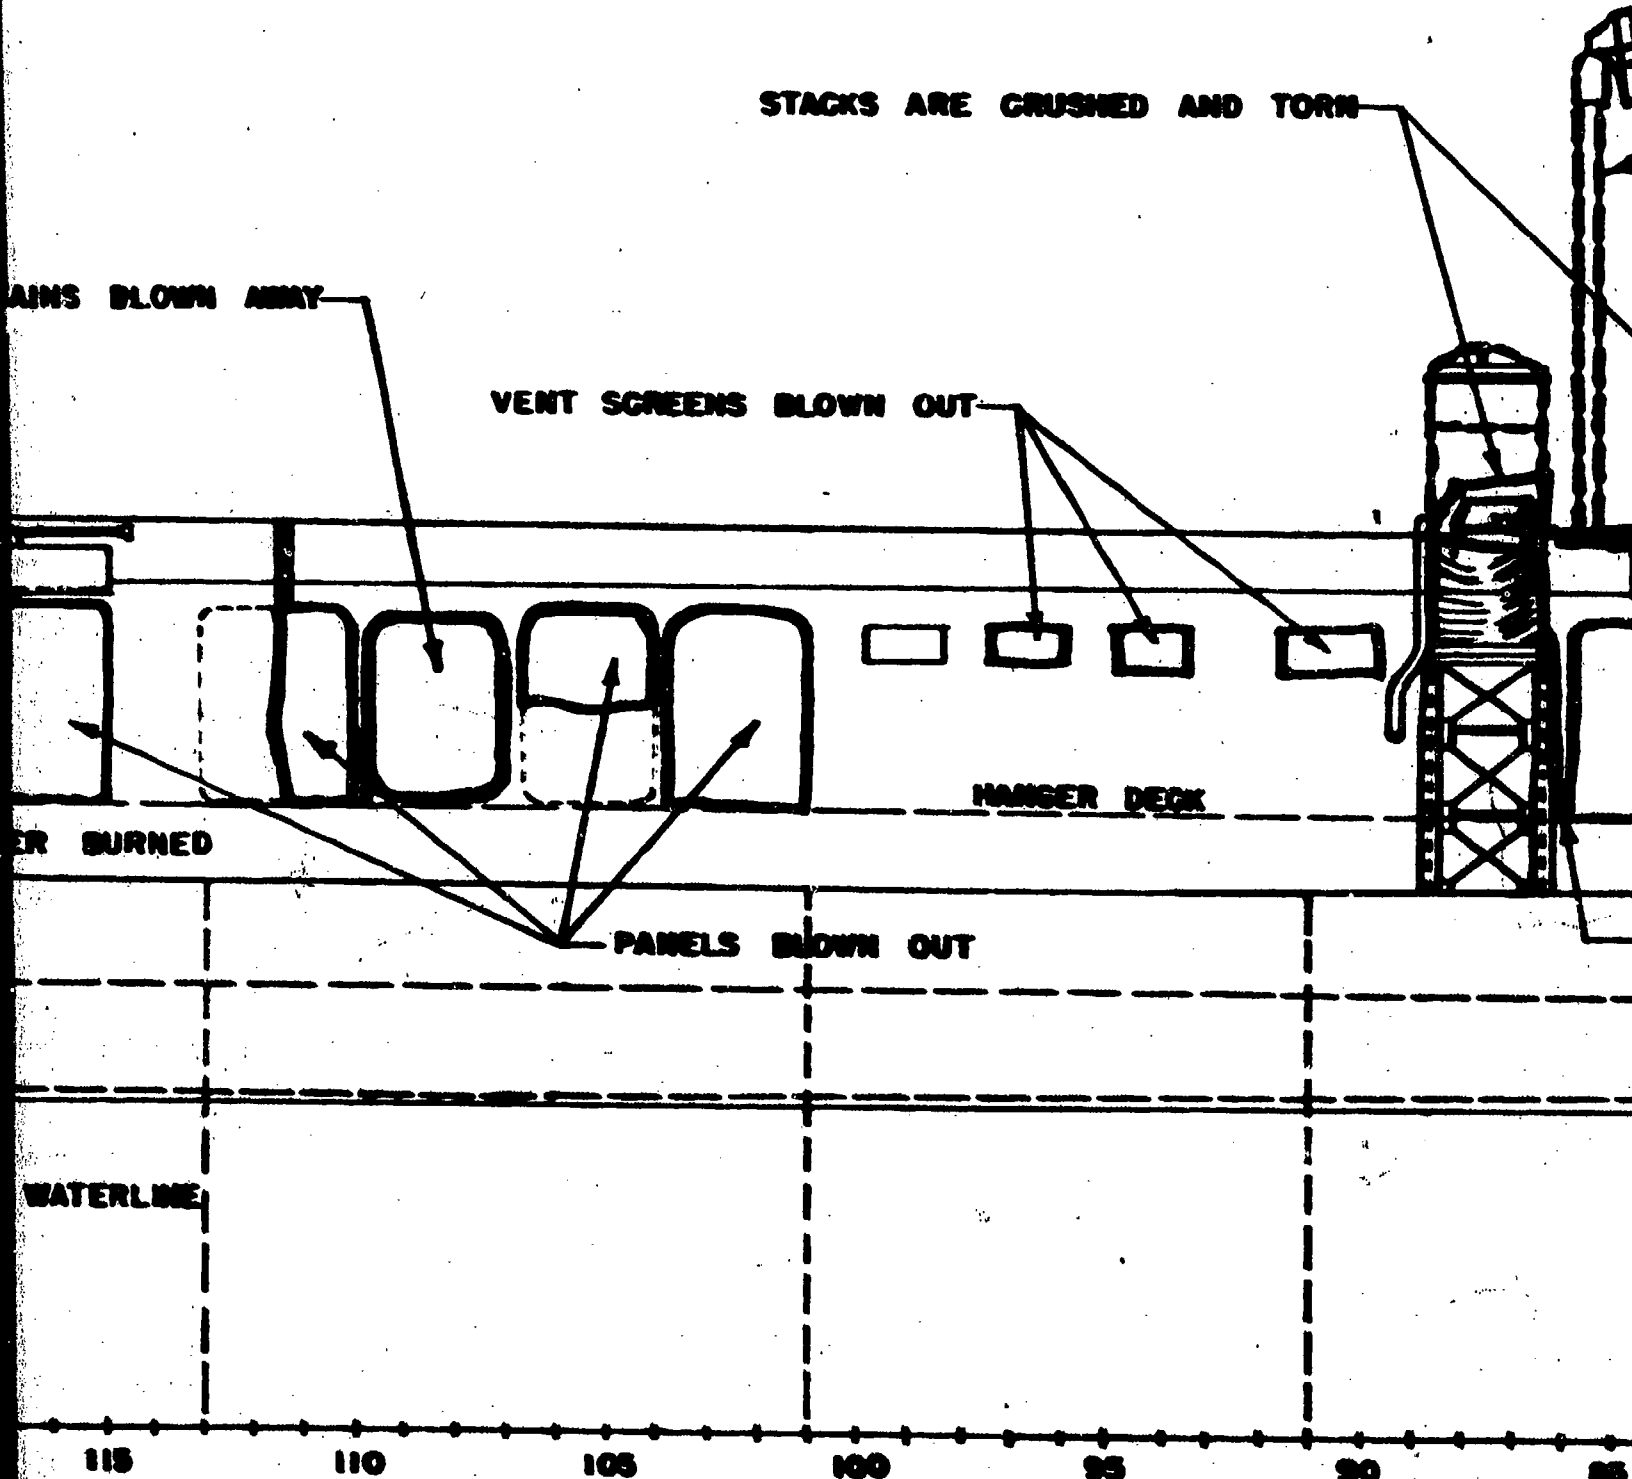
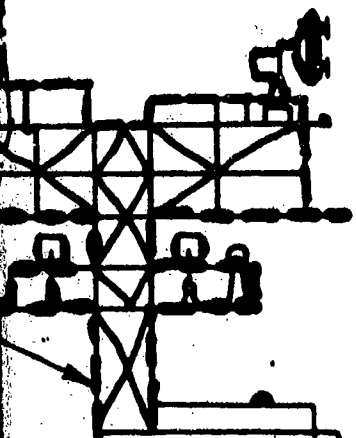
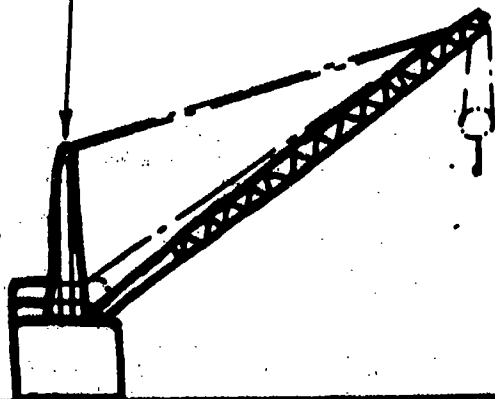
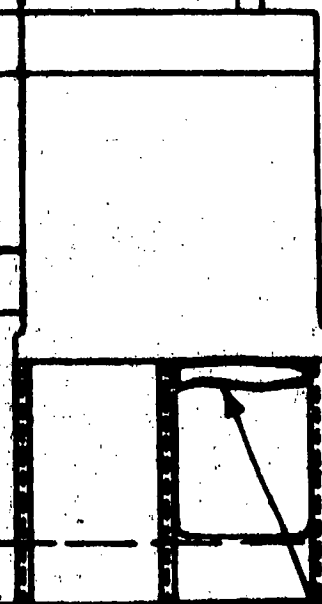
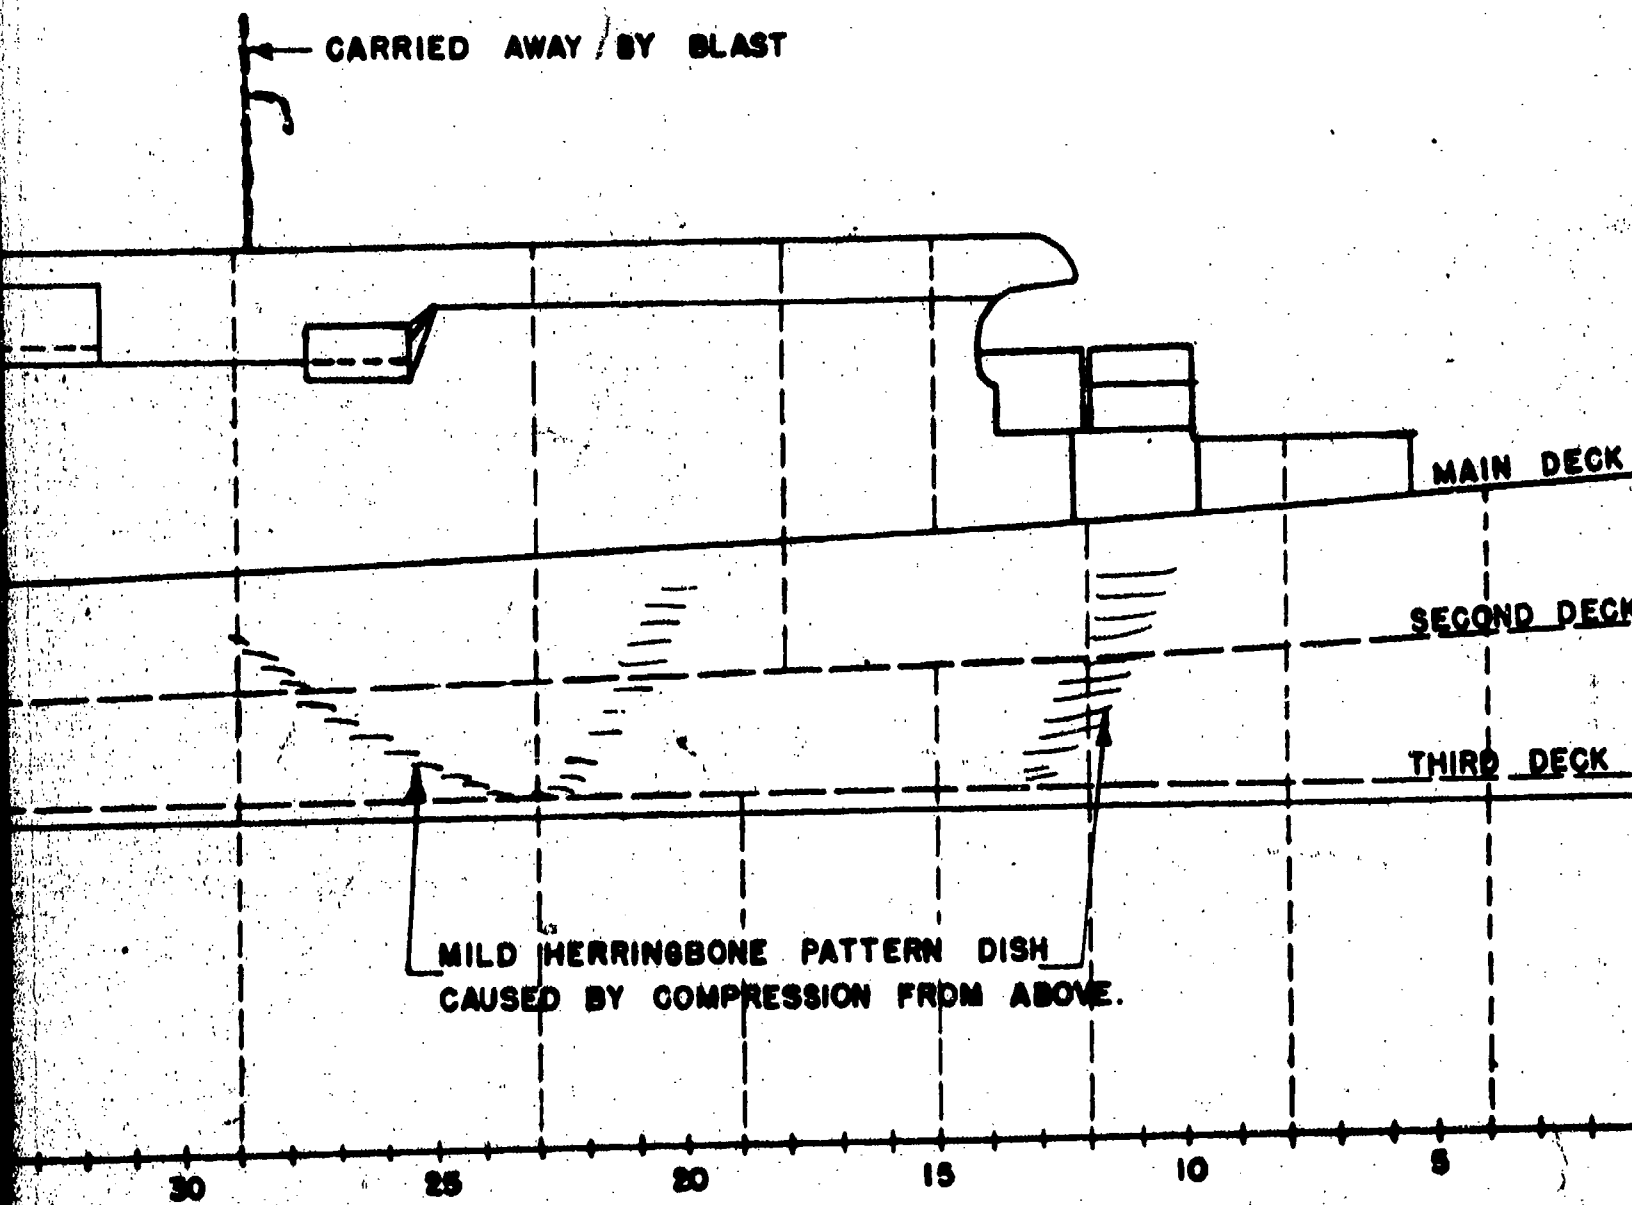
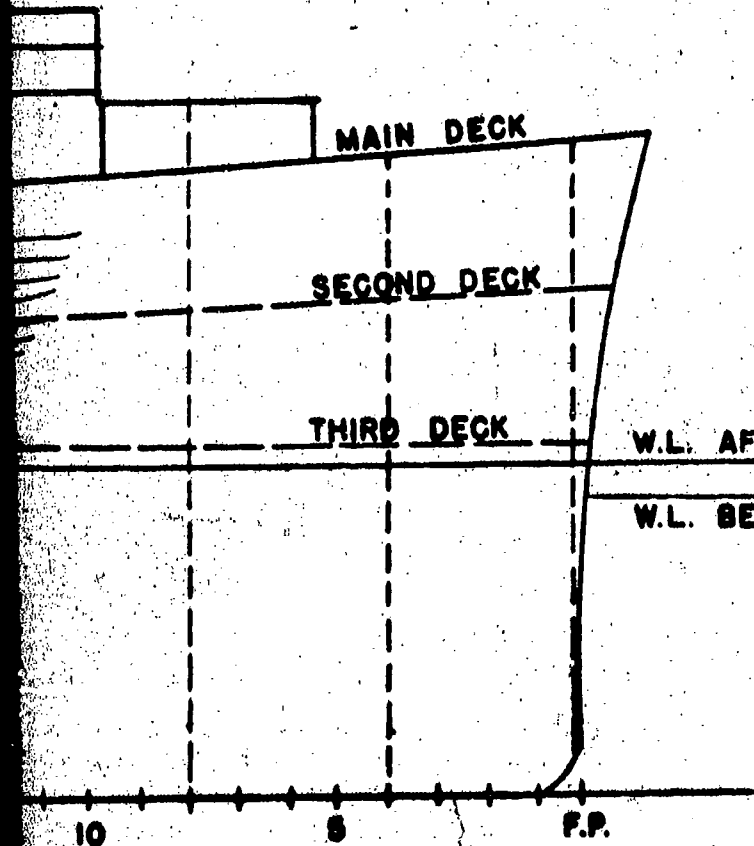
DAMAGE
STARBOARD PROFILE
TEST A

STACKS ARE BLOWN TO STBD,
CRUSHED, AND TORN.

DEFLECTED SLIGHTLY TO STBD.

ROLLER CURTAINS
BLOWN AWAY

MILD HERRINGBONE PATTERN DISH
CAUSED BY COMPRESSION FROM ABOVE.

W.L. AFTER TEST DUE TO 5° STBD. LIST.

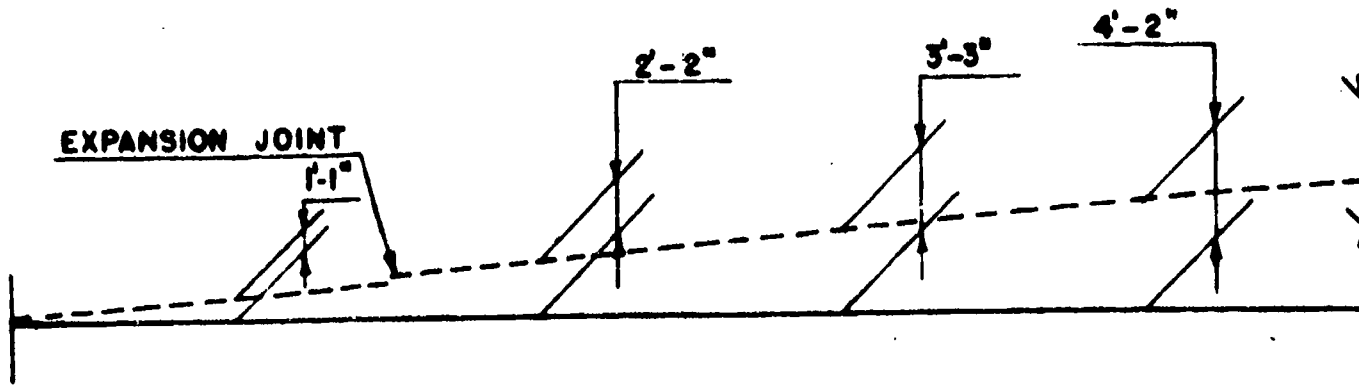
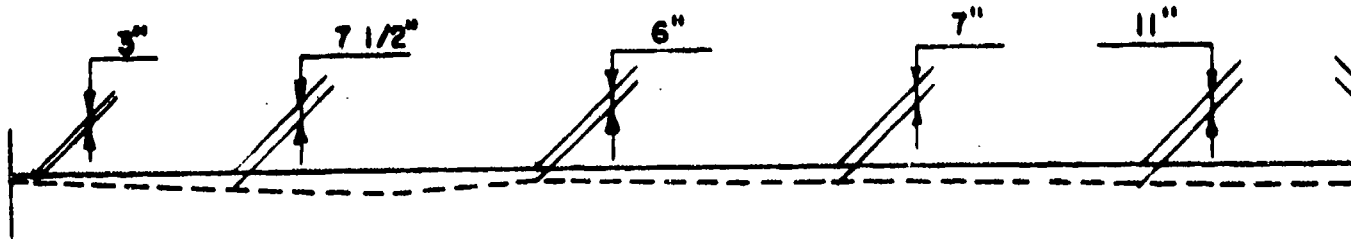
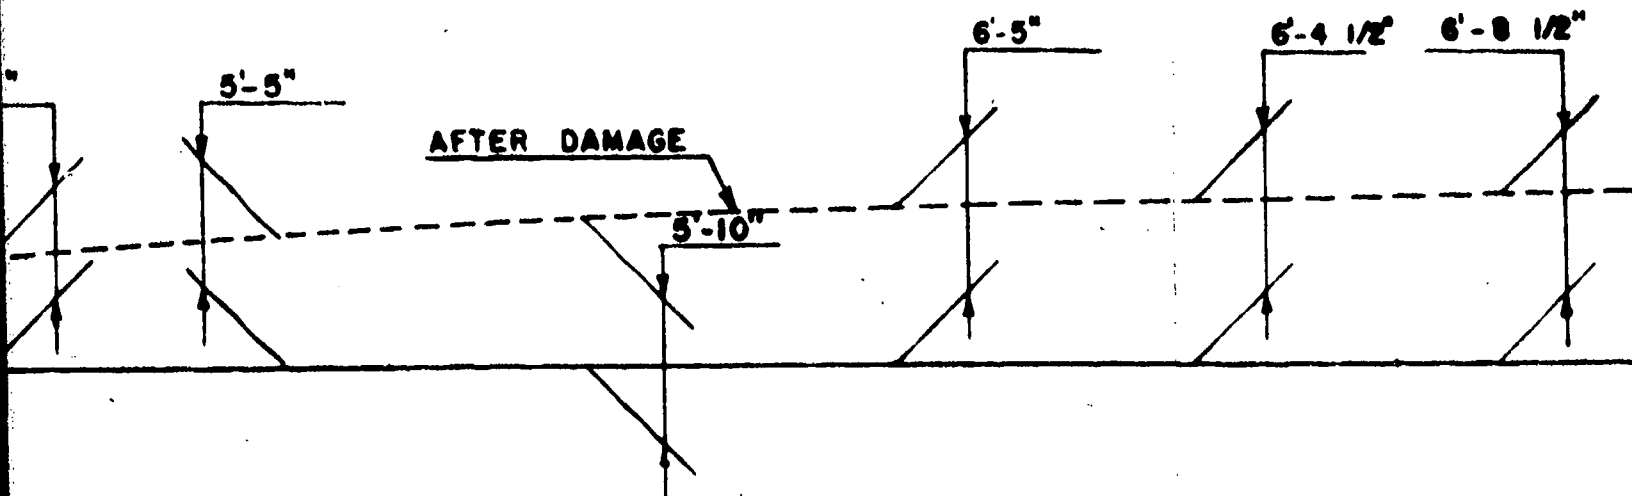
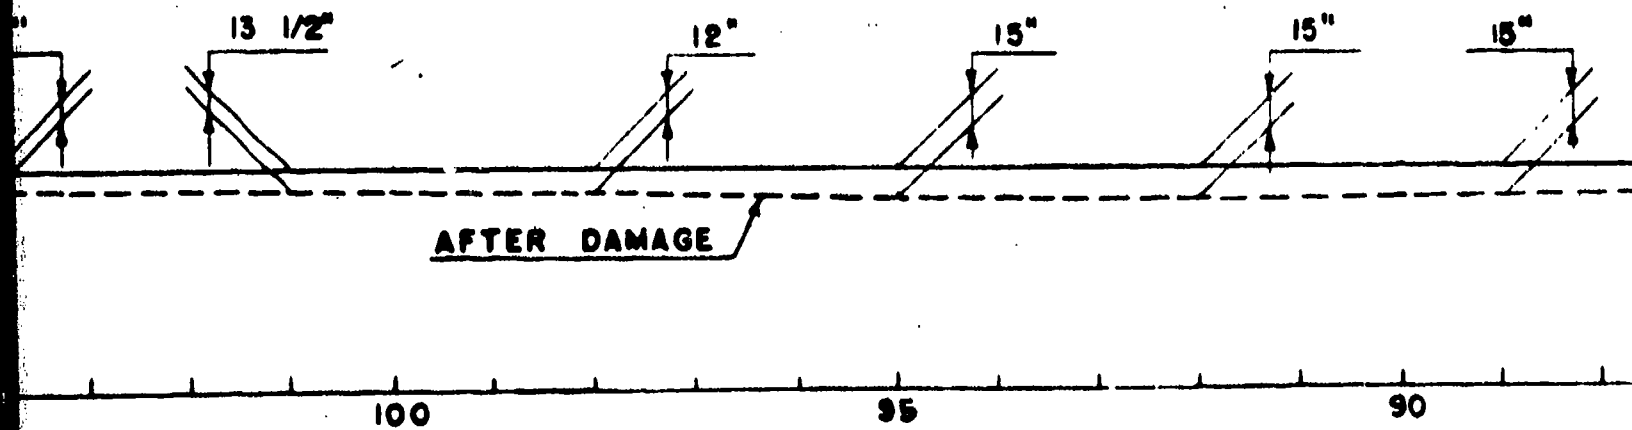
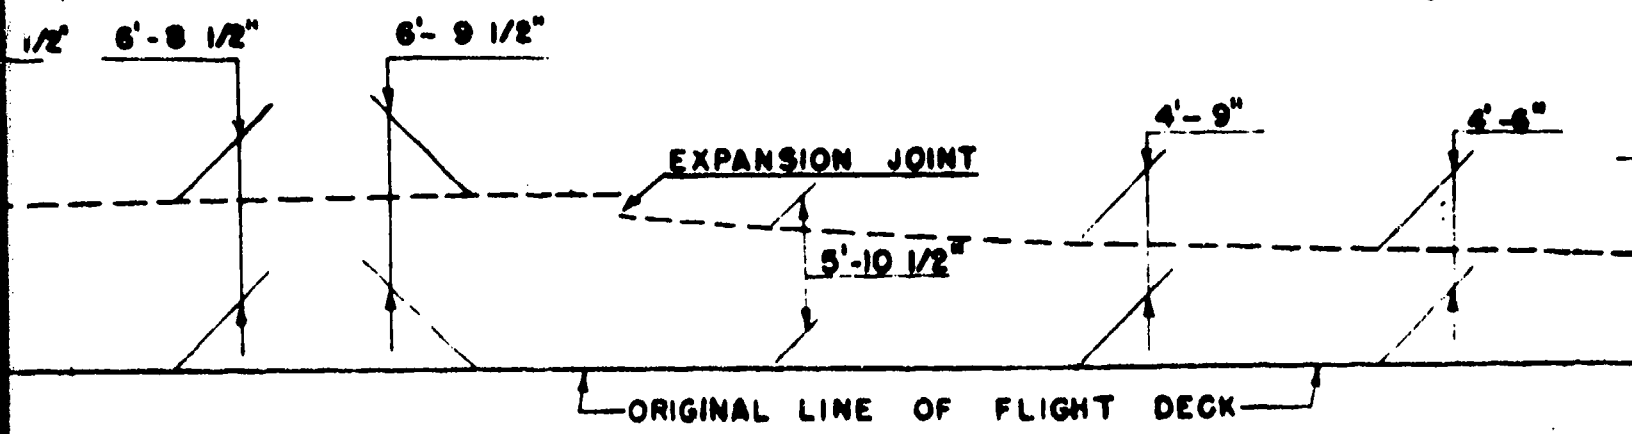
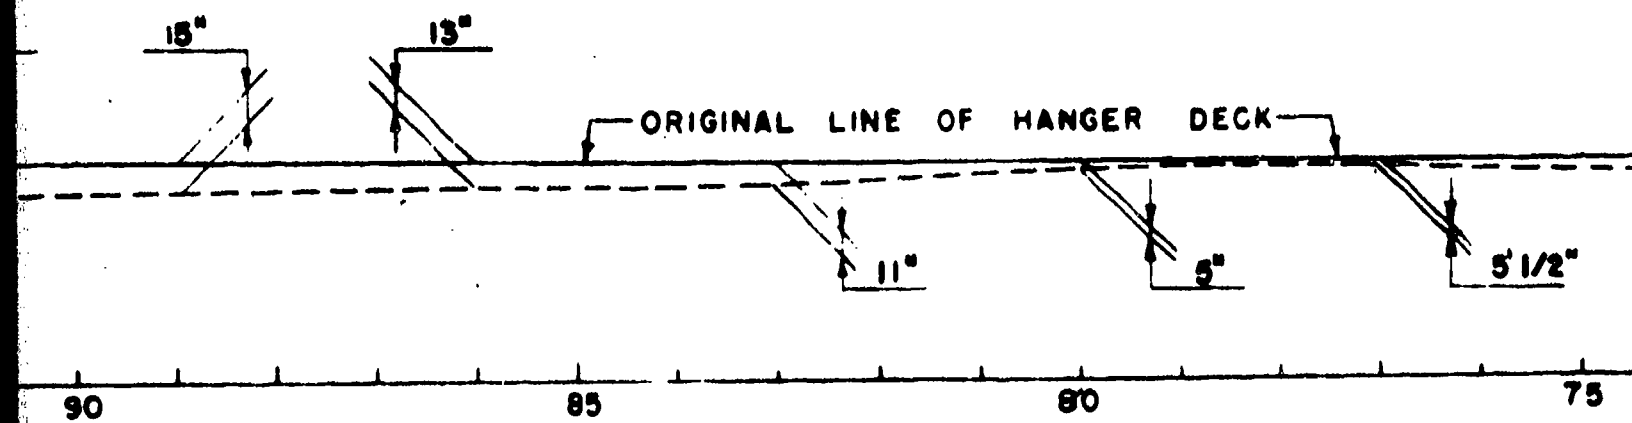
PLATE NO. 3

ELEVATION
 FLIGHT DECK & HANGER DECK CENTER
