7 BUREAU OF SHIPS GROUP
TECHNICAL INSPECTION REPORT

6 OPERATION CROSSROADS.
U.S.S. INDEPENDENCE (CVL22)

TEST ABLE,

VOLUME 1 OF 4 [U].

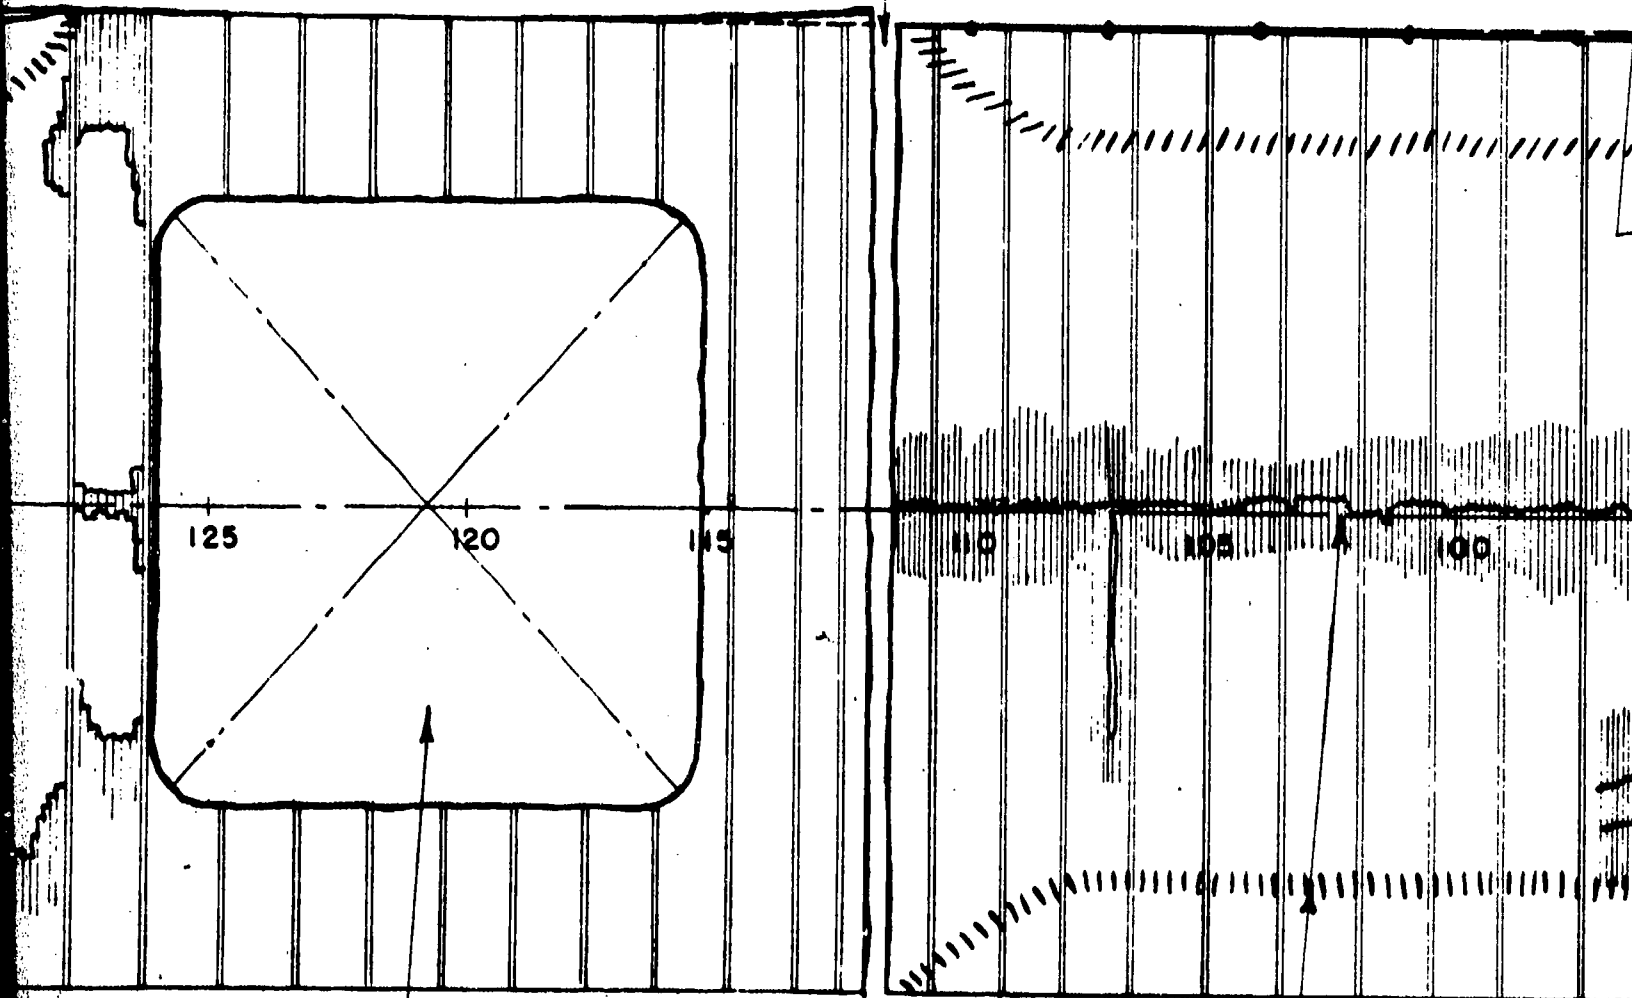
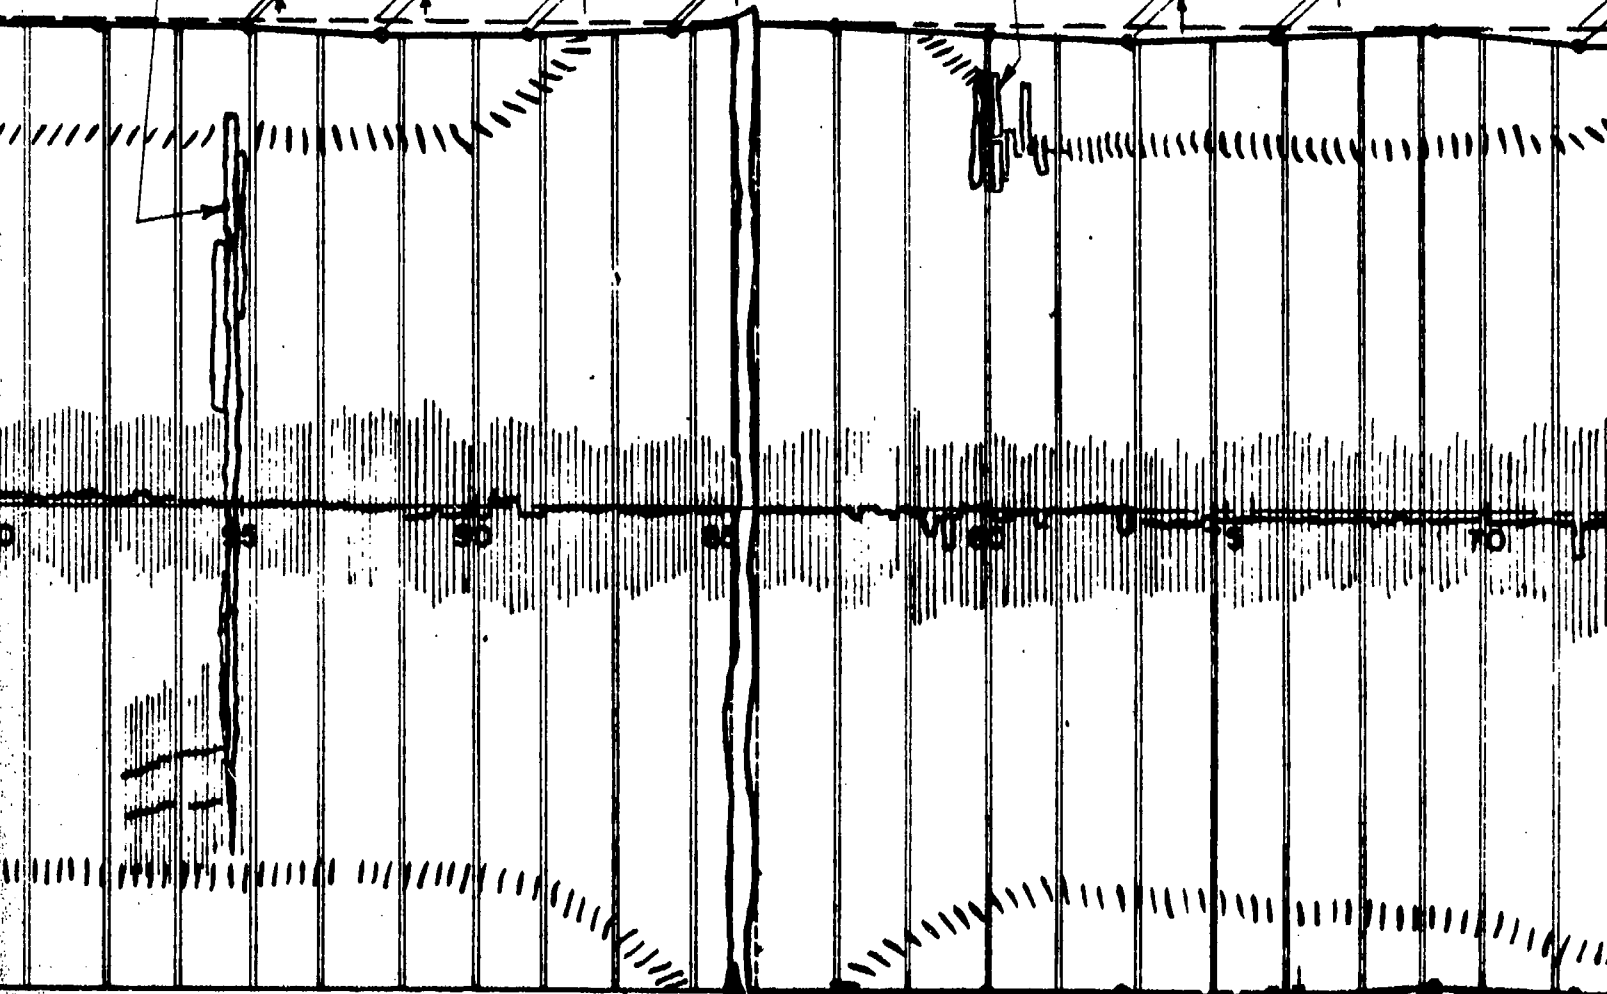
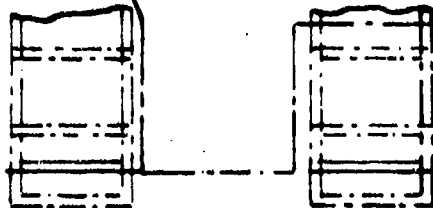
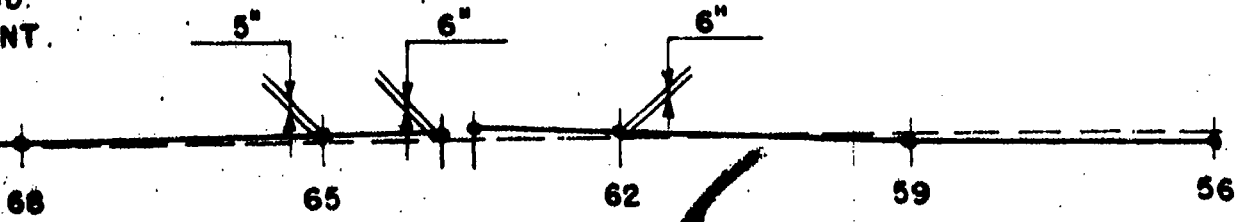
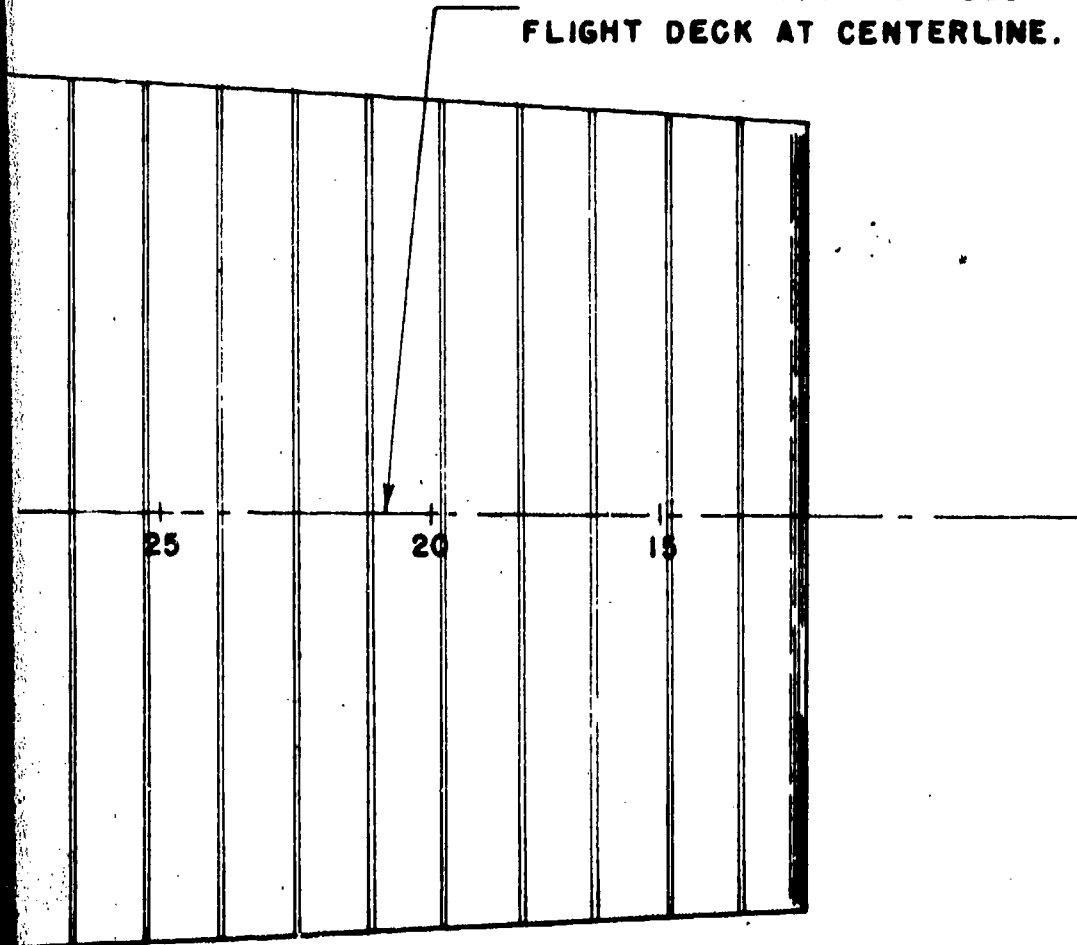
PLATE NO. 4

APT OF FRAME 137 MISSING FROM
DECK EDGE 18 FEET INBOARD.

FLIGHT DECK BADLY WARPED AND
WOOD DECKING BURNED FROM
BELOW.

EXPANSION JOINT FLEXED AND DISTORTED.

5 LB. PLATING TORN ACROSS RAISED PORTION OF DECK BETWEEN FRAMES 95 AND 96. SEE PHOTO. PAGES 201 AND 202

EXPANSION JOINT DISTORTED AND SPREAD APART.

ISLAND SEVERELY DAMAGED AND TOP-HAMPER MISSING

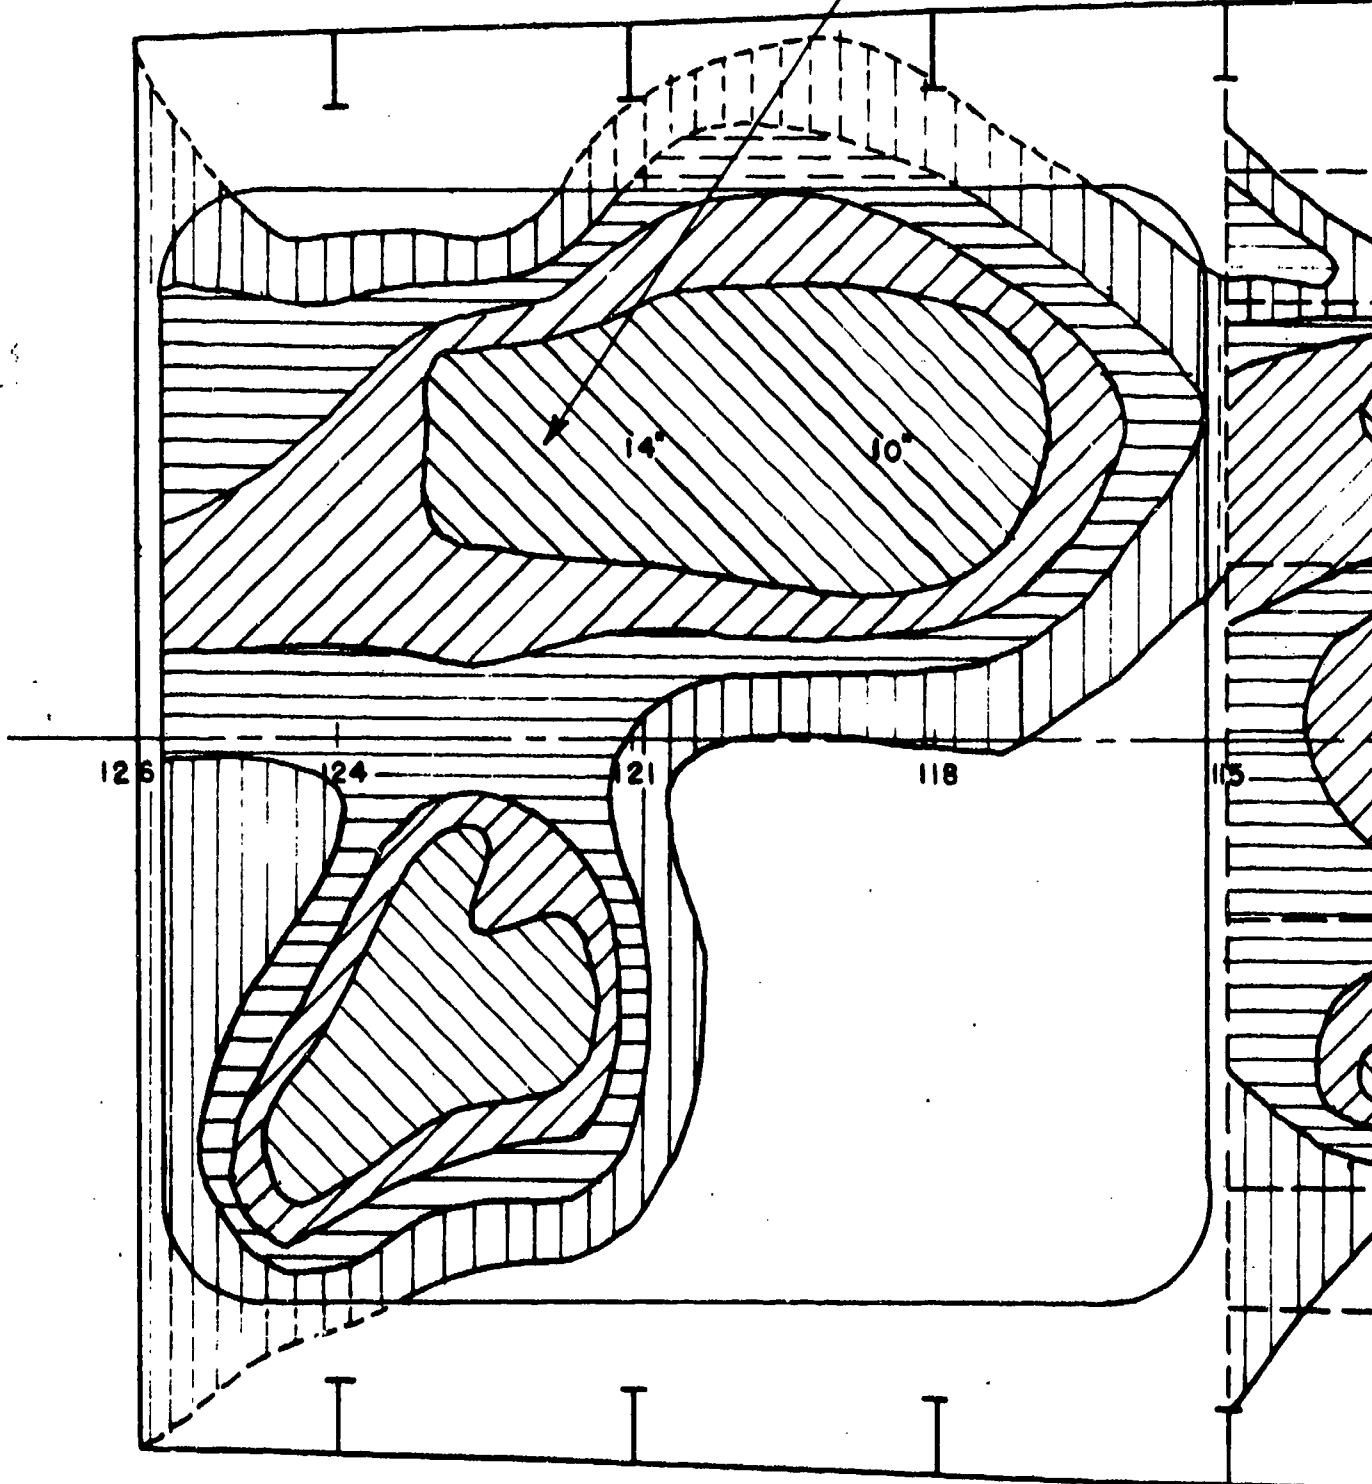
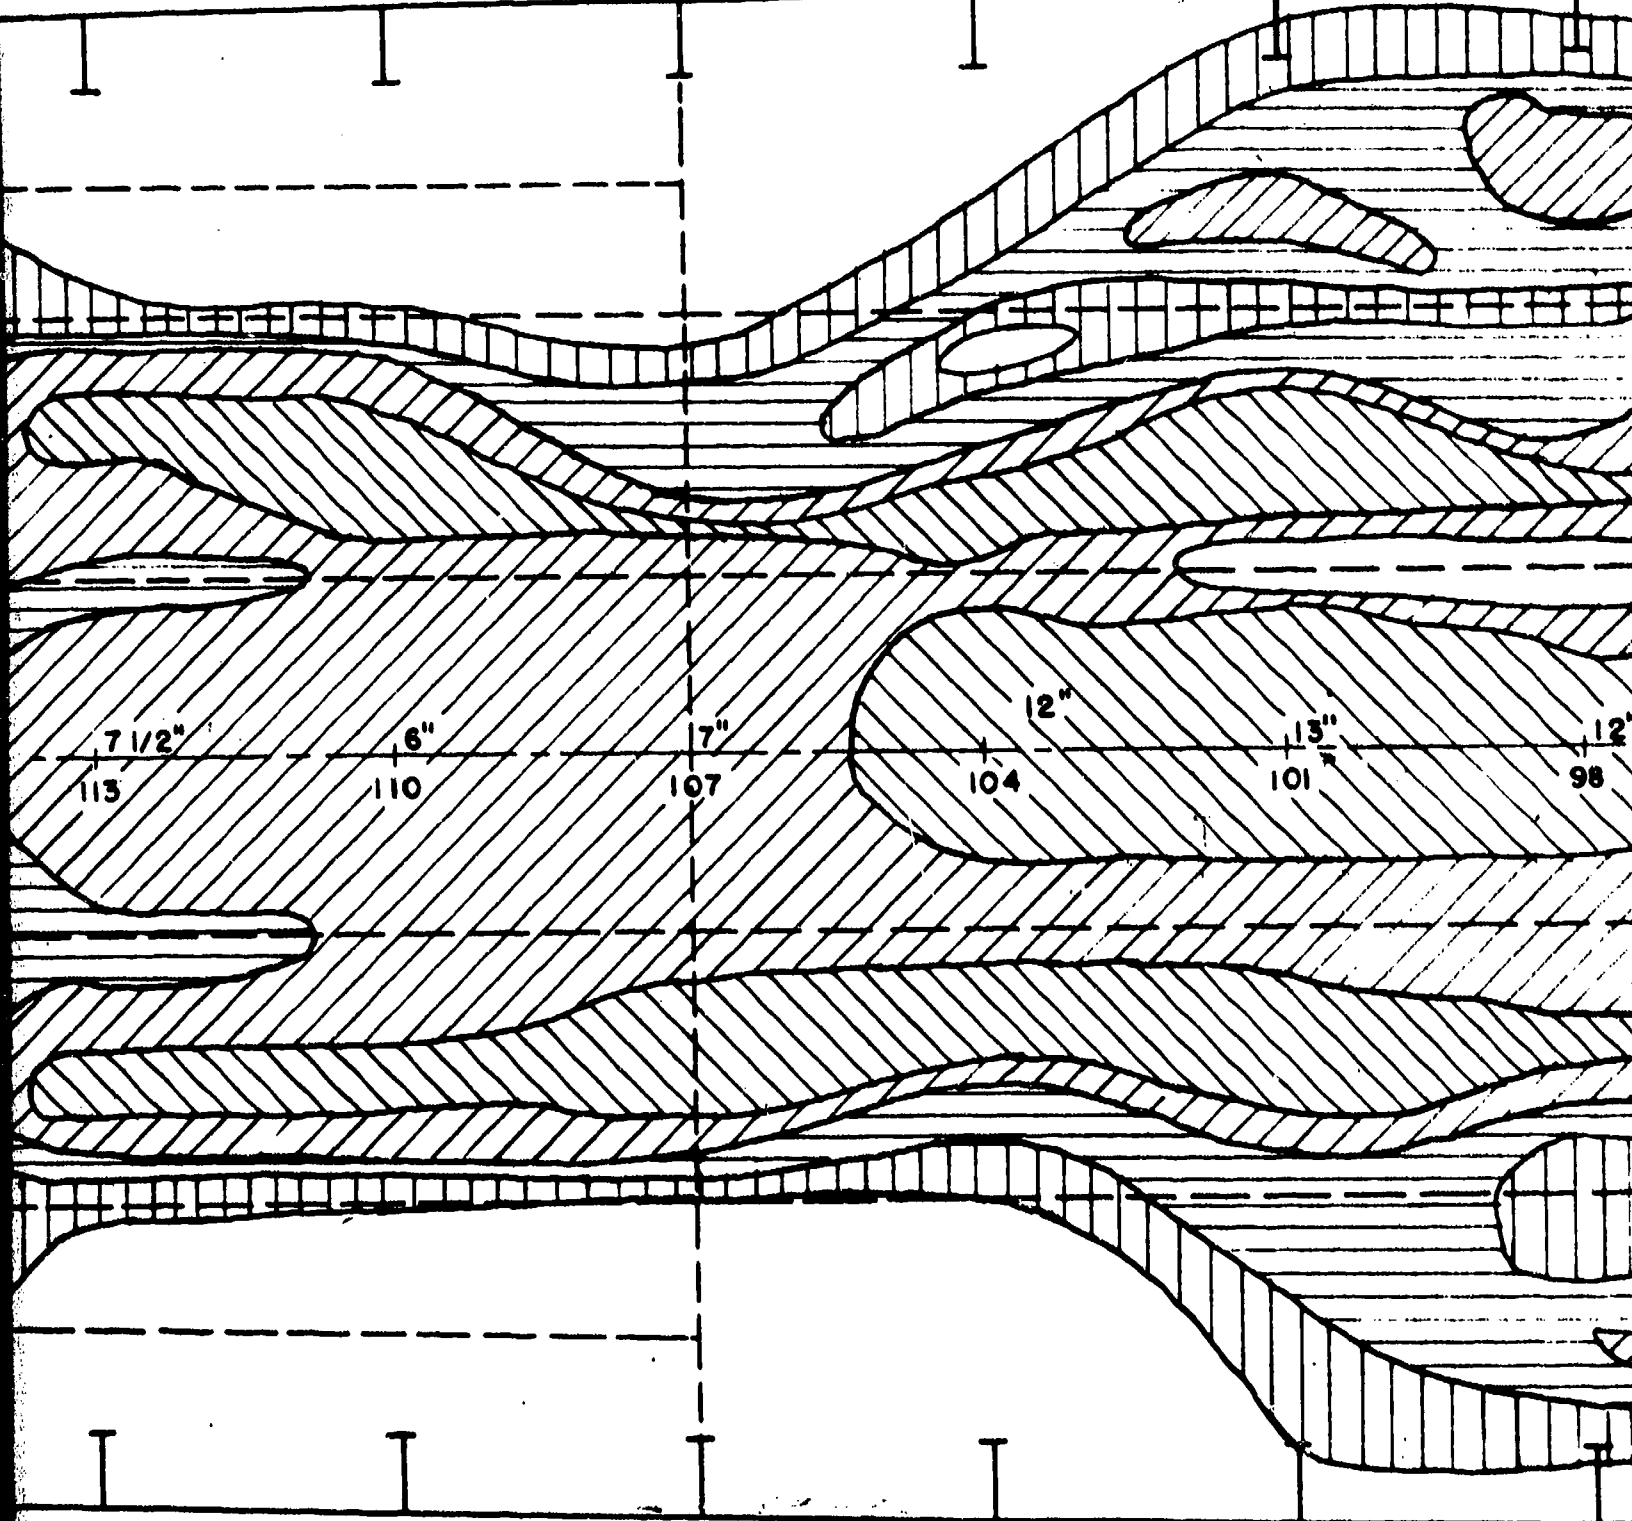
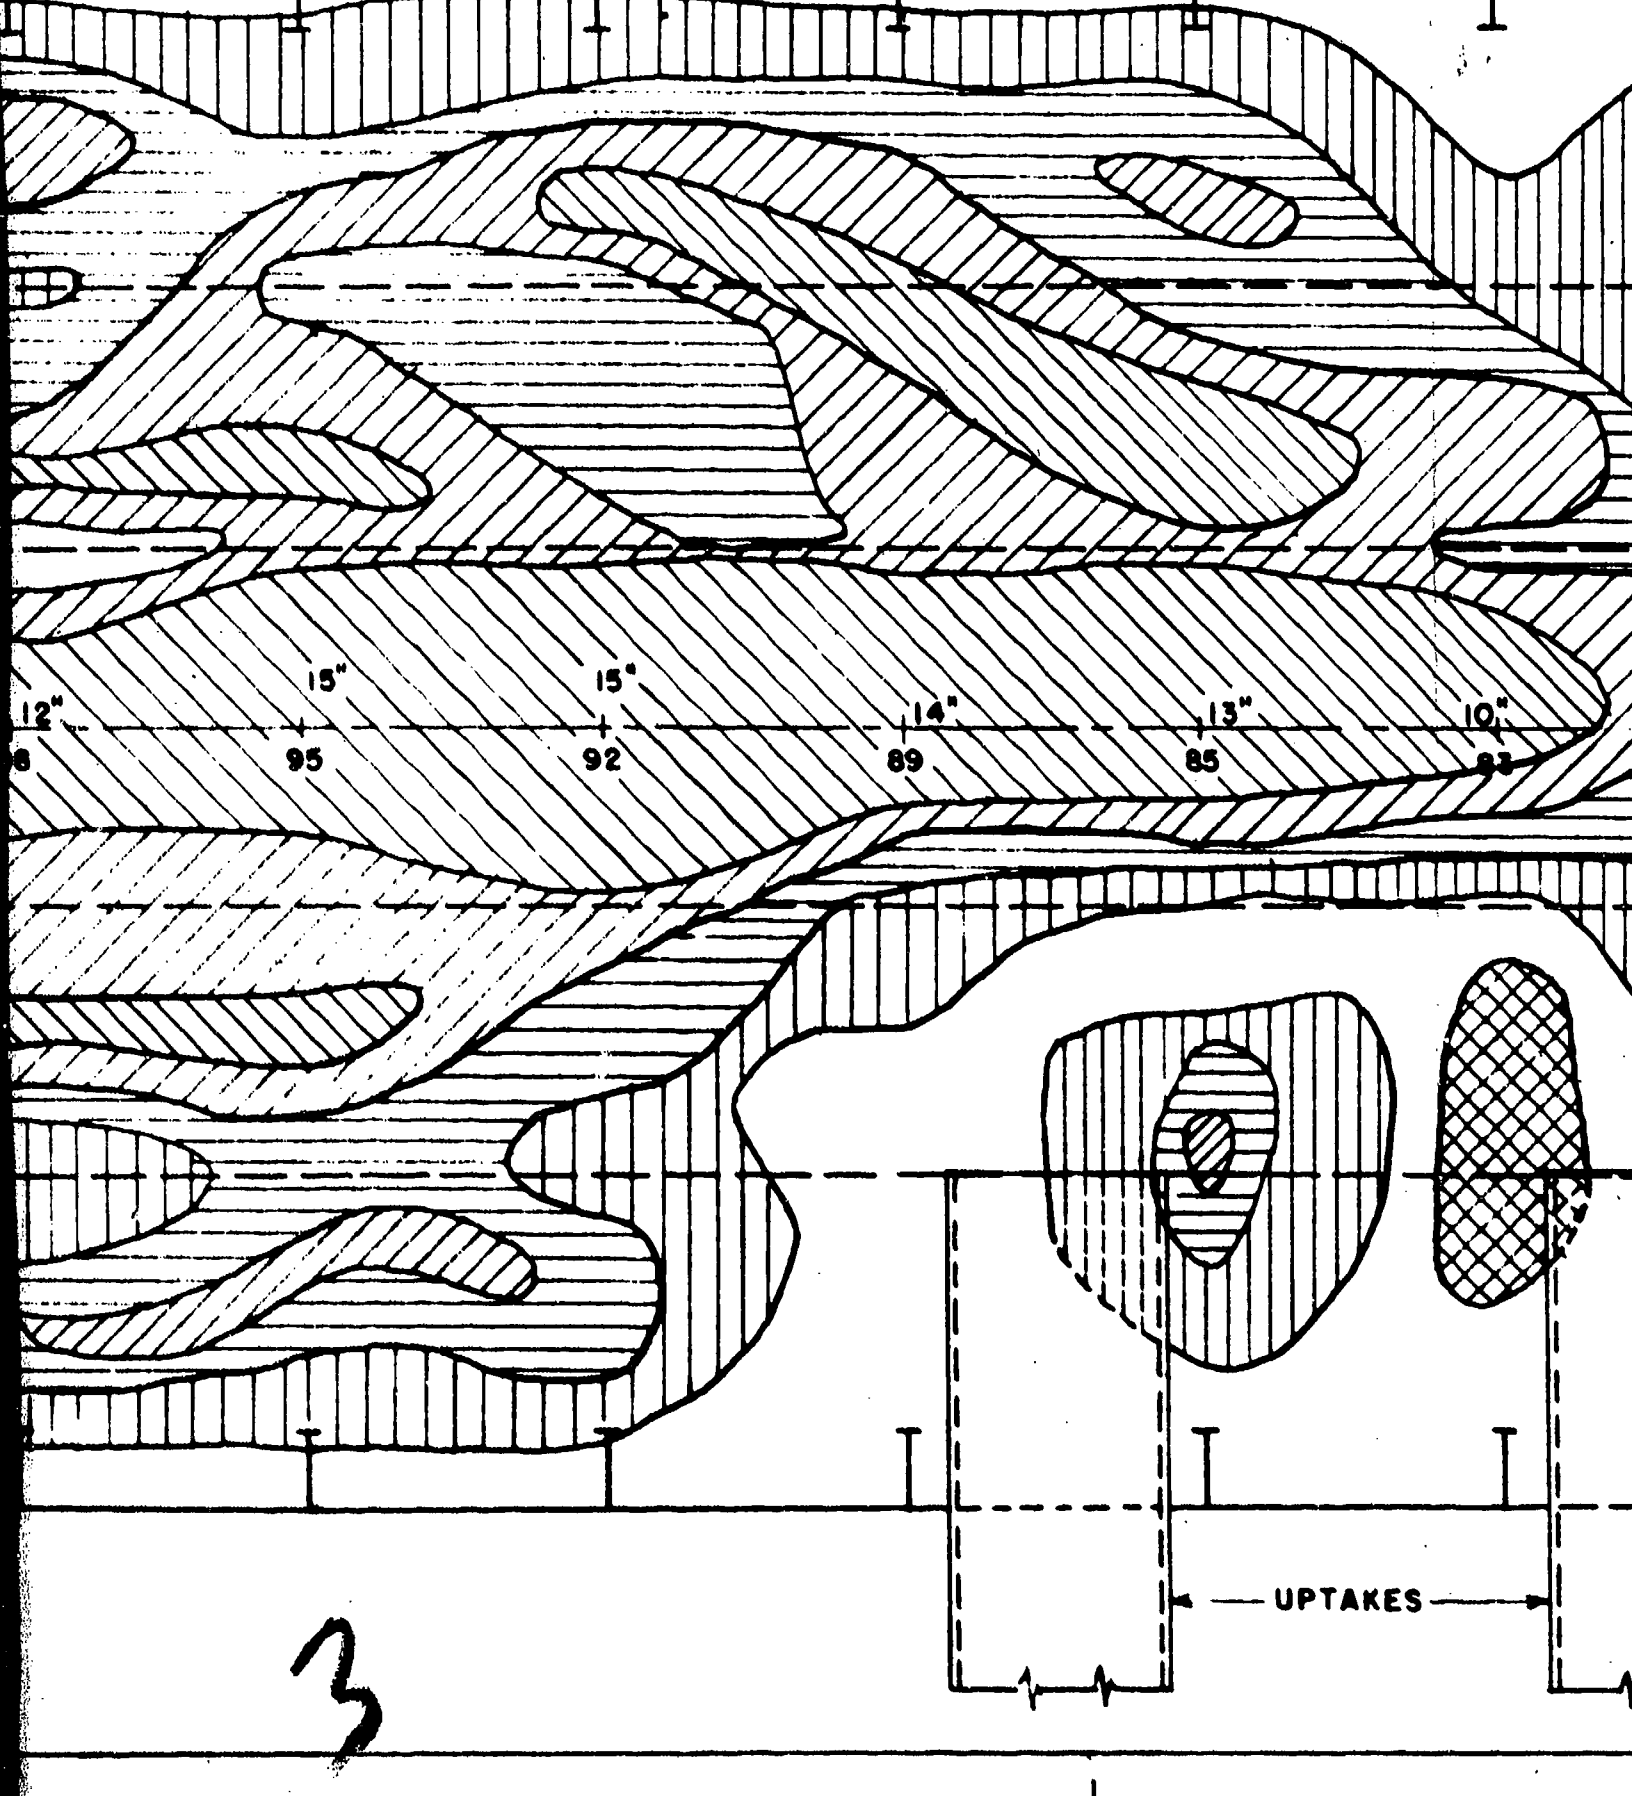
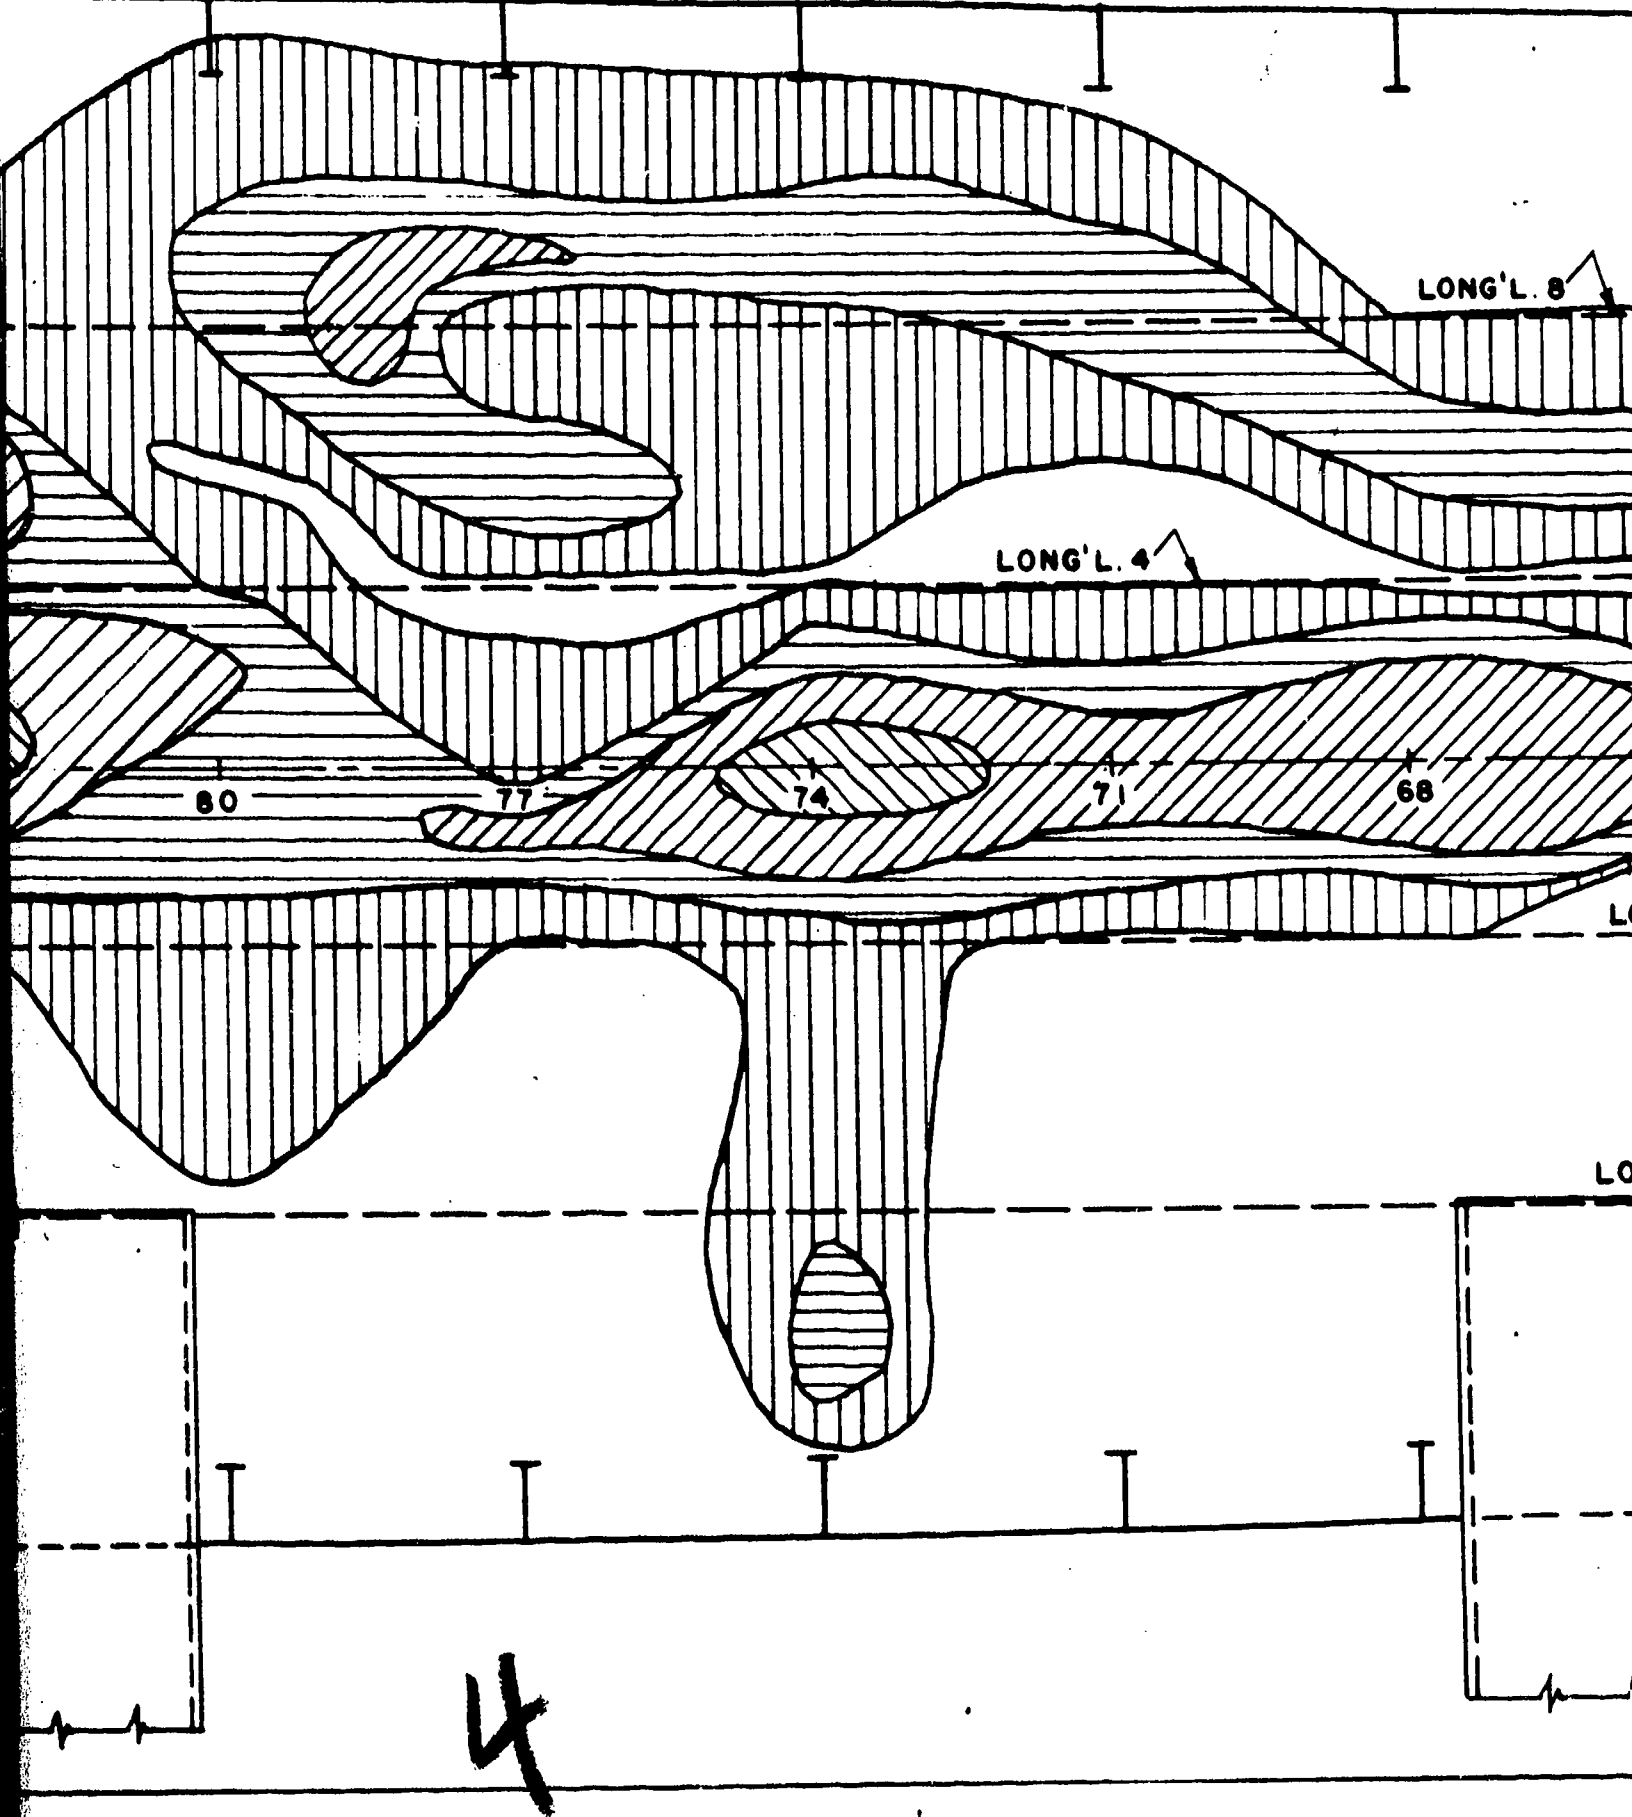
PLATE NO. 4 A

The hangar deck, which extends from frame 57 to frame 115, is generally and severely depressed. This deck is four feet above the main deck and is supported by a series of longitudinal and transverse plat floors. The longitudinal floors are located approximately 7 and 17 feet from the centerline, port and starboard, with flat bar stiffeners located 12 feet each side of the centerline at every frame. There is no longitudinal on the centerline. The omission of a longitudinal here results in a 14 foot span and accounts for the severe depression the full length of the deck. The deck survey figures on plates 41 and 42 which apply to the hangar deck have been gathered into an approximate contour map of this deck in plate 4A and show that the maximum pressure effect within the hangar occurred between frames 89 and 98 on the centerline of the ship where the depression is 15 inches. The area most affected is between frames 83 and 104 over the entire width of the deck. Although there is dishing between the transverse floors, the most noticeable pattern is created by the longitudinals and is shown on pages 279, 280, 282, 285, 286, 287, and 289; see also plate 4A.

FRACTURE ORIGINATED IN UPPER EDGE OF WELD JOINING BRACKET FLANGE TO COLUMN. WELDS TOO SMALL TO DEVELOP 100% JOINT EFFICIENCY.

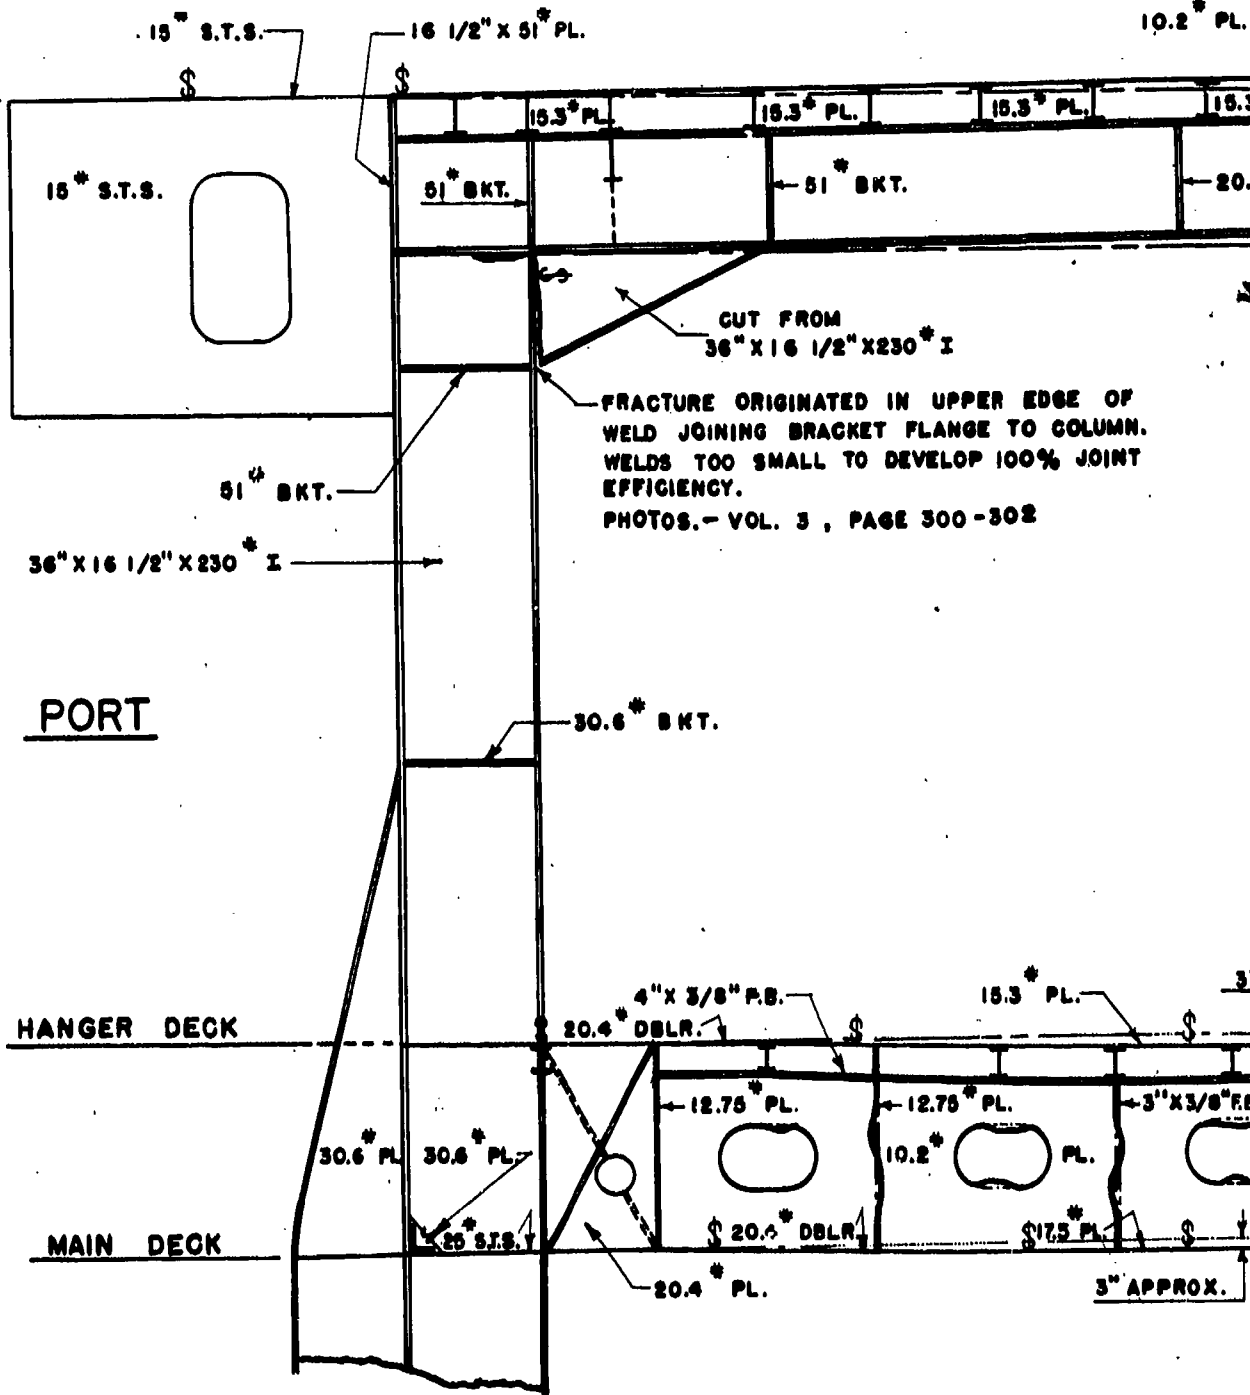
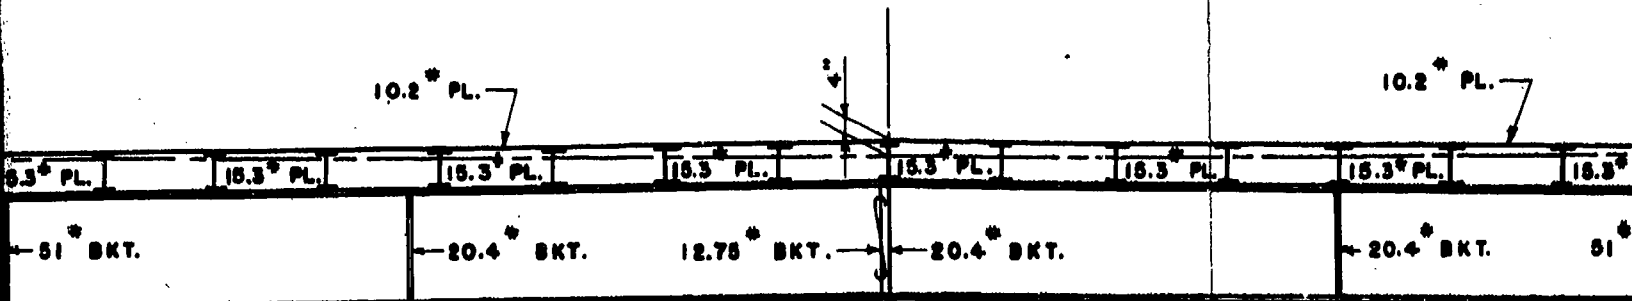
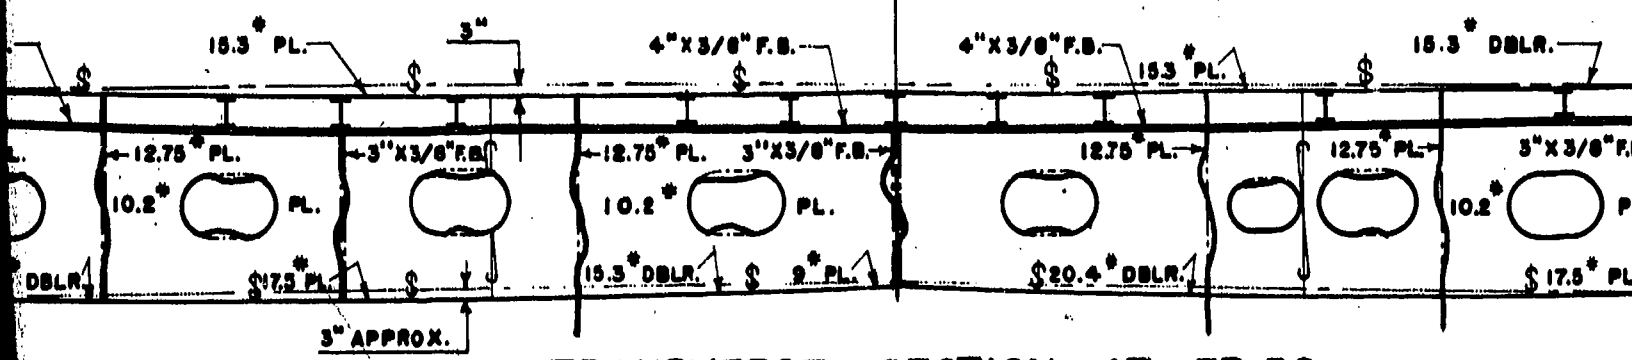
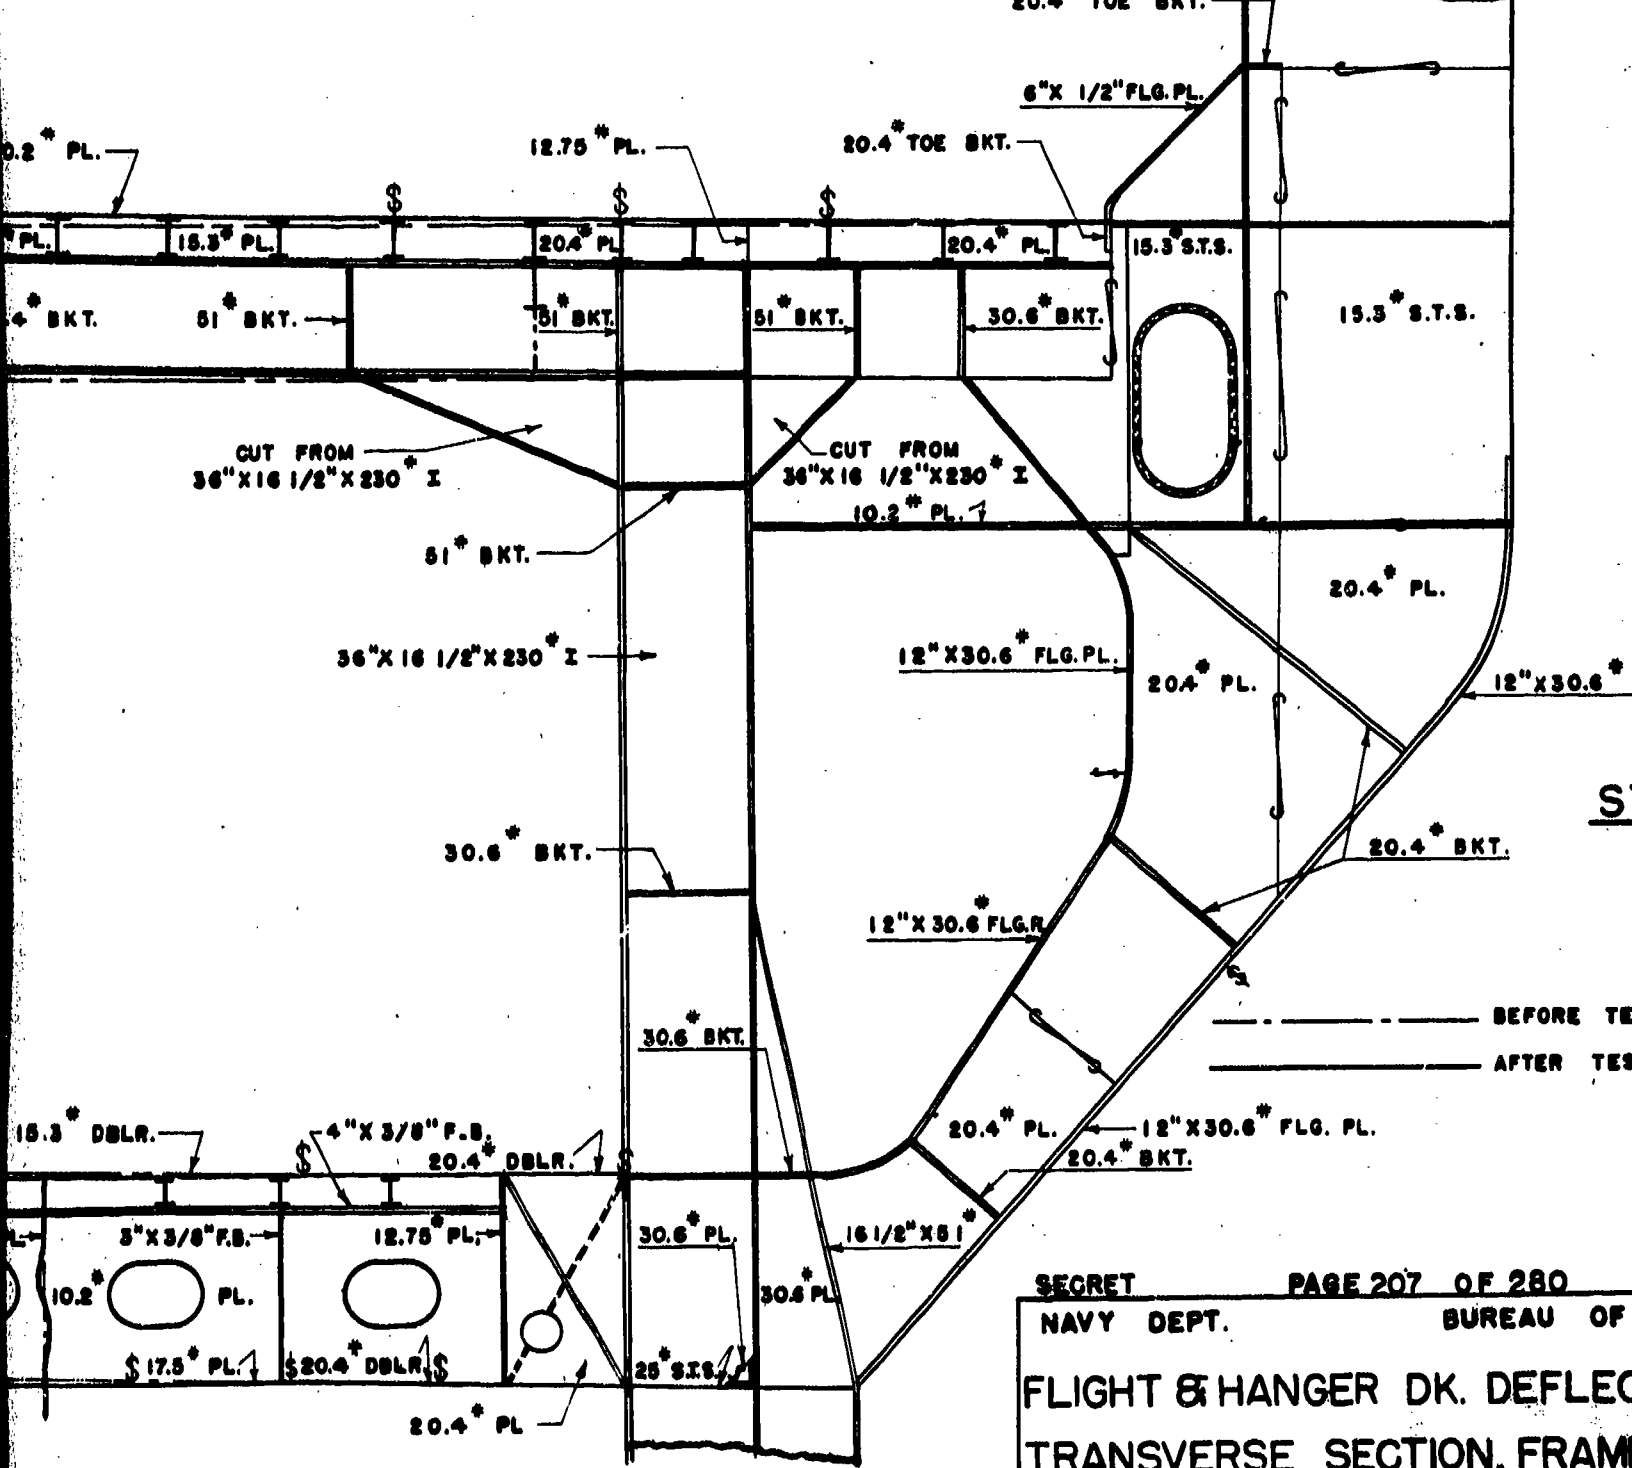
PLATE NO.5

PHOTOS. - VOL. 3, PAGE 300-302

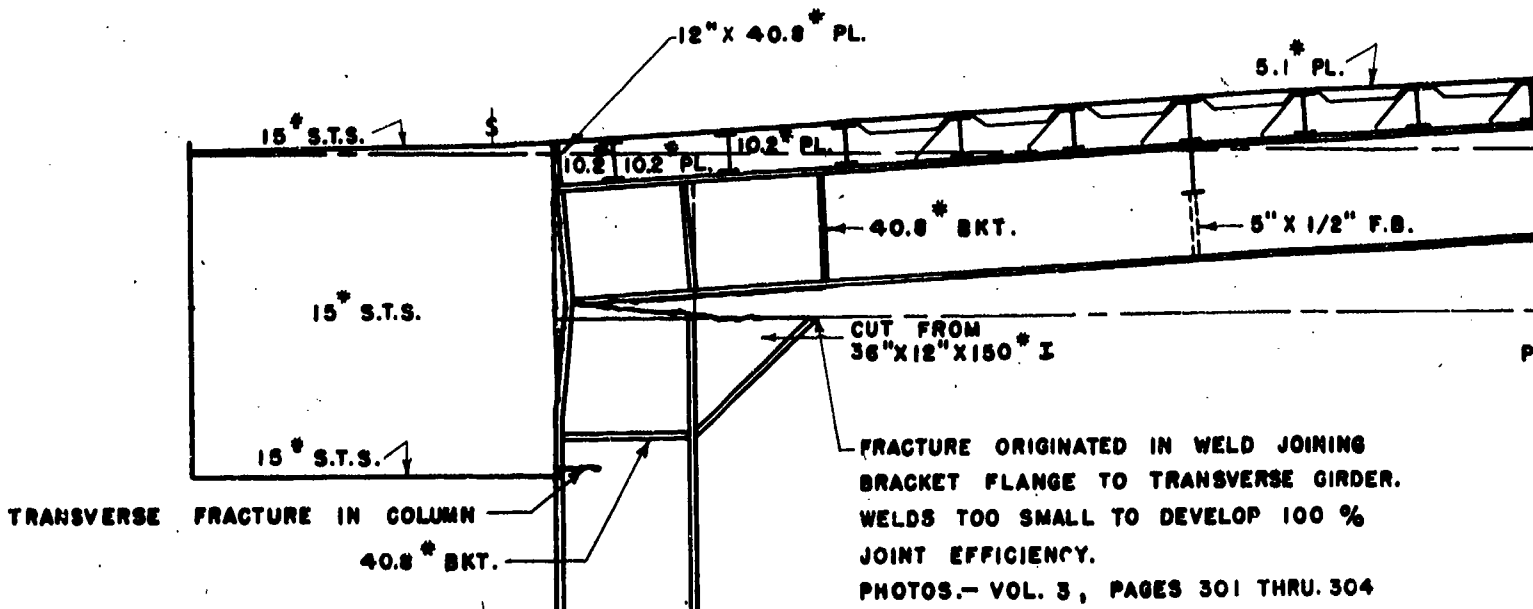
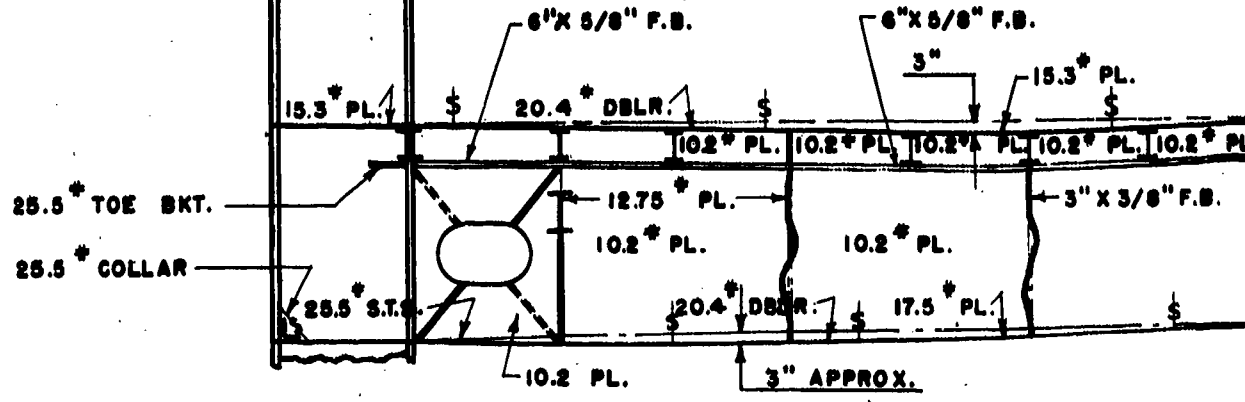
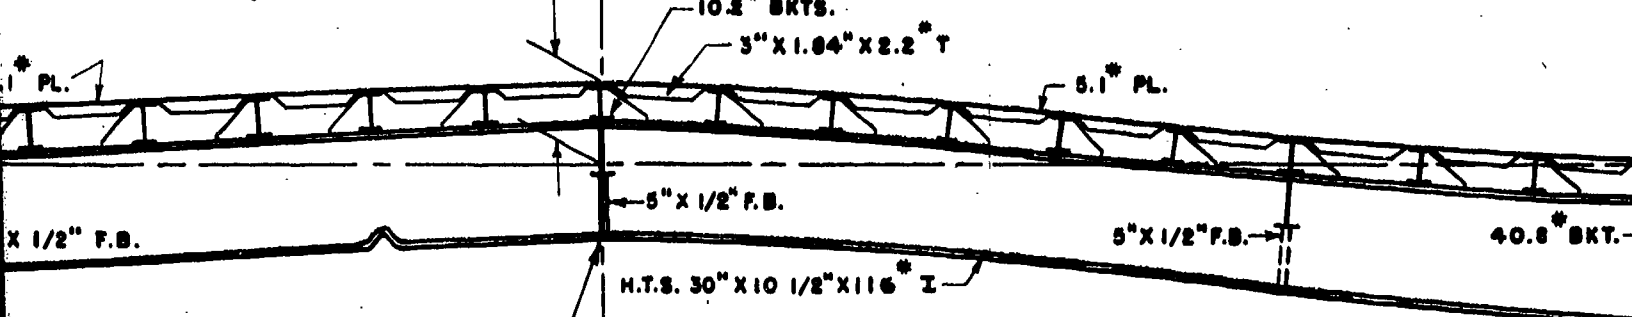
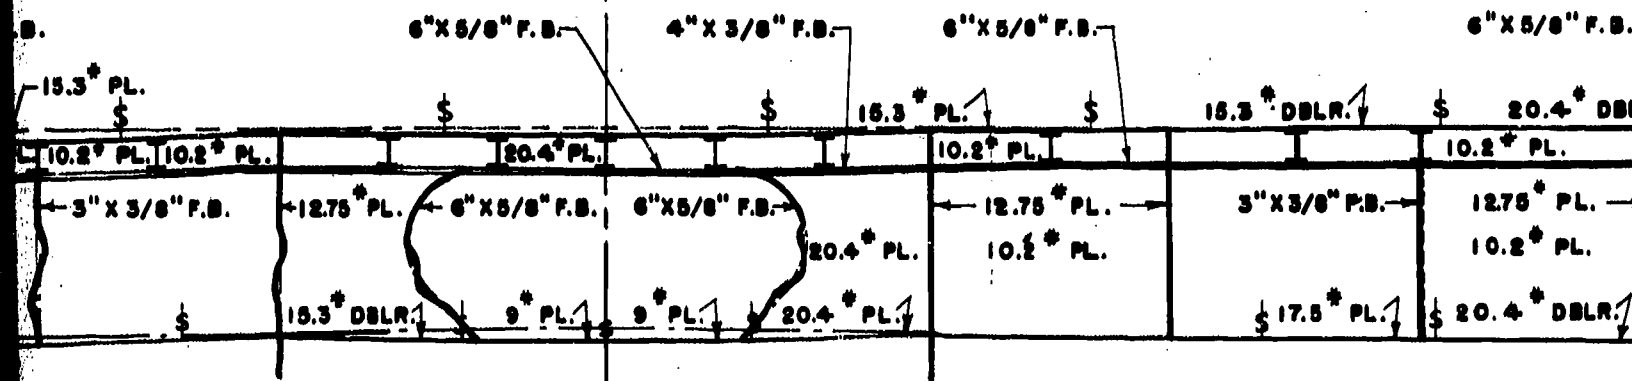
TRANSVERSE SECTION AT FR. 59
 LOOKING FORD.

PHOTO. PAGES 305-308

FRACTURE ORIGINATED IN WELD JOINT
 TRIPPING BRACKET TO INBOARD FLOOR
 TO COLUMN
 PHOTOS. - VOL. 3, PAGE 309
