7 BUREAU OF SHIPS GROUP
TECHNICAL INSPECTION REPORT

6 OPERATION CROSSROADS.
U.S.S. INDEPENDENCE (CVL22)

TEST ABLE,

VOLUME 1 OF 4 [U].

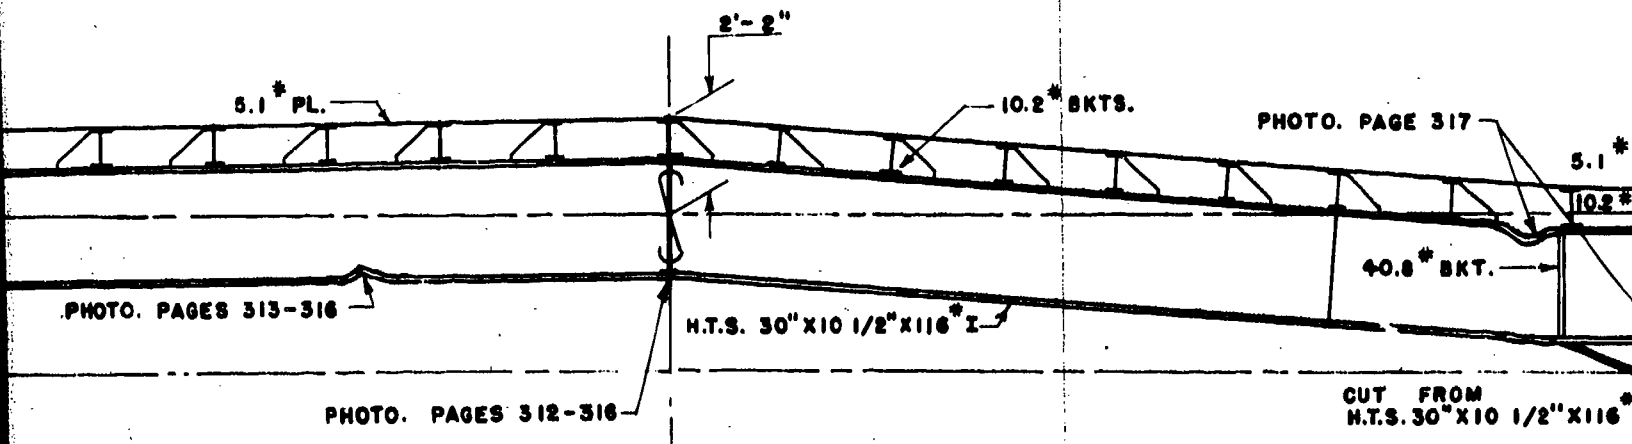
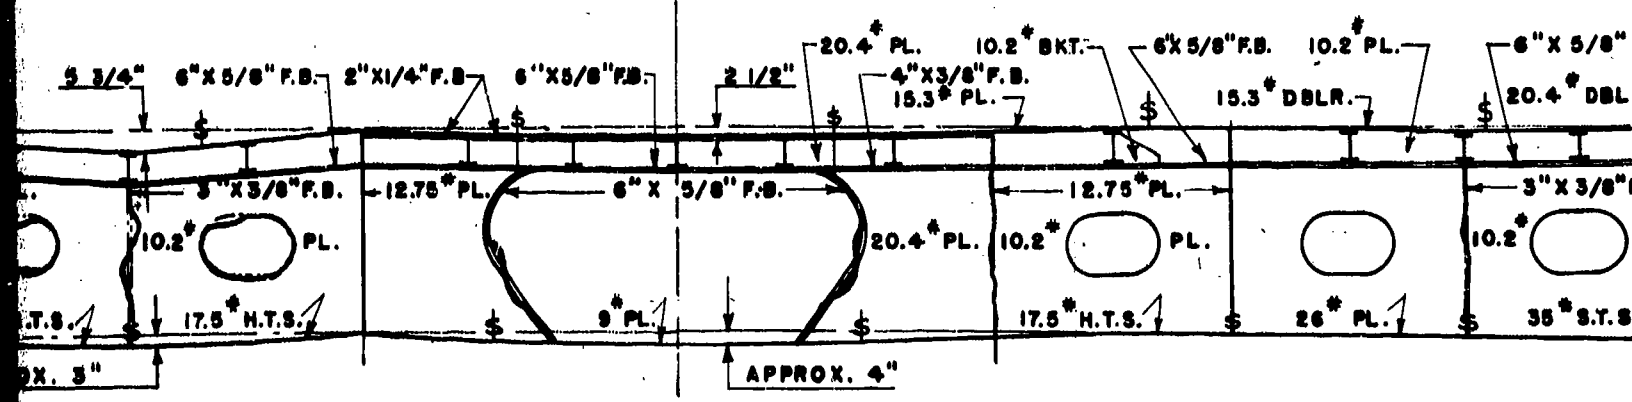
TRANSVERSE SECTION AT FR. 62
 LOOKING FORD.

36" X 116"
 PULLED LOOSE FROM DECK
 RIVETED CONNECTION.

PHOTO. PAGE 317

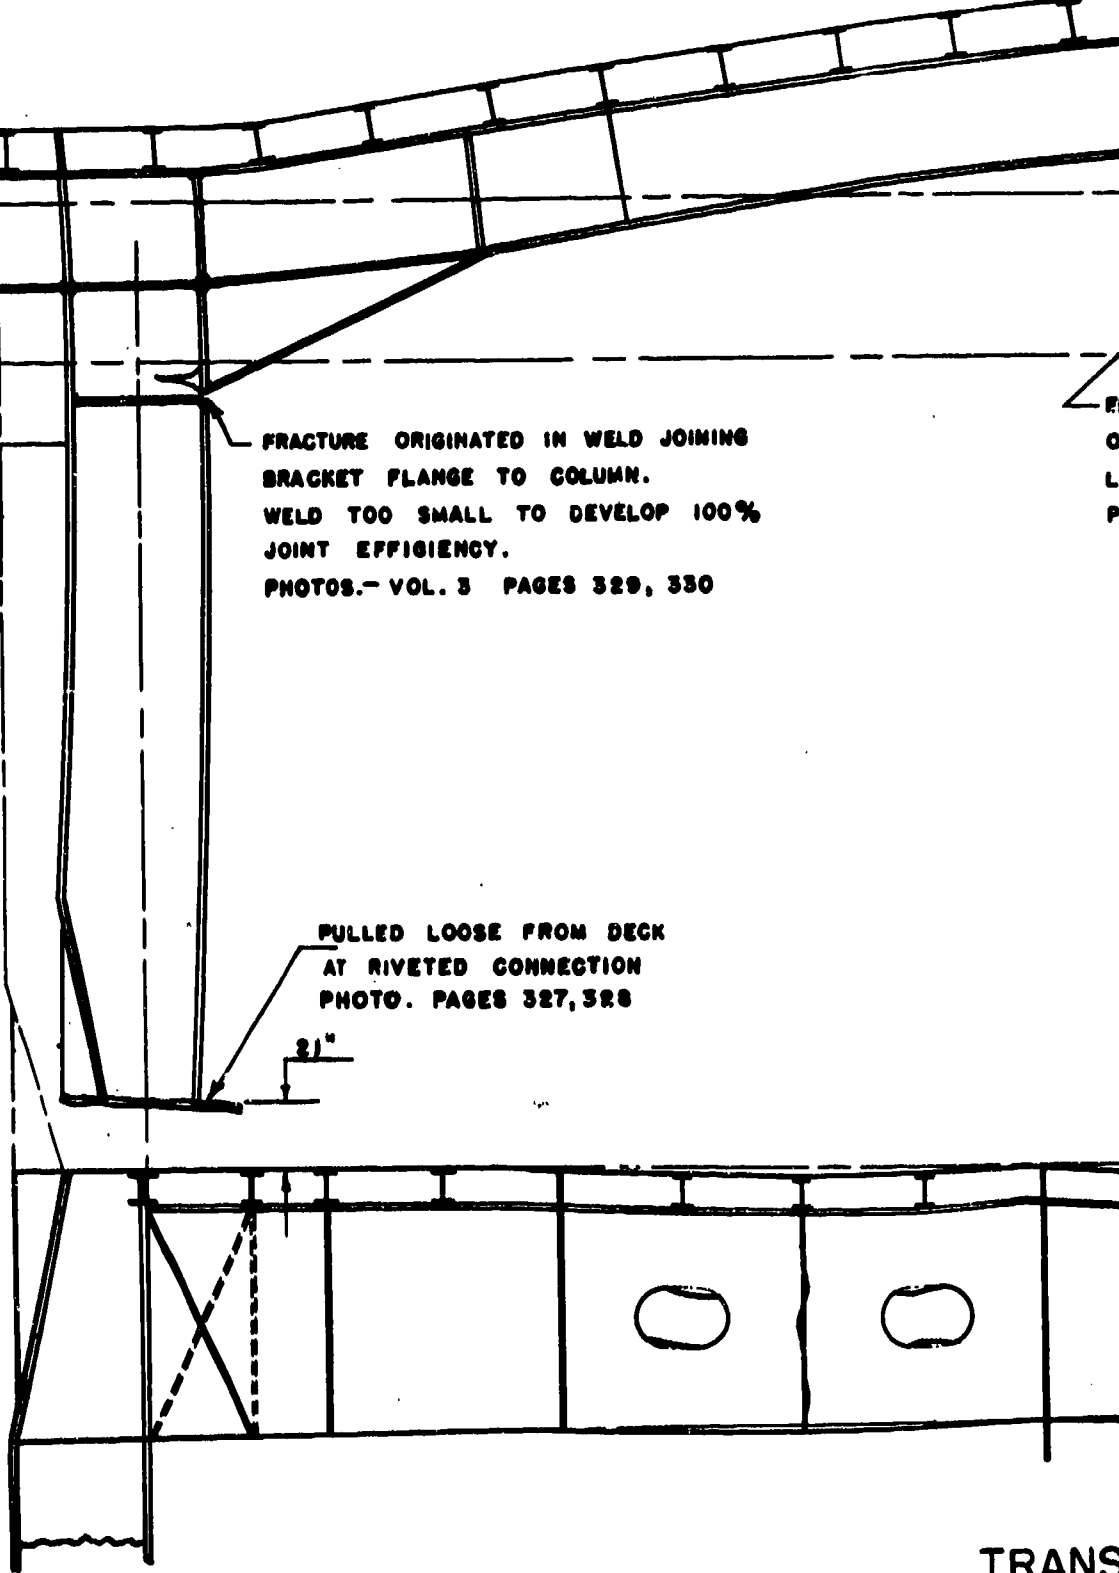
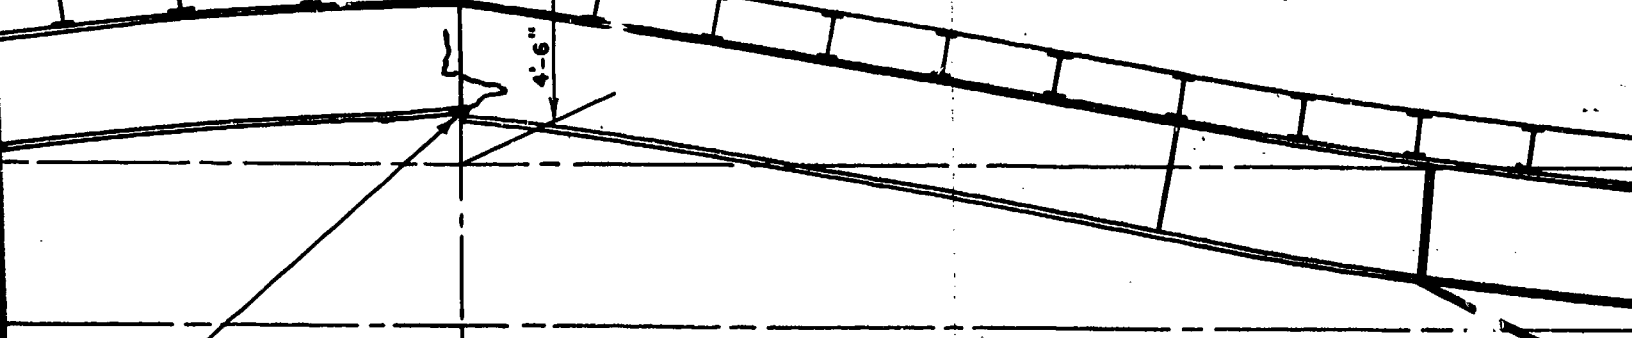
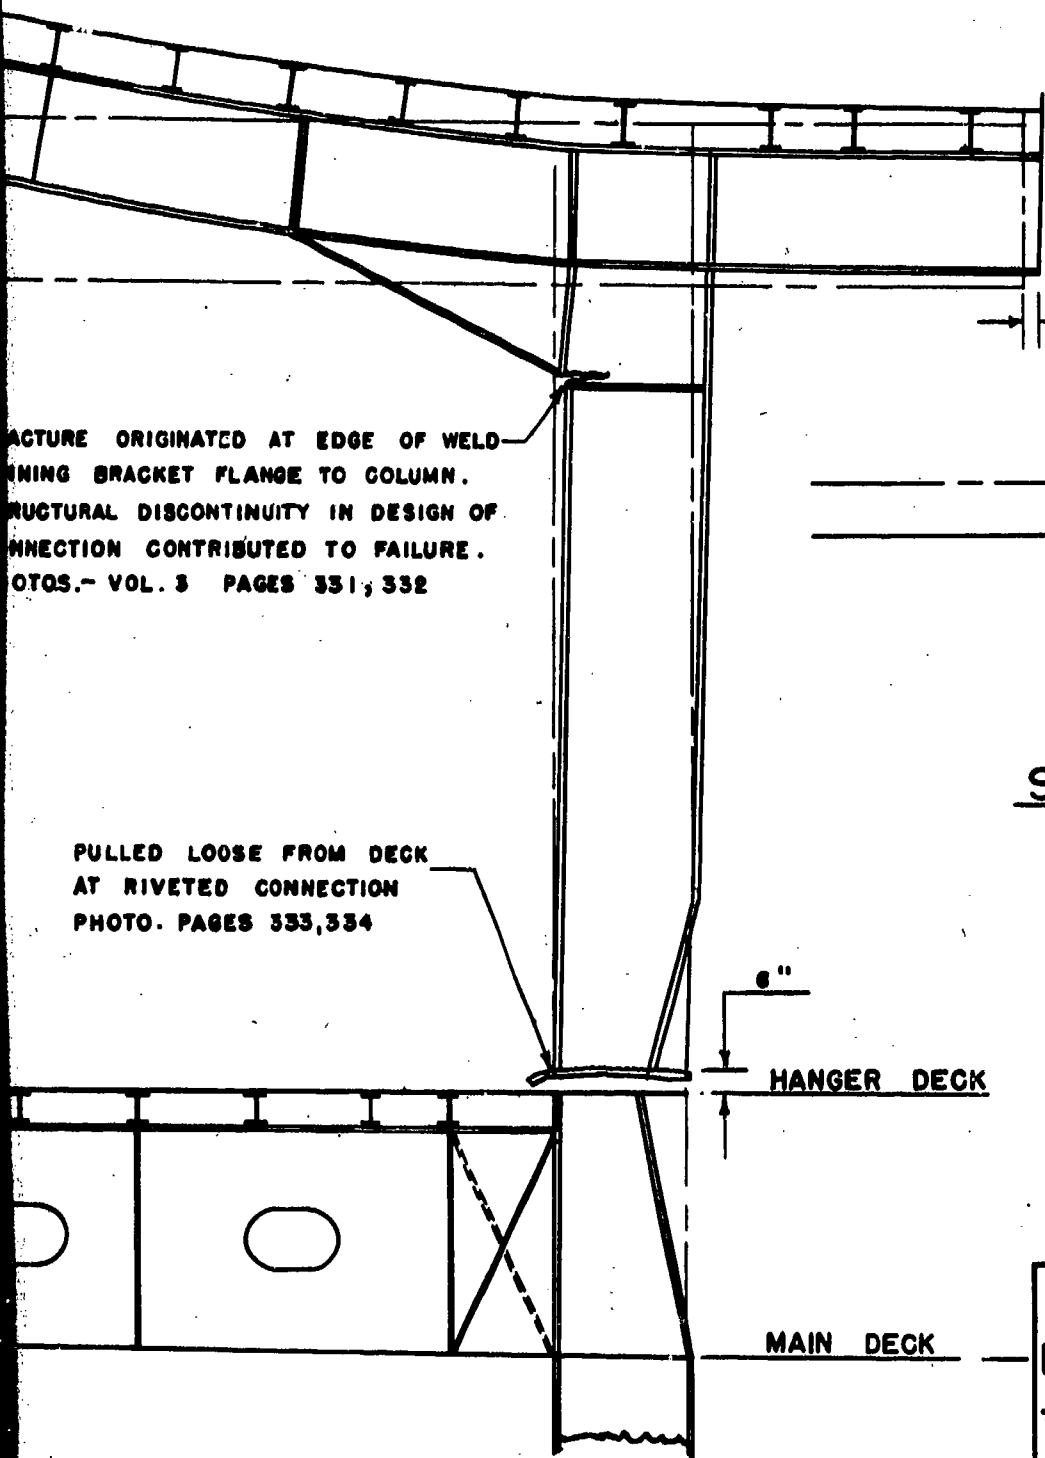
TRANSVERSE SECTION AT FR.65
LOOKING FORD.

FRACTURE ORIGINATED IN LOWER FLANGE
OF GIRDER AT EDGE OF WELDED CENTER-
LINE BUTT.

FRACTURE ORIGINATED AT EDGE OF WELD
JOINING BRACKET FLANGE TO COLUMN.
STRUCTURAL DISCONTINUITY IN DESIGN OF
CONNECTION CONTRIBUTED TO FAILURE.
PHOTOS.- VOL. 3 PAGES 331, 332

PULLED LOOSE FROM DECK
AT RIVETED CONNECTION
PHOTO. PAGES 333, 334

FAILURE ORIGINATED AT EDGE OF WELDING BRACKET FLANGE TO COLUMN. STRUCTURAL DISCONTINUITY IN DESIGN OF CONNECTION CONTRIBUTED TO FAILURE. PHOTOS.- VOL. 3 PAGES 331, 332

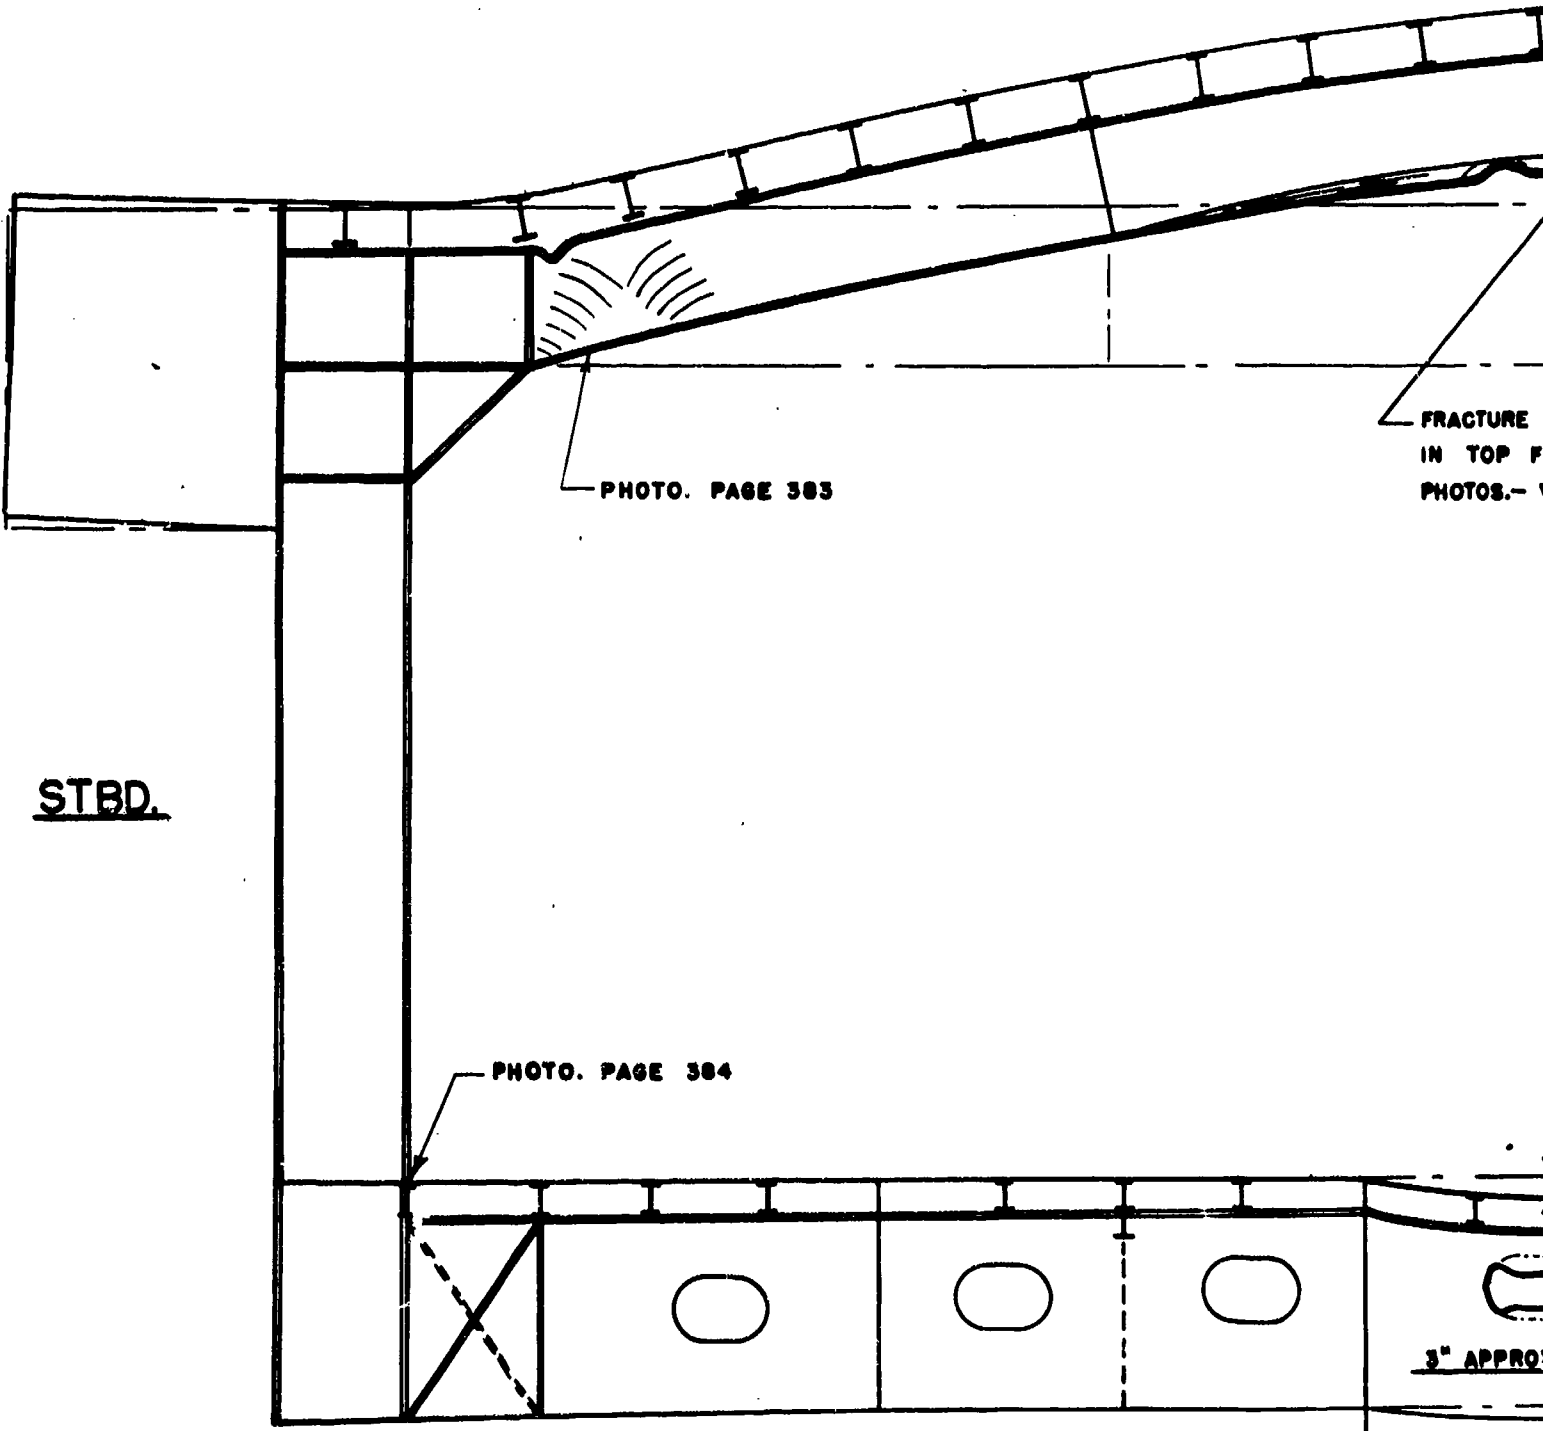
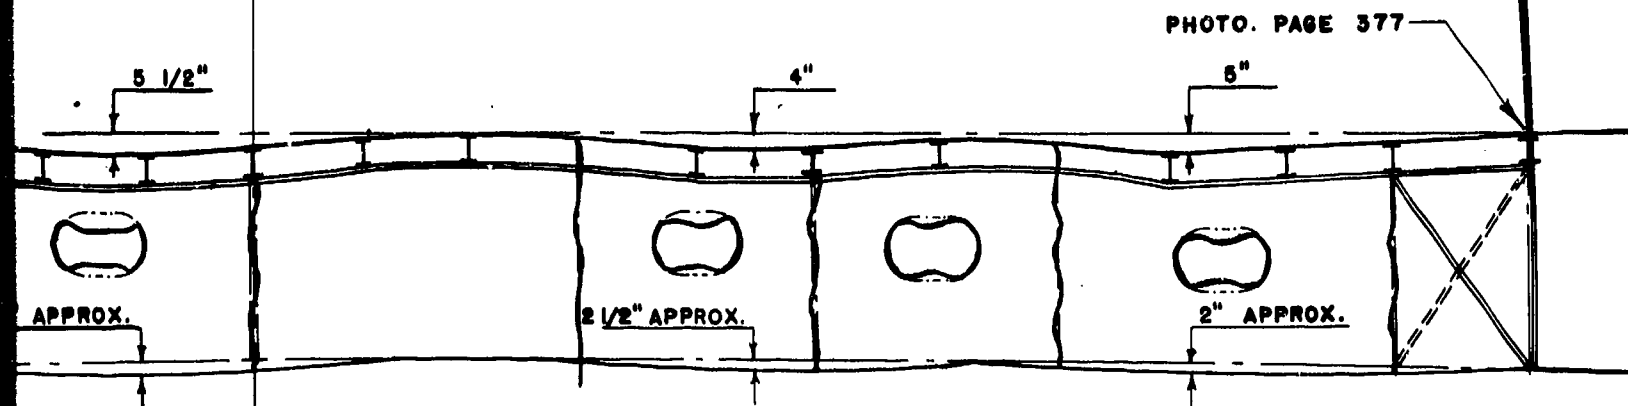
PLATE NO. 11

SLIGHT FRACTURE WITH ORIGIN AT UPPER
EDGE OF WELD JOINING COLUMN AND
BRACKET FLANGE.

PHOTOS.- VOL. 3 PAGE 378

FRACTURE WITH ORIGIN AT UPPER
 WELD JOINING COLUMN AND
 FLANGE.
 VOL. 3 PAGE 378

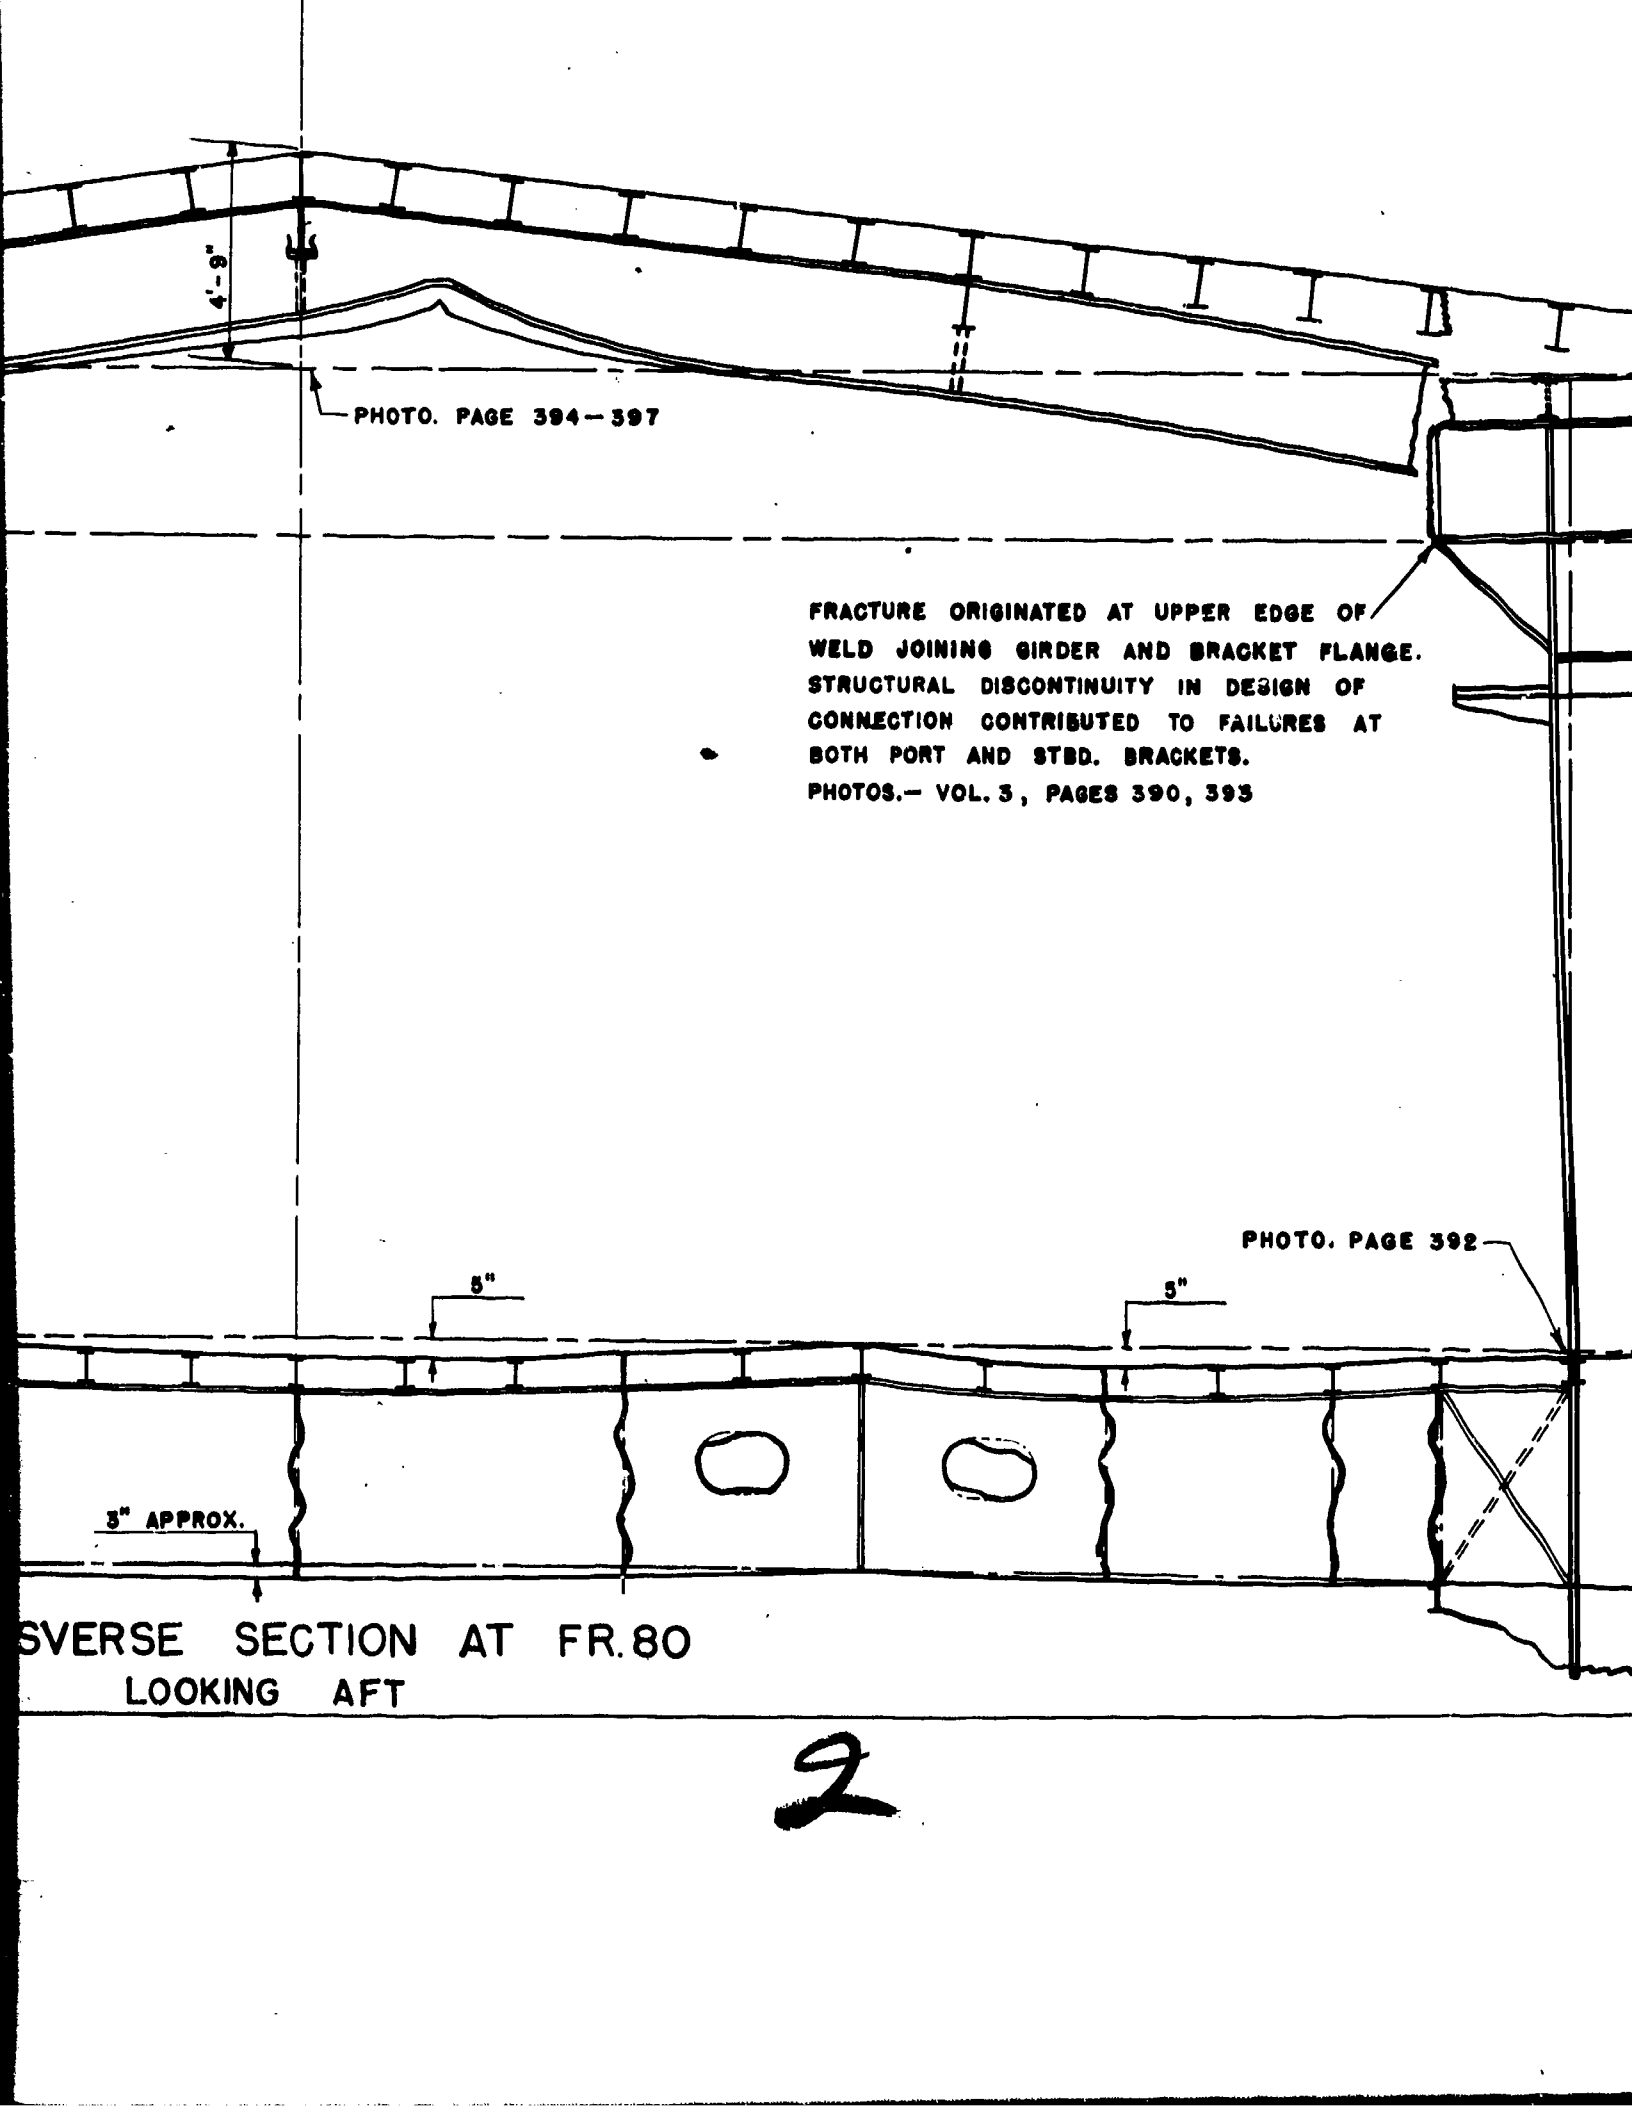
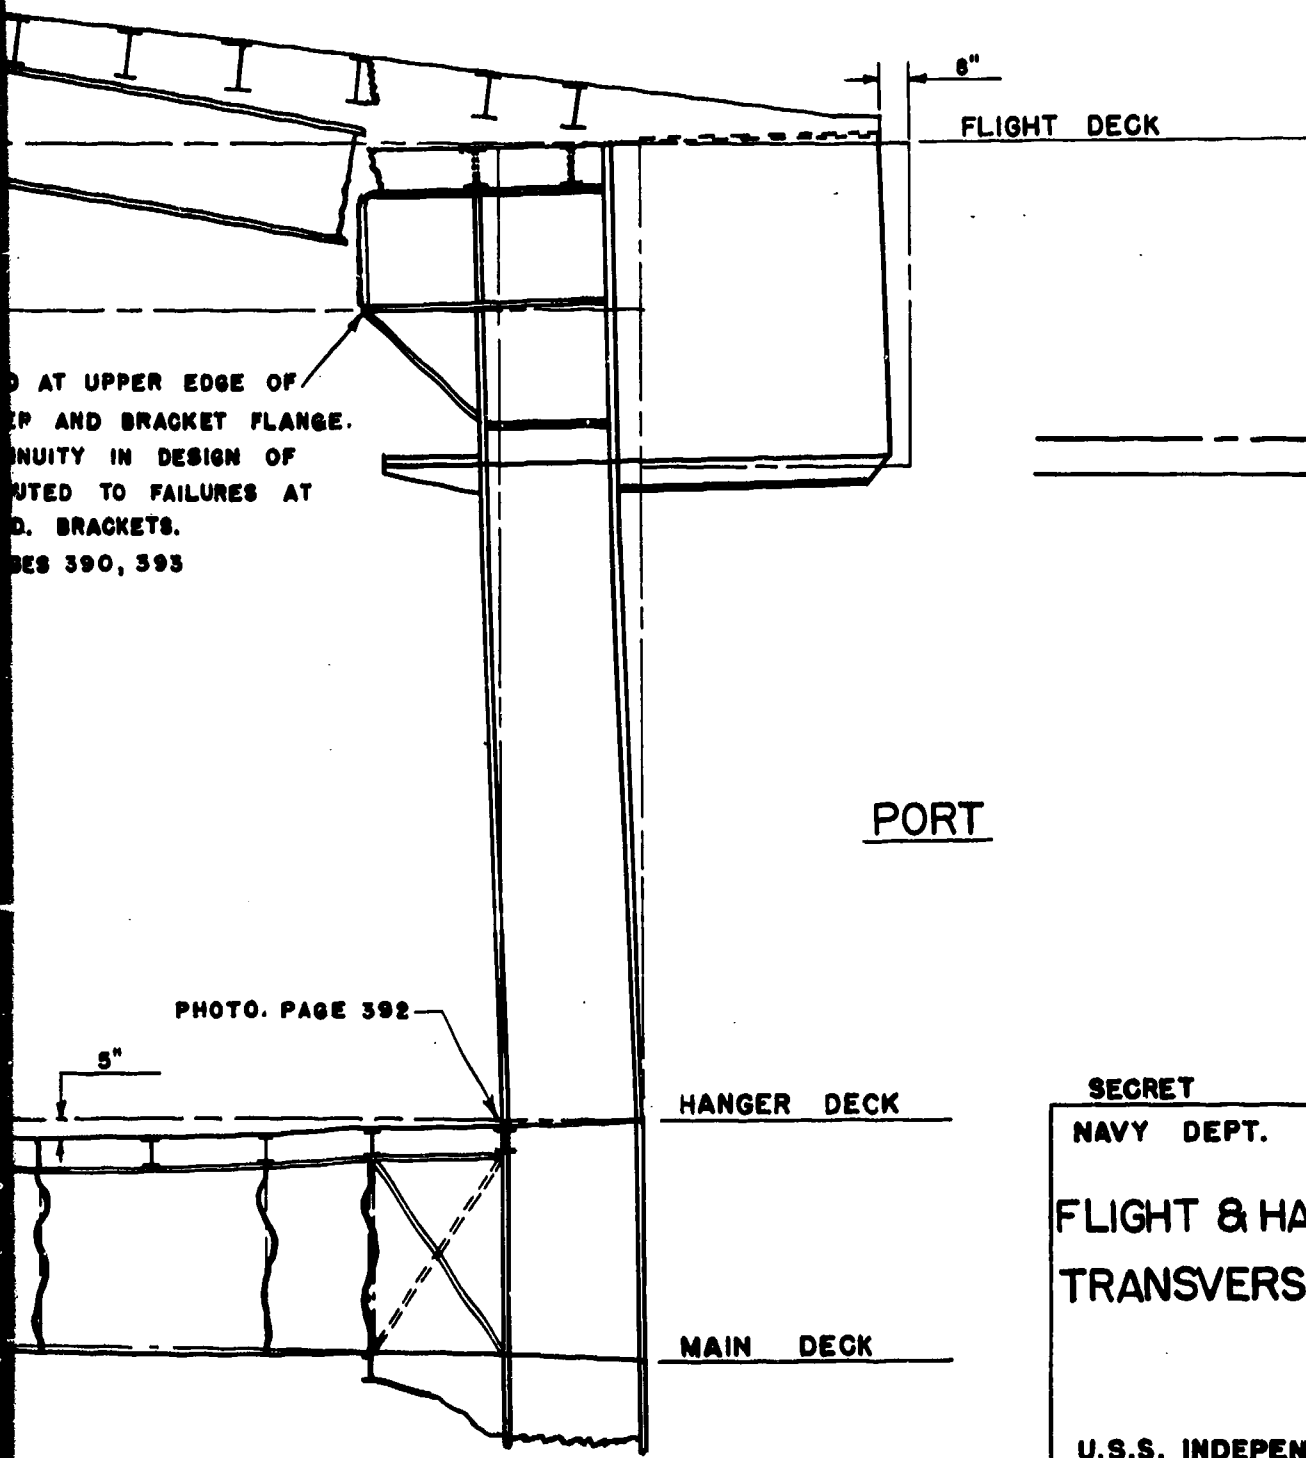
FRACTURES ORIGINATED AT (A) UPPER EDGE
OF WELDS JOINING TRANSVERSE GIRDER AND
BRACKET FLANGE AND (B) COLUMN AND
BRACKET FLANGE.
PHOTOS. - VOL. 3, PAGE 398

AT UPPER EDGE OF
 AND BRACKET FLANGE.
 CONTINUITY IN DESIGN OF
 DUE TO FAILURES AT
 BRACKETS.
 PAGES 390, 393

PHOTO. PAGE 392

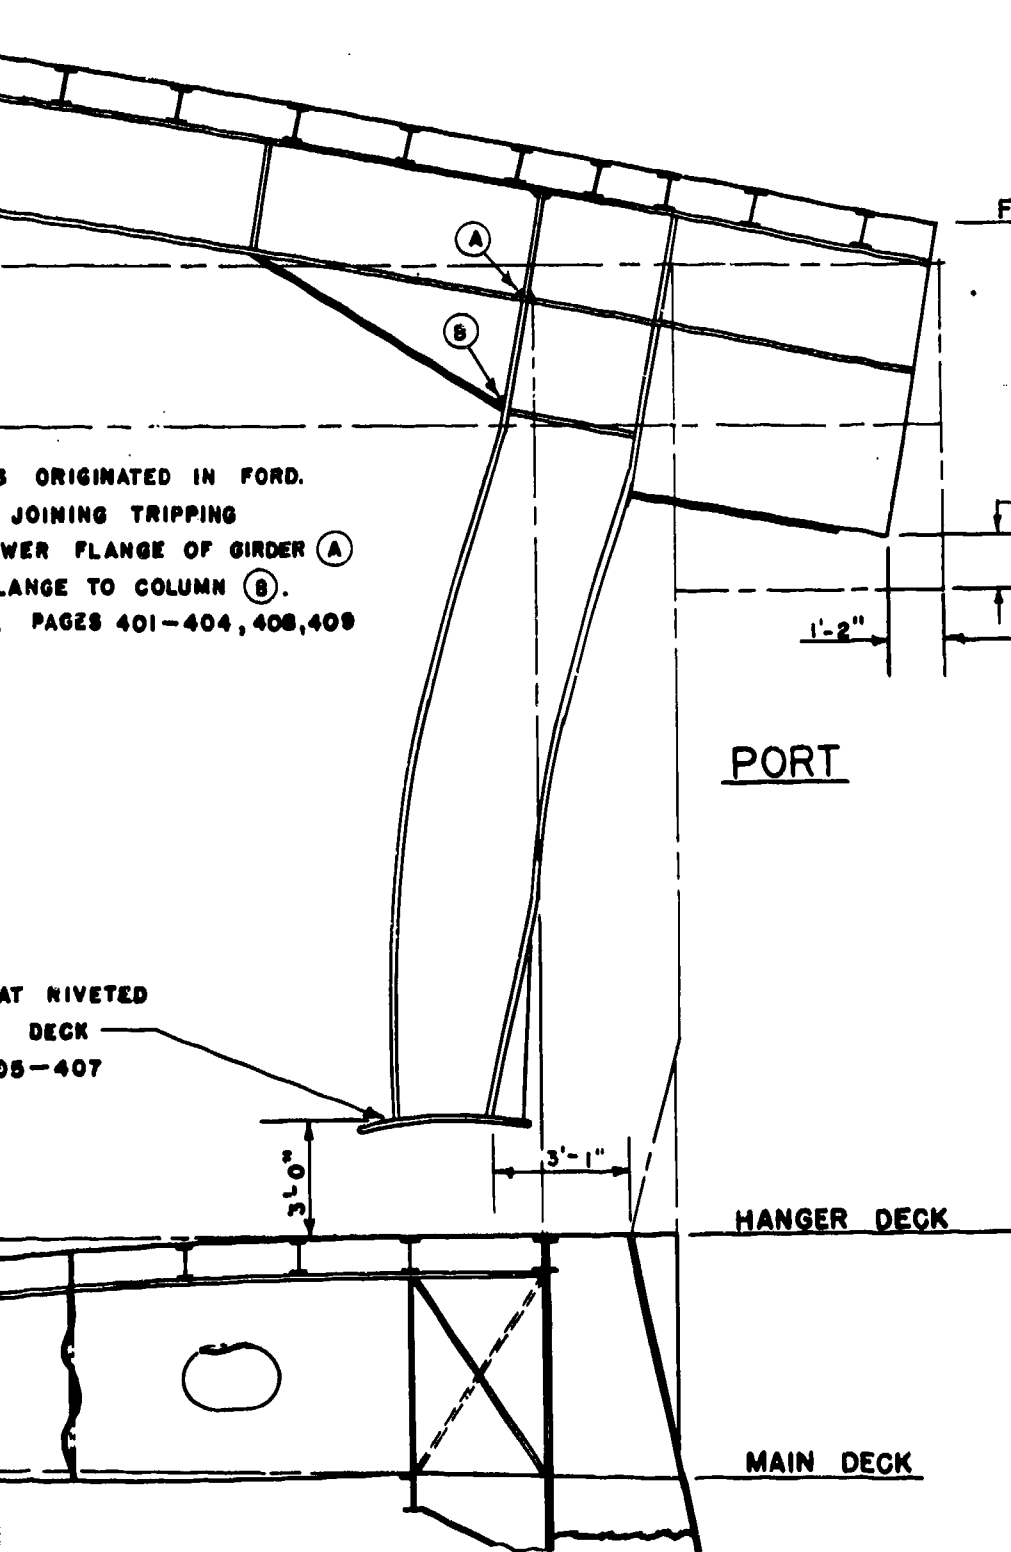
TRANSVERSE SECTION AT FR. 83
LOOKING AFT.

FRACTURE ORIGINATED AT AFTER END OF BUTT WELD IN LOWER FLANGE OF GIRDER. INCOMPLETE WELD PENETRATION CONTRIBUTED TO FAILURE.
PHOTOS.- VOL. 3 , PAGES 399,410-414

SMALL FRACTURES ORIGINATED IN FORD. END OF WELDS JOINING TRIPPING BRACKET TO LOWER FLANGE OF GIRDER (A) AND BRACKET FLANGE TO COLUMN (B).
PHOTOS.- VOL. 3 , PAGES 401-404, 408,40

PULLED LOOSE AT RIVETED CONNECTION TO DECK
PHOTO. PAGE 405-407

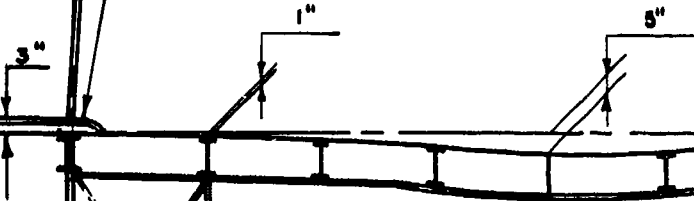
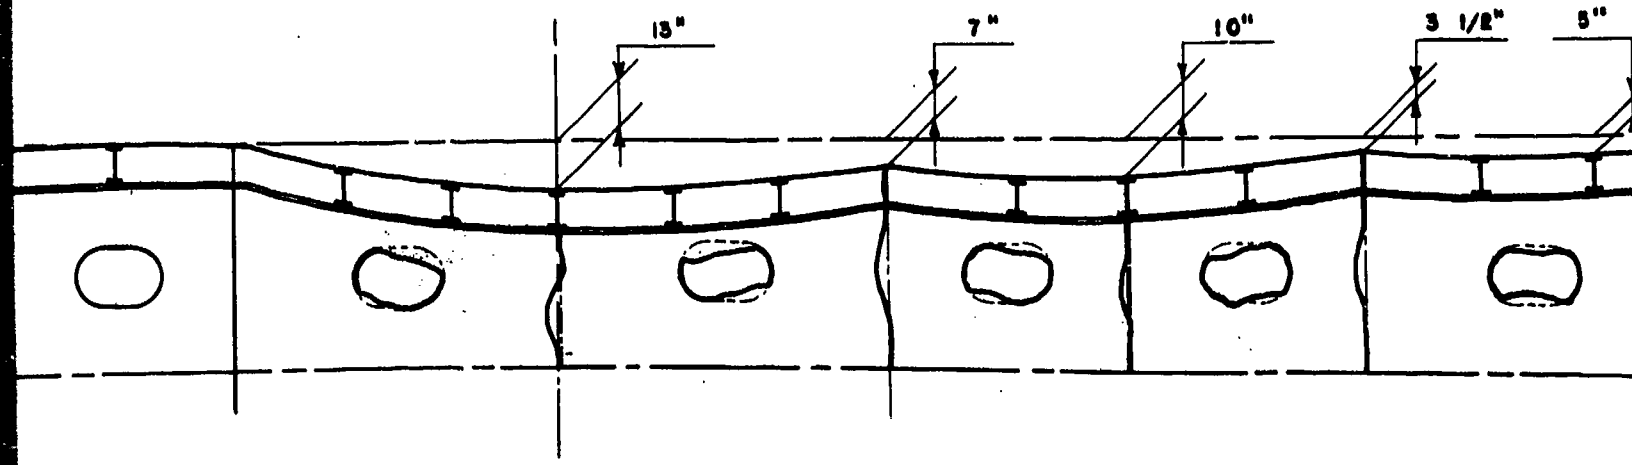
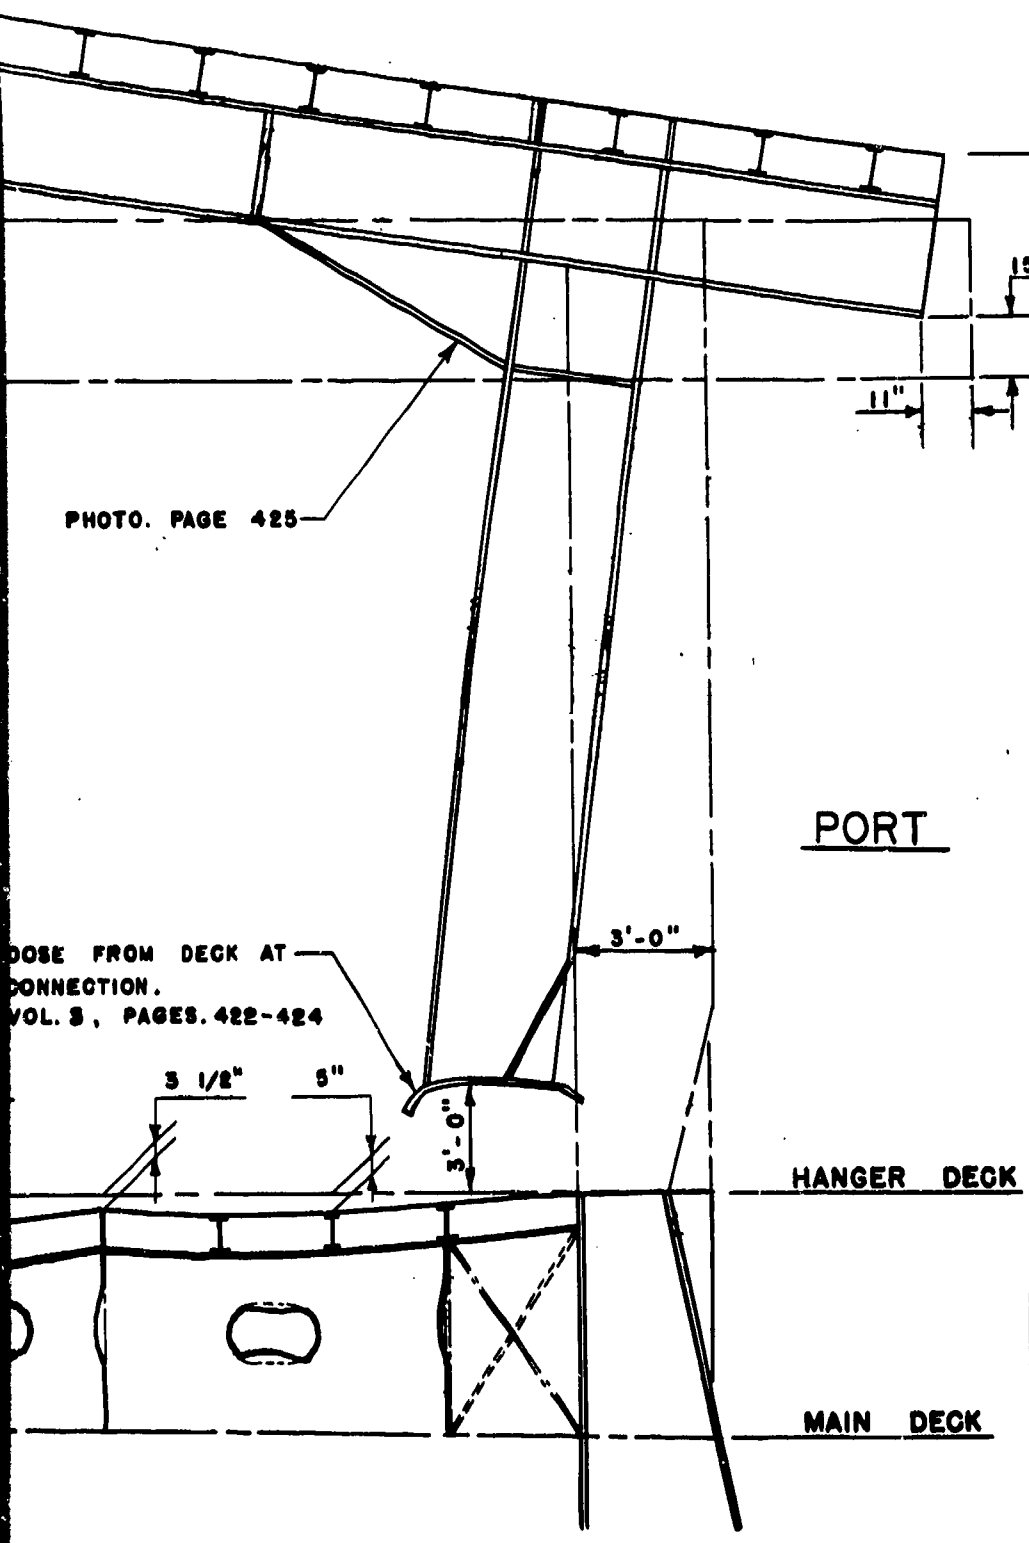
TRANSVERSE SECTION AT FR. 86
LOOKING AFT.

FRACTURE ORIGINATED AT FORWARD END OF BUTT WELD IN LOWER FLANGE OF GIRDER. INCOMPLETE WELD PENETRATION CONTRIBUTED TO FAILURE.

PHOTO. PAGE 425

PULLED LOOSE FROM DECK AT RIVETED CONNECTION.
PHOTOS. - VOL. 3, PAGES 422-424

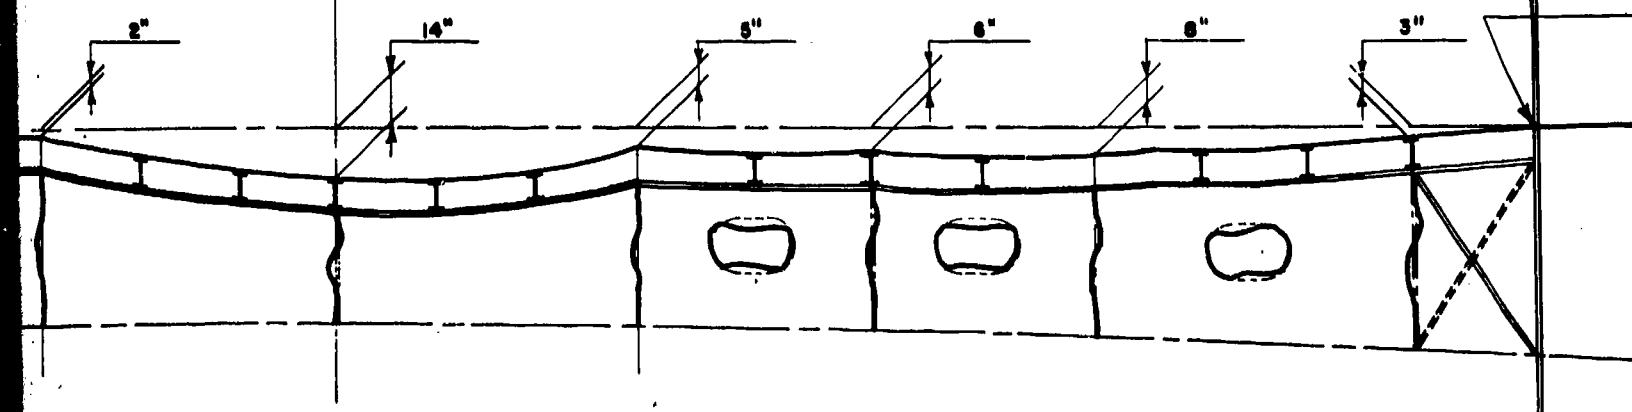
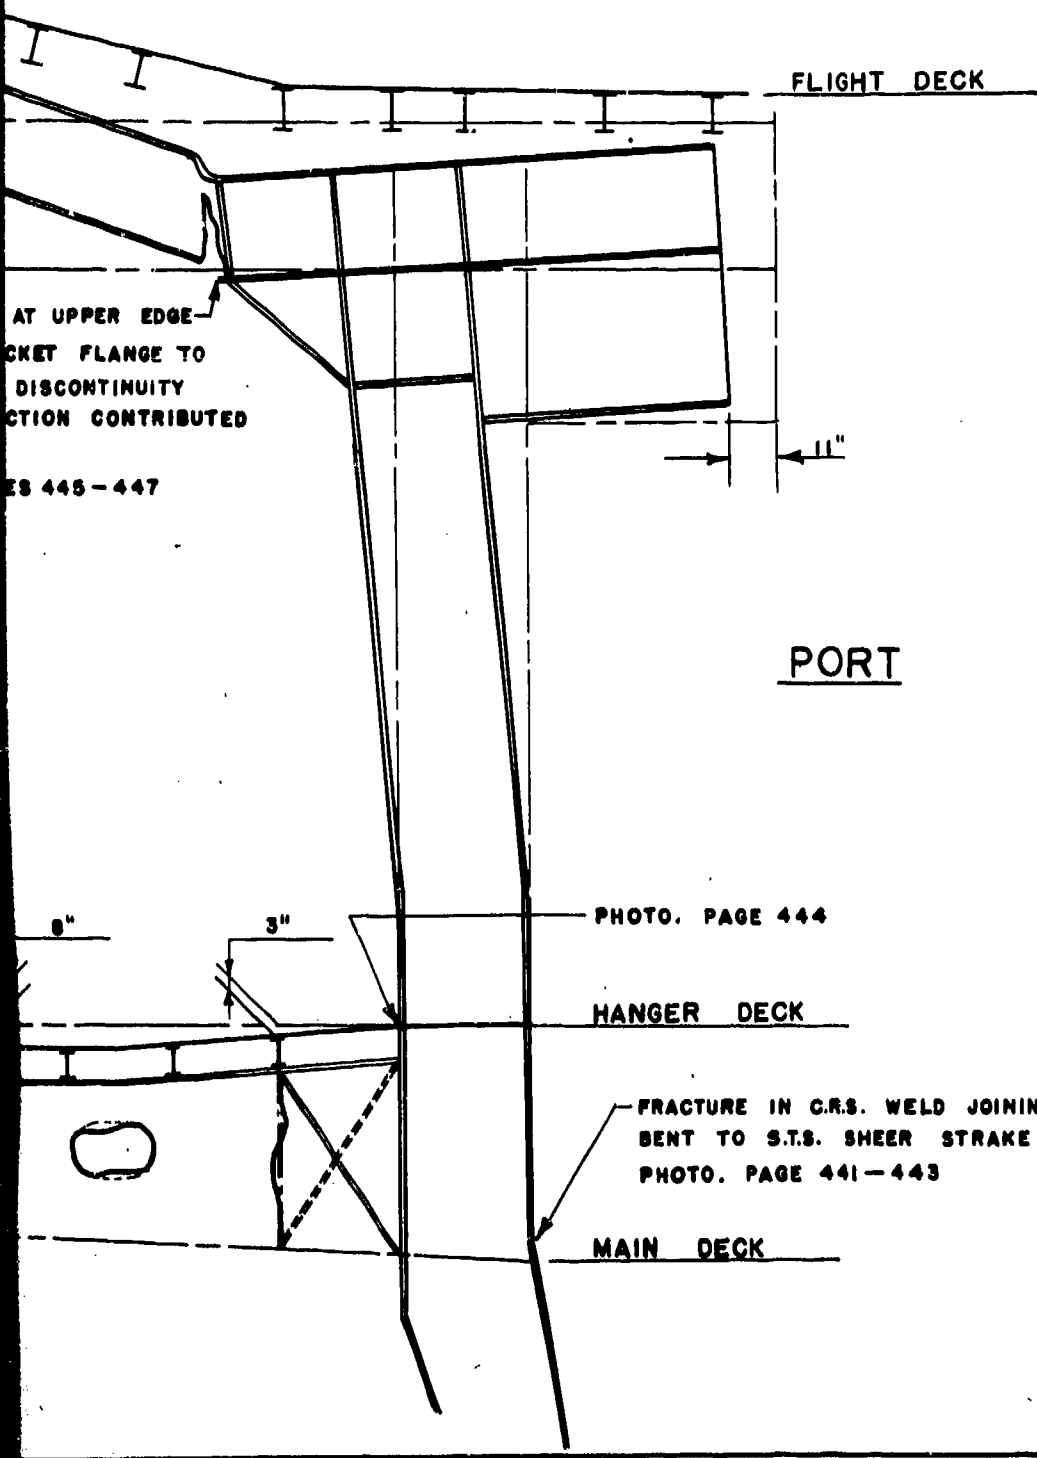
TRANSVERSE SECTION AT FR. 89
 LOOKING AFT

FRACTURE ORIGINATED AT FORWARD END OF WELD BETWEEN TRIPPING BRACKET AND LONGITUDINAL BRACKET.
 PHOTOS.— VOL. 3, PAGES 448—450

FRACTURE ORIGINATED AT UPPER EDGE OF WELD JOINING BRACKET FLANGE TO GIRDER. STRUCTURAL DISCONTINUITY IN DESIGN OF CONNECTION CONTRIBUTED TO FAILURE.
 PHOTOS.— VOL. 3, PAGES 445—447
