7 BUREAU OF SHIPS GROUP
TECHNICAL INSPECTION REPORT

6 OPERATION CROSSROADS.
U.S.S. INDEPENDENCE (CVL22)

TEST ABLE,

VOLUME 1 OF 4 [U].

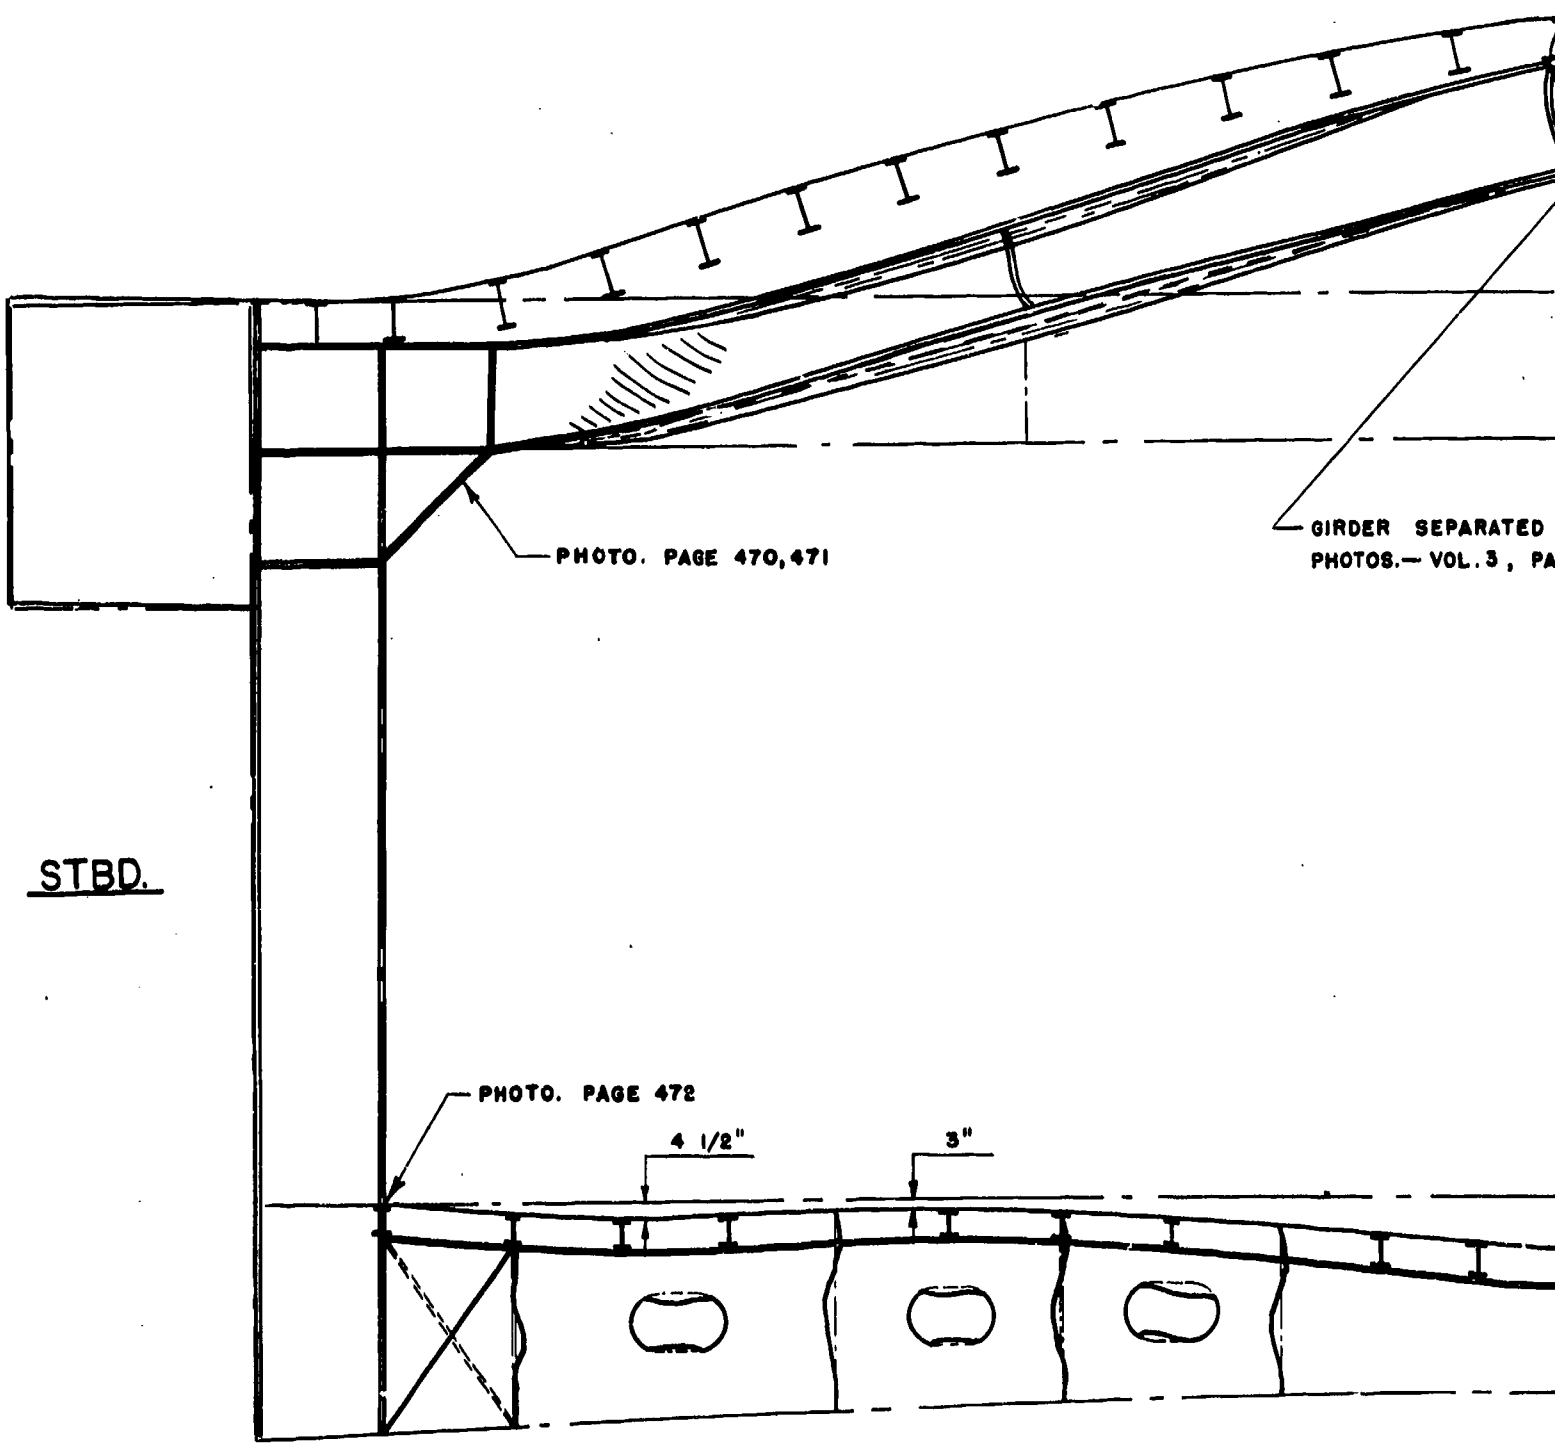
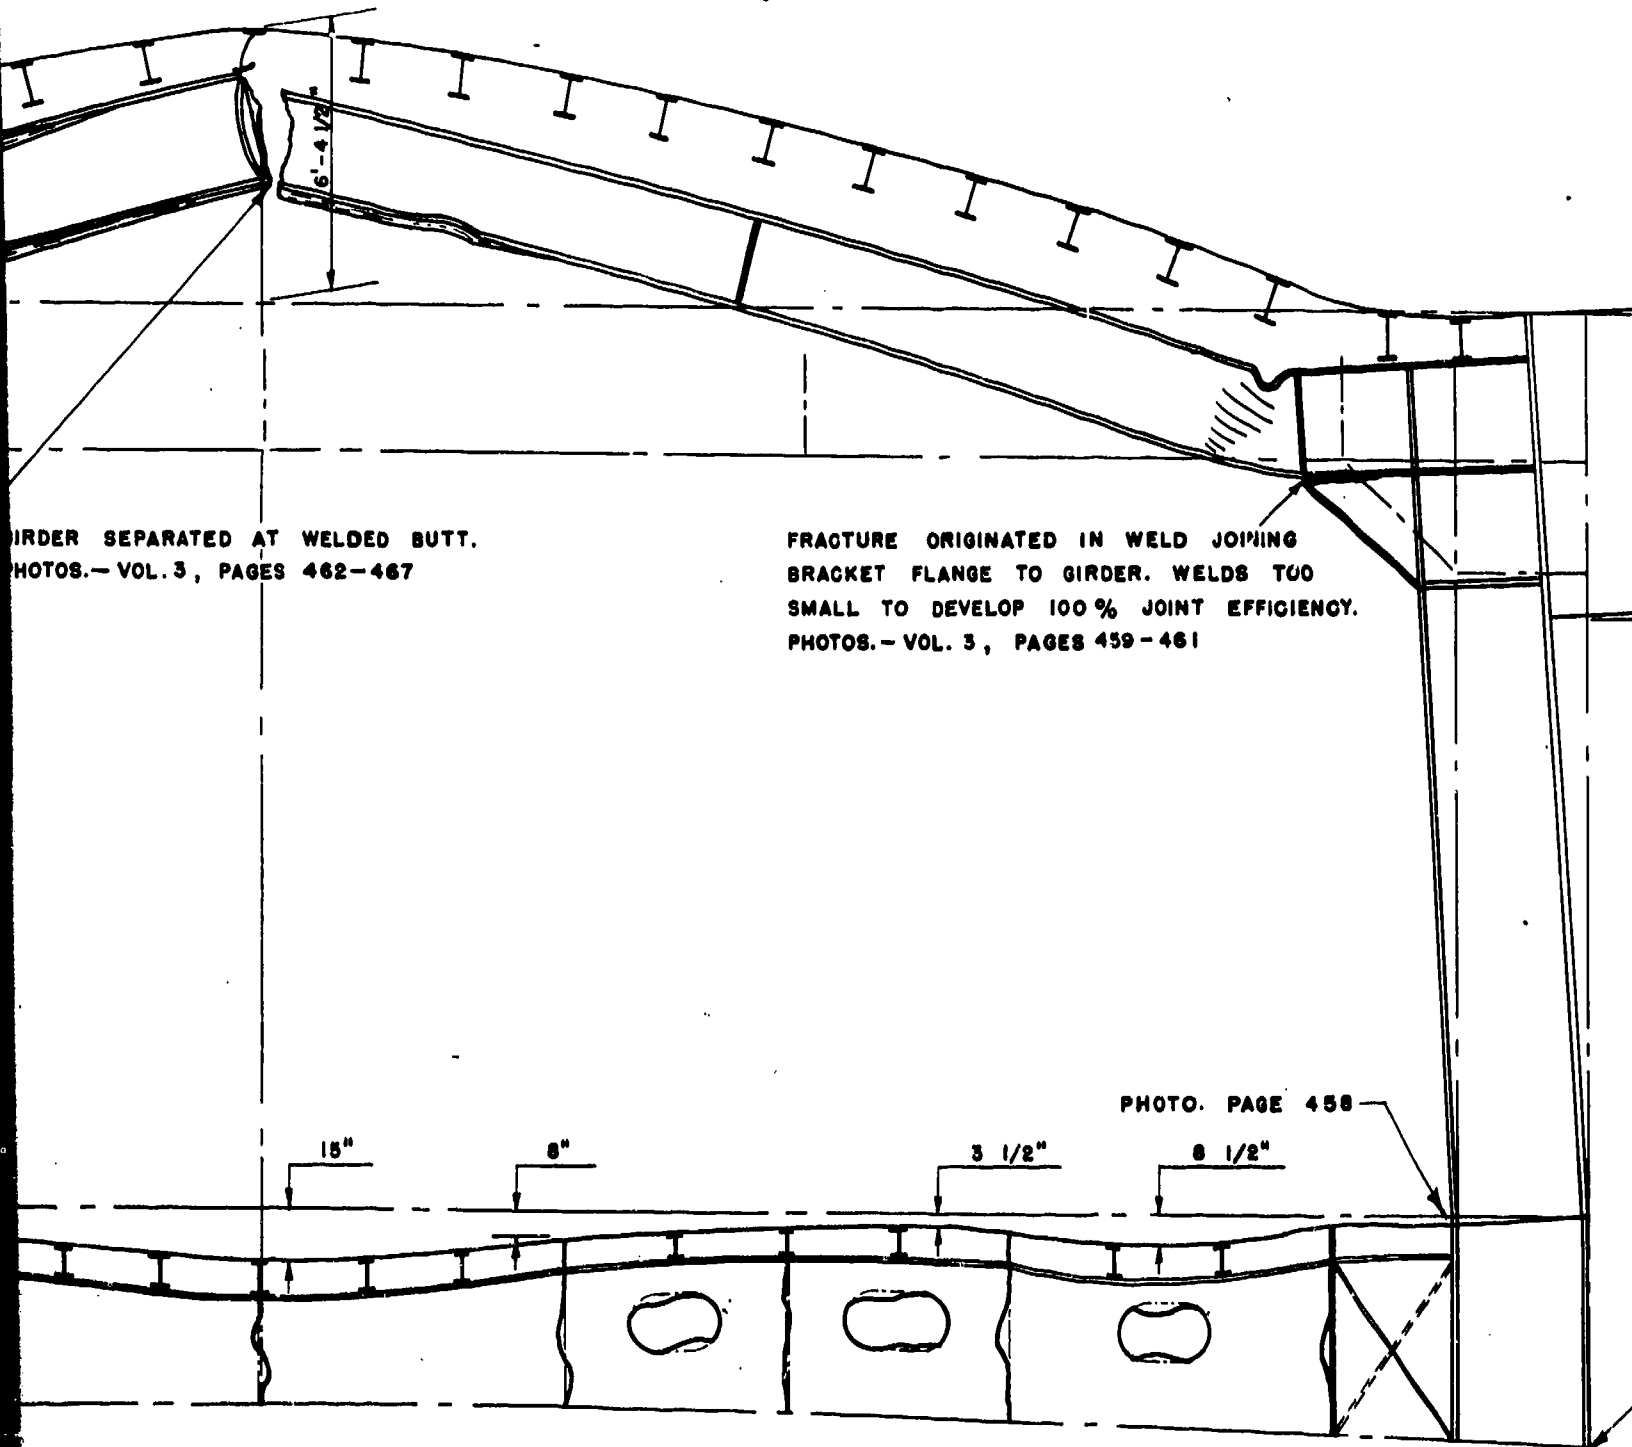
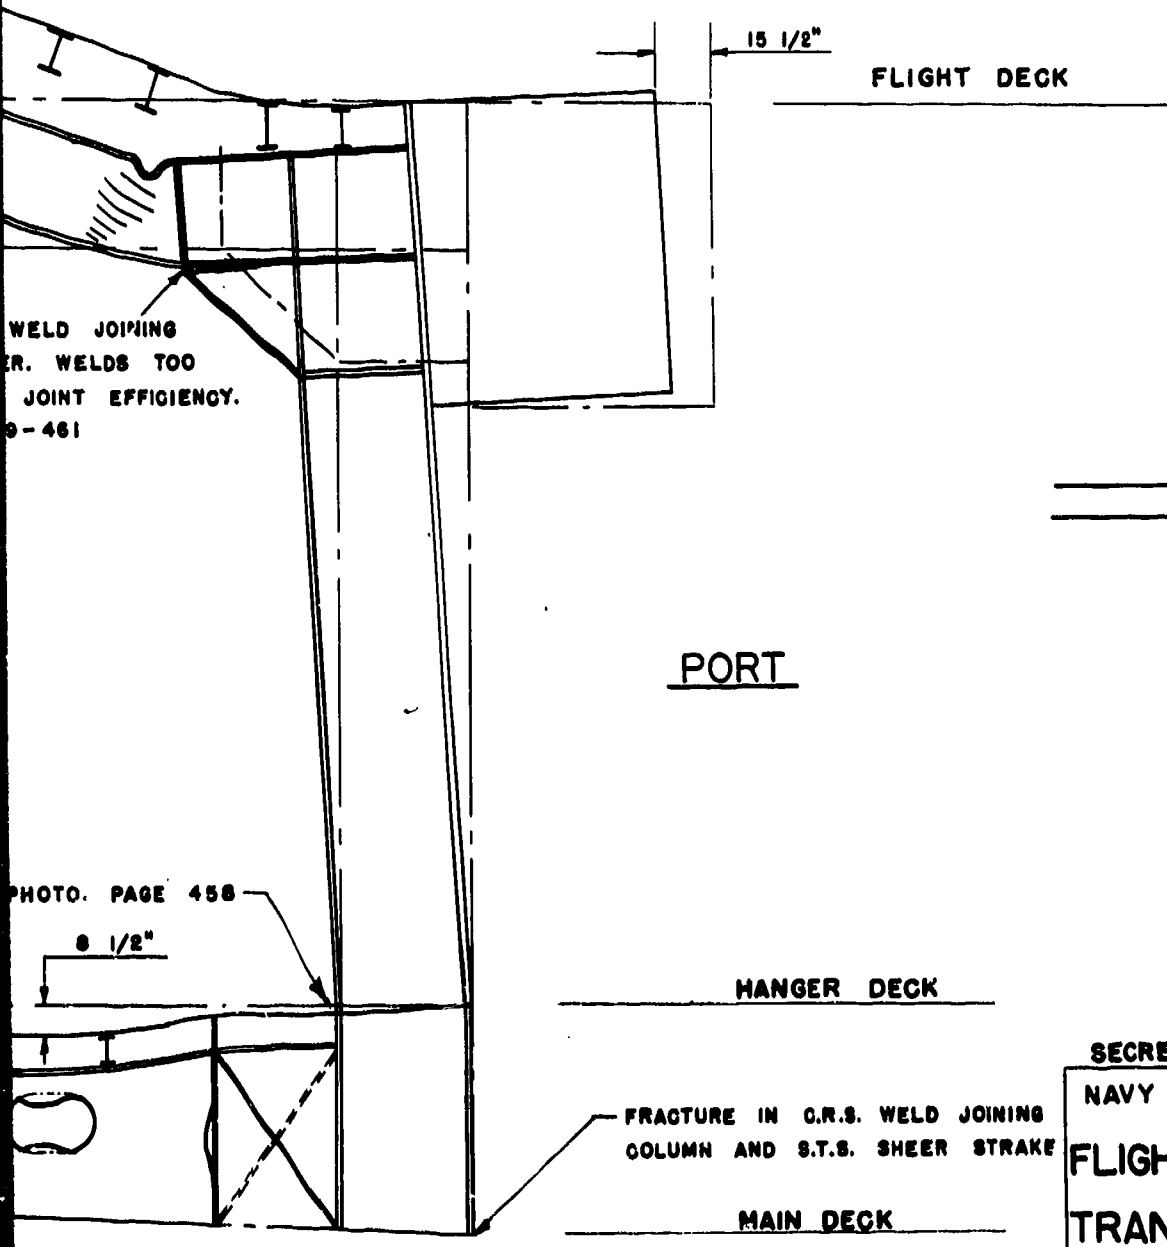
PLATE NO. 16

PHOTO. PAGE 470, 471

GIRDER SEPARATED
PHOTOS.— VOL. 3, PA

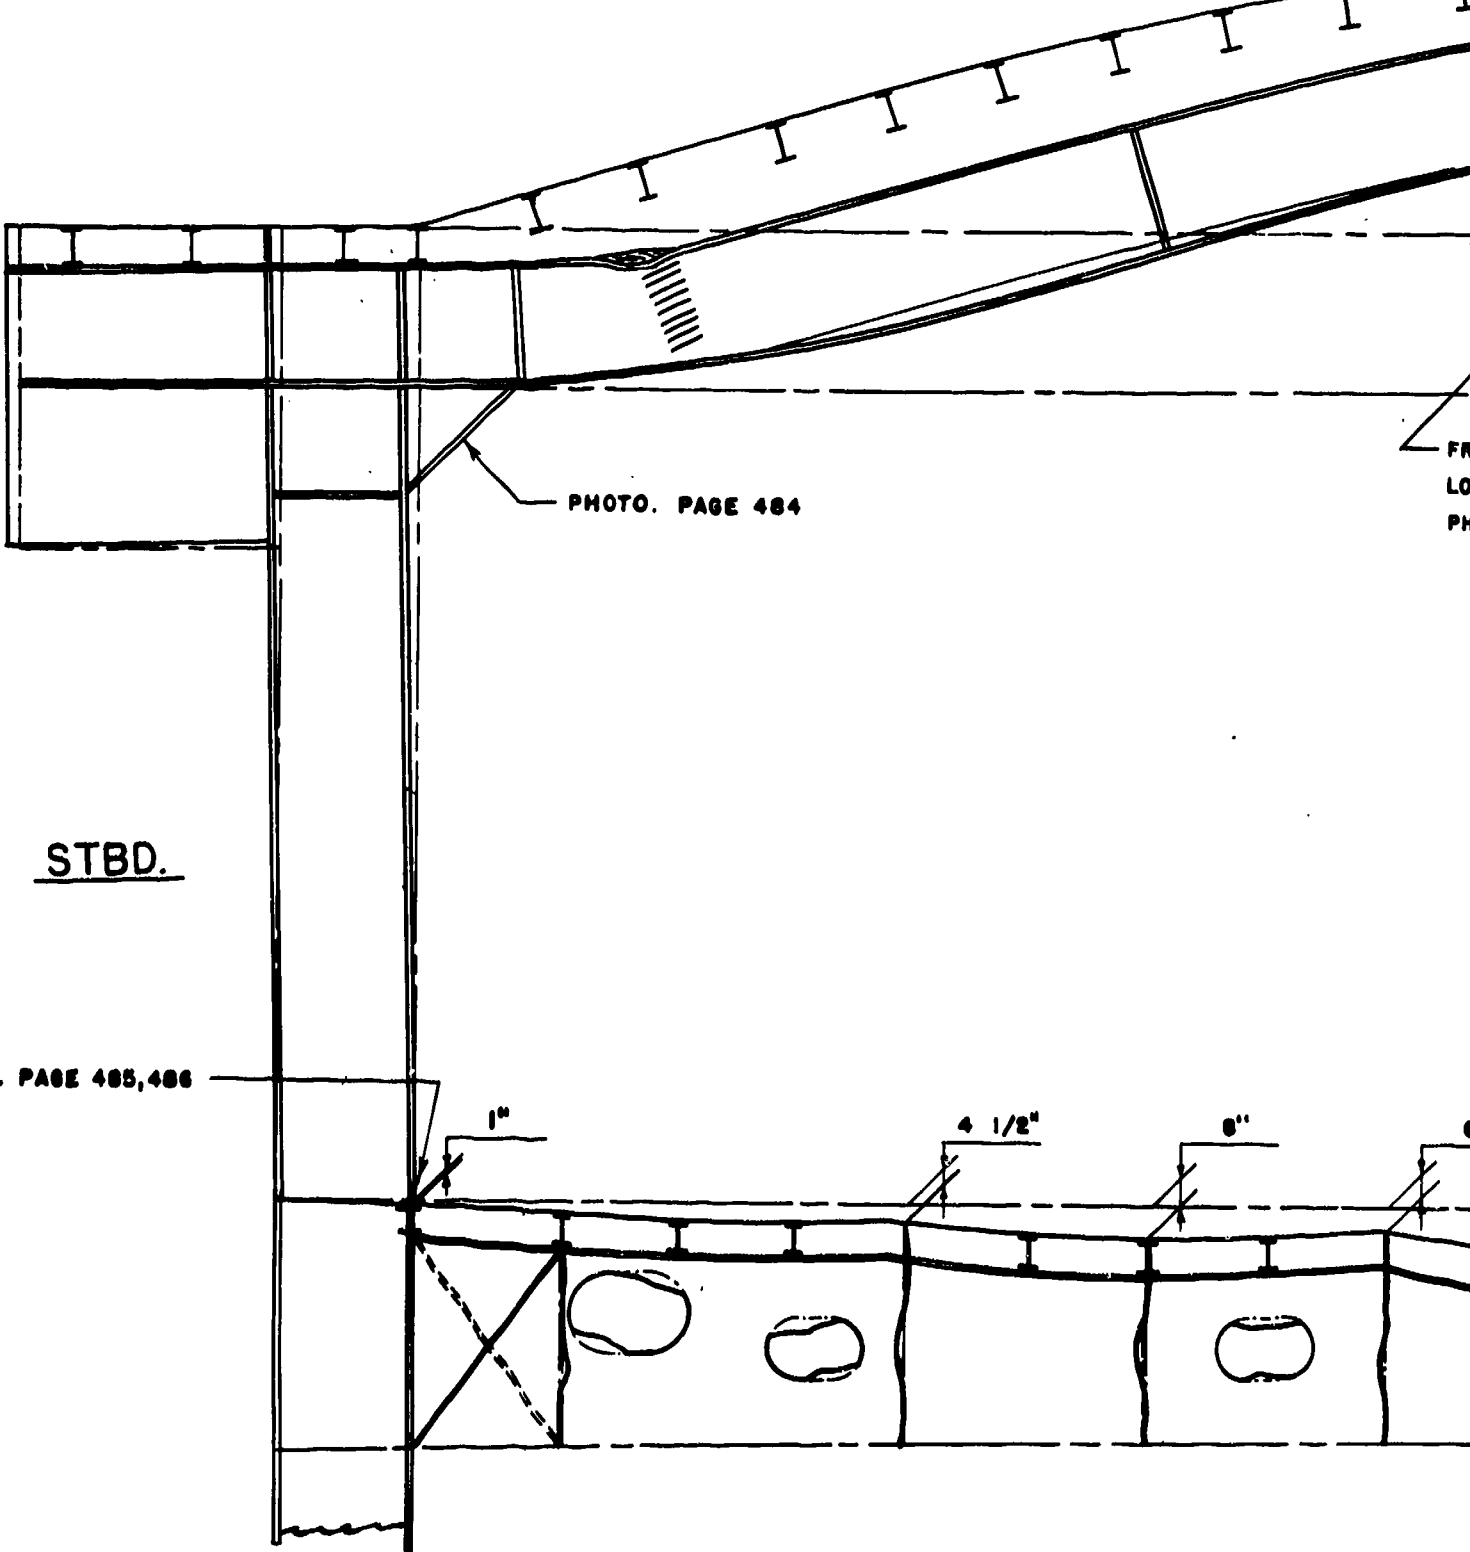
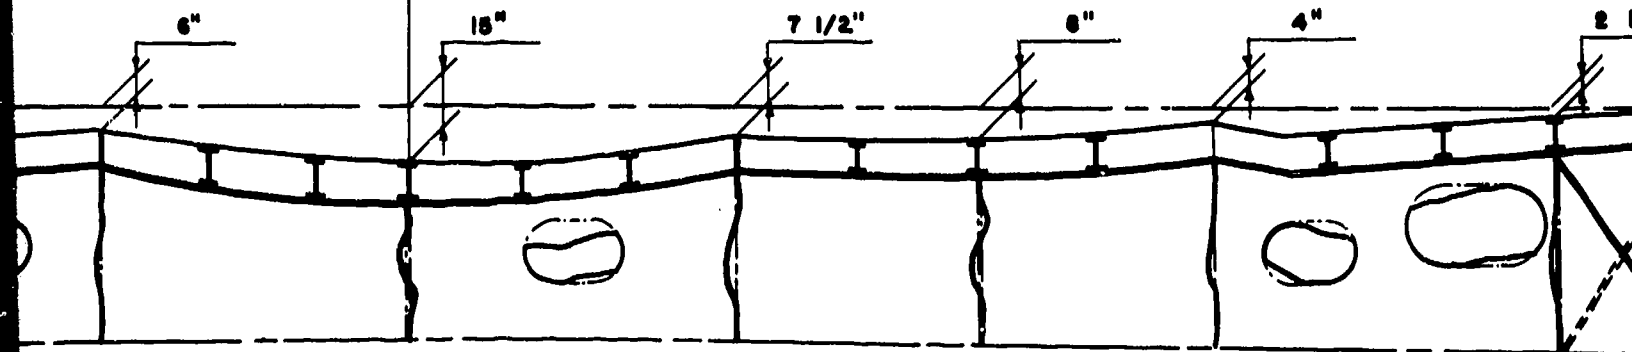
TRANSVERSE SECTION AT FR. 95
 LOOKING AFT

FRACTURE ORIGINATED IN BUTT WELD IN
 LOWER FLANGE OF GIRDER.
 PHOTOS.- VOL. 3, PAGES 475-483

FRACTURE ORIGINATED IN WELD JOINING
 BRACKET FLANGE TO TRANSVERSE GIRDER.
 WELDS TOO SMALL TO DEVELOP 100%
 JOINT EFFICIENCY.
 PHOTOS.- VOL. 3, PAGES 473, 474

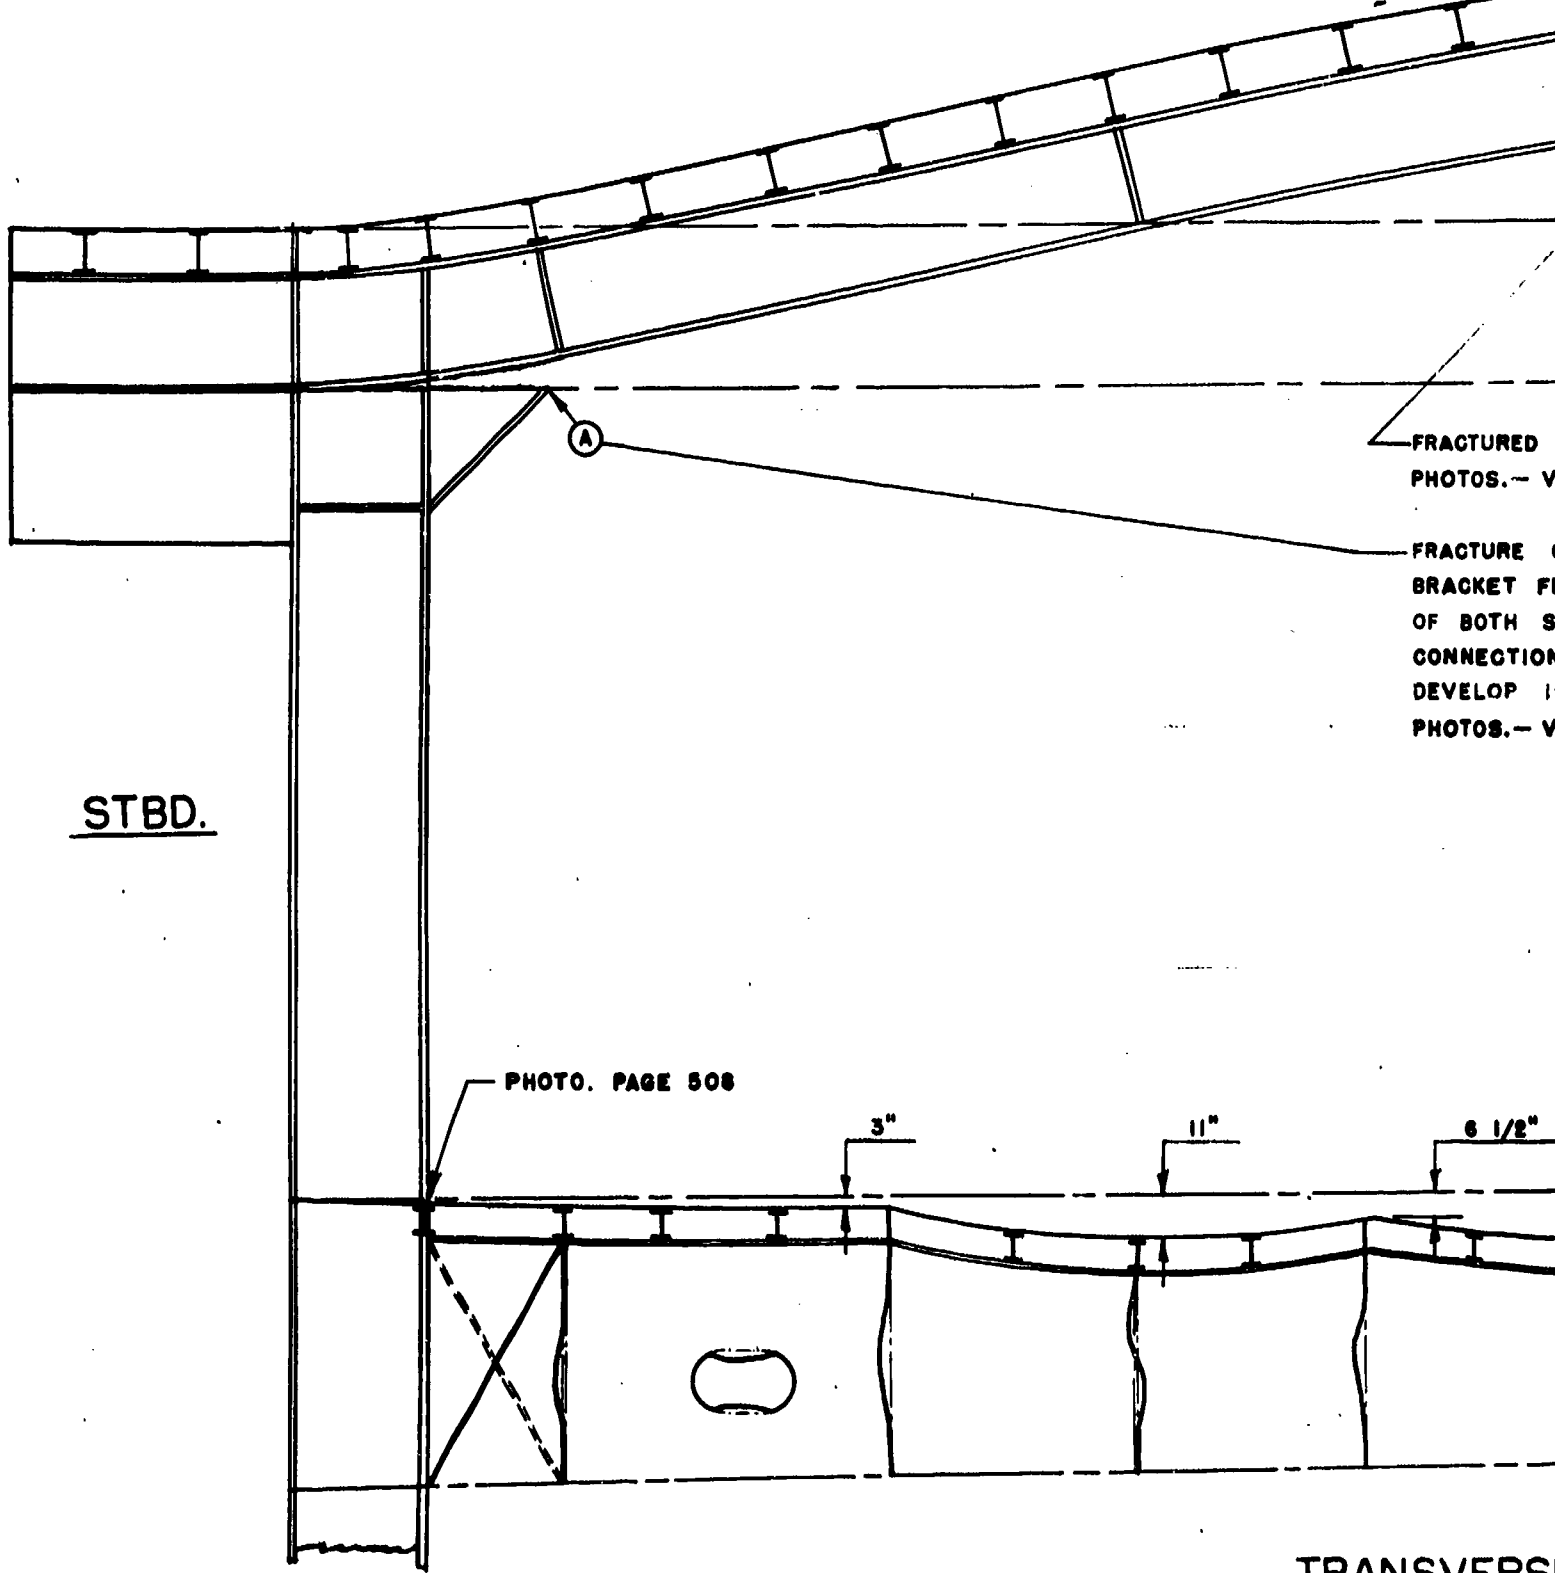
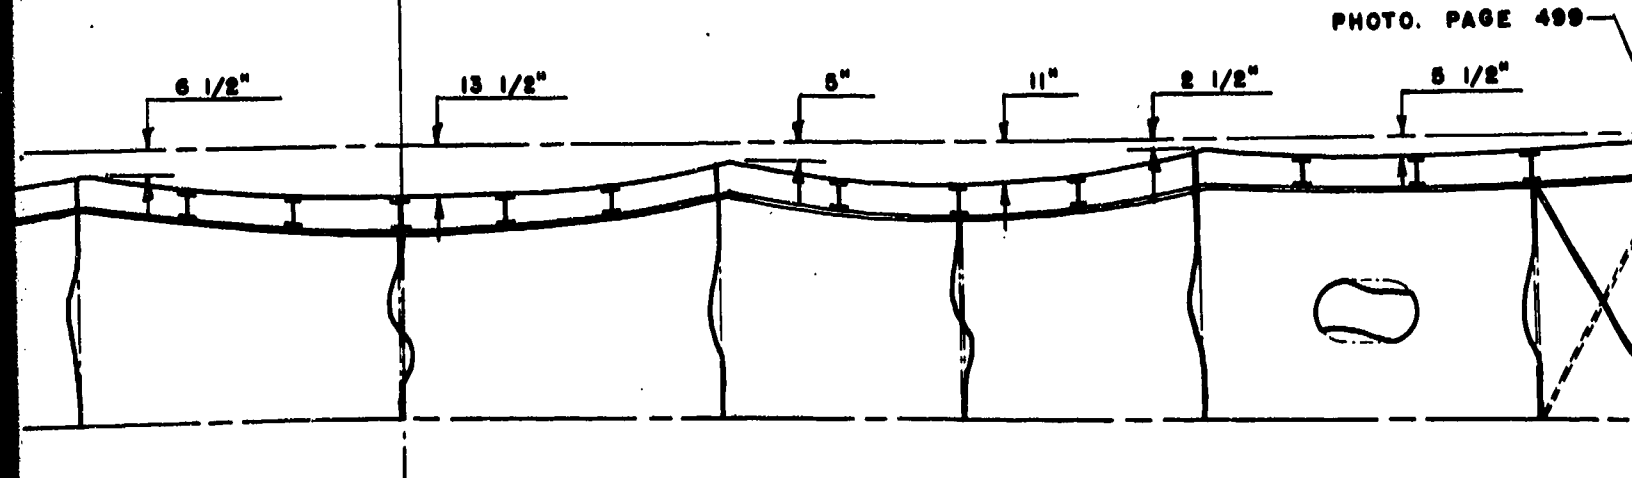
TRANSVERSE SECTION AT FR.101
 LOOKING AFT

FRACTURE ORIGINATED IN WELDS JOINING
 BRACKET FLANGE TO GIRDER IN THE CASE
 OF BOTH STBD. (A) AND PORT (B)
 CONNECTIONS. WELDS TOO SMALL TO
 DEVELOP 100% JOINT EFFICIENCY.
 PHOTOS.— VOL. 3 , PAGES (A) 506,507

(B) 500-502

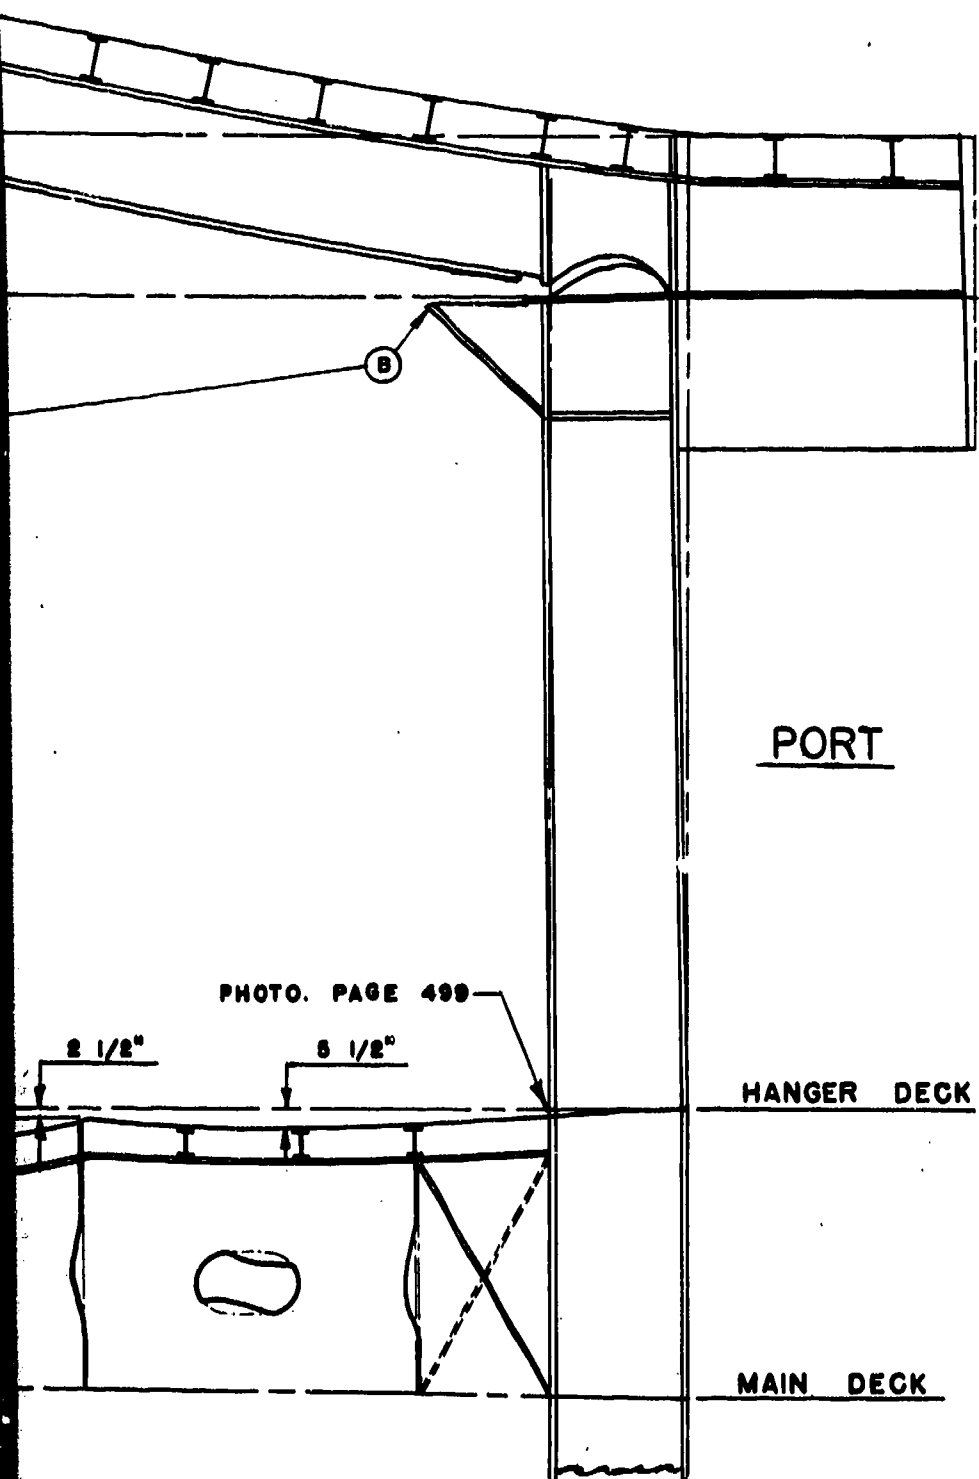
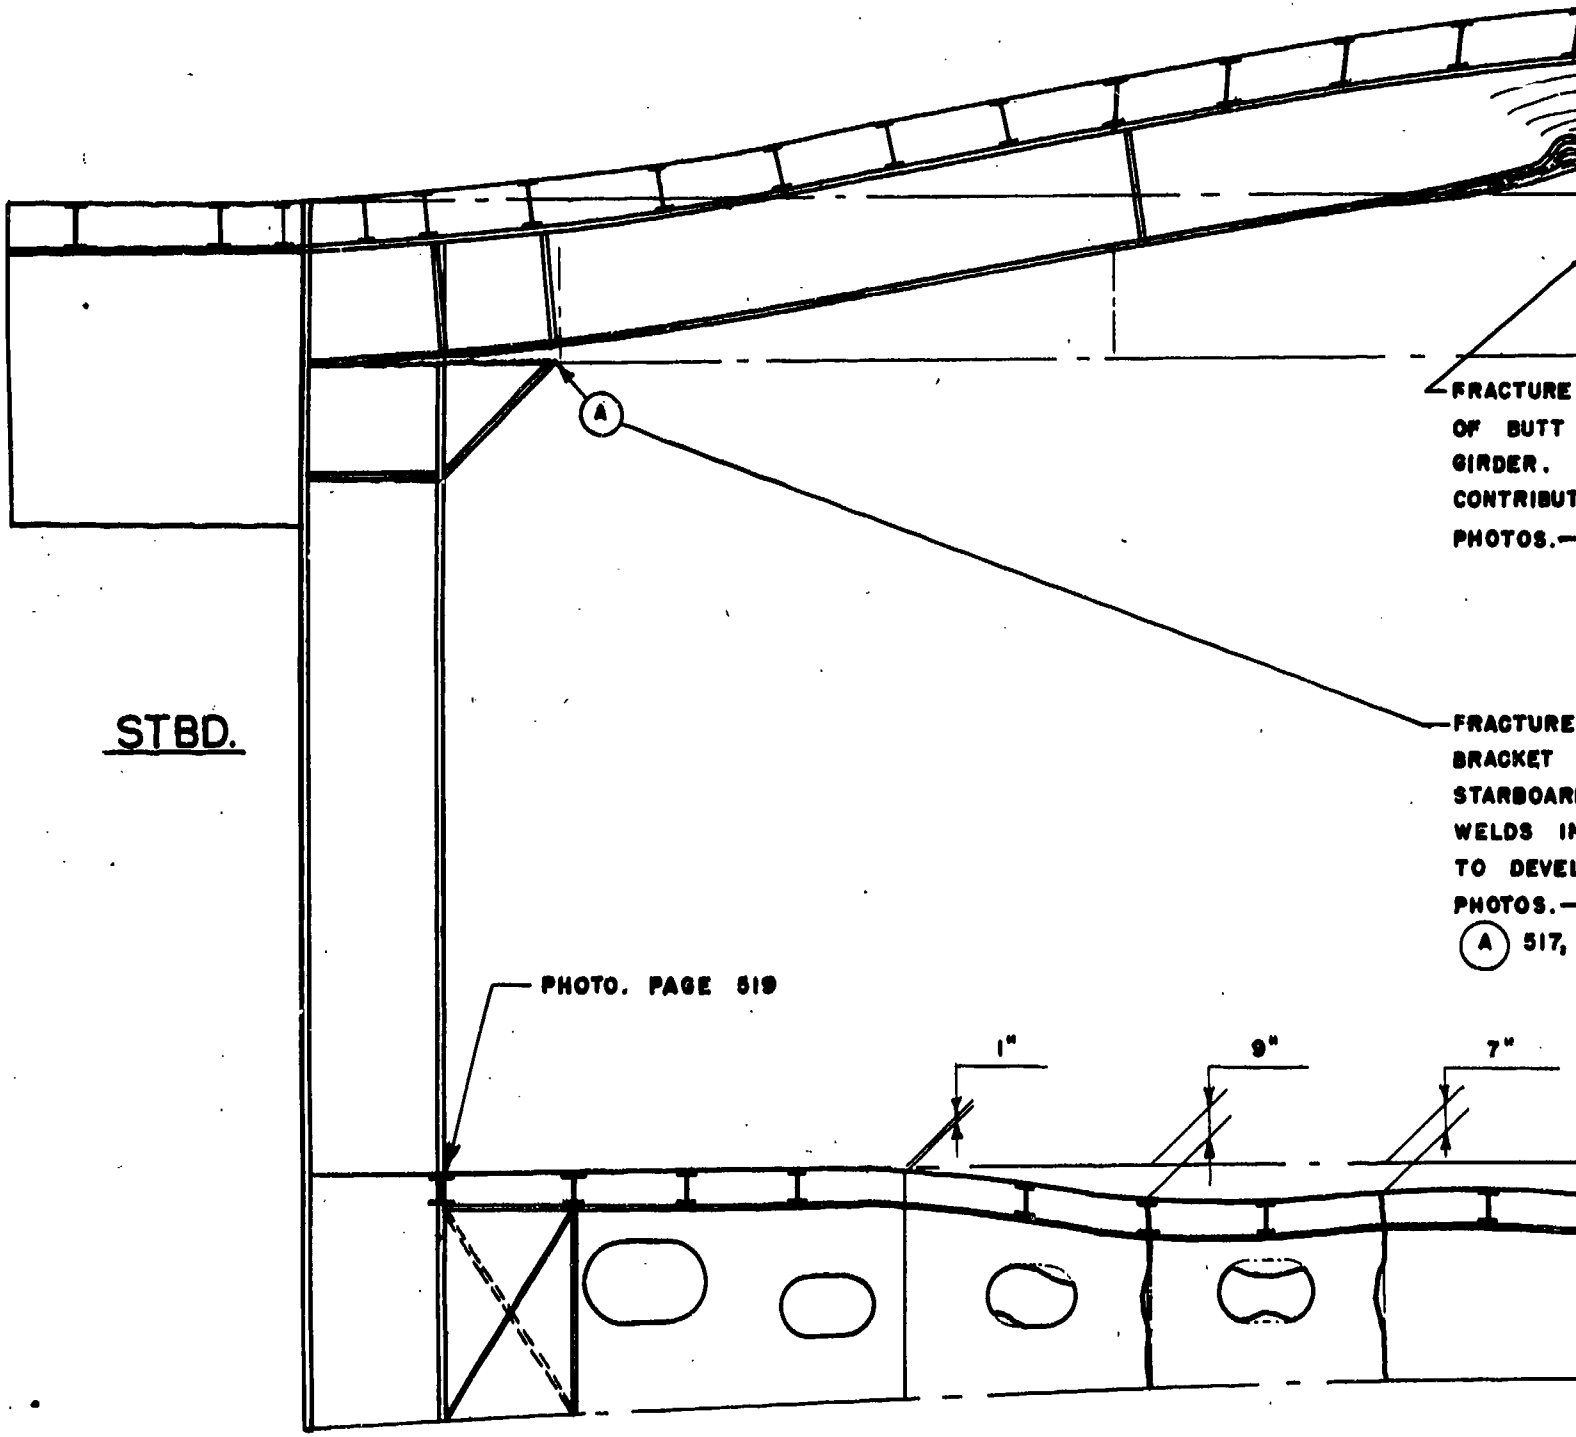
FRACTURE
OF BUTT
GIRDER.
CONTRIBUT
PHOTOS.—

FRACTURE
BRACKET
STARBOARD
WELDS IN
TO DEVEL
PHOTOS.—

FRACTURE ORIGINATED IN FORWARD END OF BUTT WELD IN LOWER FLANGE OF GIRDER. INCOMPLETE WELD PENETRATION CONTRIBUTED TO FAILURE.

FRACTURE ORIGINATED IN WELDS JOINING BRACKET FLANGE TO GIRDER IN BOTH STARBOARD (A) AND PORT (B) CONNECTIONS. WELDS IN BOTH CASES ARE TOO SMALL TO DEVELOP 100% JOINT EFFICIENCY.

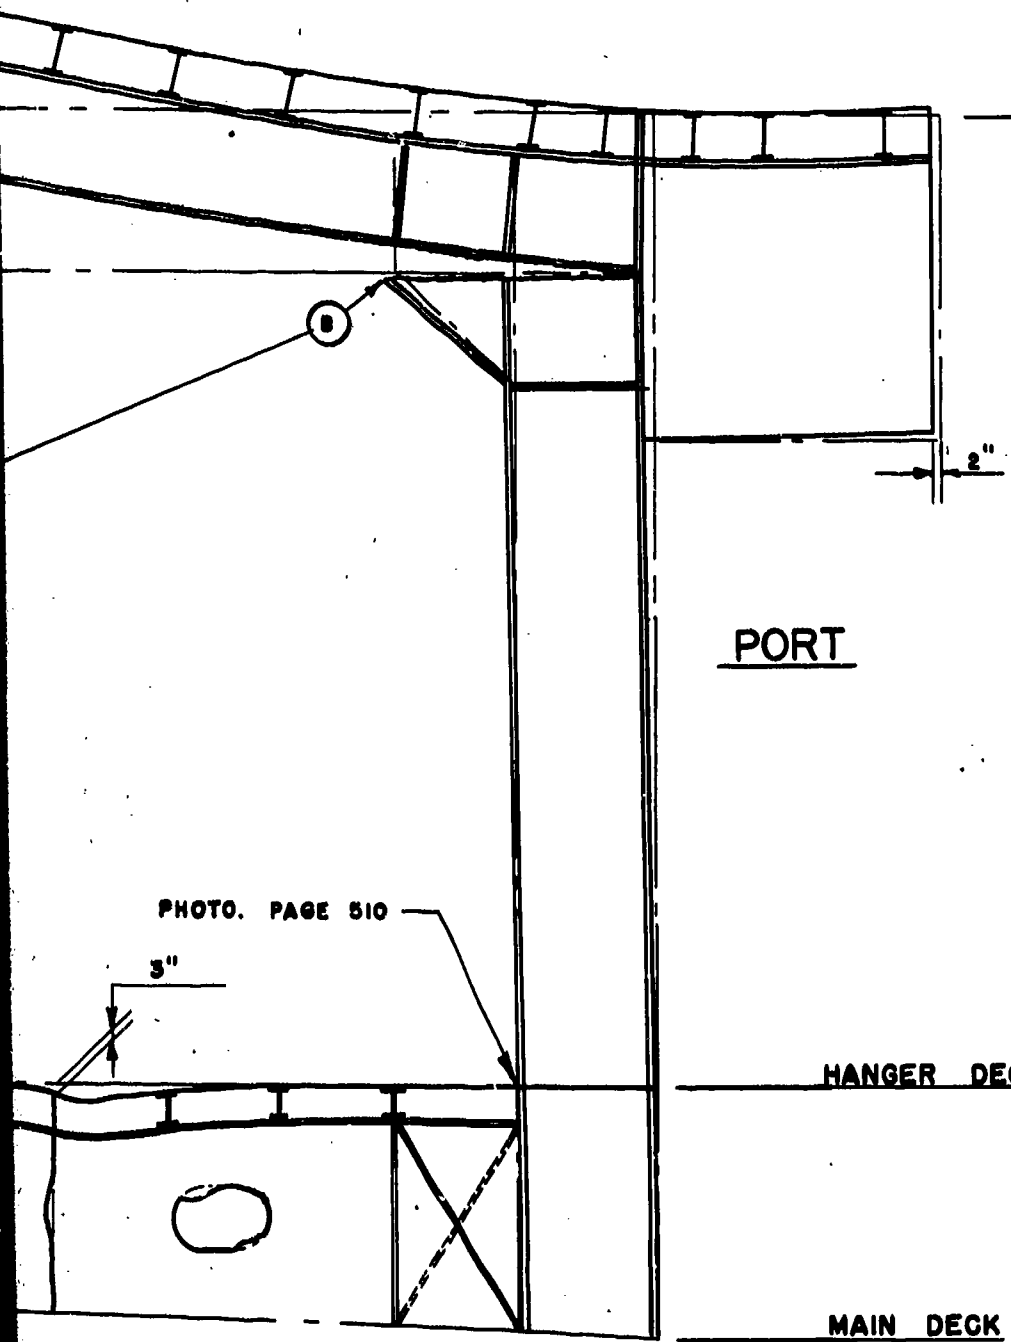
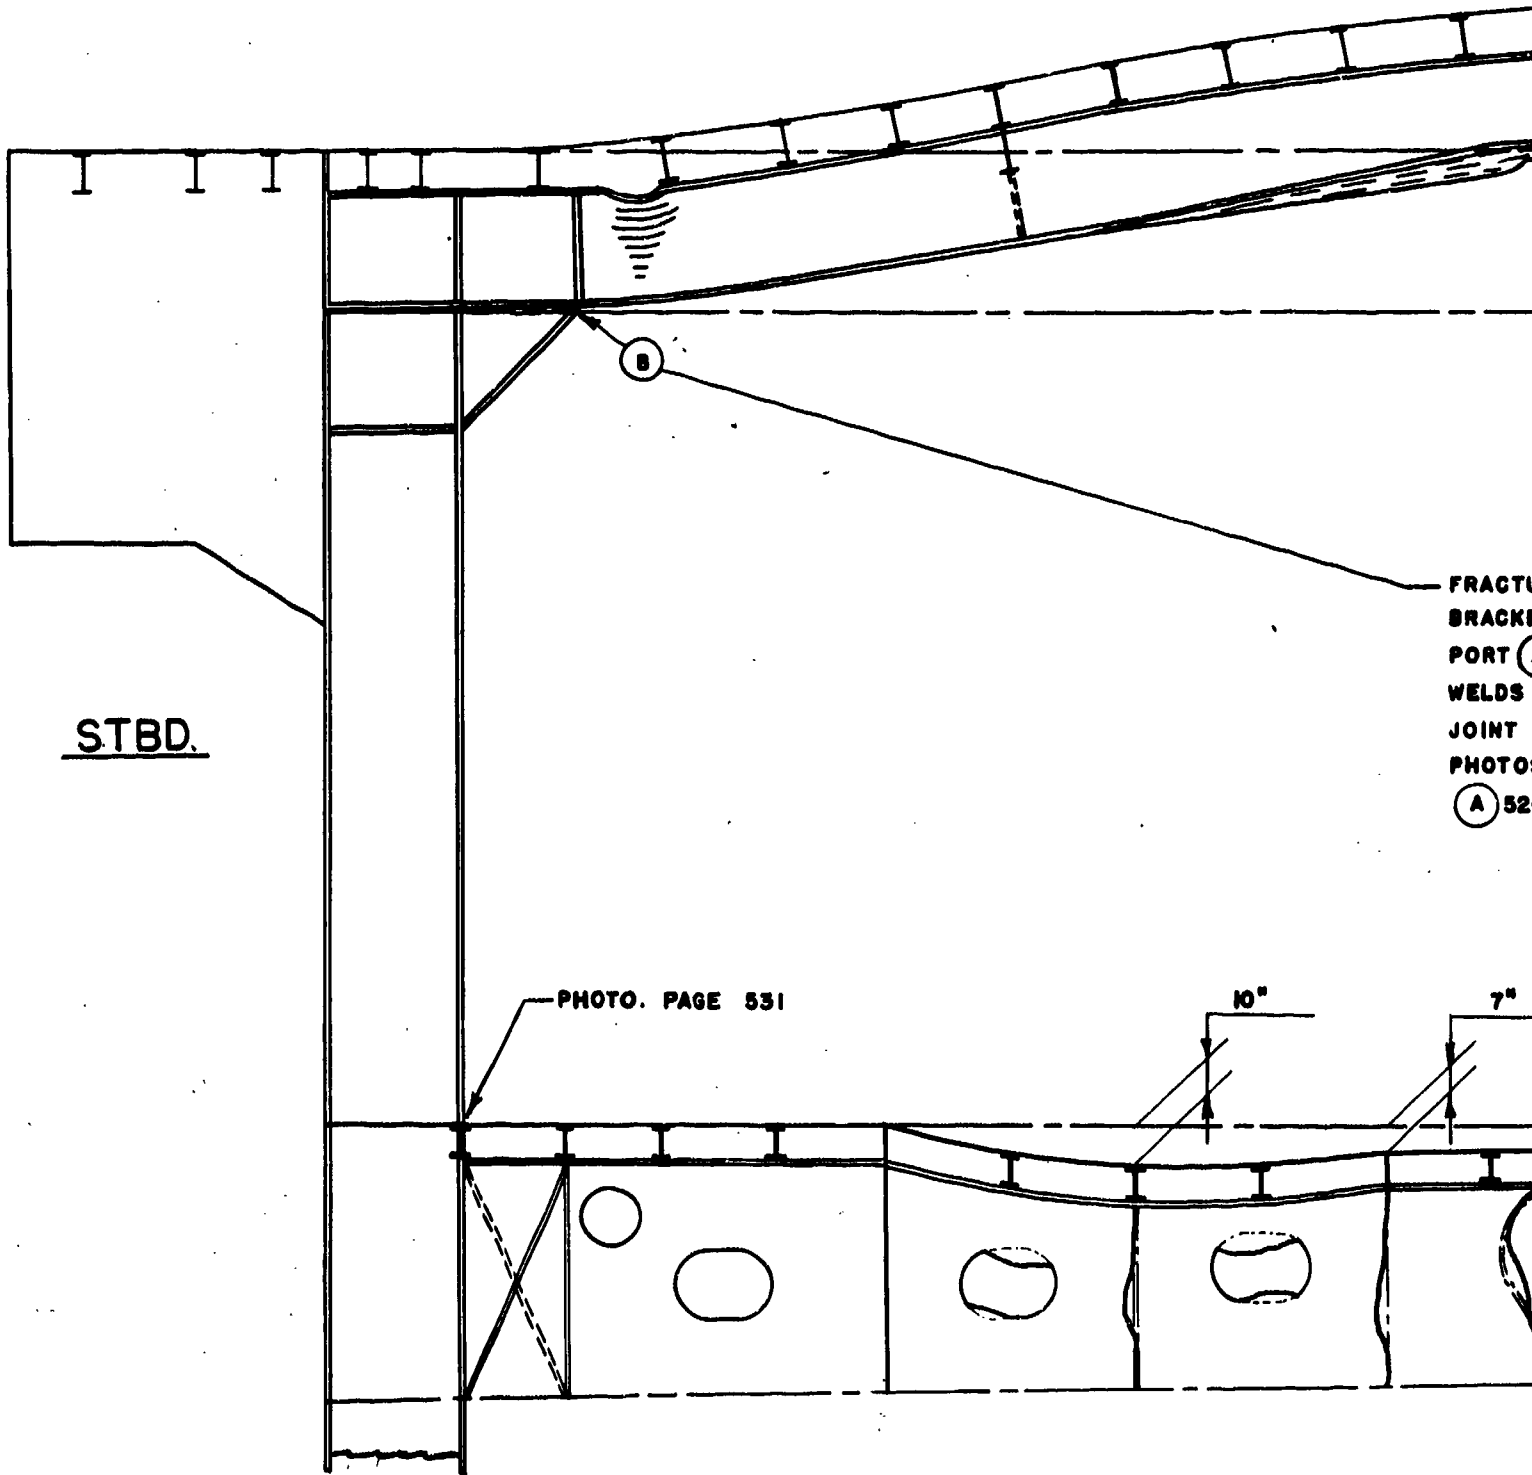
TRANSVERSE SECTION AT FR. 104
LOOKING AFT

FRACTURE
BRACKET
PORT
WELDS
JOINT
PHOTO
(A) 52

FRACTURE ORIGINATED IN WELDS JOINING
 BRACKET FLANGE AND GIRDER IN BOTH
 PORT (A) AND STARBOARD (B) CONNECTIONS.
 WELDS TOO SMALL TO DEVELOP 100 %
 JOINT EFFICIENCY.
 PHOTOS.- VOL. 4, PAGES
 (A) 520, 524, 525 (B) 523, 530

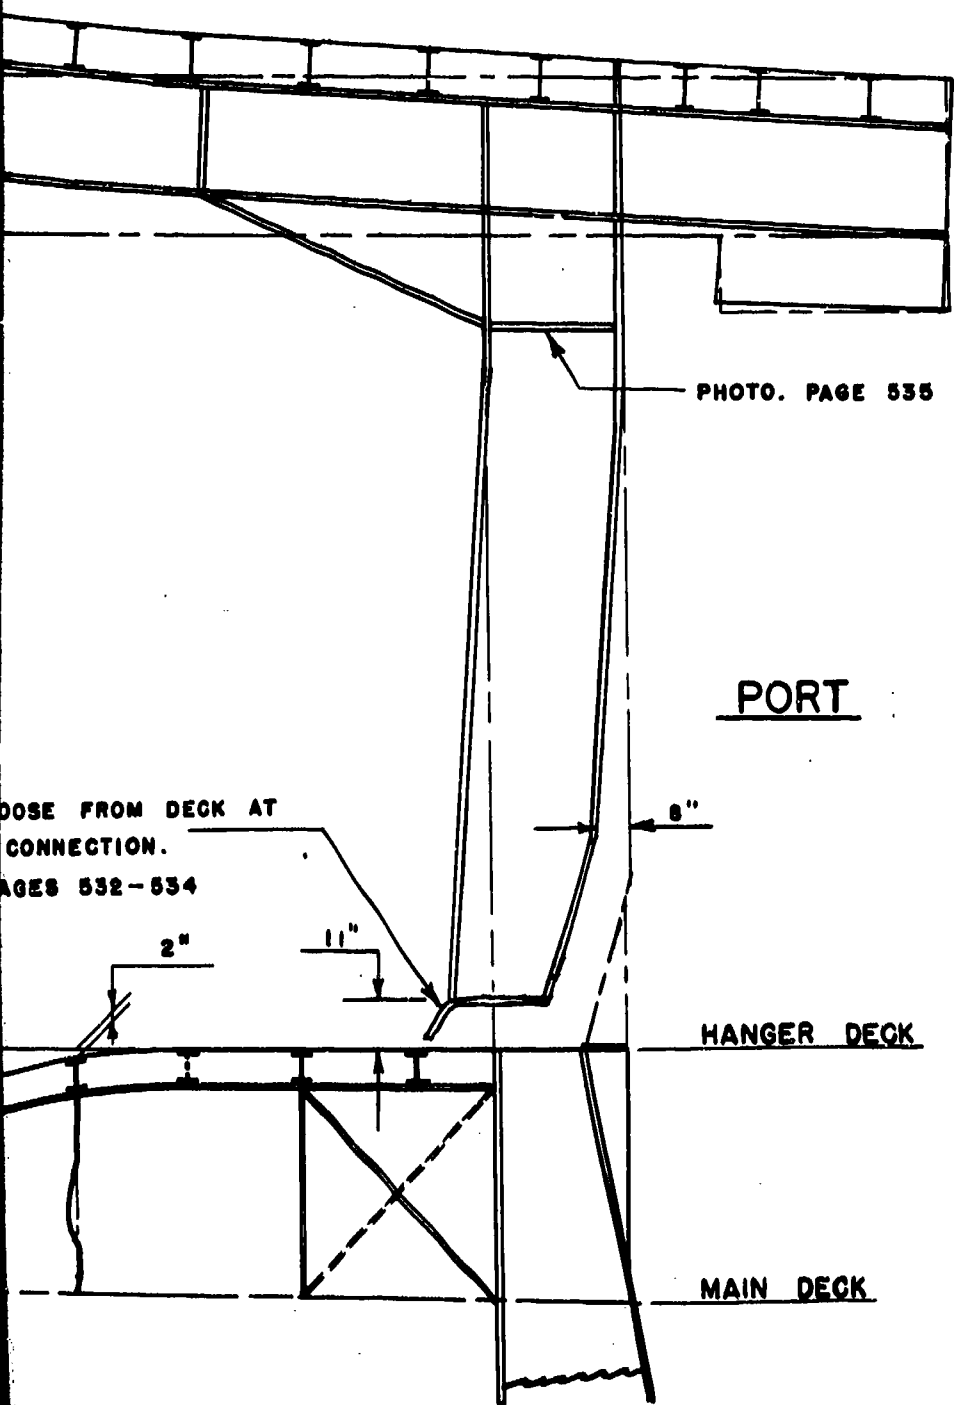
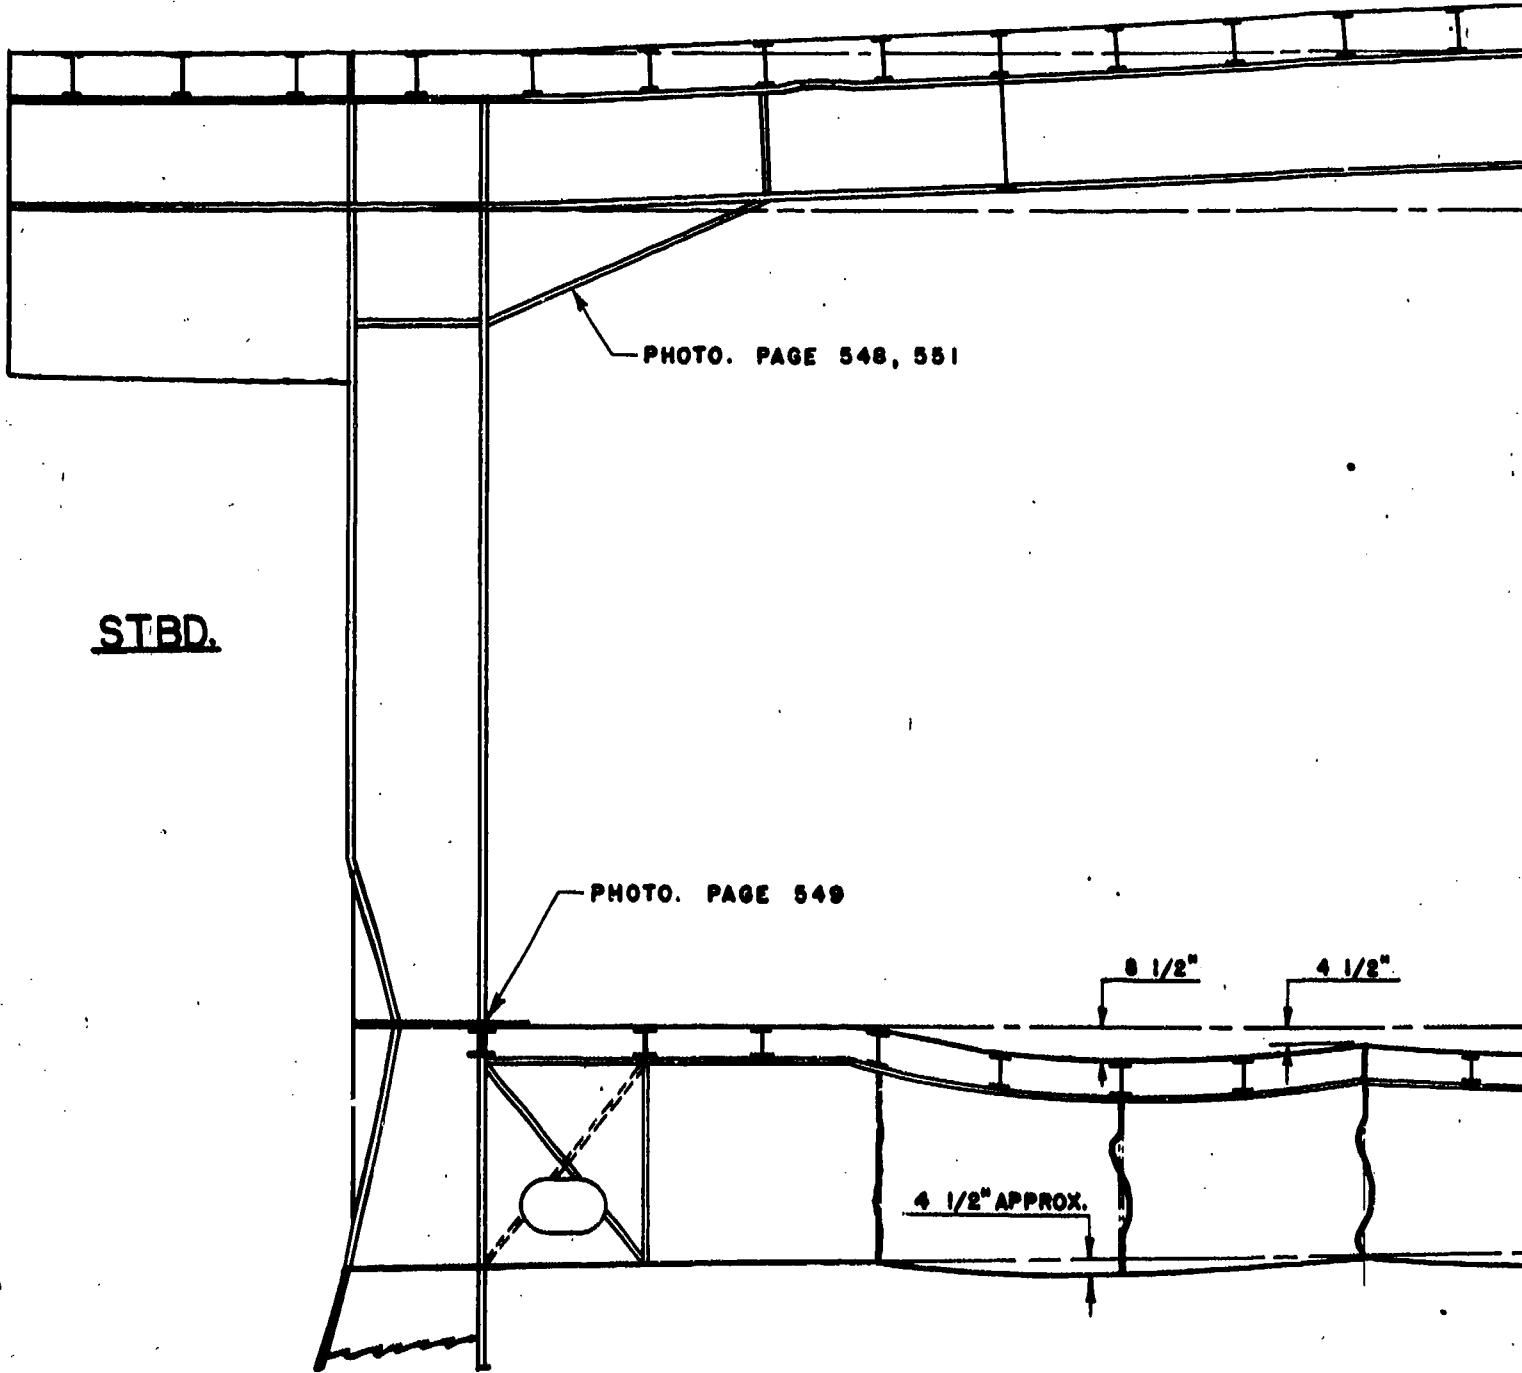
TRANSVERSE SECTION AT FR. 110
LOOKING AFT

The base of the port columns of the "wobble bents" at frames 110 and 113 are about eleven inches off the hangar deck (see photo, page 532). The girders are pivoted about the top of the starboard column. There is no noticeable athwartships displacement (see plates 23 and 24).
