7 BUREAU OF SHIPS GROUP
TECHNICAL INSPECTION REPORT

6 OPERATION CROSSROADS.
U.S.S. INDEPENDENCE (CVL22)

TEST ABLE,

VOLUME 1 OF 4 [U].

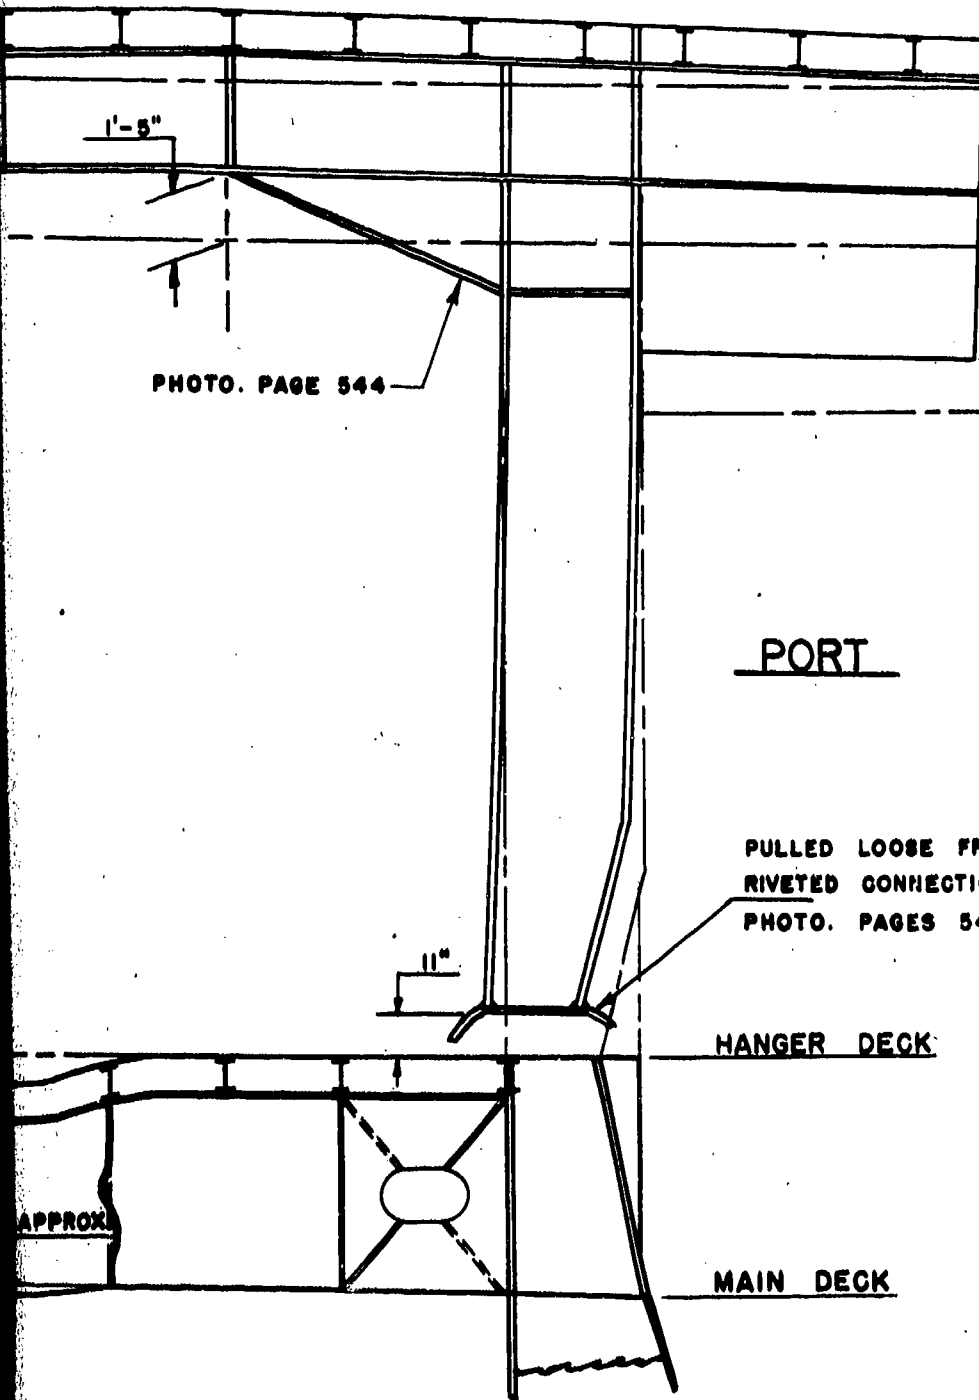
TRANSVERSE SECTION AT FR. 113
LOOKING AFT

The base of the port columns of the "wobble bents" at frames 110 and 113 are about eleven inches off the hangar deck (see photo, page 532). The girders are pivoted about the top of the starboard column. There is no noticeable athwartships displacement (see plates 23 and 24).

PULLED LOOSE FROM DECK AT
RIVETED CONNECTION.
PHOTO. PAGES 545, 546

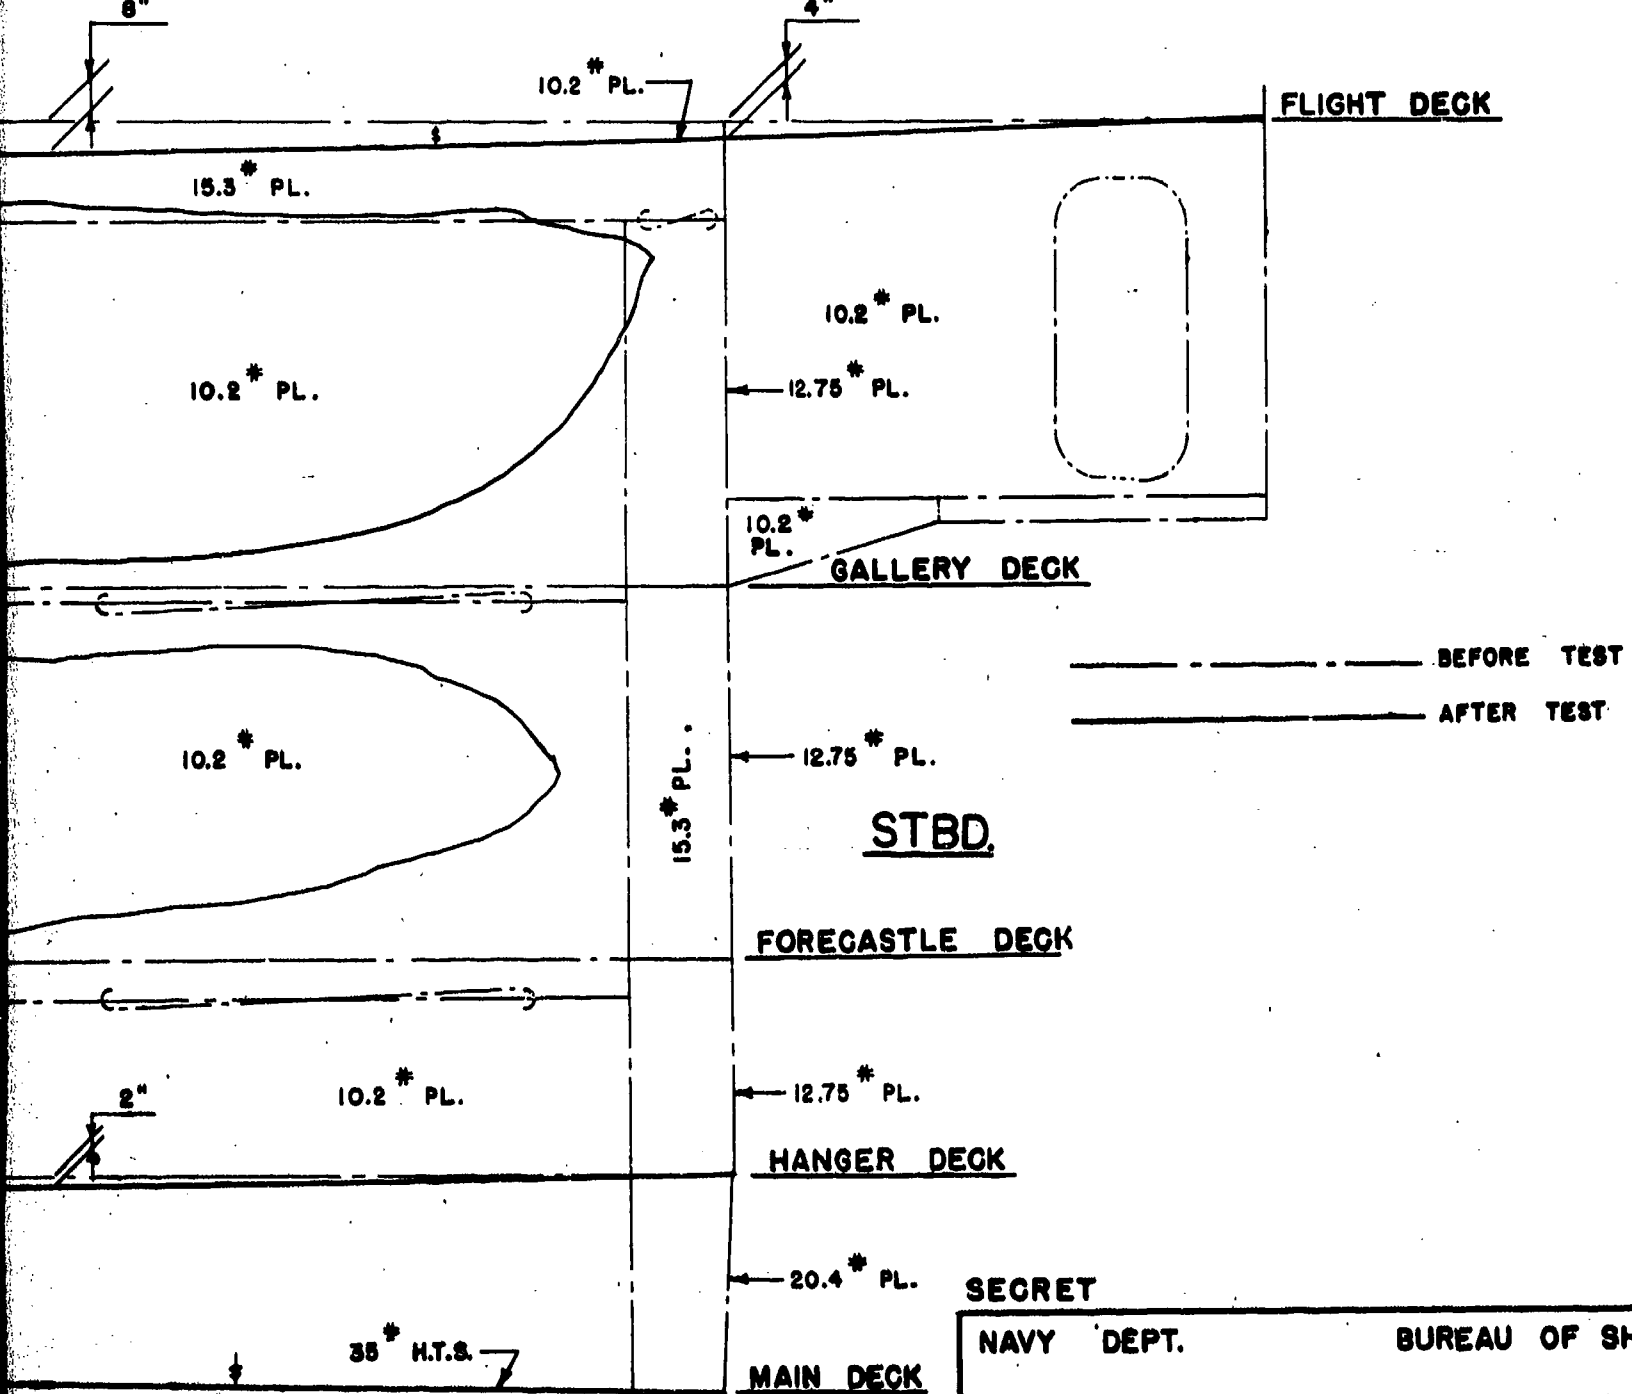
TRANSV. W.T. BHD. 45
LOOKING FORD.

SEVERELY DISHED (FWD.)
12" TO 18"

SLIGHTLY DISHED (FWD.)
3" TO 6"
PHOTO. PAGES 243, 245, 265-271

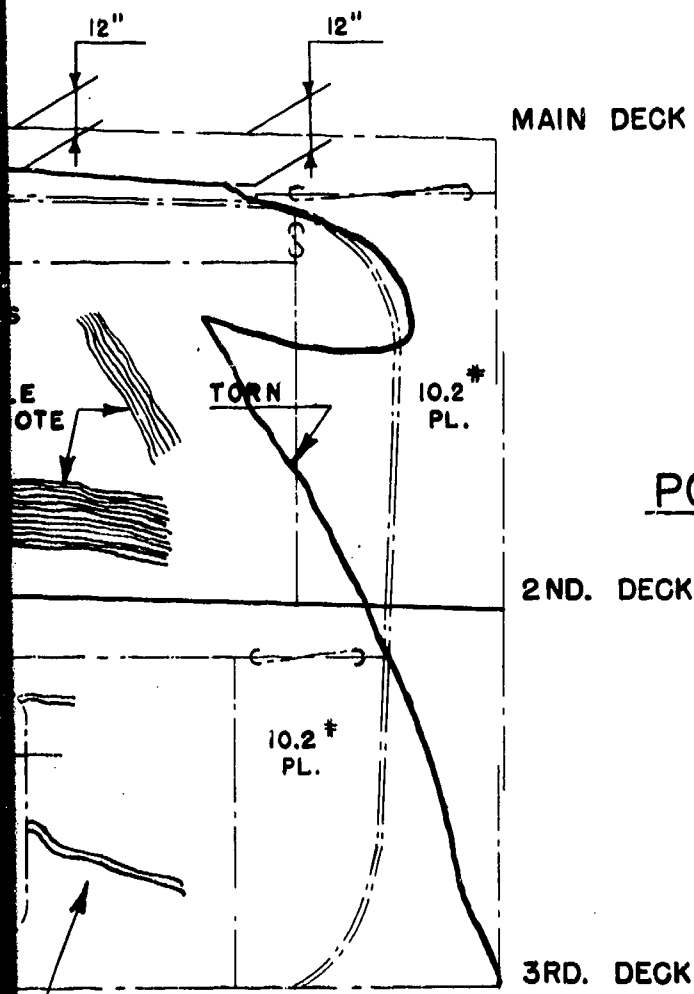
NOTE:
 NO. OF LINES INDICATE DEPTH
 OF WRINKLE IN PLATING (INCHES).

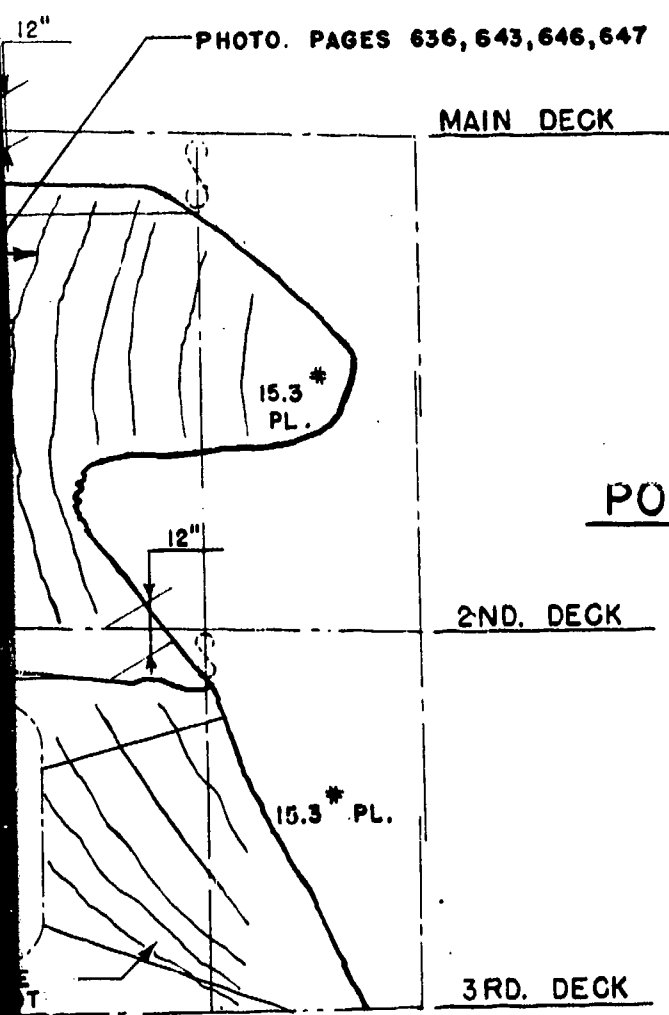
TRANSV. BHD. 138
LOOKING AFT.

NOTE:
 NO. OF LINES INDICATES DEPTH
 OF WRINKLE IN PLATING (INCHES).

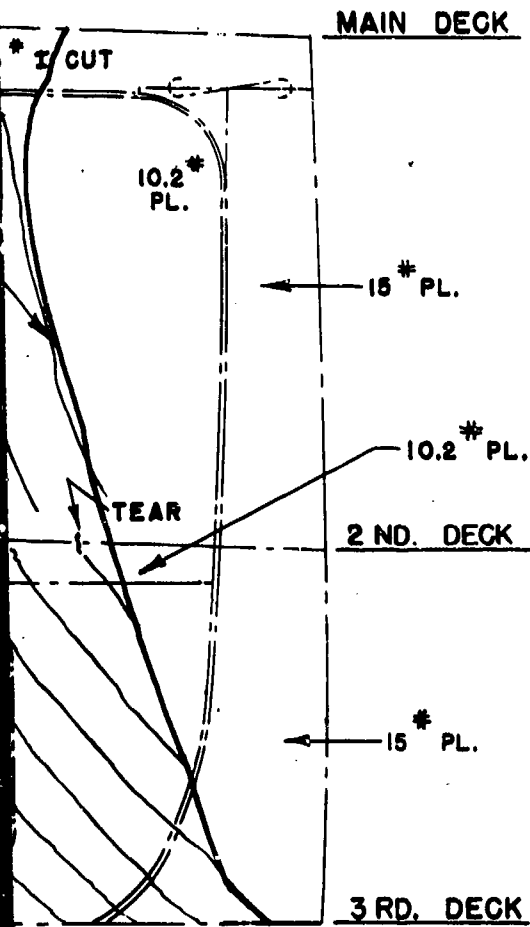
TRANSV. W.T. BHD. 144
LOOKING AFT.

1. NO. OF LINES INDICATES DEPTH OF WRINKLE IN PLATING (INCHES).
2. NO DATA AVAILABLE REGARDING DECK DEFLECTION. SHELL DAMAGE INDICATED TAKEN FROM PHOTOS.

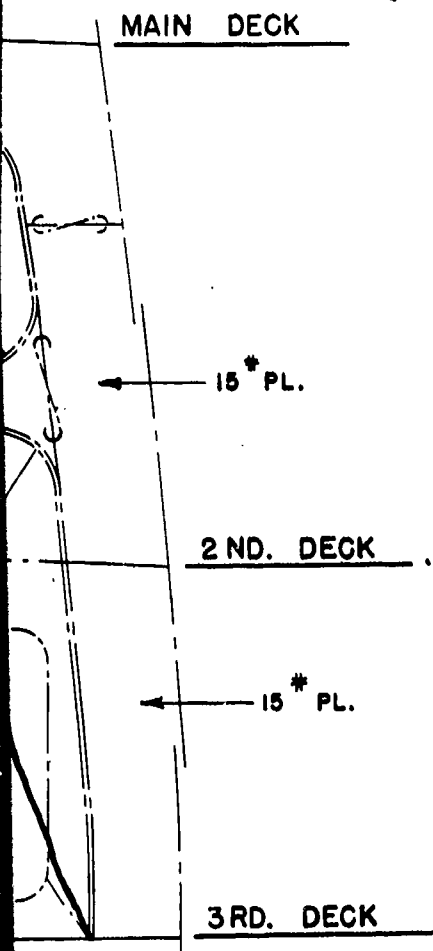
SV. N.T. & W.T. BHD. 147
LOOKING AFT.

NOTE:
 NO DATA AVAILABLE REGARDING DECK
 BULKHEAD DEFLECTION. SHELL DAMAGE
 INDICATED TAKEN FROM PHOTOS.

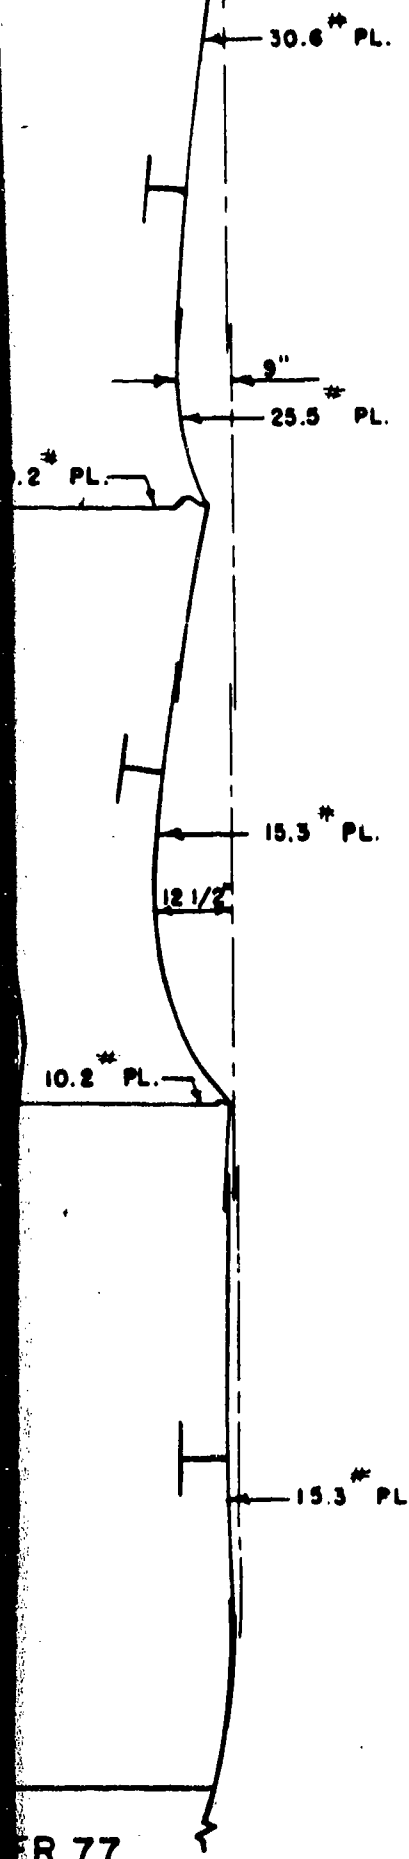
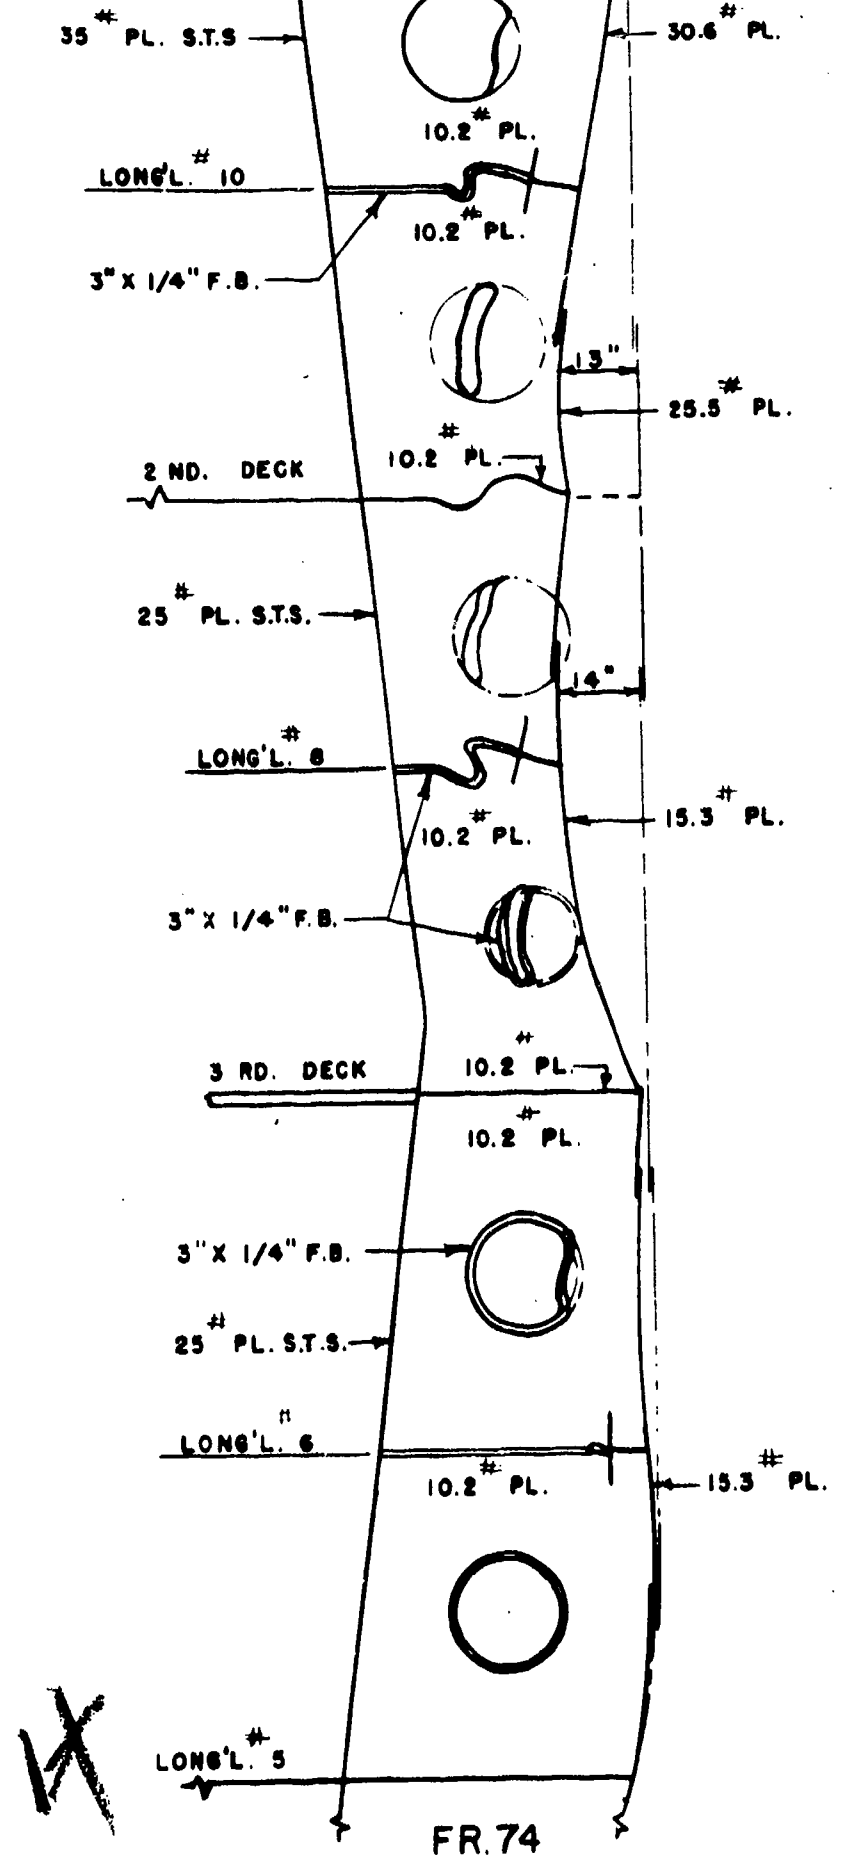
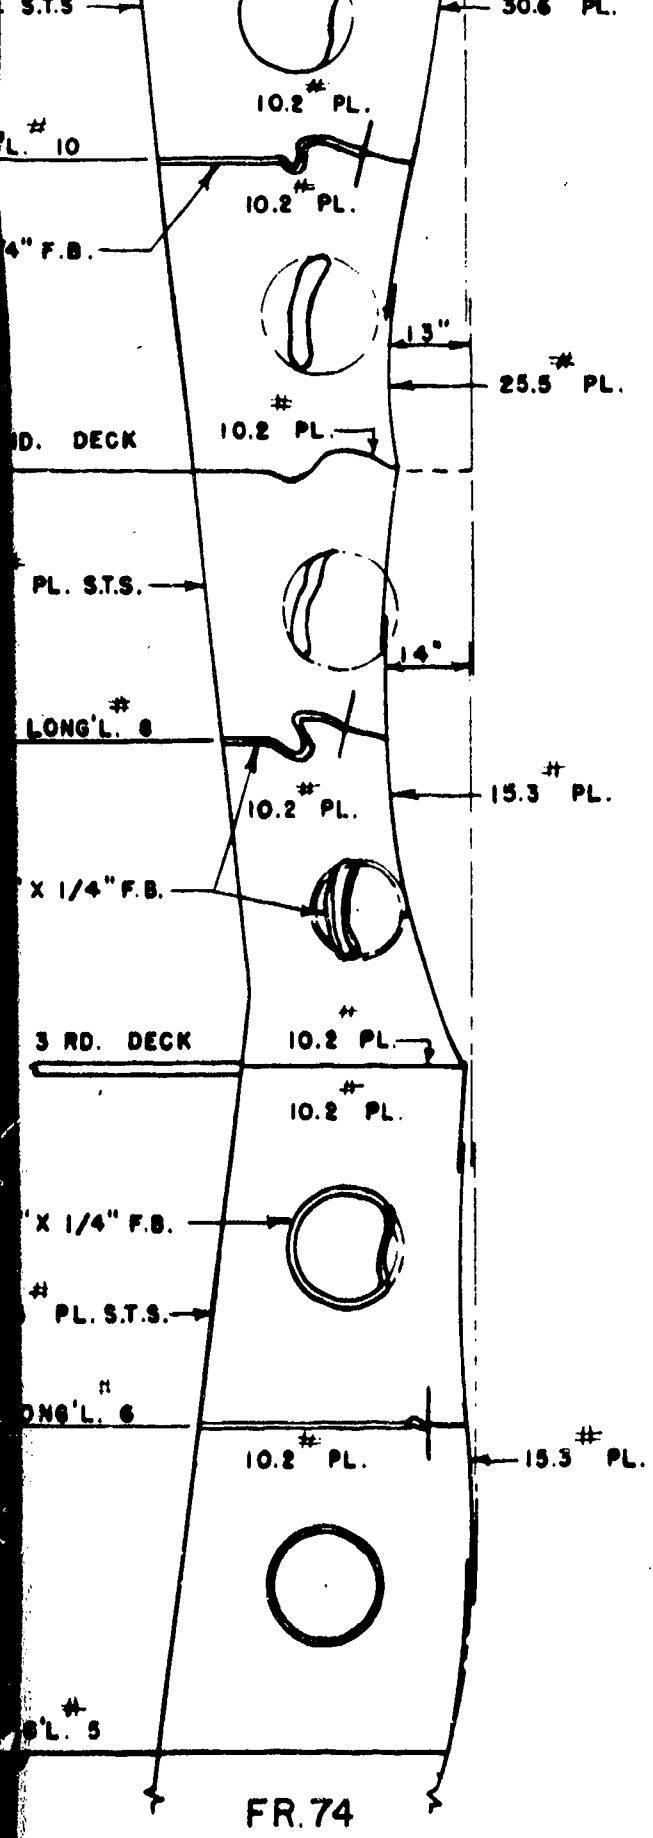
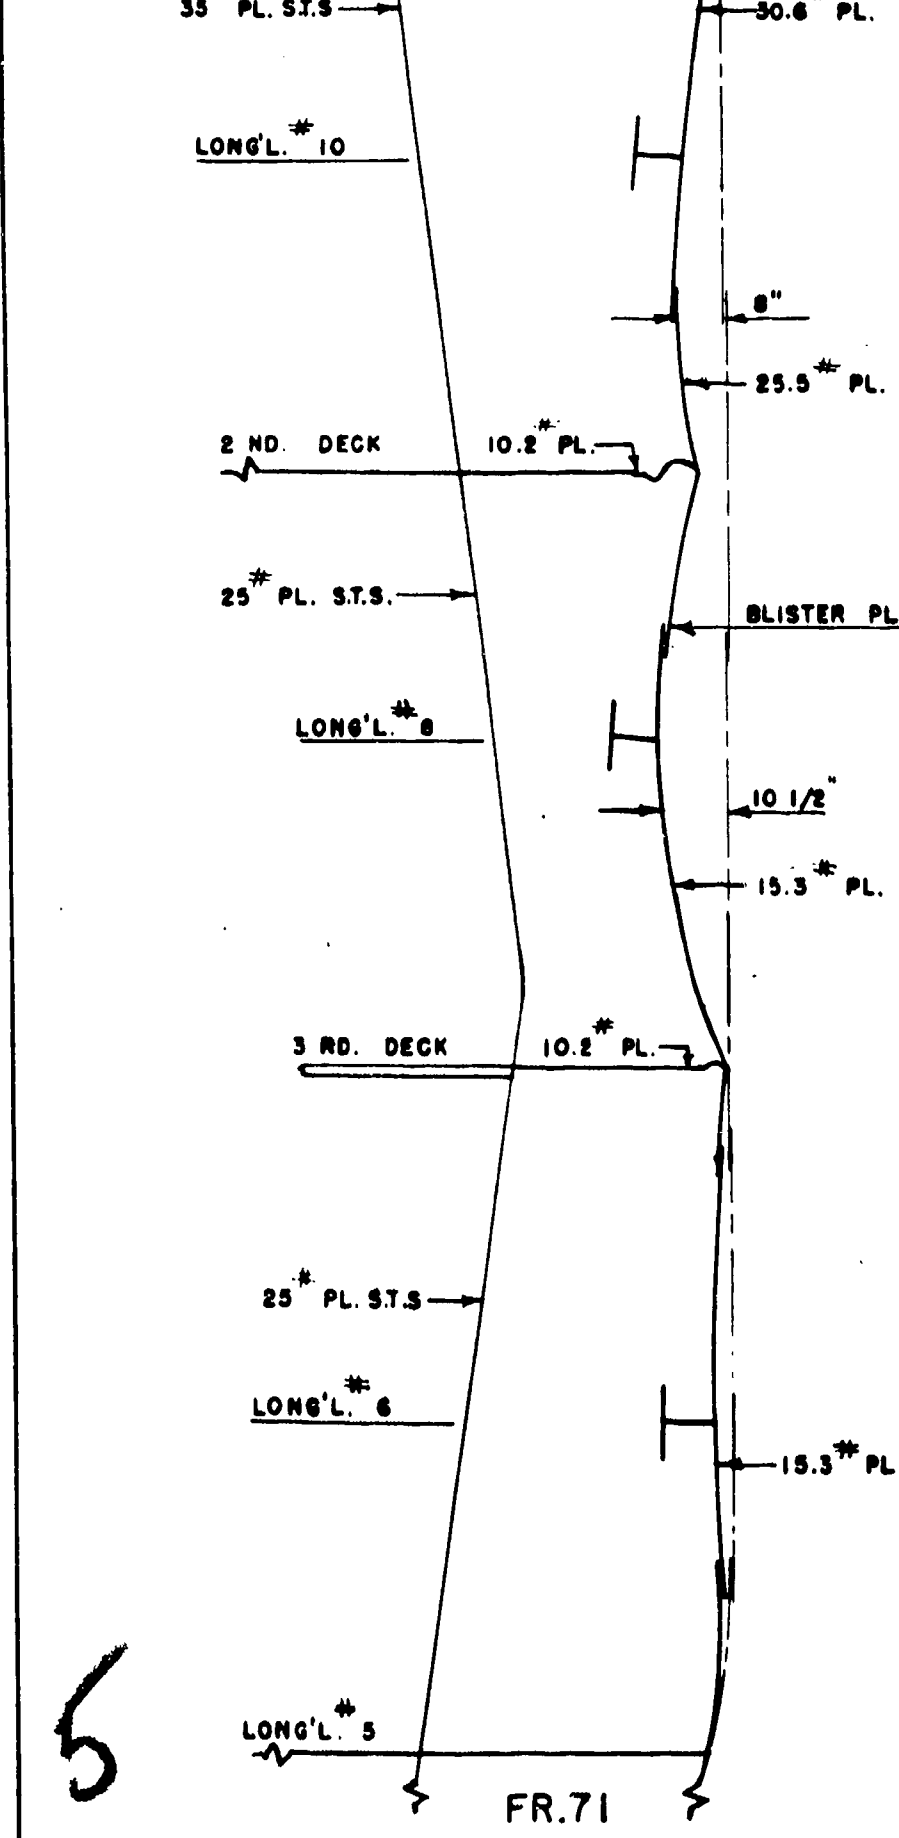
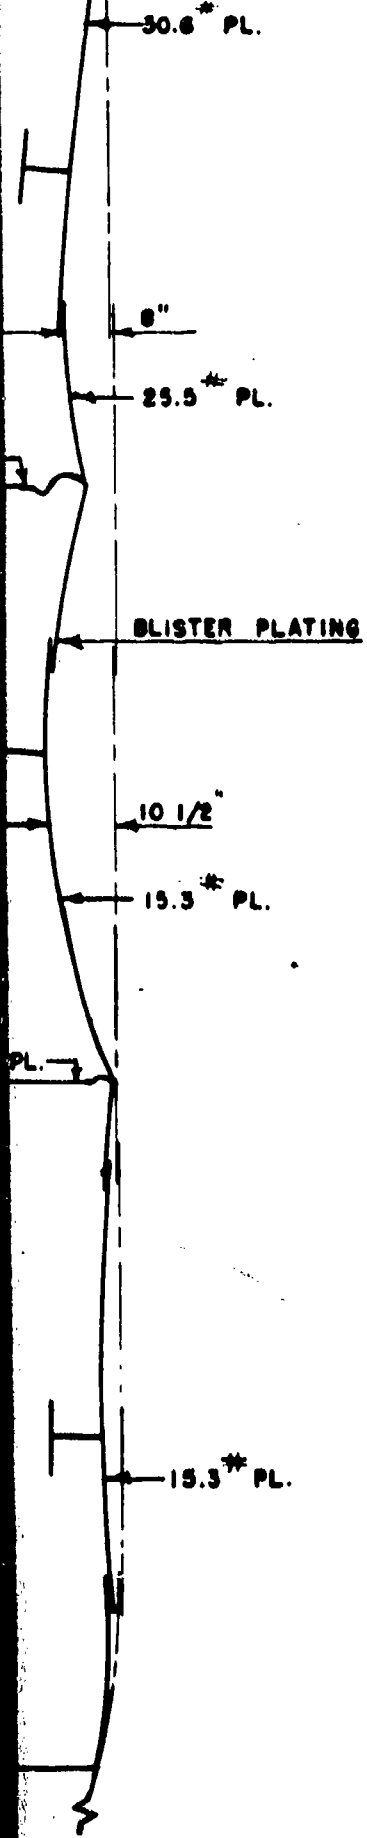
1. NO DATA AVAILABLE REGARDING DEFLECTION OF INNER SHELL PLATING.
2. ALL SECTIONS ARE SHOWN PORT SIDE LOOKING AFT.
3. FWD. OF FR. NO. 71 DEFLECTION DIMISHES TO "0" AT FR. 59, FWD. OF FR. 59 LIGHT WASH BOARD EFFECT.

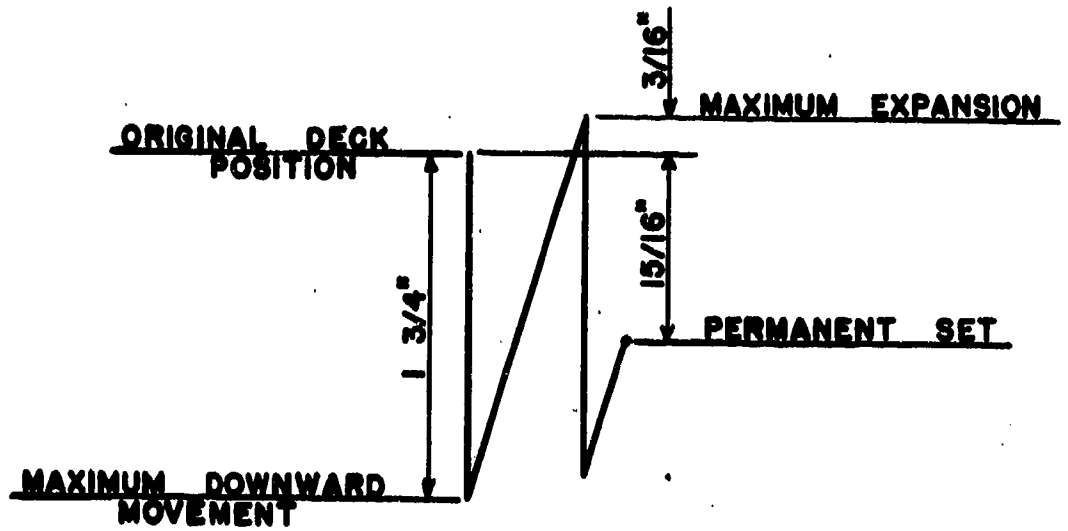
U.S.S. INDEPENDENCE, TEST ABLE, PLOT OF MAIN DECK
MOVEMENT. SCRATCH GAGE LOCATION, 2ND. DECK
FRAME 63 PORT 16'-0" OFF CENTER LINE.

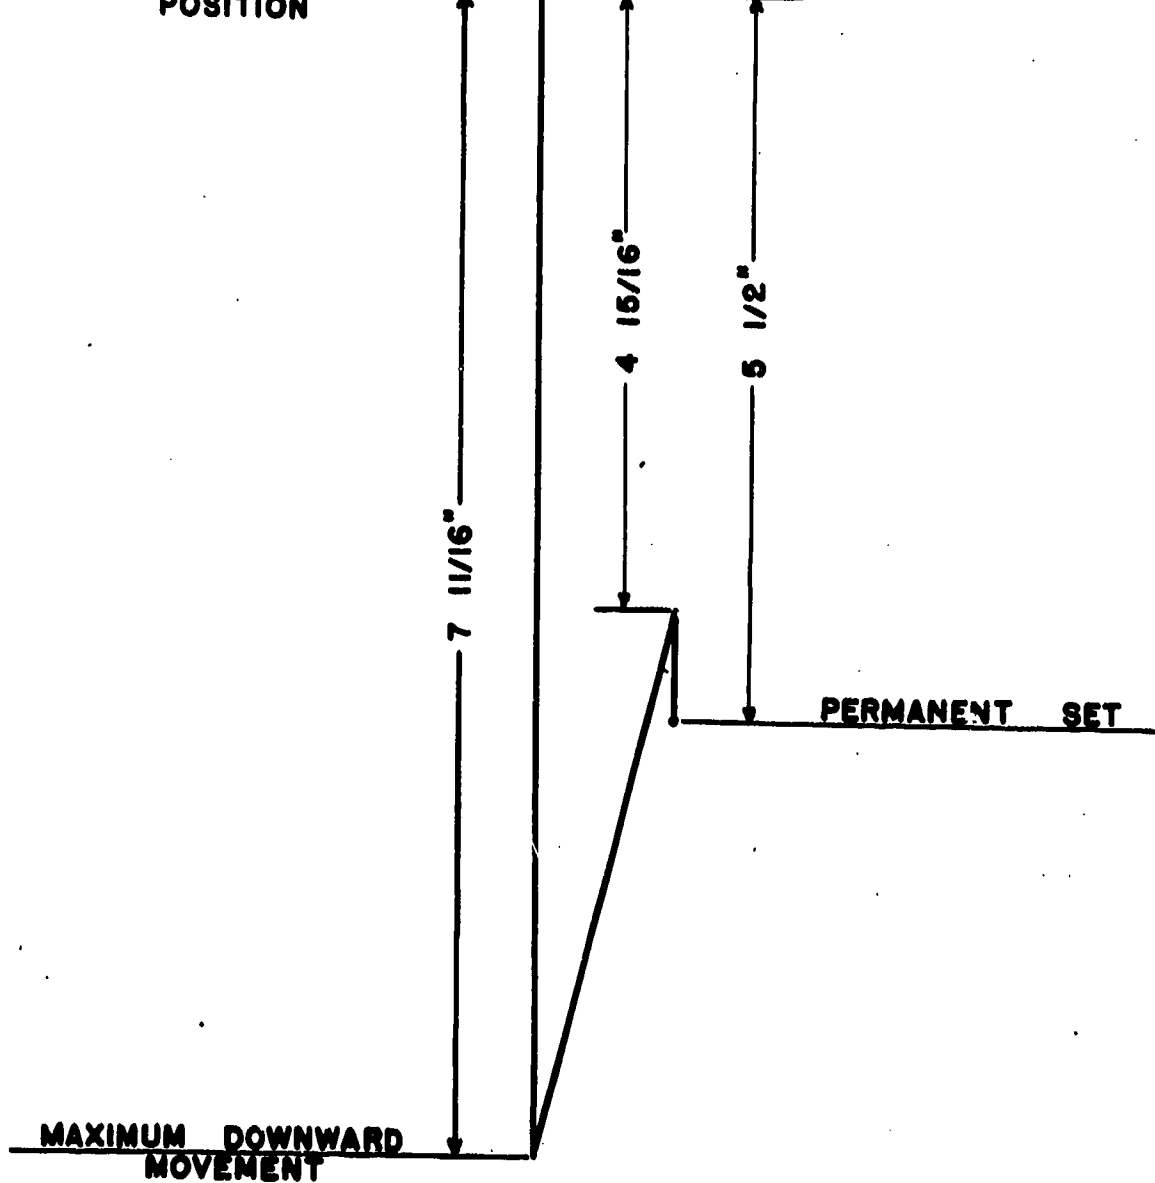
U.S.S. INDEPENDENCE, TEST ABLE, PLOT OF MAIN DECK
MOVEMENT. SCRATCH GAGE LOCATION, 2 ND. DECK'
FRAME 120 PORT 17'-0" OFF CENTER LINE.

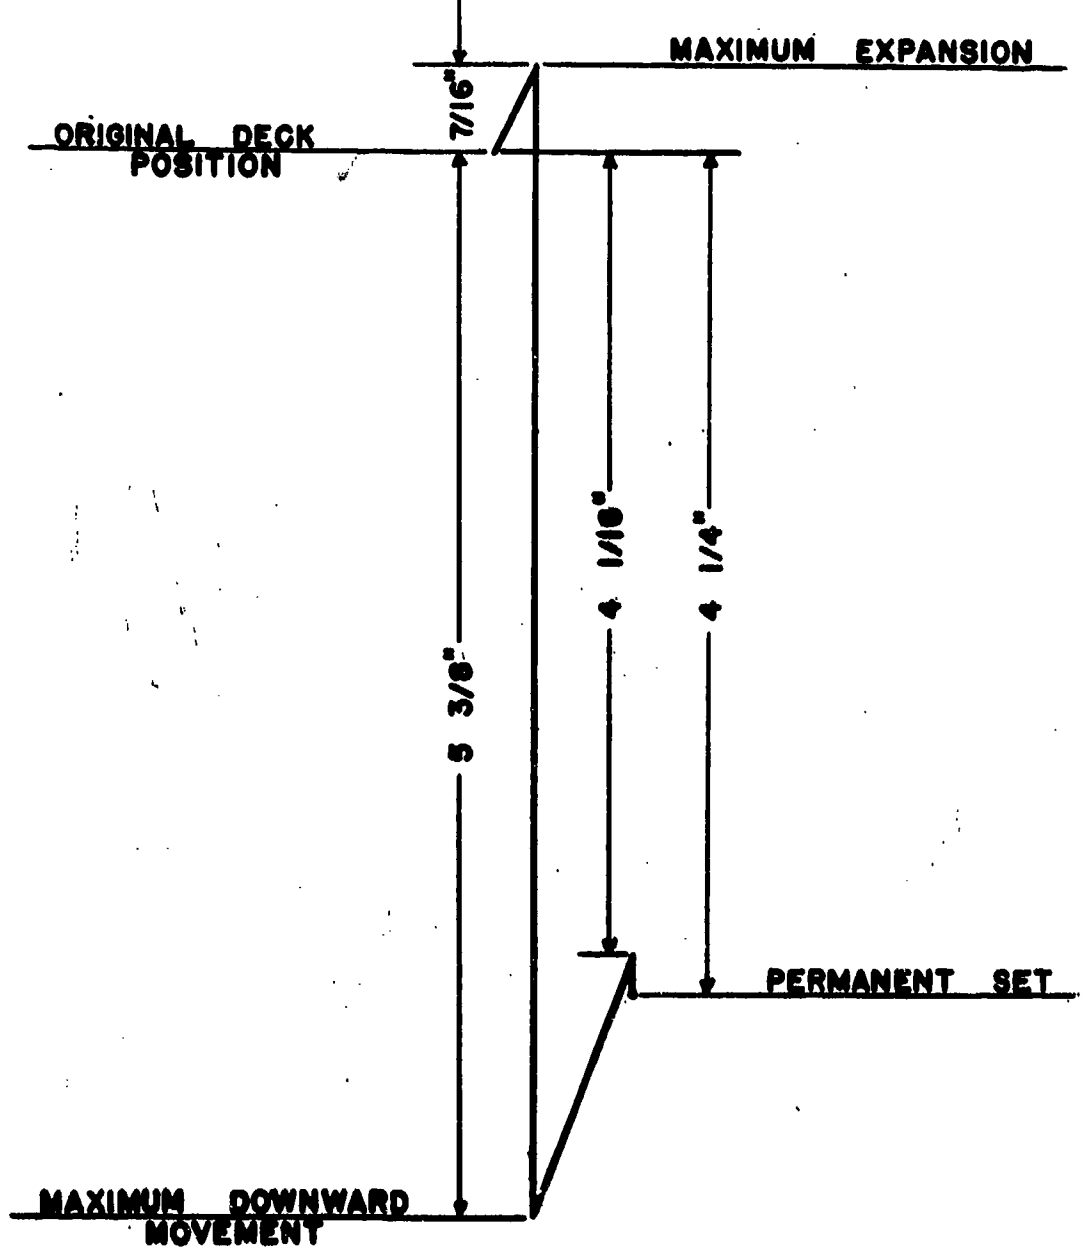
U.S.S. INDEPENDENCE, TEST ABLE, PLOT OF MAIN DECK
 MOVEMENT. SCRATCH GAGE LOCATION, 2 ND. DECK
 FRAME 120 STBD. 16'-7" OFF CENTER LINE.

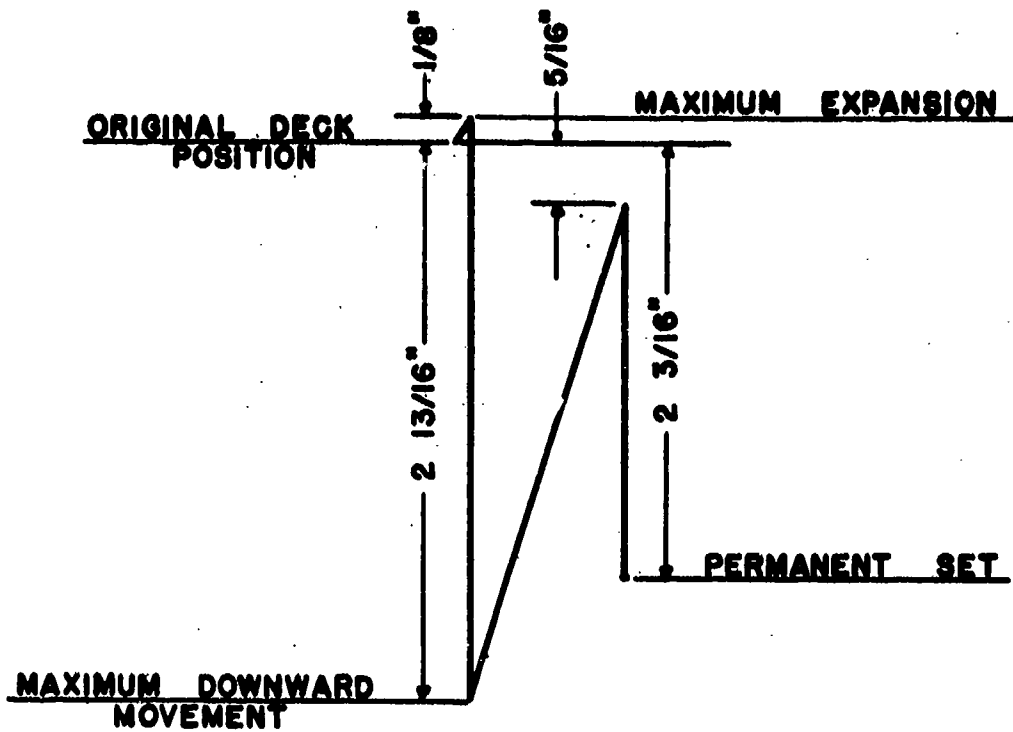
U.S.S. INDEPENDENCE, TEST ABLE, PLOT OF MAIN DECK
 MOVEMENT. SCRATCH GAGE LOCATION, 2 ND. DECK
 FRAME 121 CENTER LINE.

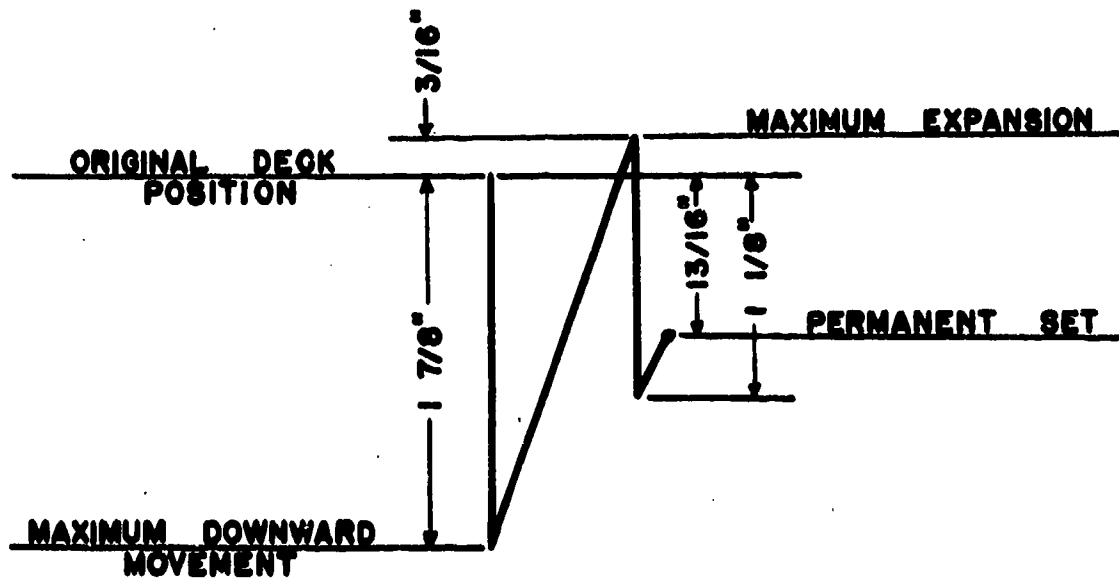
PLATE NO. 48
 PAGE 250 OF 280

U.S.S. INDEPENDENCE, TEST ABLE, PLOT OF MAIN DECK
MOVEMENT. SCRATCH GAGE LOCATION, 2ND. DECK
FRAME 124 CENTER LINE.
