MSC-02680

APOLLO 13 MISSION REPORT

September 1970

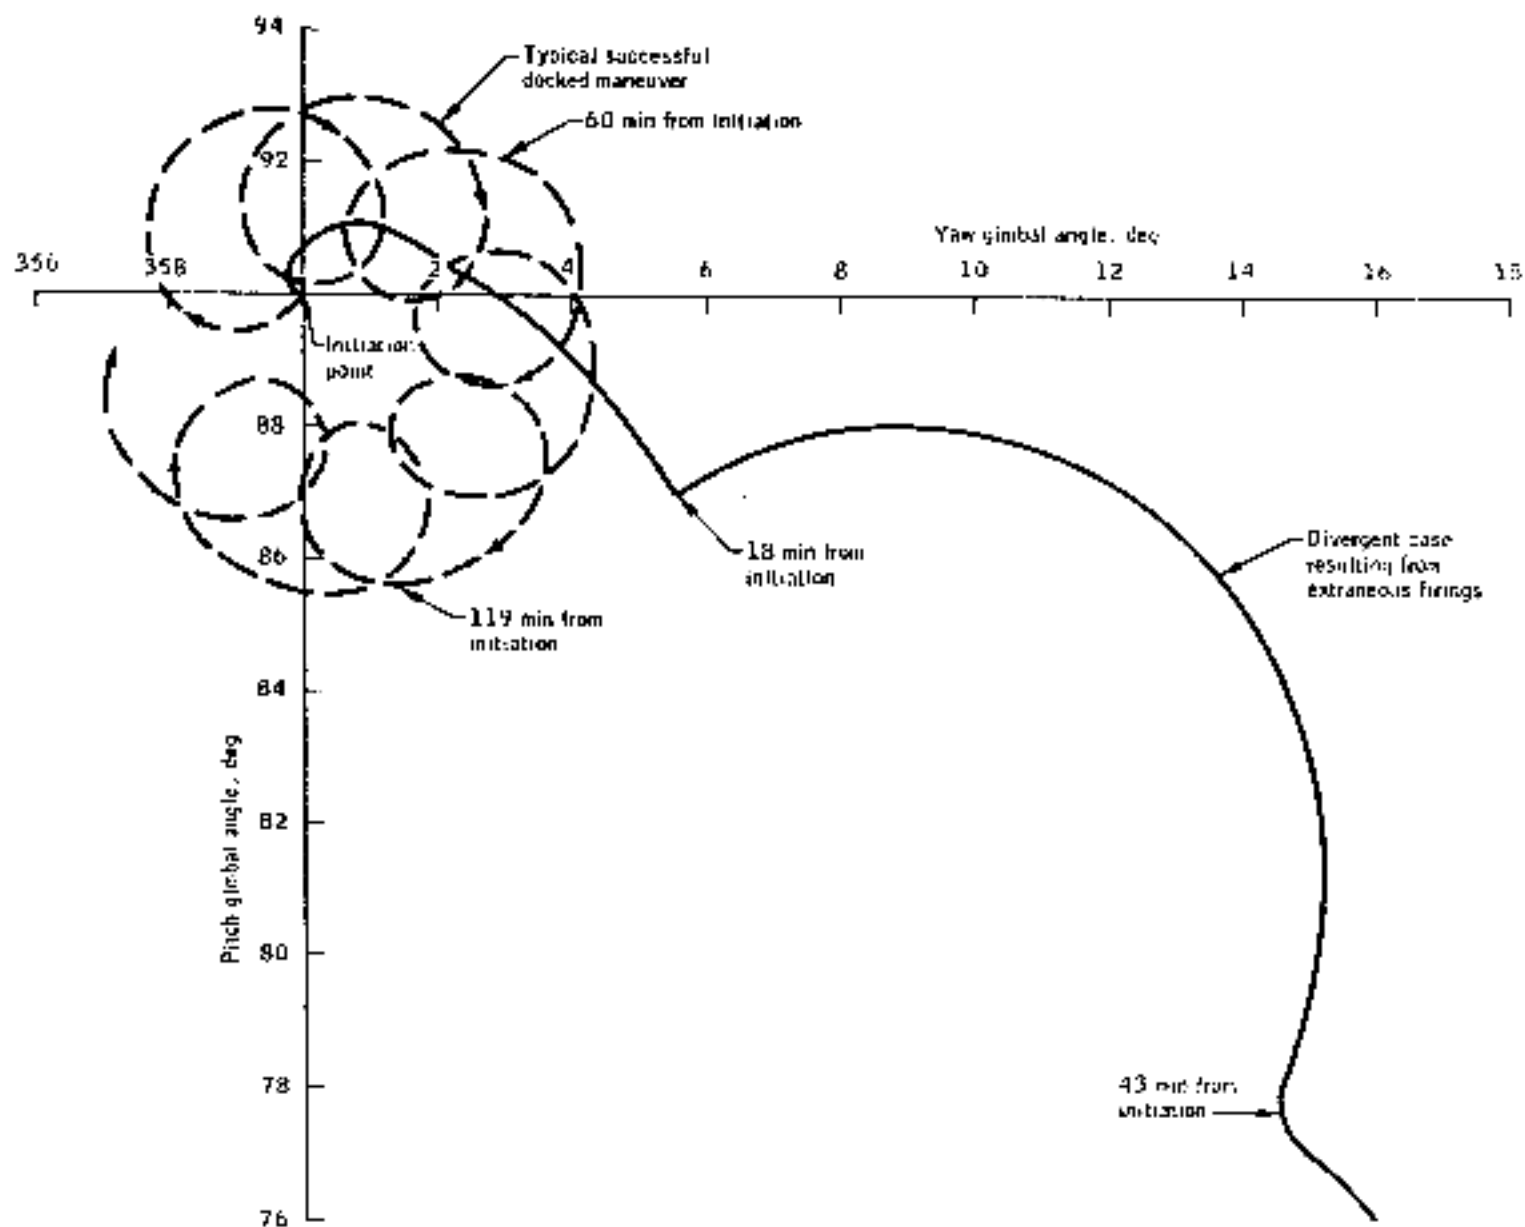
Figure 5.6-1.- Comparison of early translunar maneuver to establish a passive thermal control mode.

firing could have been avoided procedurally by disabling all engines before doing any control system switching. The passive thermal control mode attempted at 32:21:49 is compared with a typical case in figure 5.6-1, which shows the adverse effects of two extraneous firings. All subsequent passive thermal control modes using the command and service module were established normally.

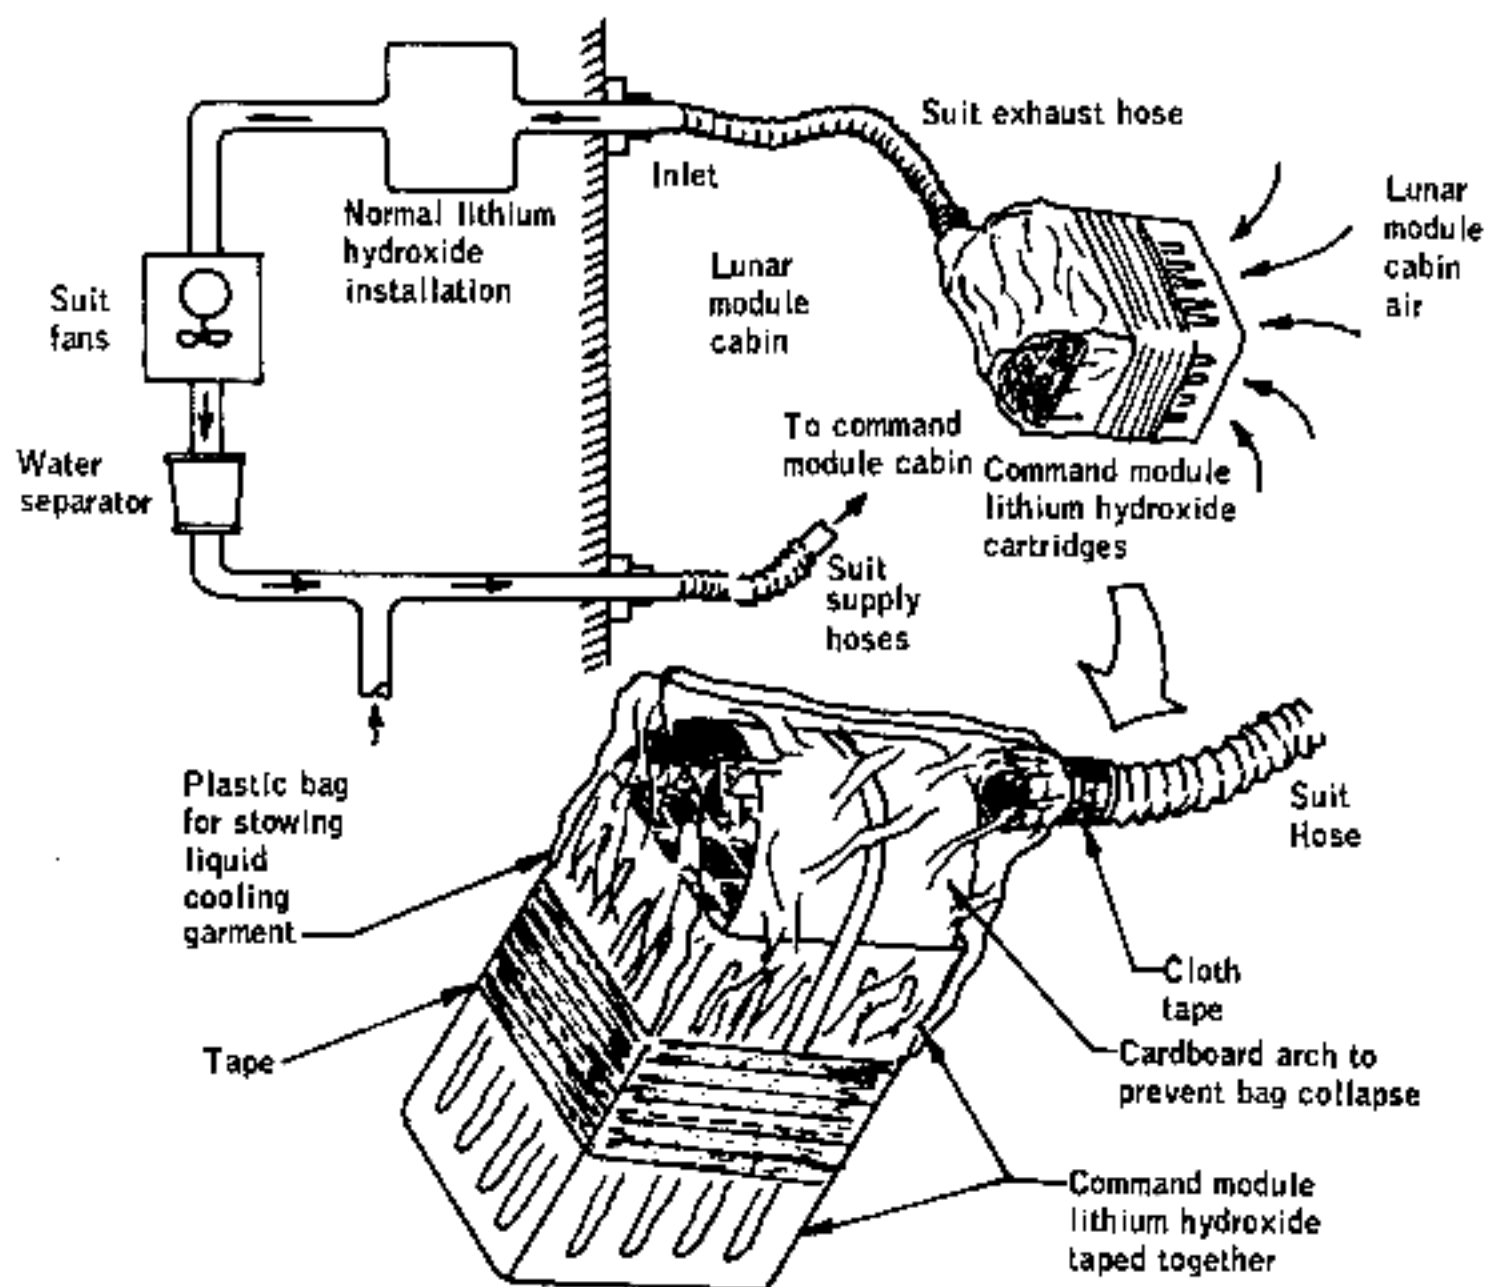
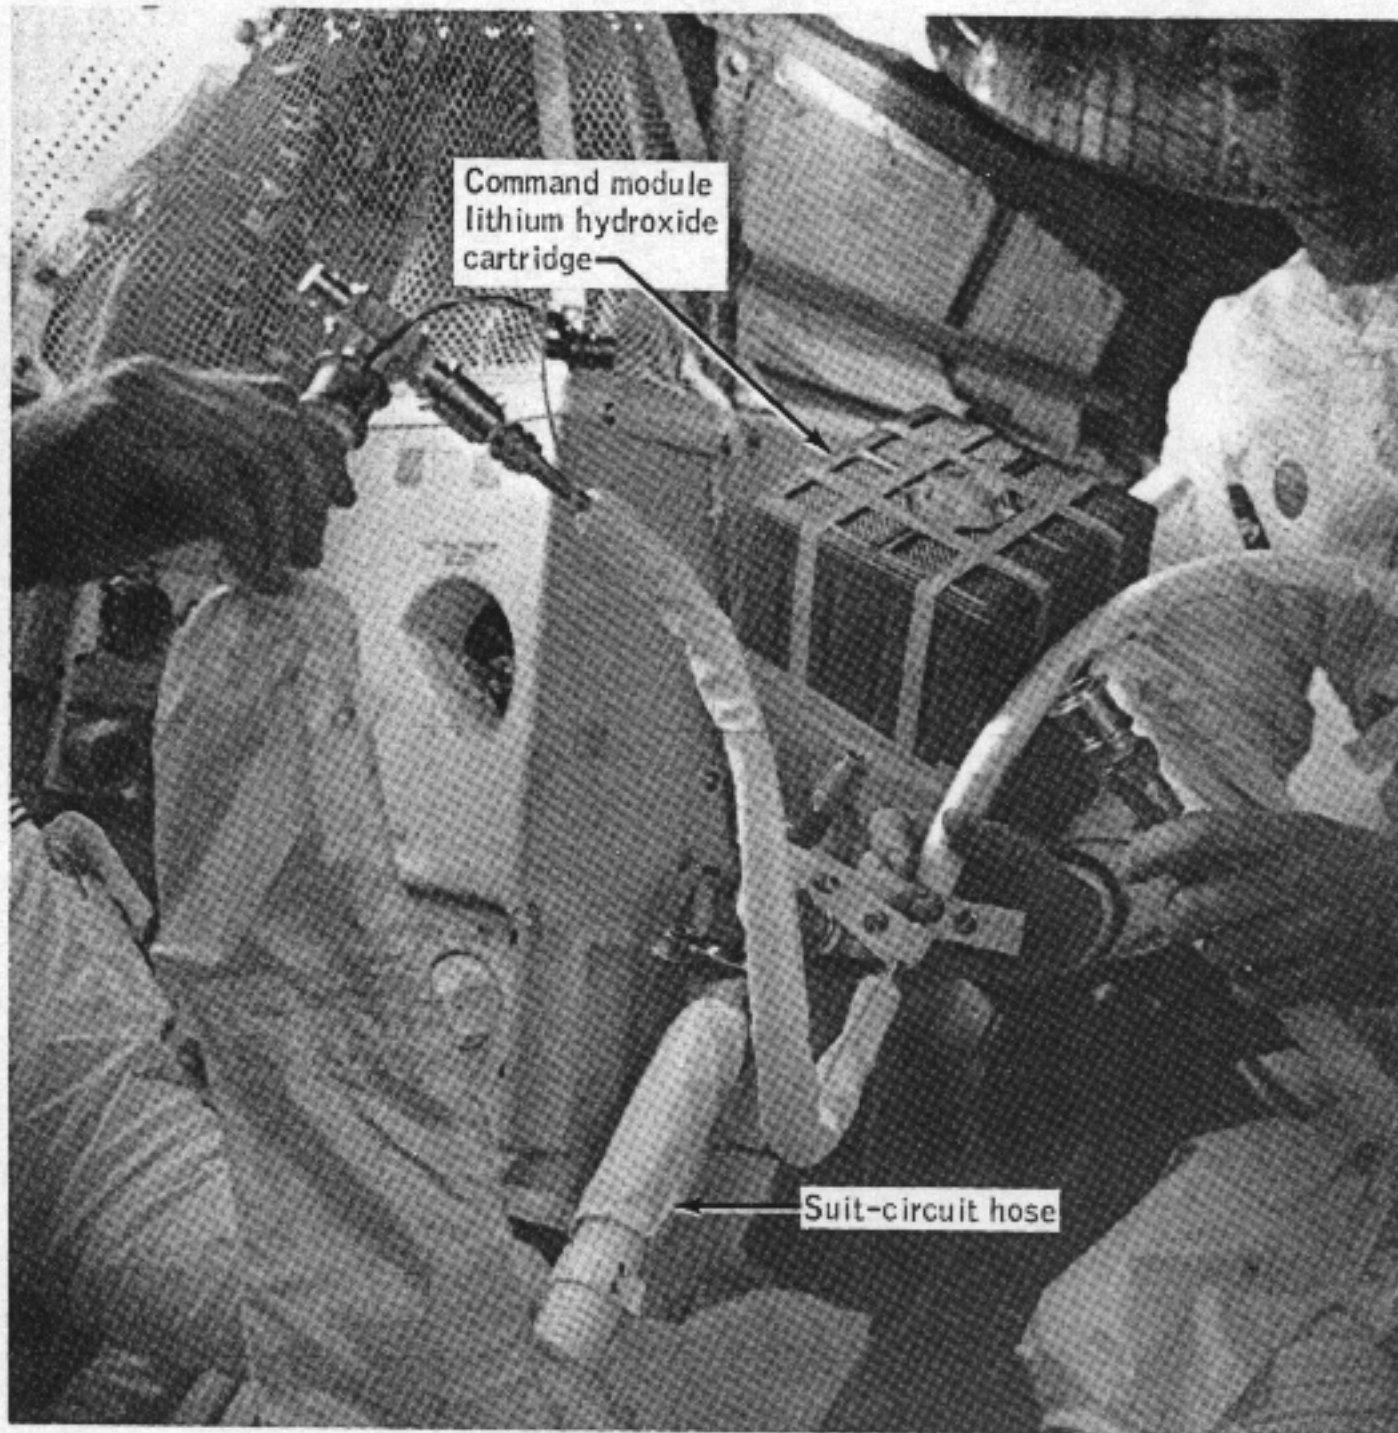
Figure 6.7-1.- Supplemental carbon dioxide removal system.

It became apparent that there were insufficient lithium hydroxide cartridges in the lunar module to support the abort mission, even with allowable carbon dioxide levels extended to a partial pressure of 15 mm Hg. With ground instructions, a system was constructed which attached a command module lithium hydroxide cartridge to each of two lunar module suit hoses. The Commander's remaining hose was placed in the tunnel area to provide fresh oxygen to the command module, while the Lunar Module Pilot's remaining hose was positioned in the lunar module environmental control area. At a later time, a second cartridge was added in series to the cartridges initially installed, as shown in figure 6.7-1. In each case, the drop in carbon dioxide levels reported by the ground showed satisfactory operation of this improvised carbon dioxide removal system.

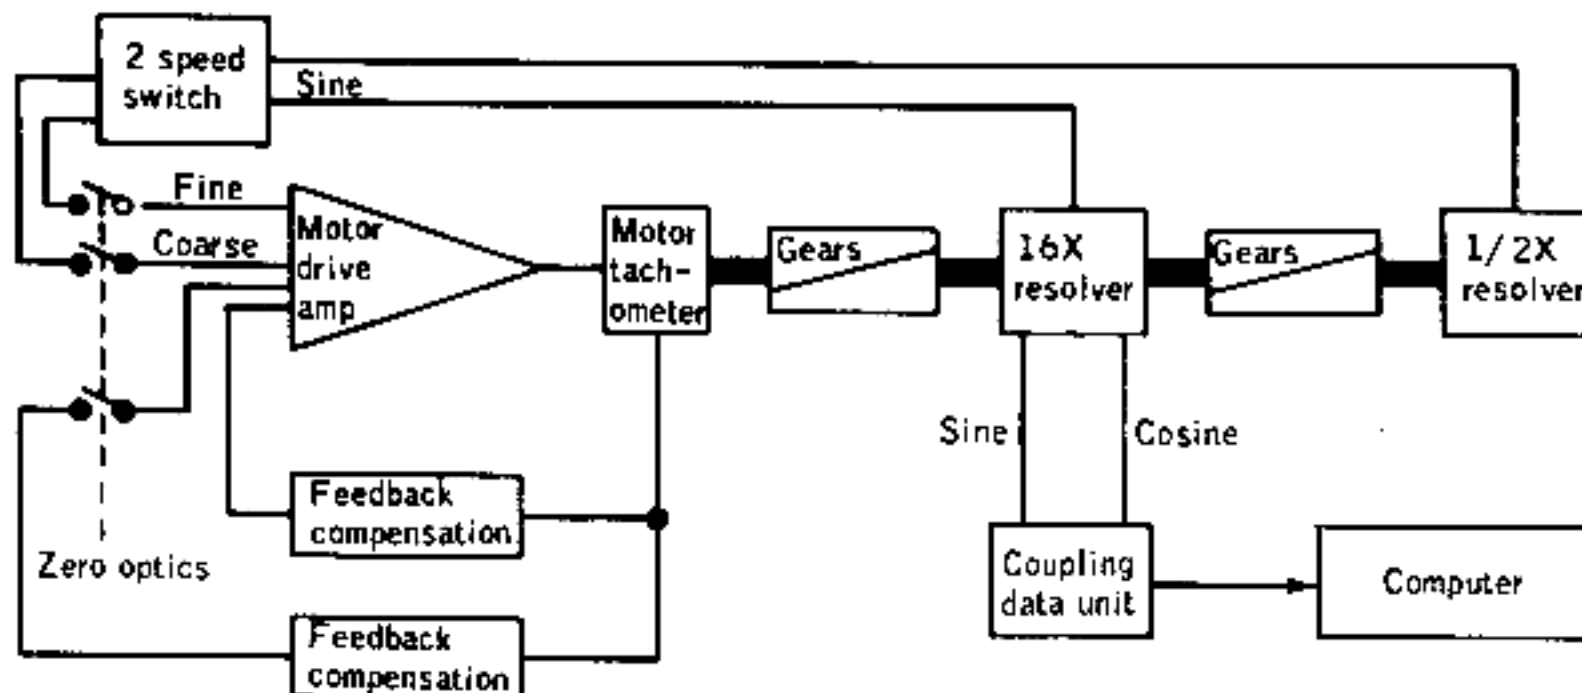
Figure 14-2.- Zero optics mode circuitry.

A simplified schematic of the optics shaft servo loop mechanization is shown in figure 14-2. In the zero optics mode, the sine outputs of

the half-speed and 16-speed resolvers are routed through a coarse/fine switching network to the motor drive amplifier and are used to null the system. Rate feedback from the motor tachometer is routed to the drive amplifier through a compensation network which removes any bias in the signal. When the zero optics mode is selected, the coupling-data-unit counter and the computer register which contains the shaft angle are zeroed for 15 seconds and then released to follow the 16-speed resolver. The half-speed resolver, the fine/coarse switching network, and the tachometer feedback compensation are used only in the zero optics mode.

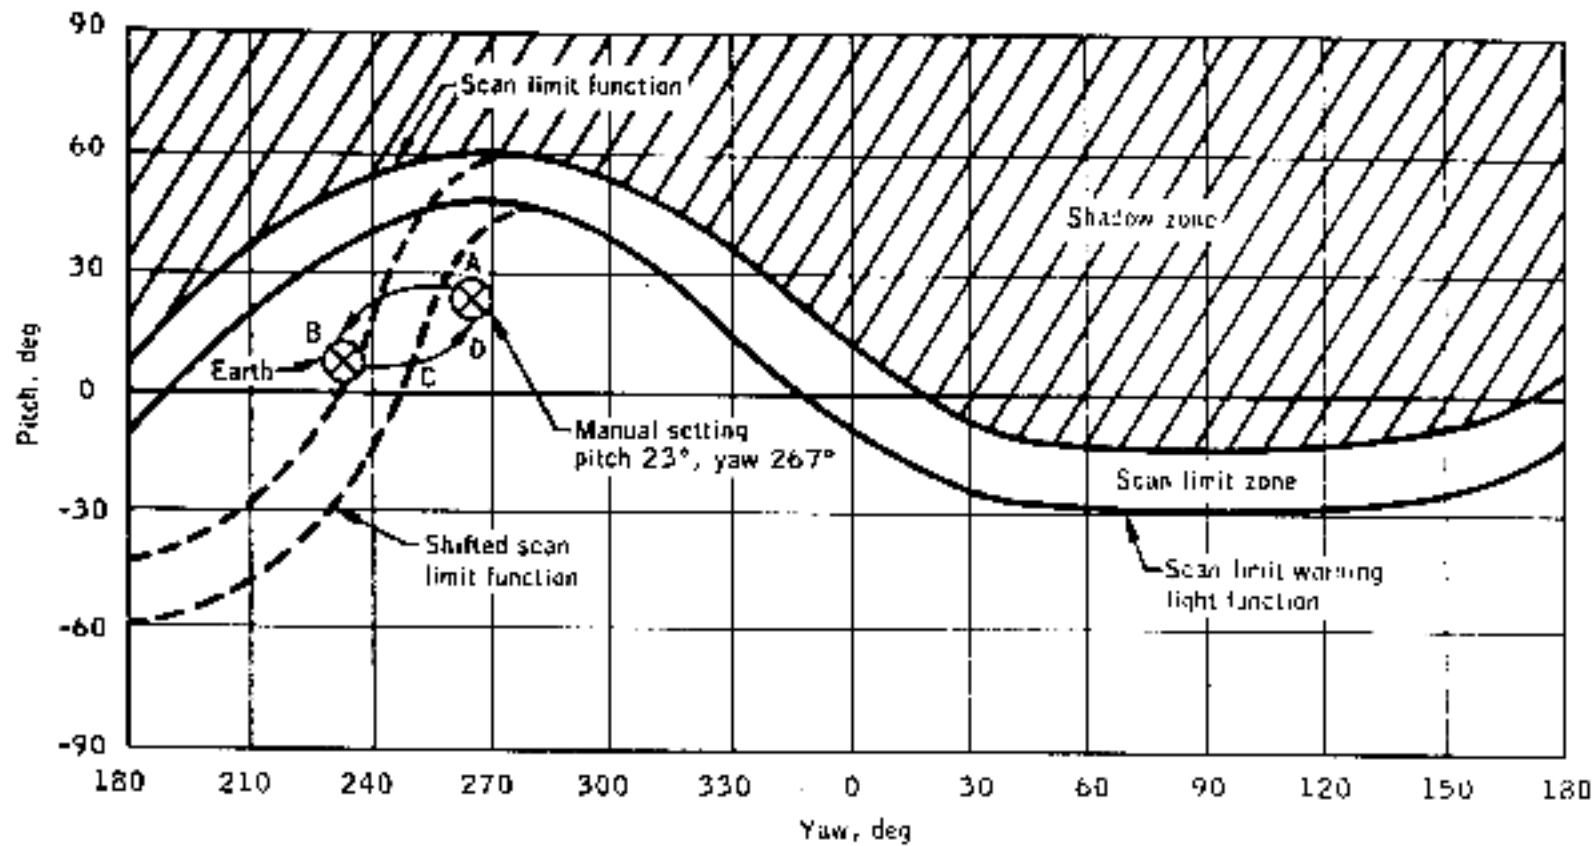
Figure 14-5.- Shift in scan-limit, scan-limit-warning illustrated.

Starting at 55:00:10 and continuing to 55:00:40, deep repetitive transients approximately every 5 seconds were noted on the phase modulated downlink carrier (fig. 14-5). This type of signature can be caused by a malfunction which would shift the scan-limit and scan-limit-warning function lines, as illustrated in figure 14-5. These function lines would have to shift such that they are both positioned between the antenna manual settings and the true line of sight to earth. Also, the antenna would have to be operating in the auto-reacquisition mode to provide these signatures. The antenna functions which caused the cyclic inflight RF signatures resulting from a shift in the function lines can be explained with the aid of figures 14-5 and 14-6, with the letters A, B, C, and D corresponding to events during the cycle. Starting at approximately 55:00:10, the antenna was switched from manual to auto reacquisition with the beamwidth switch in the medium-beam position. From point A to the scan limit function line just prior to point B, the antenna acquired the earth in wide beam. When the antenna reached the scan limit function line, the antenna control logic would switch the system to the manual

mode and drive back toward the manual settings until the scan limit warning function line at point C was reached, thereby maintaining wide-beam operation. When the antenna reaches the scan limit warning function line, the system would automatically switch to the medium-beam mode and continue to drive in the manual mode until the manual setting error was nulled out at point A. The antenna would then switch to the auto-track mode and repeat the cycle. The most important feature of this cycle is that the antenna moves at the manual scan rate between points B and D, which is confirmed by the rapid changes in the downlink signal strength.

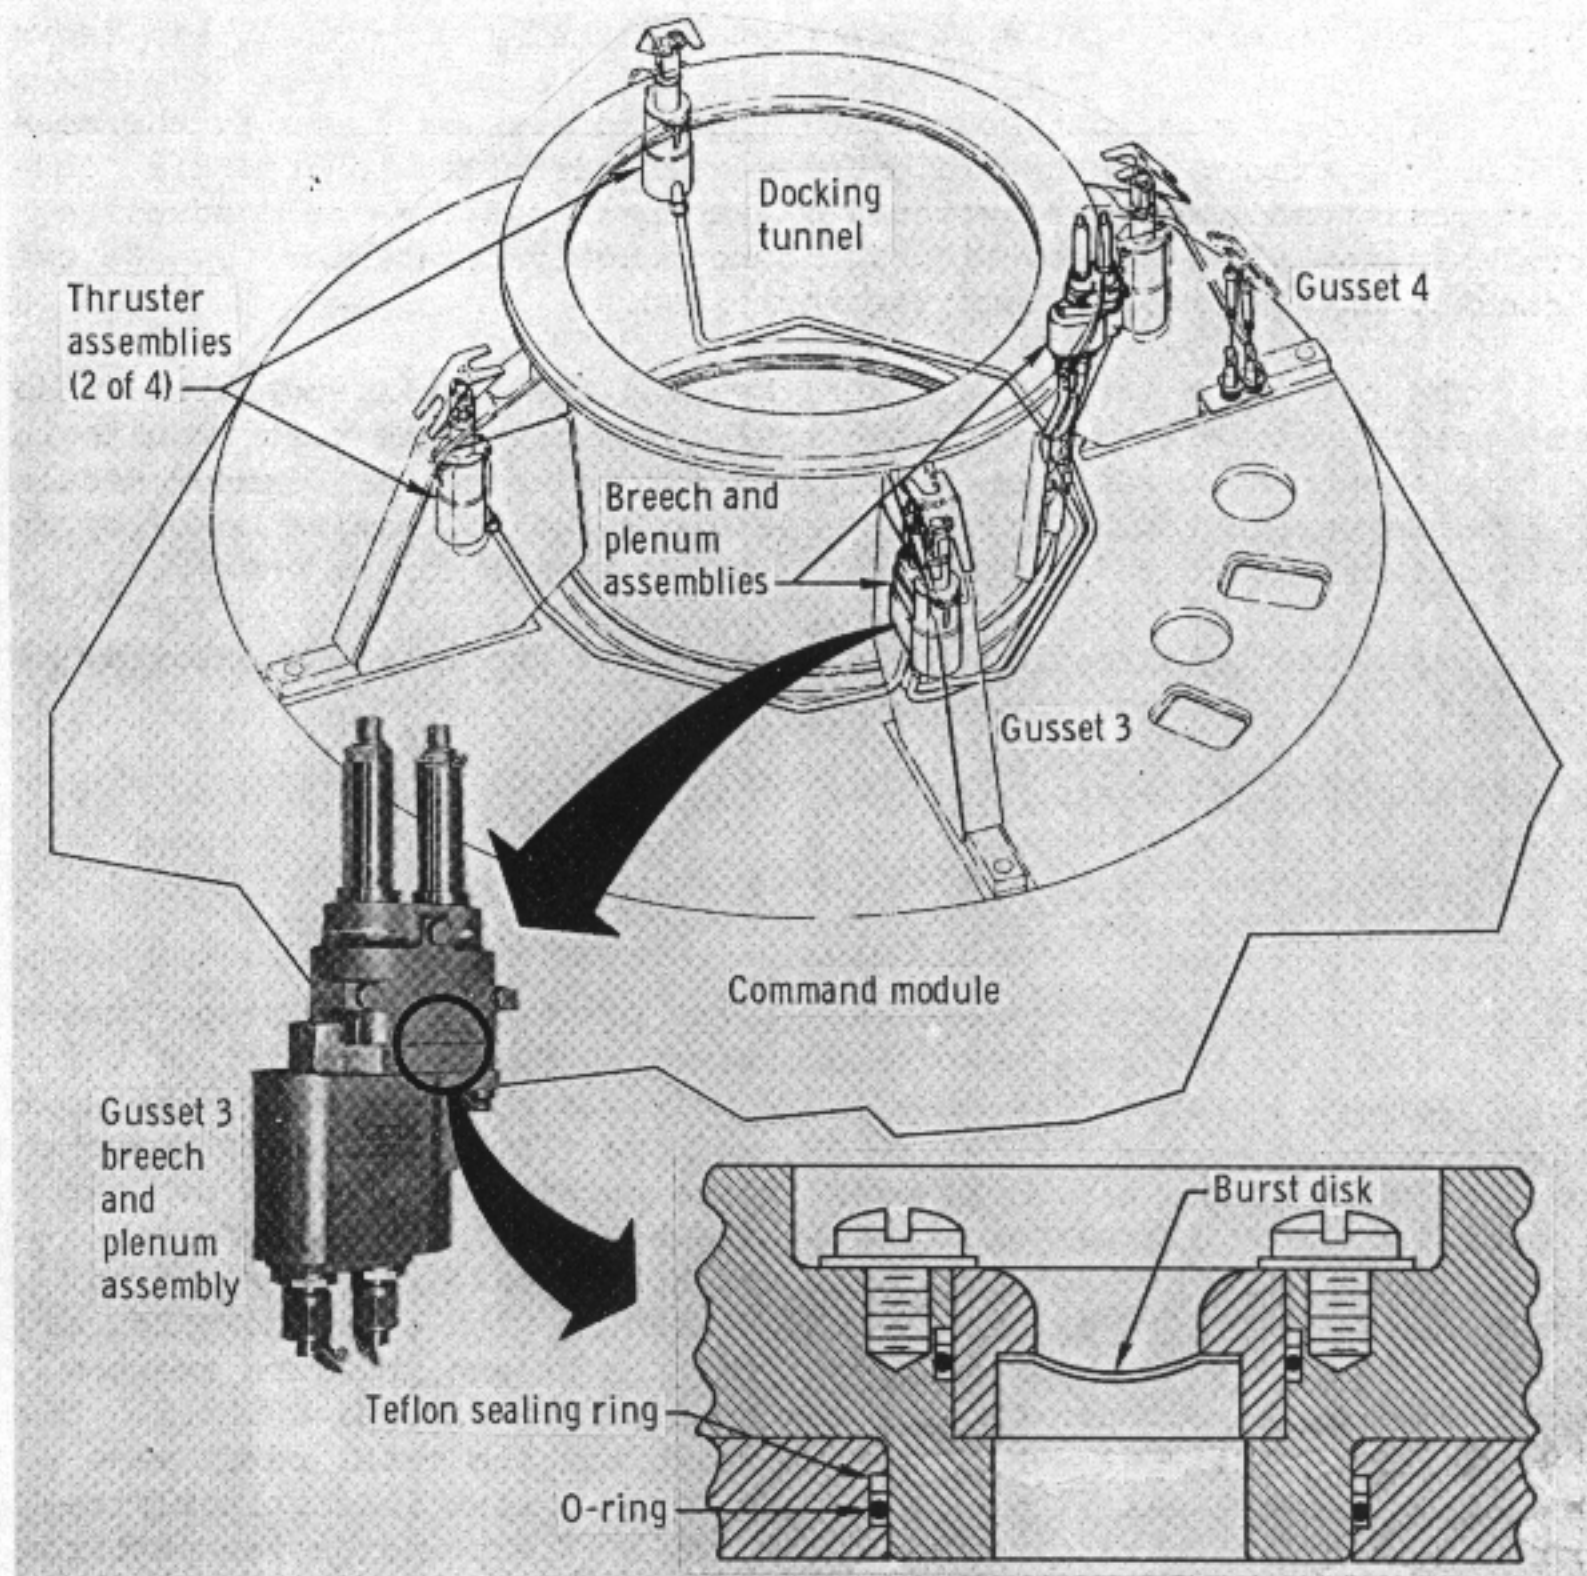
Figure 14-7.- Apex cover jettison system.

During postflight inspection, it was discovered that propellant gas had leaked from the gusset-4 breech assembly, which is a part of the apex cover jettison system (fig. 14-7). A hole was burned through the aluminum gusset cover plate (fig. 14-8), and the fiberglass pilot parachute mortar cover on the parachute side of the gusset was charred but not penetrated. The leakage occurred at the breech-plenum interface (fig. 14-9). The breech and plenum are bolted male and female parts which are sealed with a large O-ring backed up with a Teflon ring, as shown in figure 14-7. During operation, the breech pressure reaches approximately 14 000 psi and the gas temperature exceeds 2000° F. The O-ring and backup ring were burned through and the metal parts were eroded by the hot gas at the leak path. The system is completely redundant in that either thruster system will effect apex cover jettison. No evidence of gas leakage existed on the previous firings of 56 units.

The possible causes of the gas leakage include:

- a. Out of tolerance parts - Measurement of the failed parts indicate acceptable dimensions of the metal parts.
- b. Damaged O-rings - The 21 000-psi static proof-pressure test was successful.
- c. Gap in backup ring - The installation procedure specifies the backup ring may be trimmed on assembly to meet installation requirements,

but does not specify any dimensional control over the scarf joint. Since the gap portion was burned away, a gap in the backup ring could have caused the problem.

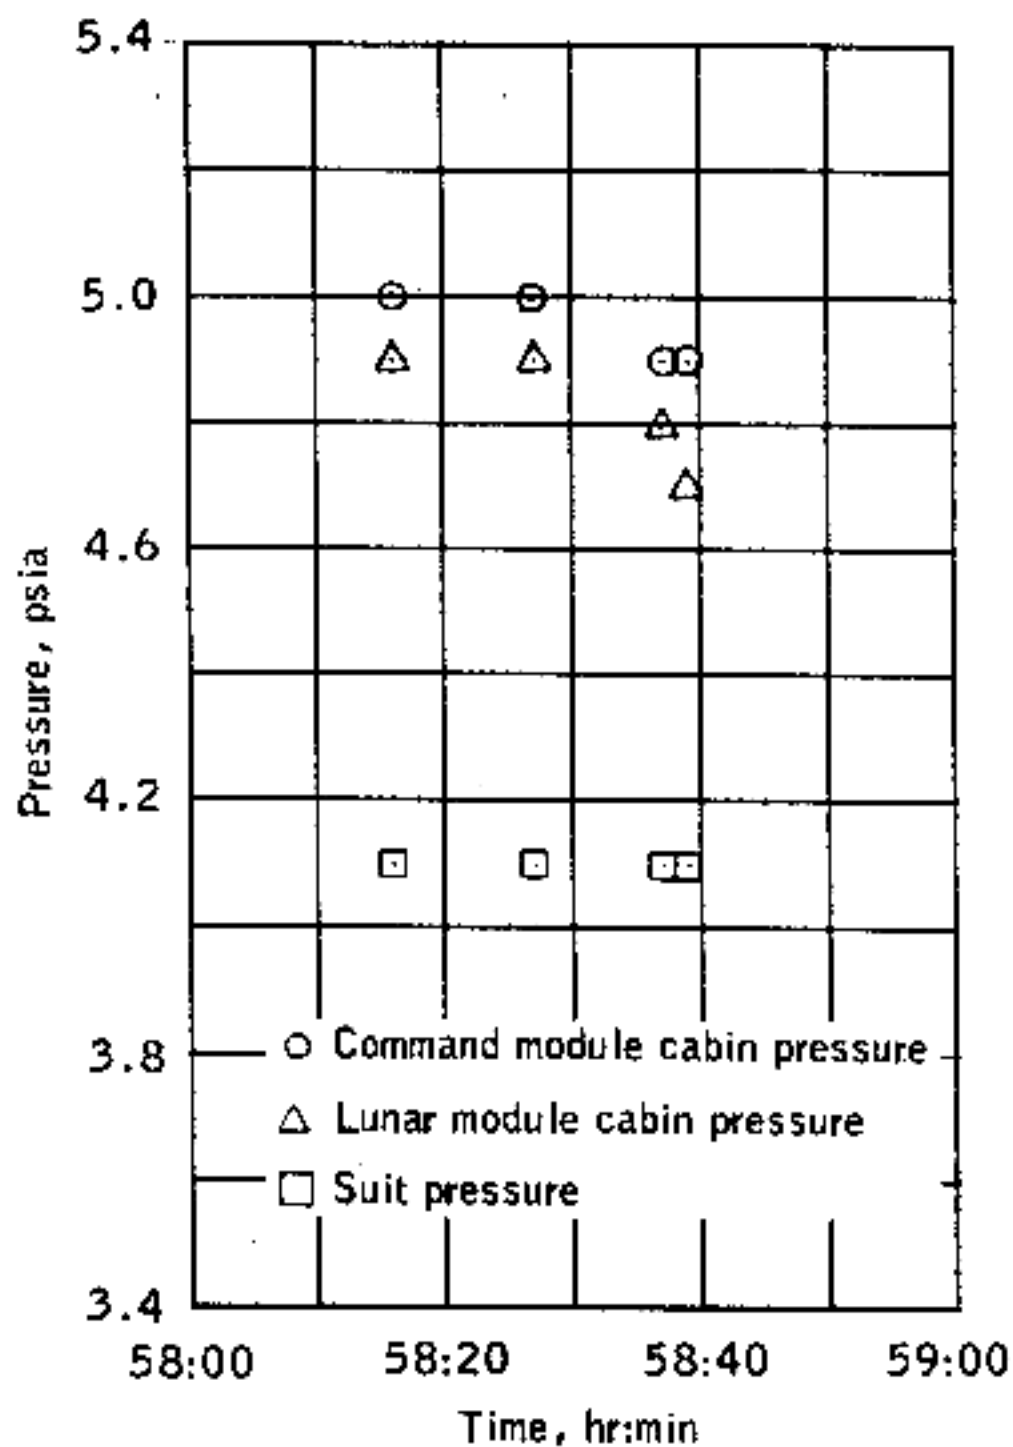
Figure 14-12.- Suit and cabin pressure.

During launch the suit pressure transducer reading remained consistent with cabin pressure until 00:02:45, then suddenly dropped from 6.7 to 5.7 psia coincidentally with S-II engine ignition (fig. 14-12). The difference between the two measurements decreased to only 0.2 by 1-1/2 hours, when the cabin reached its nominal regulated pressure of 5.0 psia. For this shirtsleeve mode, the suit and cabin pressure readings should be nearly equal. During normal variations in the command module cabin pressure, the suit pressure measurement responded sluggishly and indicated as much as 1 psi low. Subsequently, the measurement output decayed and remained in the 4.1 to 4.3 psia range for a cabin pressure of 5.0 psia until system deactivation at about 59 hours (fig. 14-12).

During periods when the lunar module and the command module cabins were interconnected, the lunar module and command module cabin pressure readings were approximately equal, verifying the operation of the command module cabin pressure transducers.

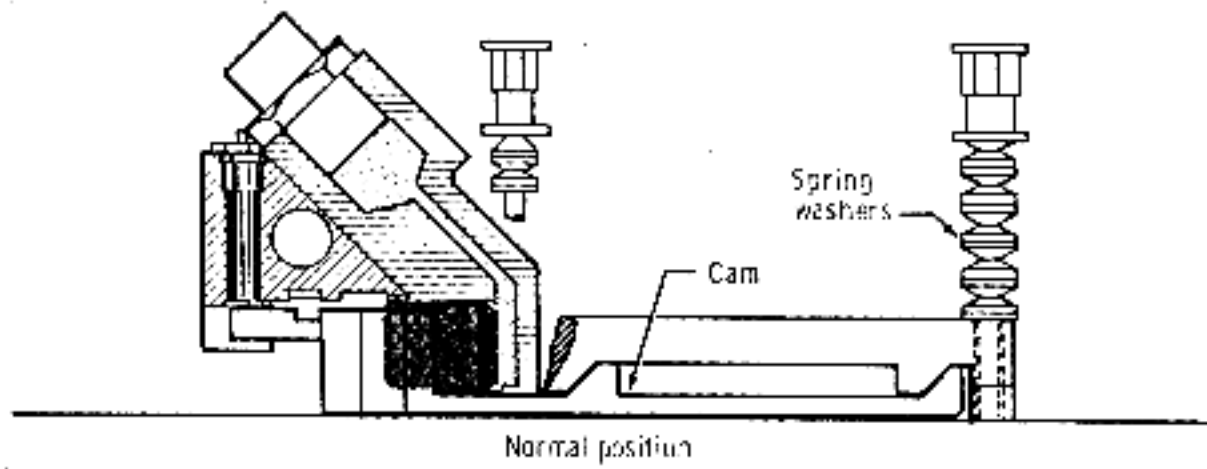
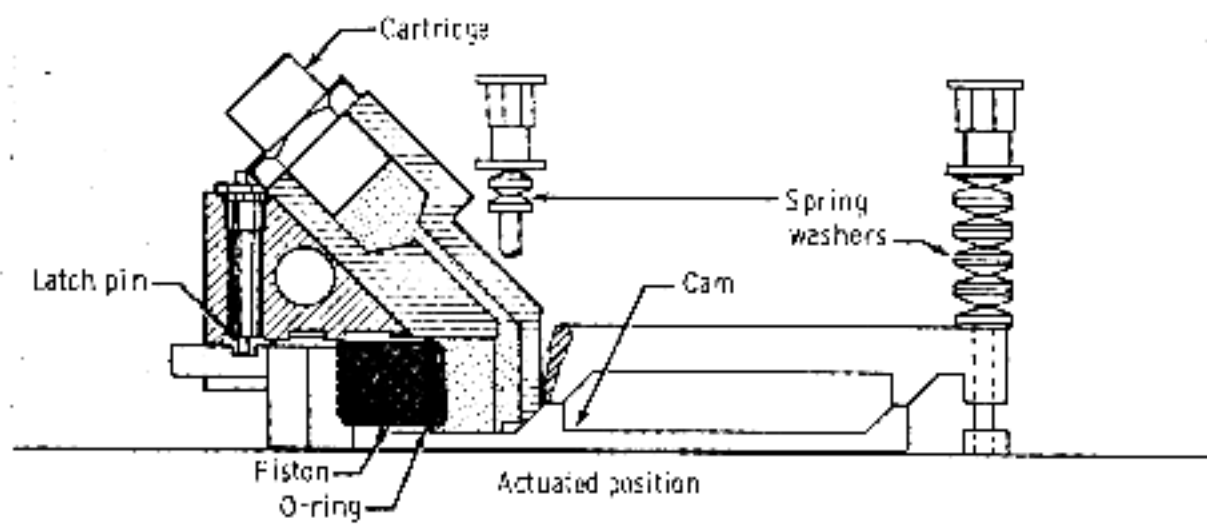
Figure 14-13.- Circuit interrupter.

During postflight inspection of the command module, propellant gas was noted to have escaped from the left-hand electrical circuit interrupter, mounted in the lower equipment bay, and deposited soot on adjacent equipment. The right-hand circuit interrupter showed no evidence of a gas leakage. The removed breech, showing the displaced O-ring and crushed attenuator block, is shown in figure 14-13.

The two interrupters open the electrical circuits about 30 milliseconds before the wires are severed by the command module/service module umbilical guillotine. As illustrated in the figure, a cam fork is moved by a piston, which is operated by propellant gas from redundant cartridges, to function a lift plate. Motion of this plate disconnects the male and female portions of electrical connectors located, respectively, in the lift plate and in the base plate of the interrupter. At the completion of the stroke, the fork is brought to rest by impacting and crushing an aluminum block mounted on the interrupter housing.

The worse-case tolerance buildup is when the fork contacts the attenuator block and the piston O-ring is 0.075 inch from entering the chamfer in the breech assembly. The O-ring enters this chamfer when the block has been crushed about 94 percent, at which point an O-ring displacement and accompanying gas escape could be expected. The factors which affect the degree of attenuator crushing are generally uncontrollable within narrow limits and include:
