"AIRPLANES, COMBAT AND MAINTENANCE CREWS, AND AIR BASES"

The World War II and Early Cold War Architectural Legacy
of Holloman Air Force Base (ca. 1942-1962)

by
Martyn D. Tagg

Holloman Air Force Base
Cultural Resources Publication No. 6

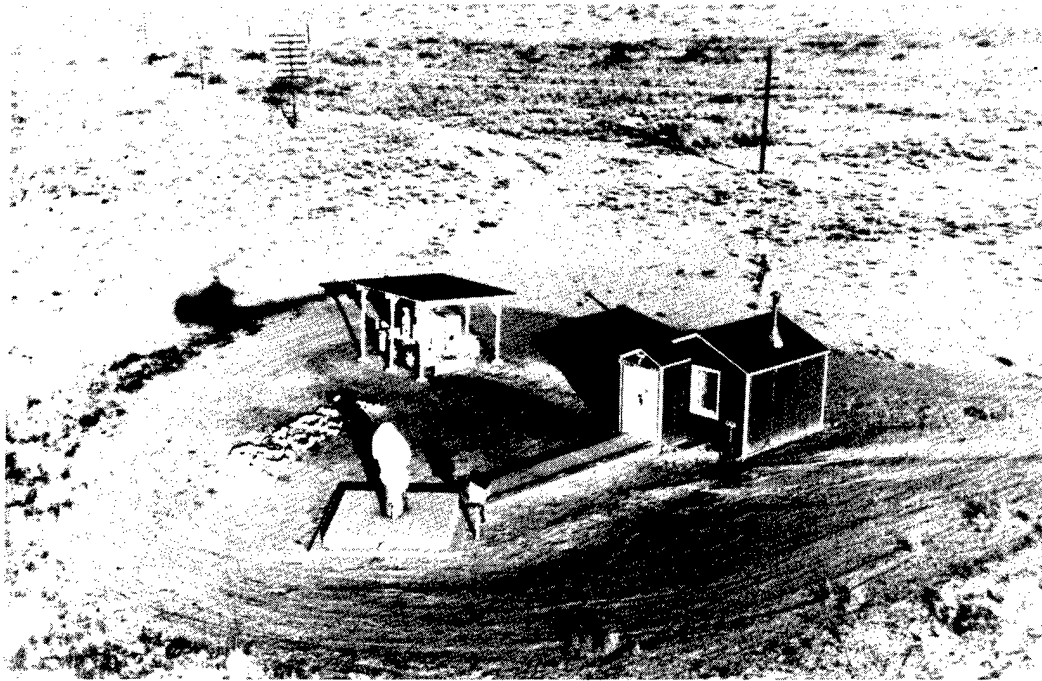
Figure 7. Bern site (George 54) cinetheodolite ground station at HAFB, looking east, 26 November 1963 (HAFB Environmental Flight, Cultural Resources Photo Archives).

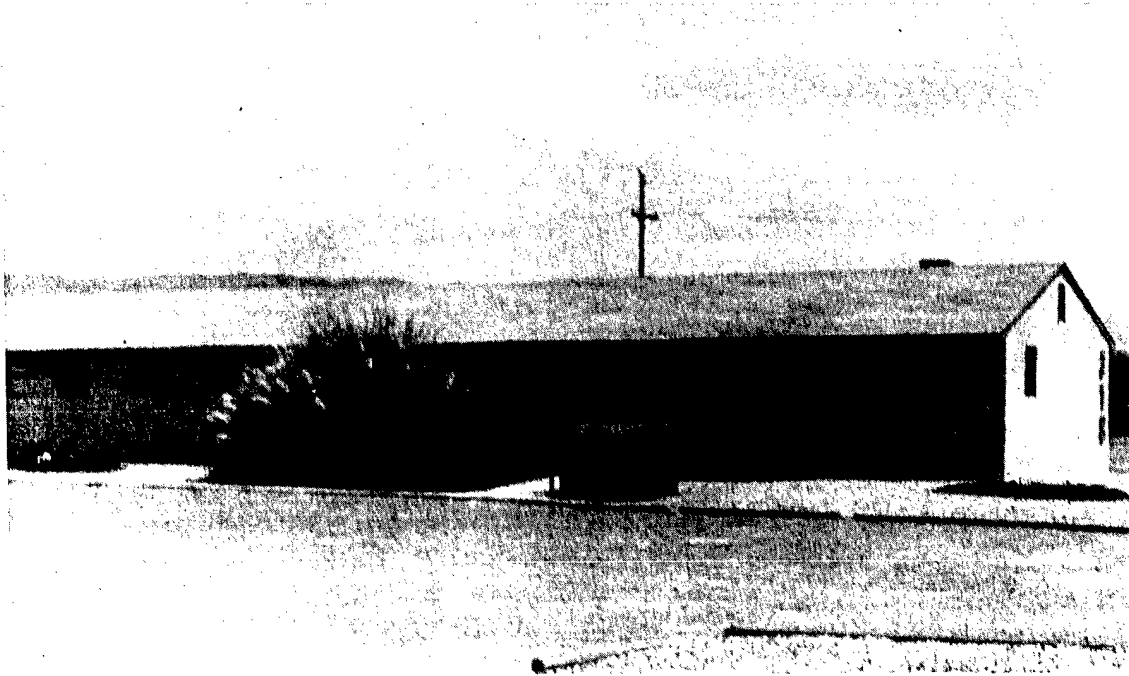
Figure 14. Building 218 as the Thrift Shop in 1996, northwest and southwest elevations.

Building 218, located in the central part of the Main Base, was a temporary facility completed ca. 1943 as an Airmen Dormitory (see Figure 10 and Appendix C). The building is one story with a long, rectangular footprint, an offset at the center of the rear (southeast) elevation, and a low, gable roof (Figure 14). Original construction consisted of asbestos cement shingles on gypsum sheathing and a wood frame. The roof was slate, the floor wood and mastipave, and the foundation concrete piers on isolated footings. The

Building 218 appears to have been one of the 20' x 100' TO-type temporary structures originally constructed to house military personnel in 1943 and is the only remaining WW II housing unit on HAFB. The building retains its original rectangular footprint, single story scope, and gable roof profile, although it no longer retains historic integrity due to extensive architectural modifications. All original doors and windows have been replaced and one window opening has been framed in. At the northwest (principal)

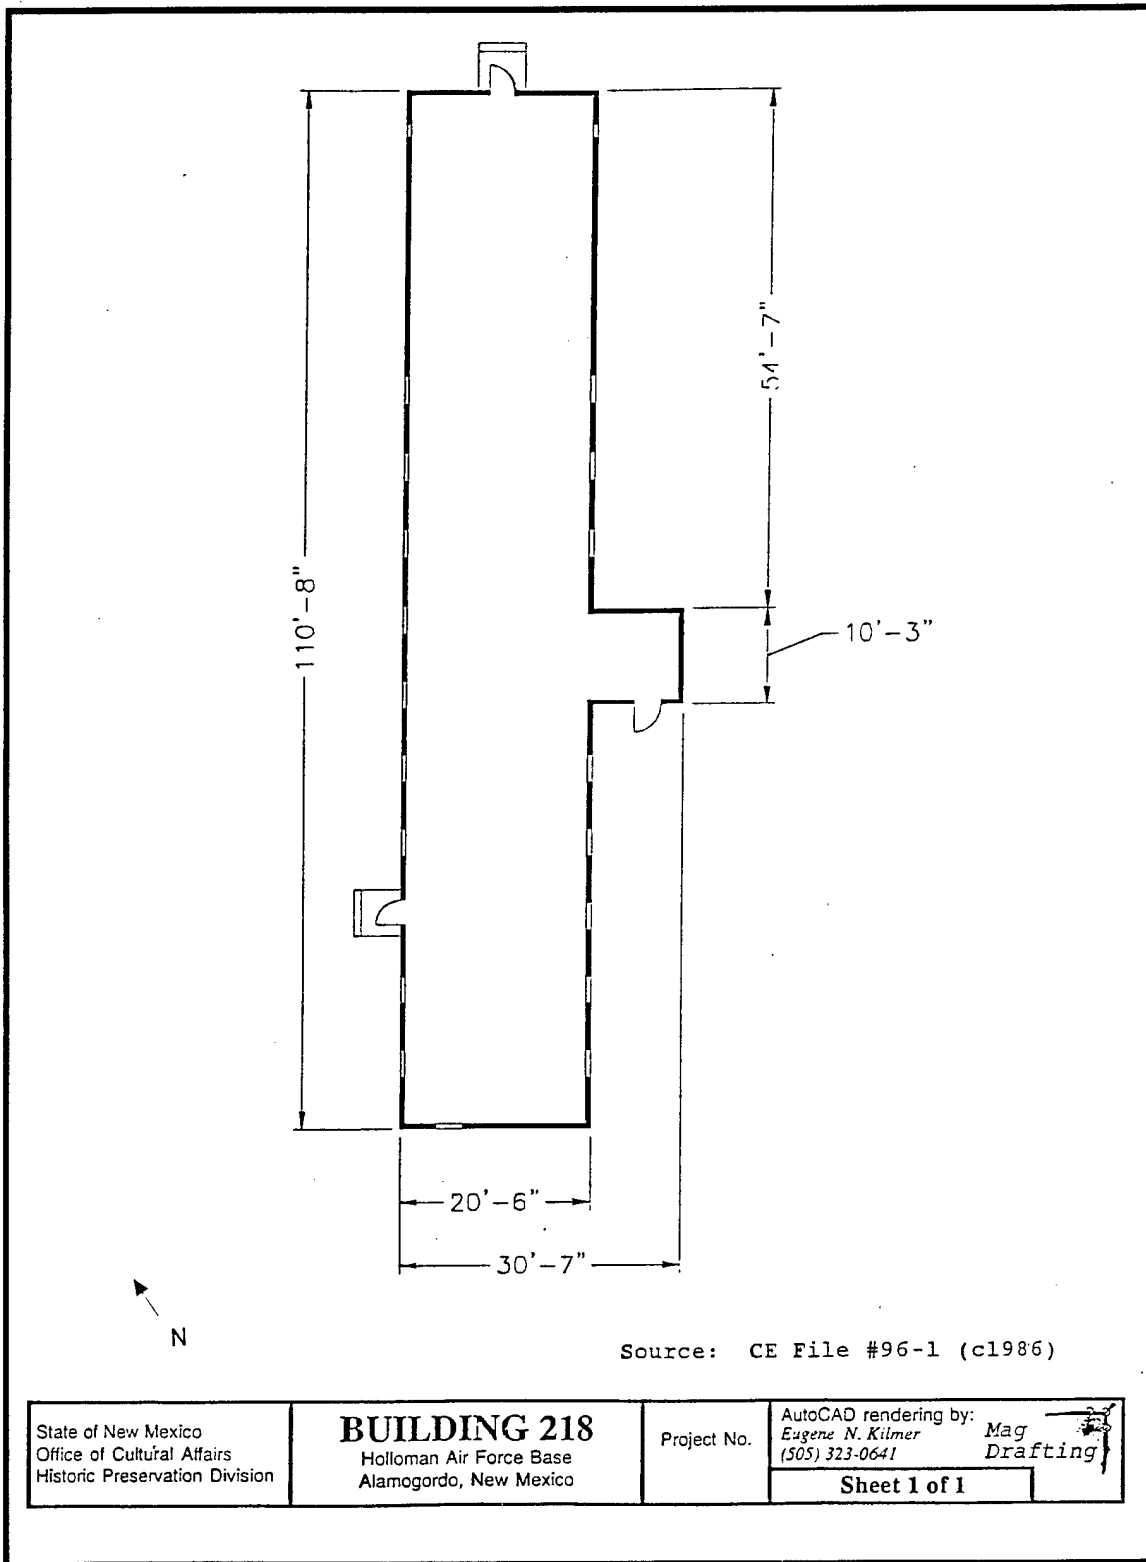
Figure 15. Building 218 floor plan, probably as an Air Force Headquarters Group or Administrative office, ca. 1986.

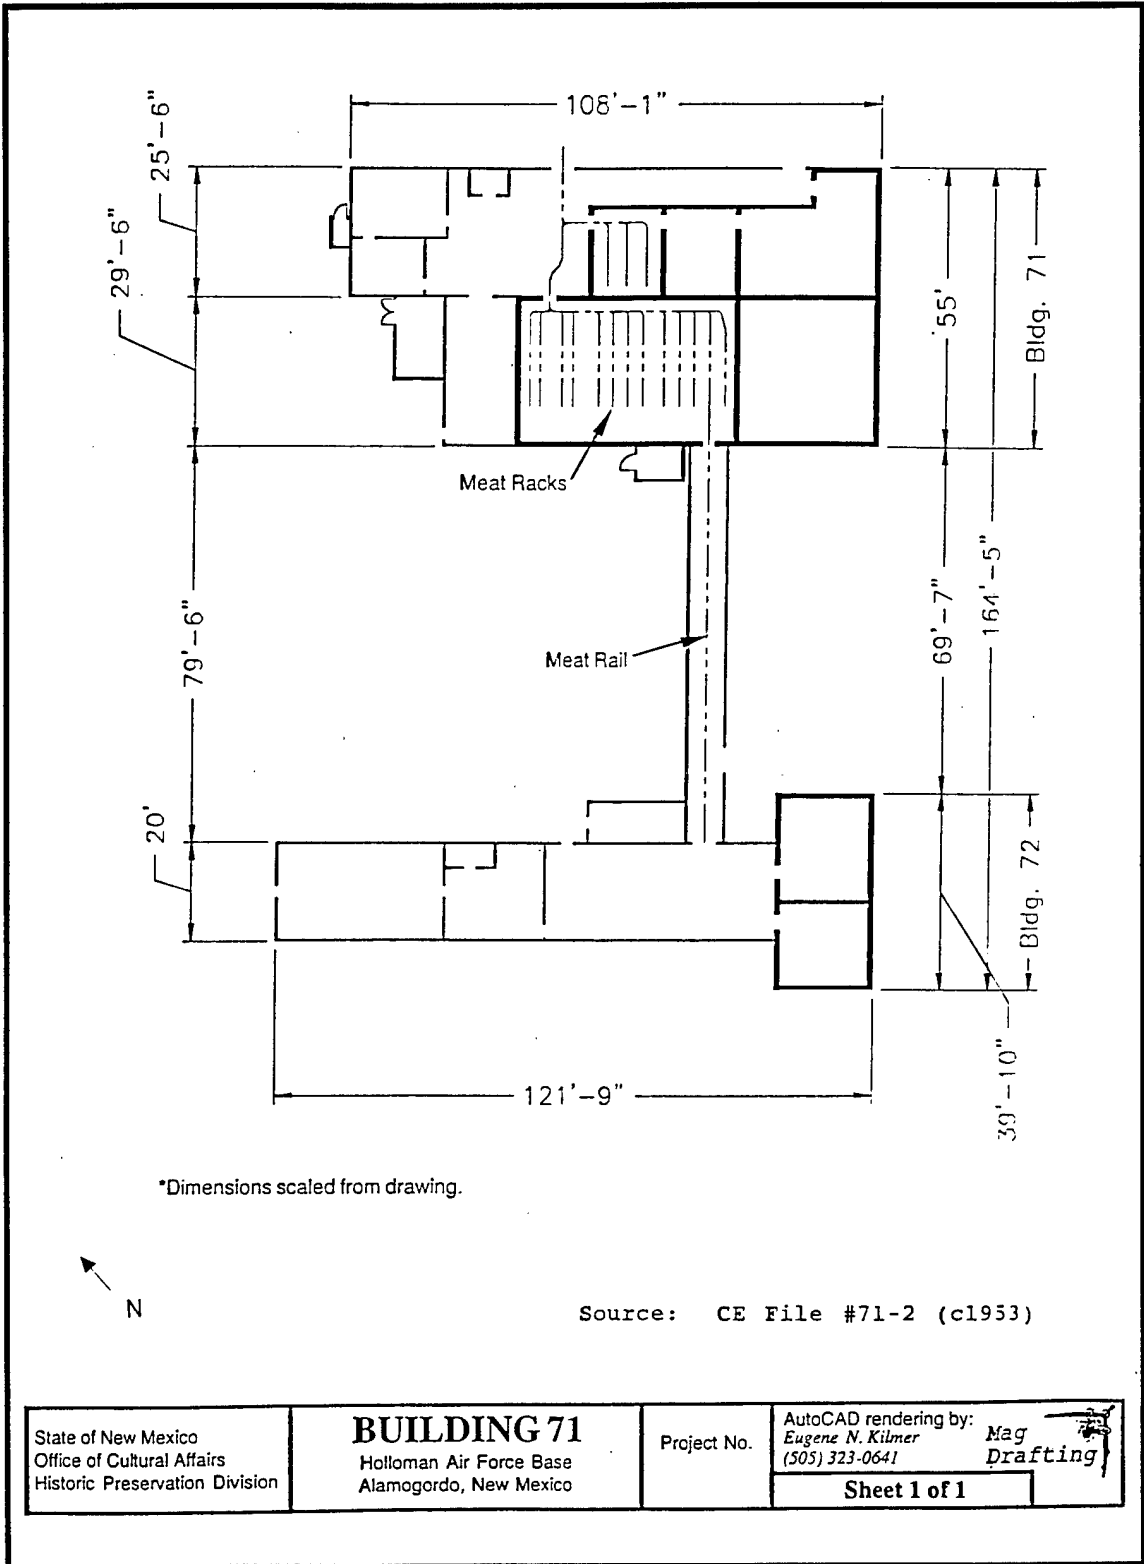
Figure 17. Building 71, floor plan of Base Food Cold Storage facility when it was attached to Building 72, ca. 1953.

The earliest drawing located for the facility was completed in 1953 when the building appears to have been the Base Food Cold Storage structure. Buildings 71 and 72 are shown connected by a 79'6" long meat rail and cover an area of 121'9" x 164'2" (Figure 17). Building 71, the northern (main) building, was roughly rectangular, 108'1" x 54'9" in size, with two double-hung doors at the northeast elevation, a double- and two single-hung doors at the northwest elevation, and a single-hung door at the southwest elevation. The double doors at the northwest elevation opened into a hallway and open area with partitioned rooms around the edges and what appears to have been two meat rack rooms in the center. The doors at the northwest and southwest elevations opened into small offsets. Building 72, the southern wing, was roughly T-shaped, measured 39'10" x 121'9" in size, and exhibited single-hung doors on the west and north elevations. The interior was divided into rooms of various size. Two windows are shown at a small offset at the northeast elevation and four each are symmetrically placed at both meat rail elevations. No original drawings were located and neither the architect nor builder is known (Facility Assessment Form/71).

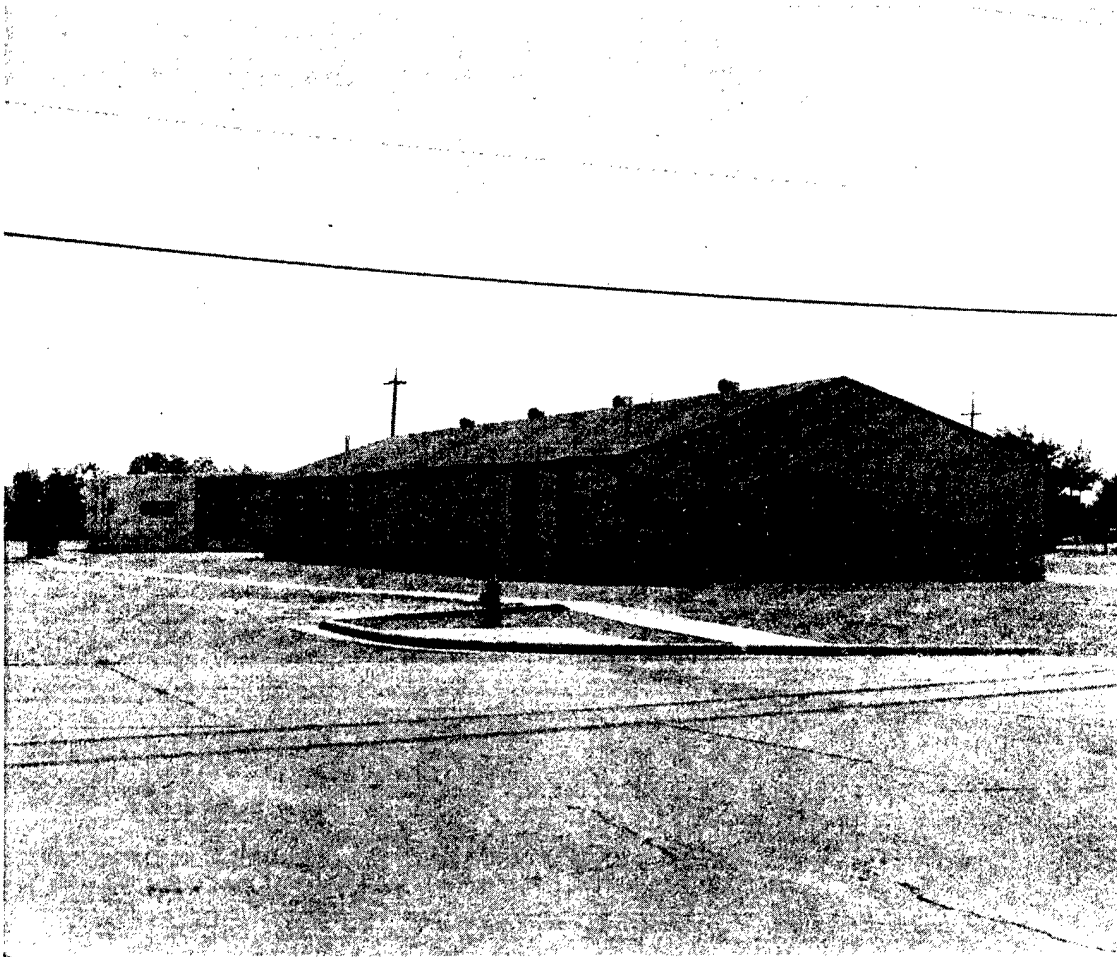
Figure 18. Building 96 as the Housing Supply and Storage facility in 1996, northwest and northeast elevations.

Building 96 retains its original rectangular footprint, single story scope, and gable roof profile, although most of the original architectural features and finishes have been replaced, removed, or obscured. Between 1951 and 1991, at least two extensive renovations occurred at the interior and exterior. The 19 six-light windows have been removed from the southwest and northeast elevations and wood equipment doors have been replaced with roll-up metal doors. An exterior insulation and finish siding system (stucco) replaced

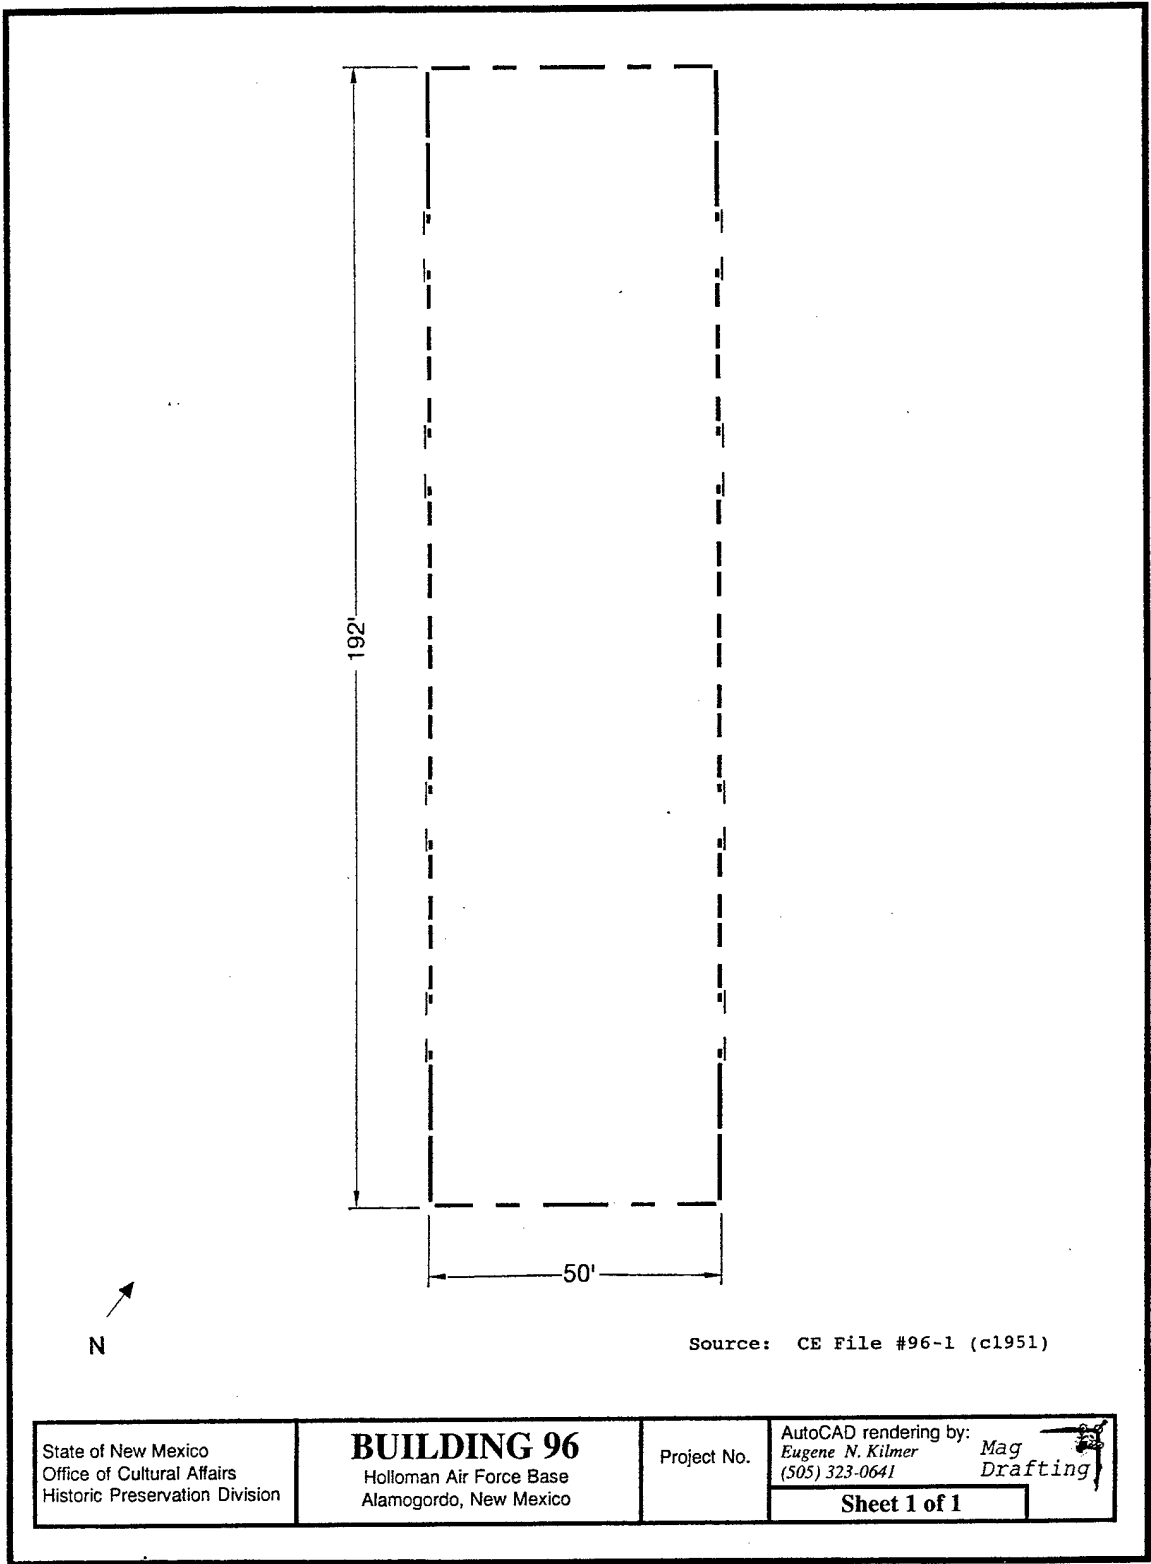
Figure 19. Building 96, floor plan as a Base Warehouse, ca. 1951.

The earliest drawing (1951) shows the 50' x 192' building with an unpartitioned interior (Figure 19). It had four double equipment doors and at least eight windows on both the northeast and southwest elevations,

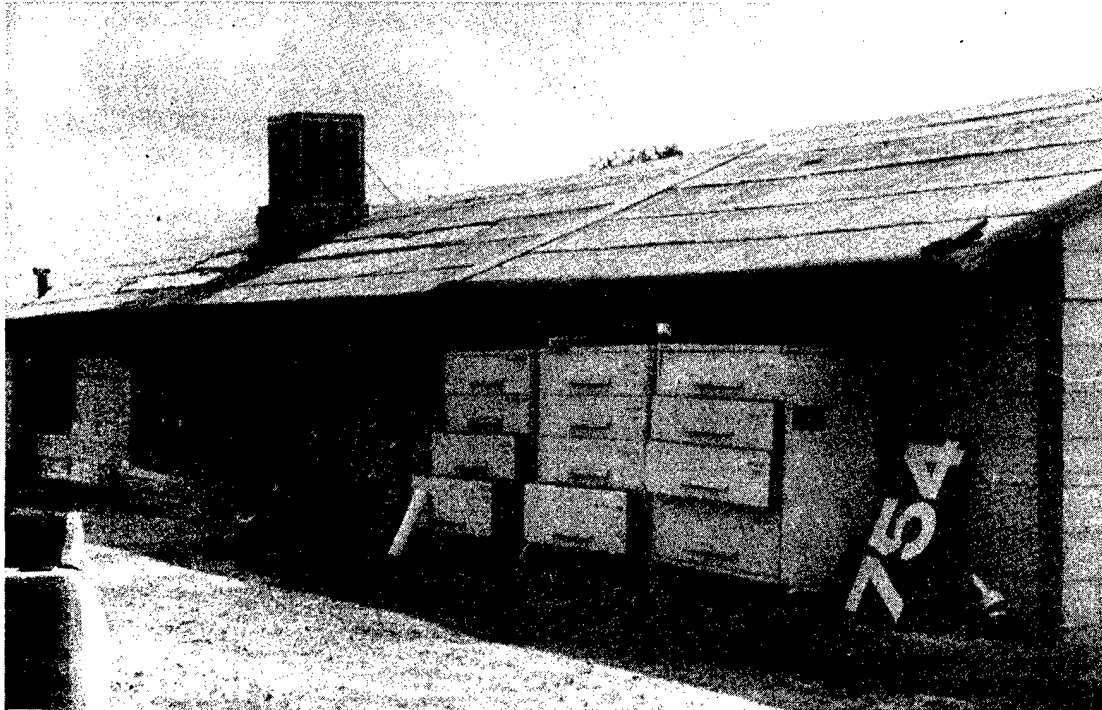
Figure 20. Building 754 as a Golf Course storage facility in 1996 prior to demolition, north and east elevations.

At the time of the assessment, Building 754 maintained its original rectangular footprint, single story scope, and gable roof profile, although it no longer retained historic integrity due to extensive alterations

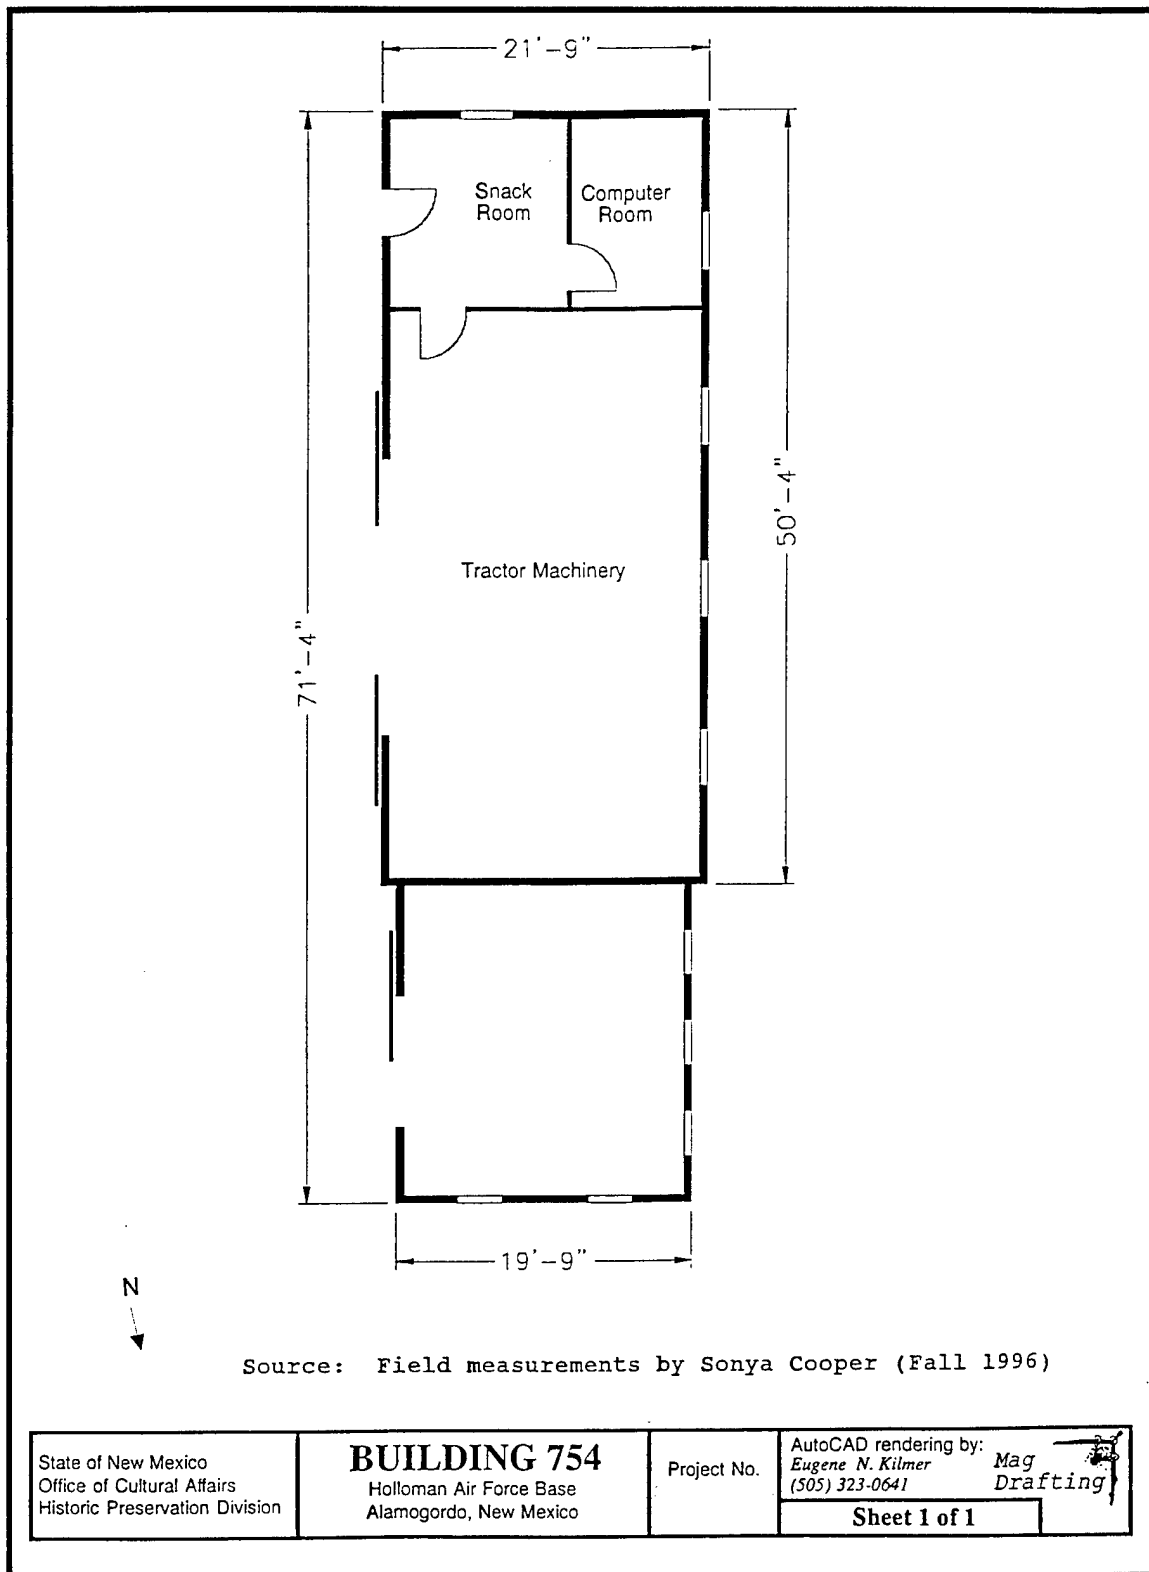
Figure 21. Building 754, floor plan of Golf Course storage building in 1996.

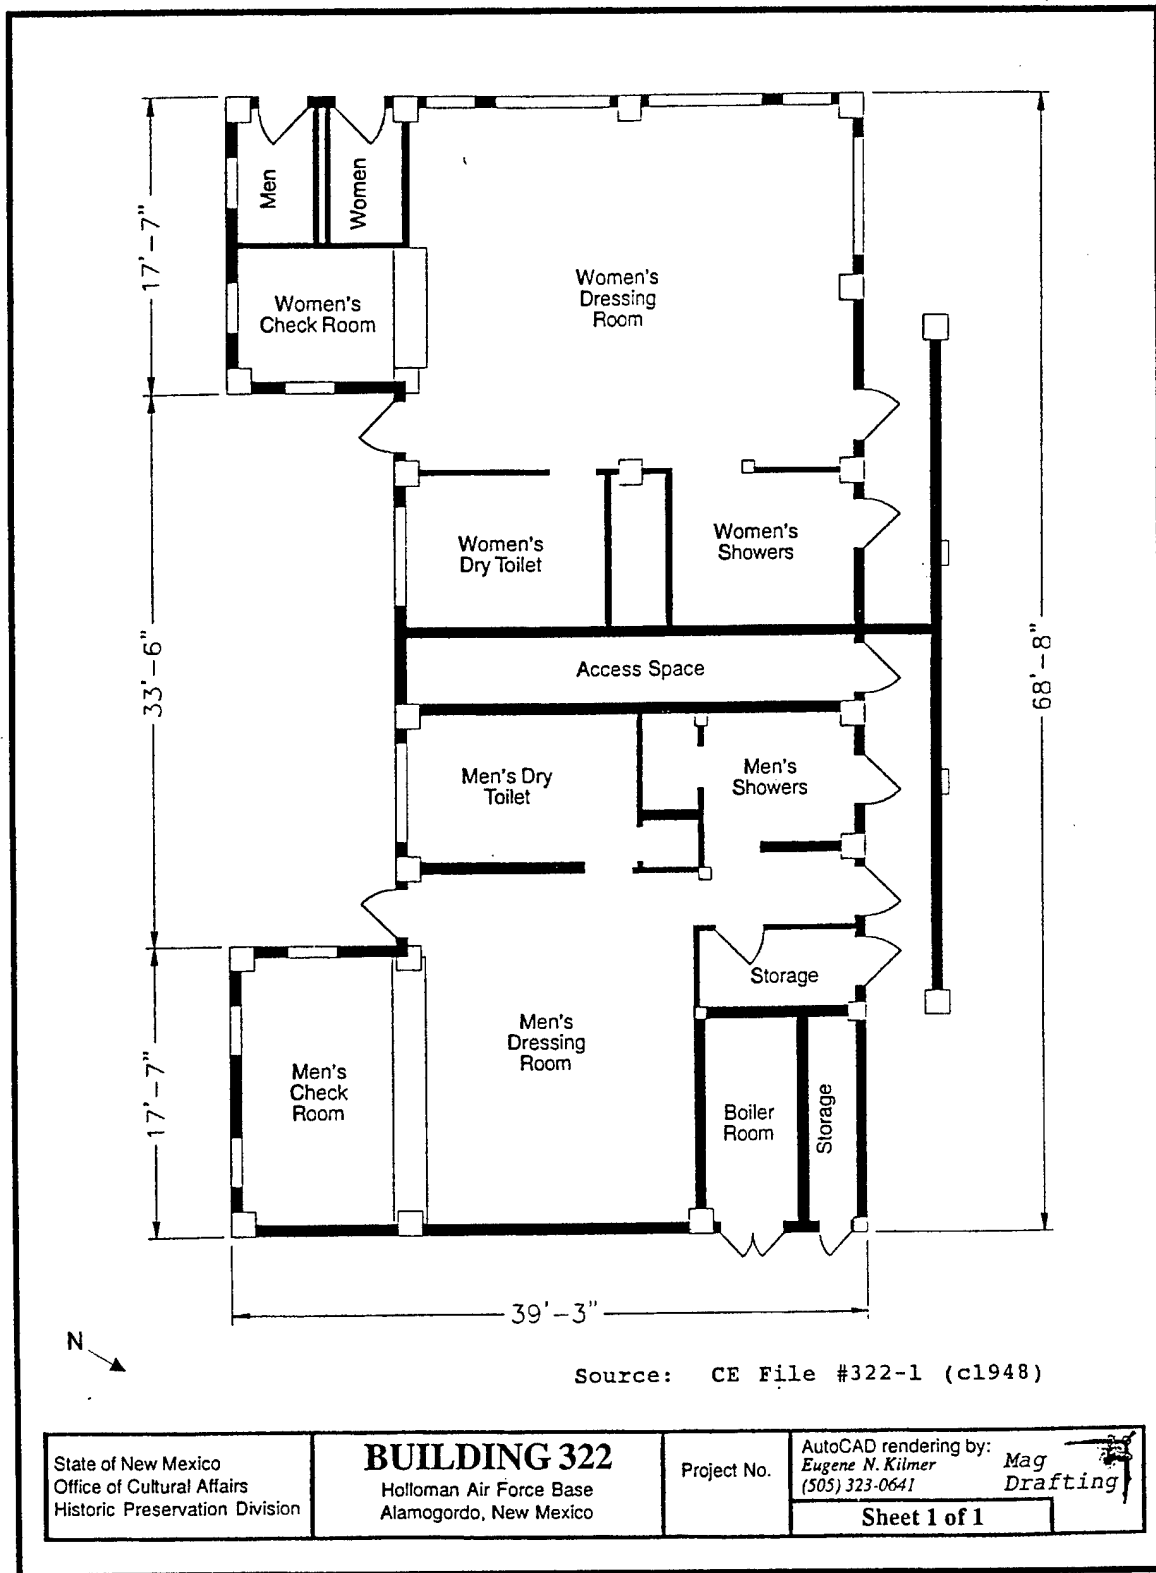
Figure 23. Building 322, floor plan of Swimmer's Bathhouse, ca. 1948.

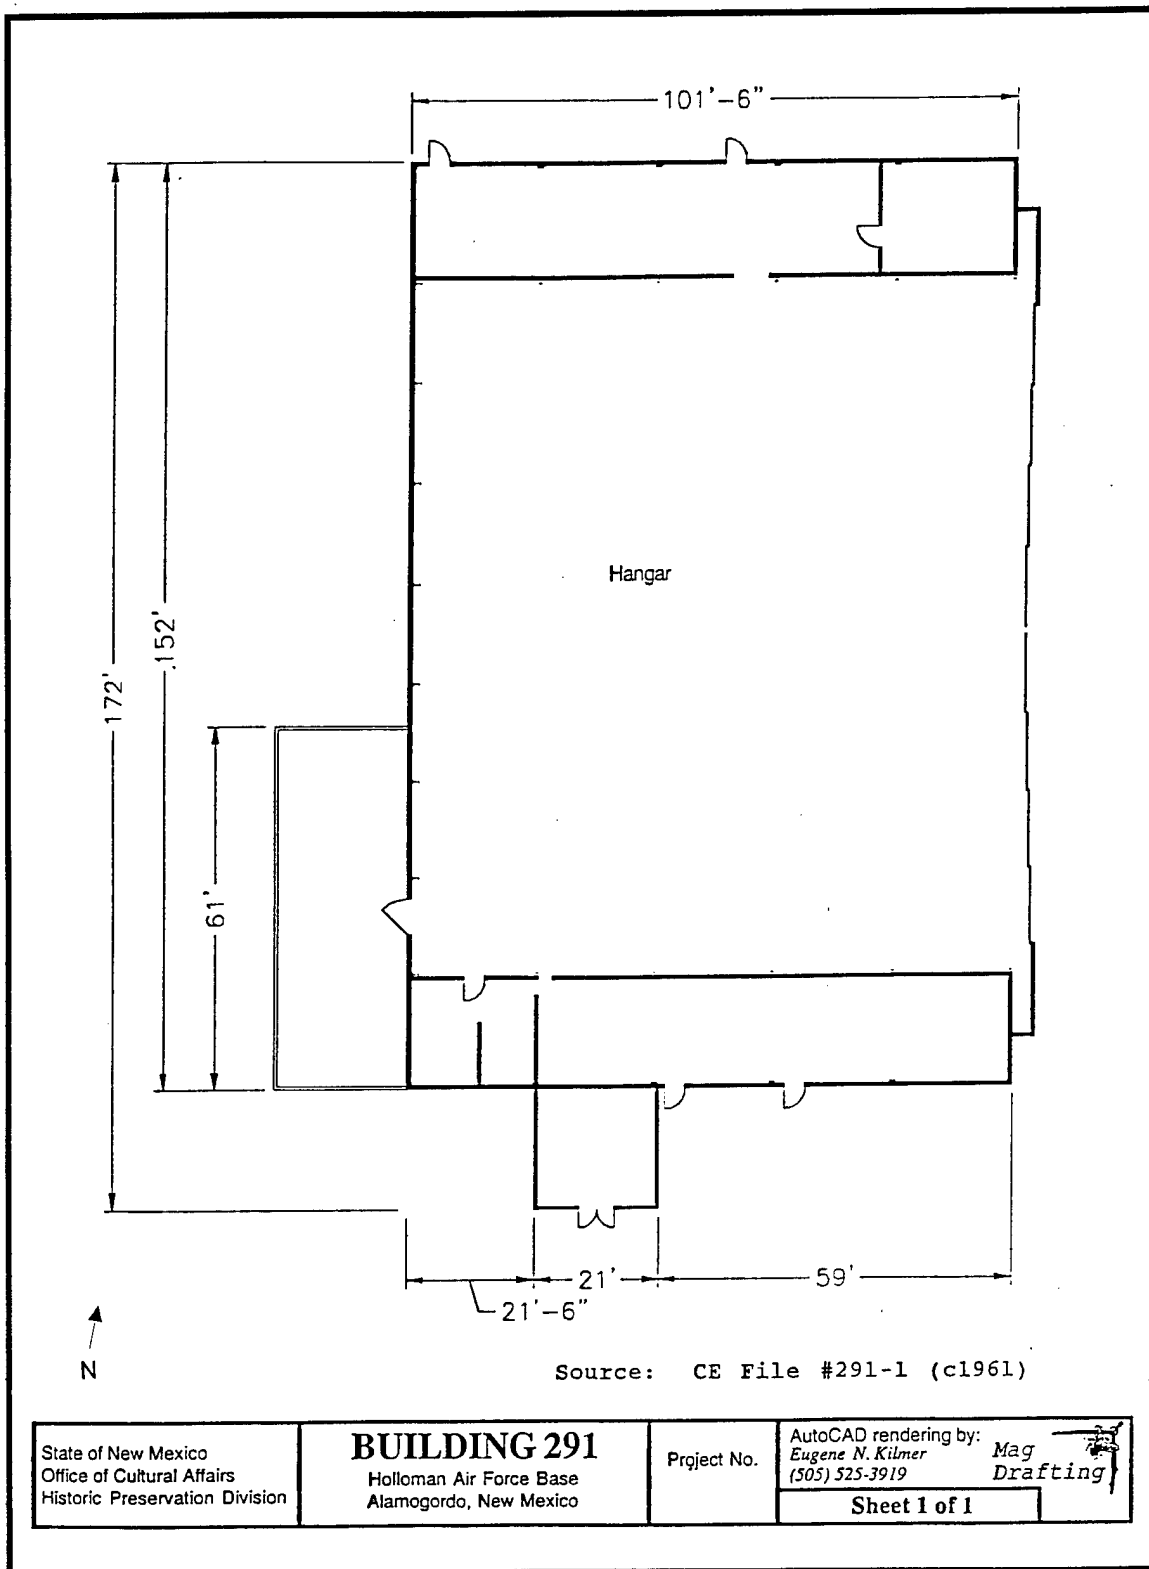
Figure 33. Building 291, floor plan as a probable Maintenance Dock for Small Aircraft, ca. 1961.

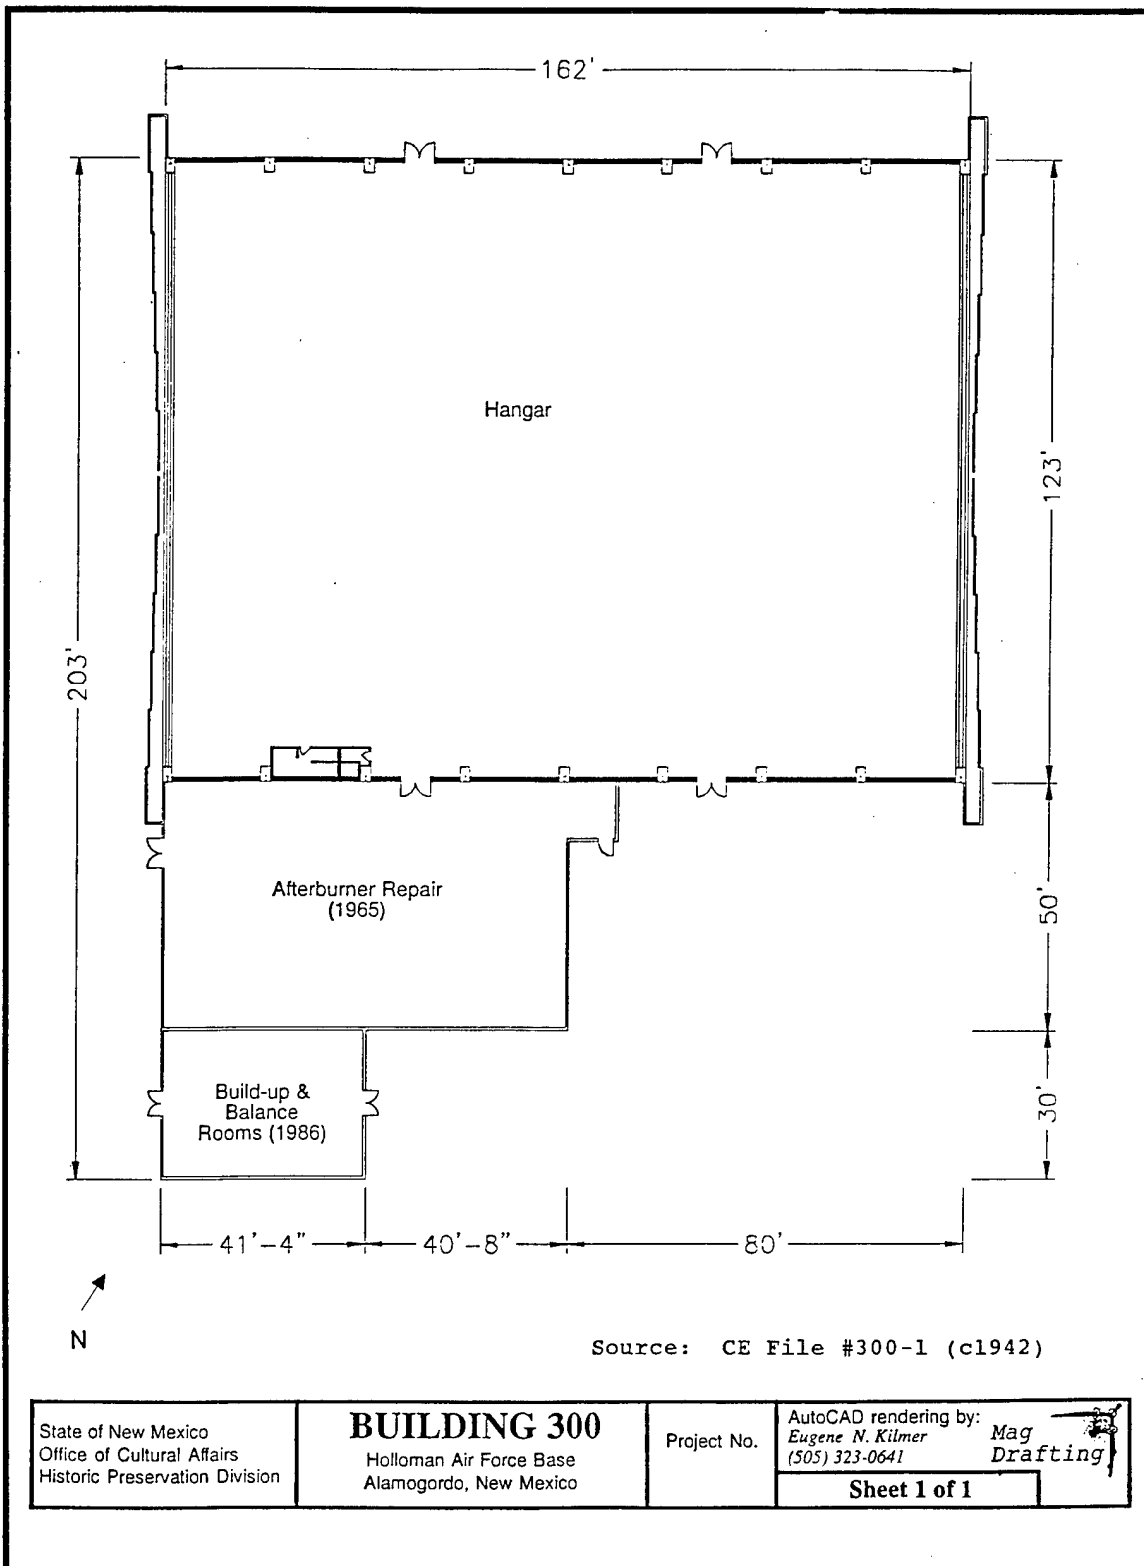
Figure 35. Building 300, floor plan of Field Maintenance Hangar, ca. 1942.

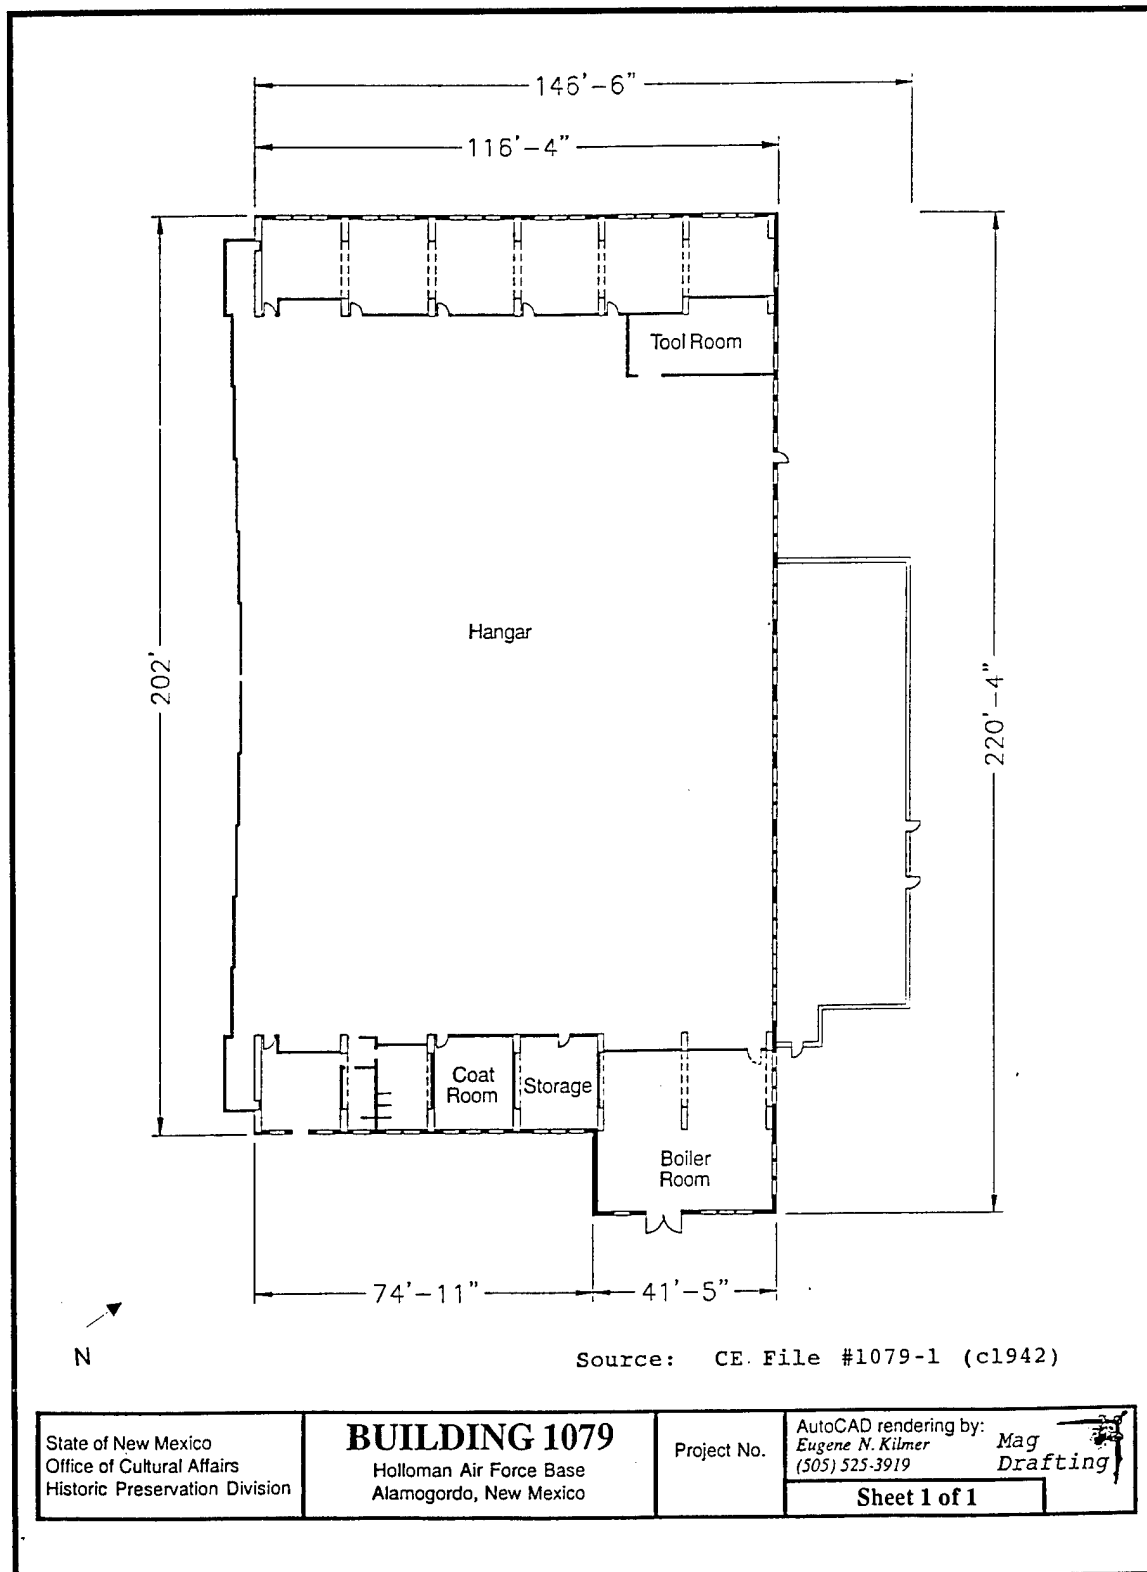
Figure 39. Building 1079, floor plan as a Field Maintenance Hangar, ca. 1942.

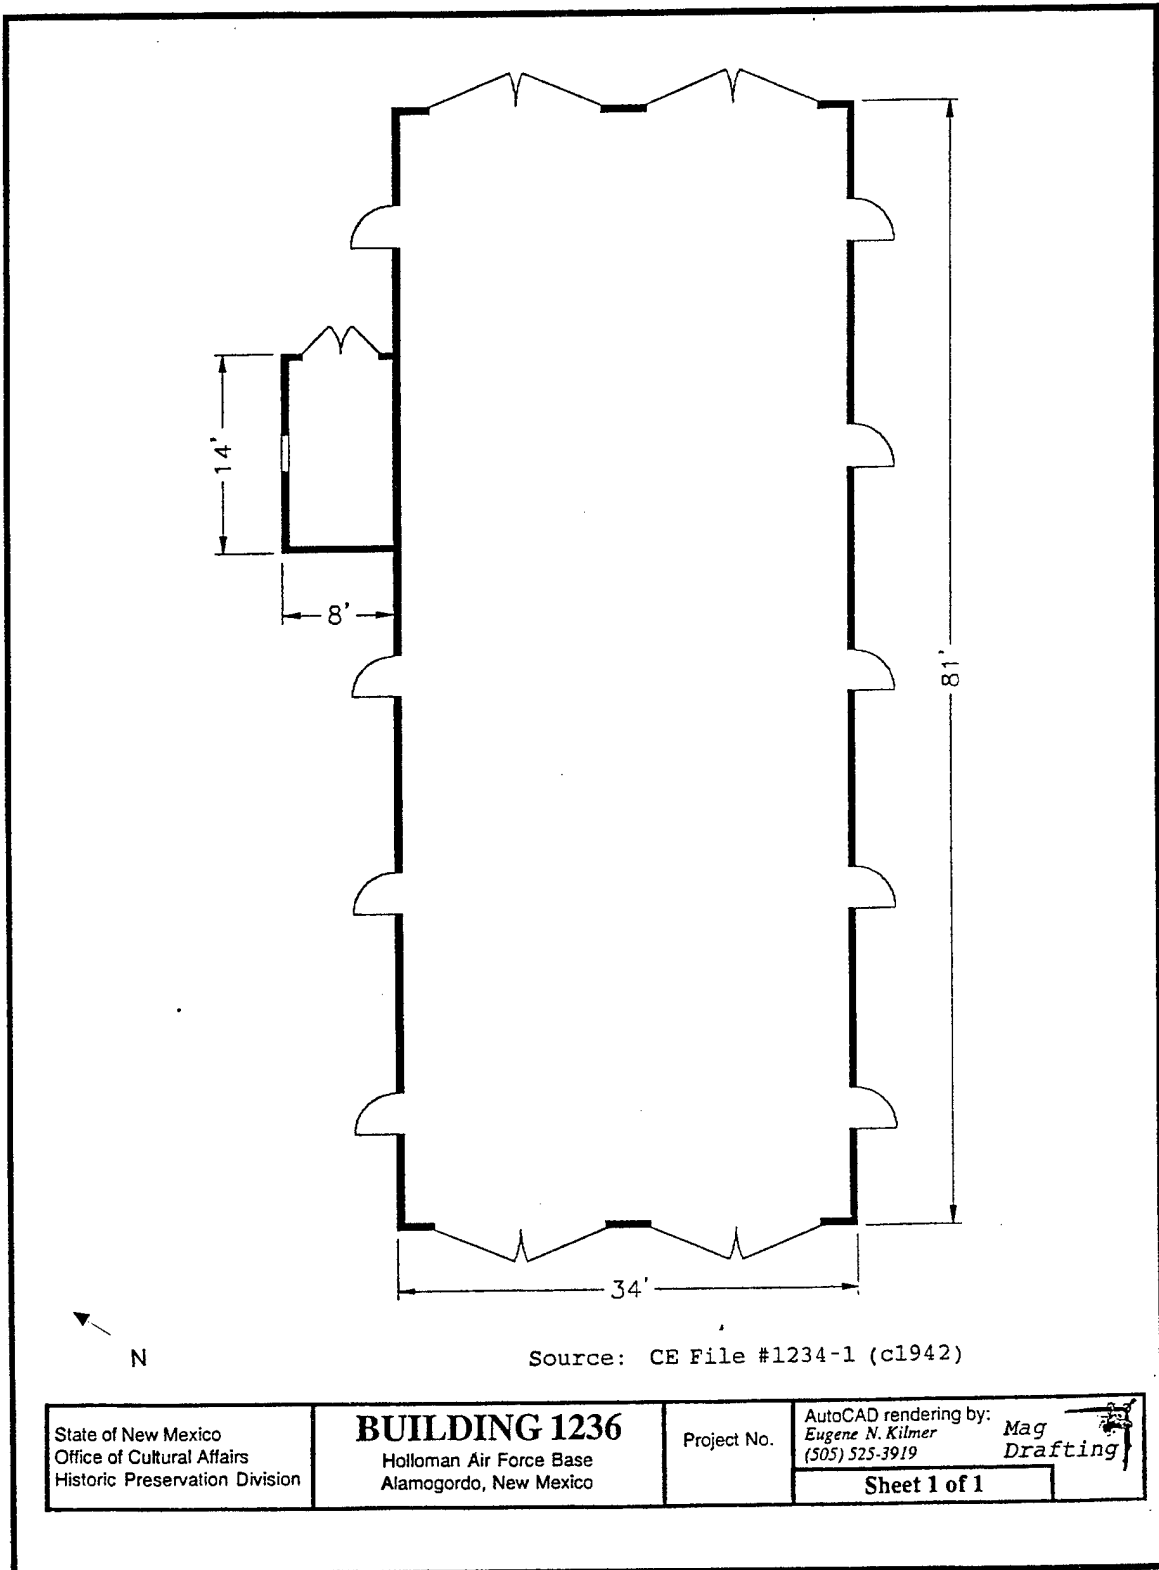
Figure 44. Building 1236, floor plan as a Spare Inert (Munitions) Storage facility, ca. 1942.

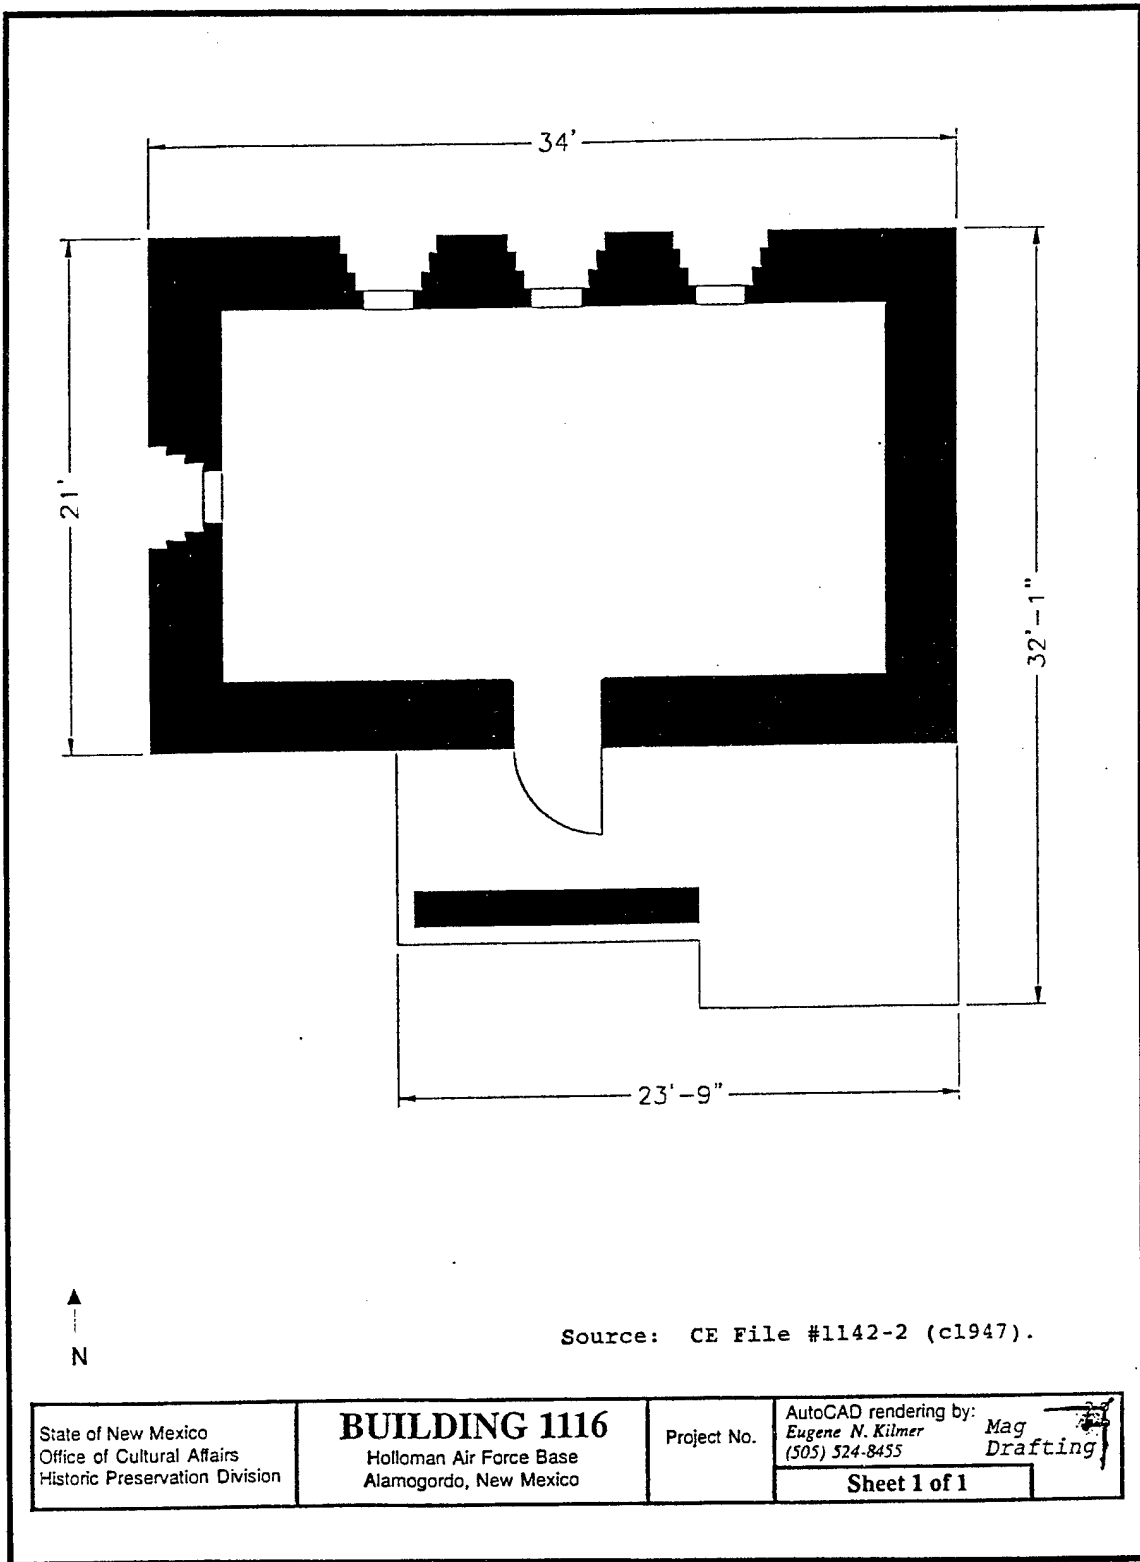
Figure 68. Building 1116, floor plan of the Nativ blockhouse, ca. 1947.
