"AIRPLANES, COMBAT AND MAINTENANCE CREWS, AND AIR BASES"

The World War II and Early Cold War Architectural Legacy
of Holloman Air Force Base (ca. 1942-1962)

by
Martyn D. Tagg

Holloman Air Force Base
Cultural Resources Publication No. 6

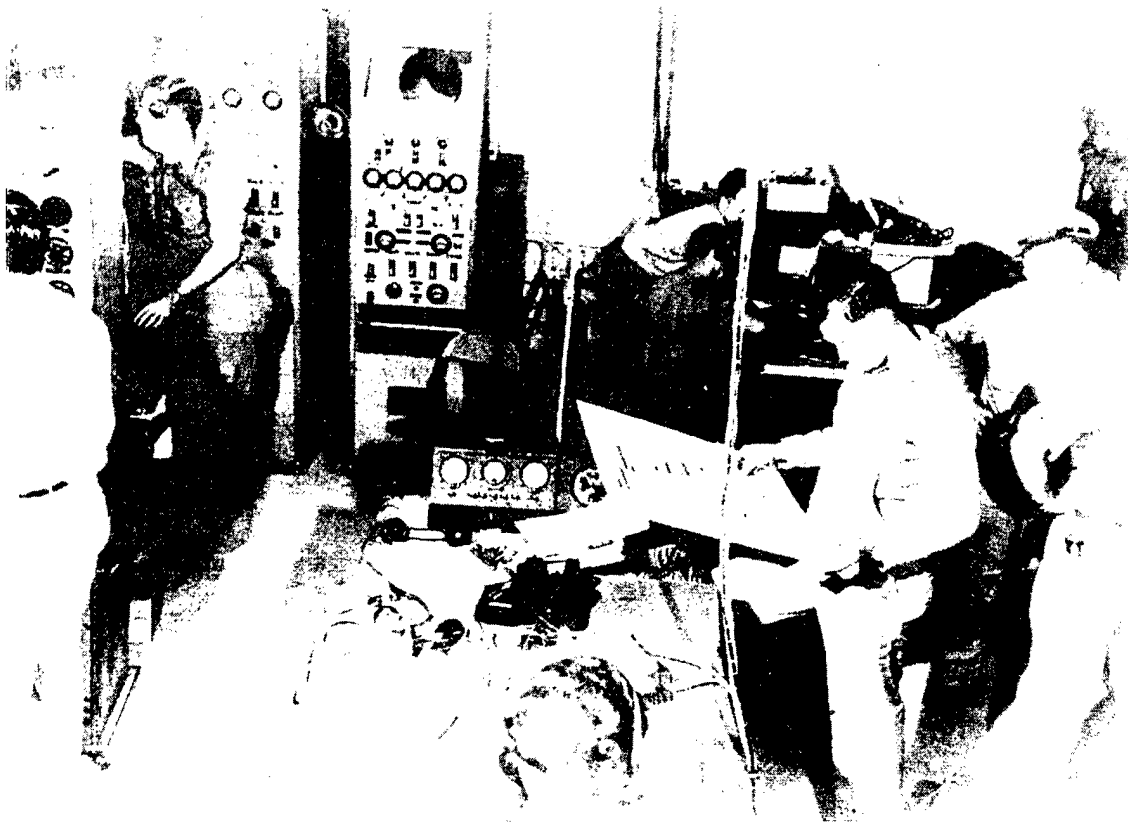
Figure 69. Interior of Building 1116, the Nativ blockhouse, showing instruments and military personnel during countdown, ca. 1948 (HAFB Environmental Flight, Cultural Resources Photo Archives).

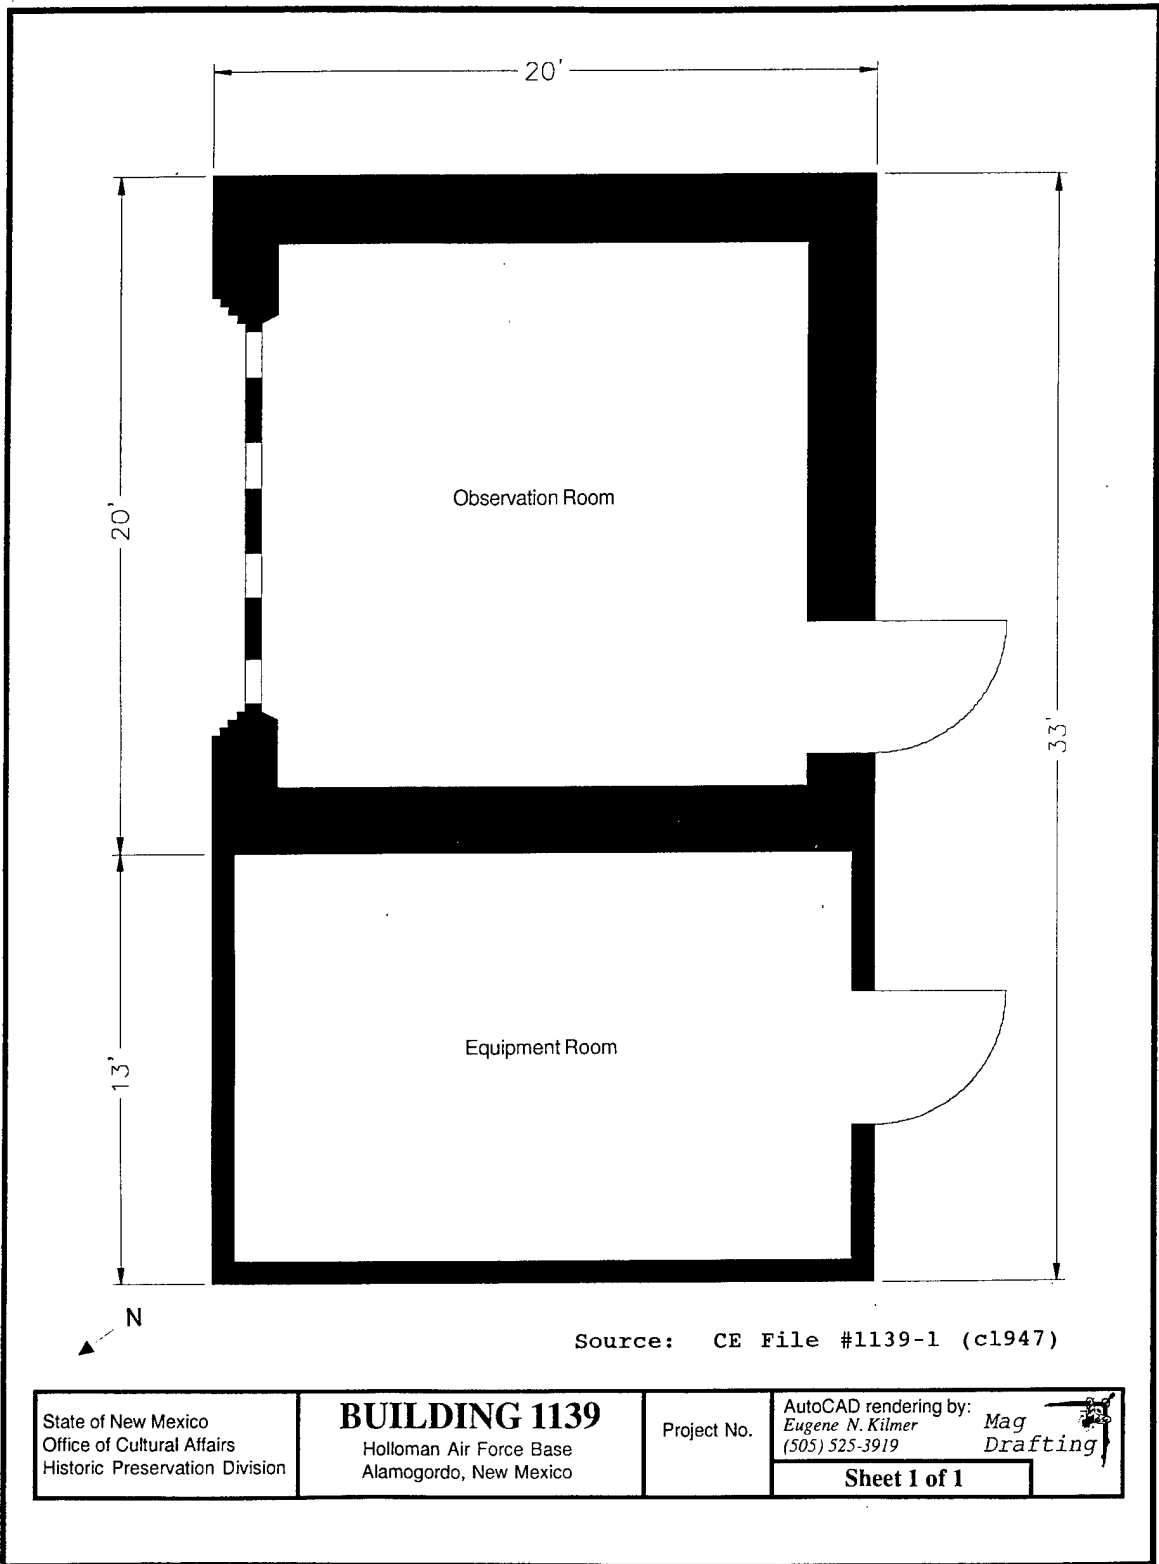
Figure 71. Building 1139, floor plan of the Gapa blockhouse, ca. 1947.

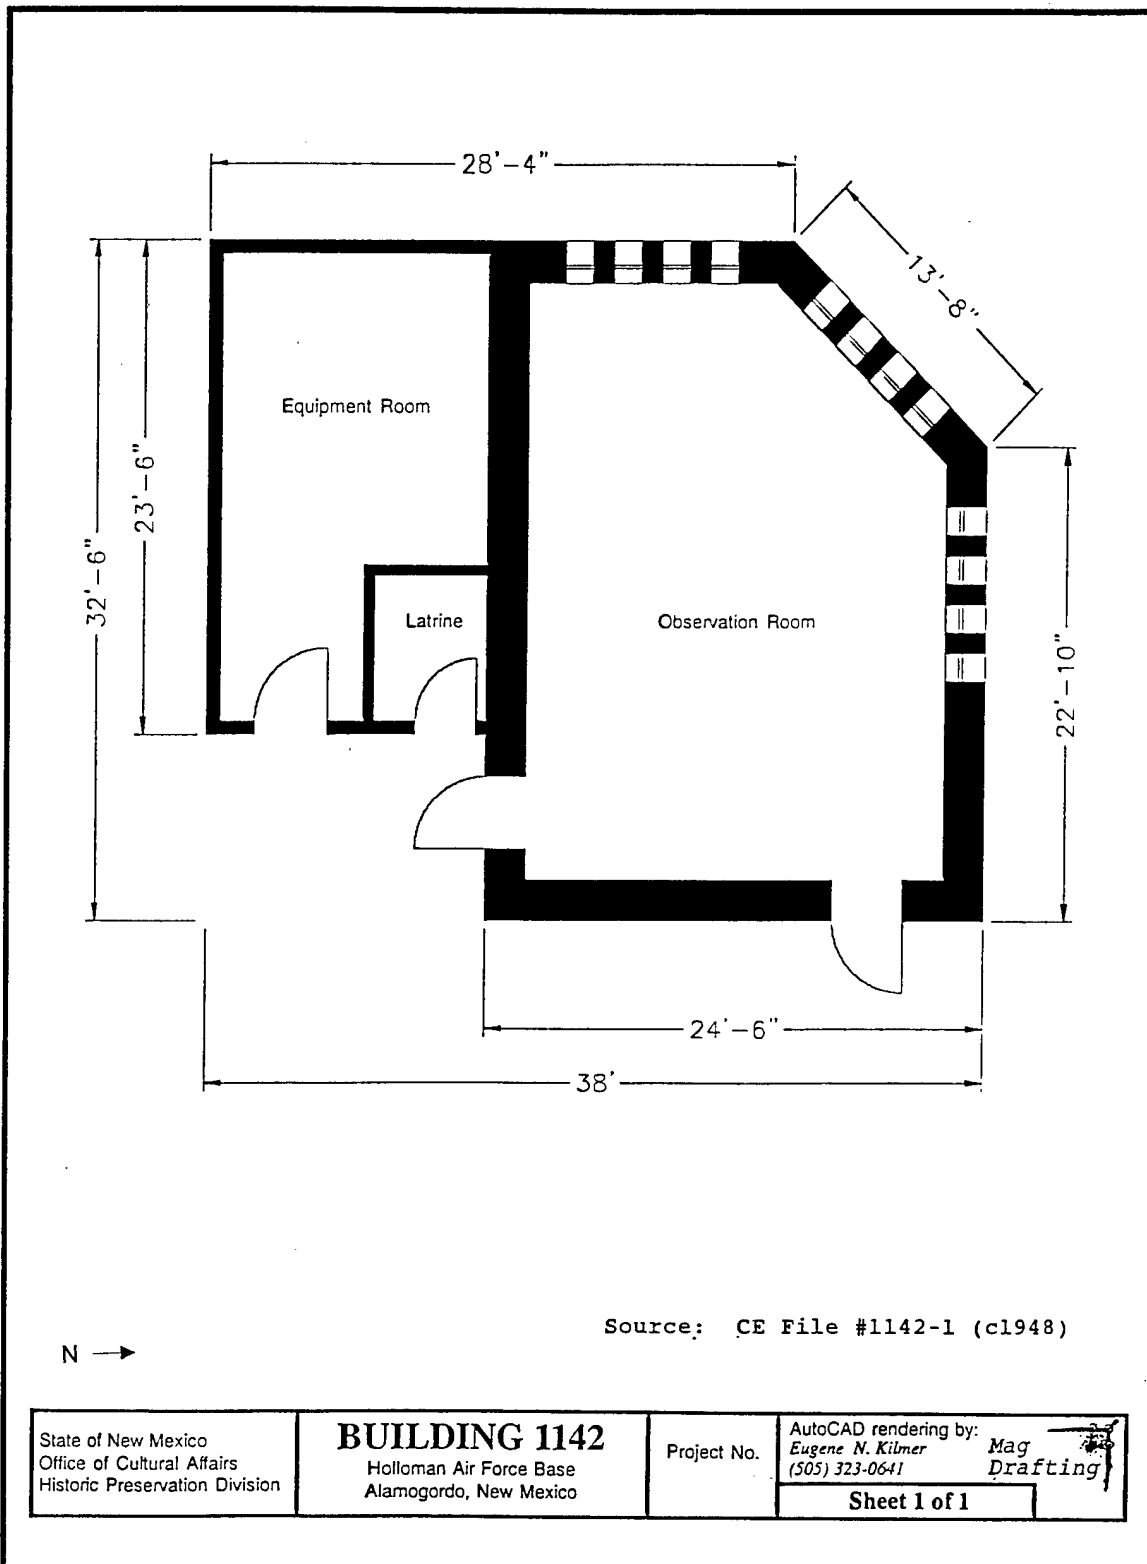
Figure 73. Building 1142, floor plan of the Aerobee blockhouse, ca. 1948.

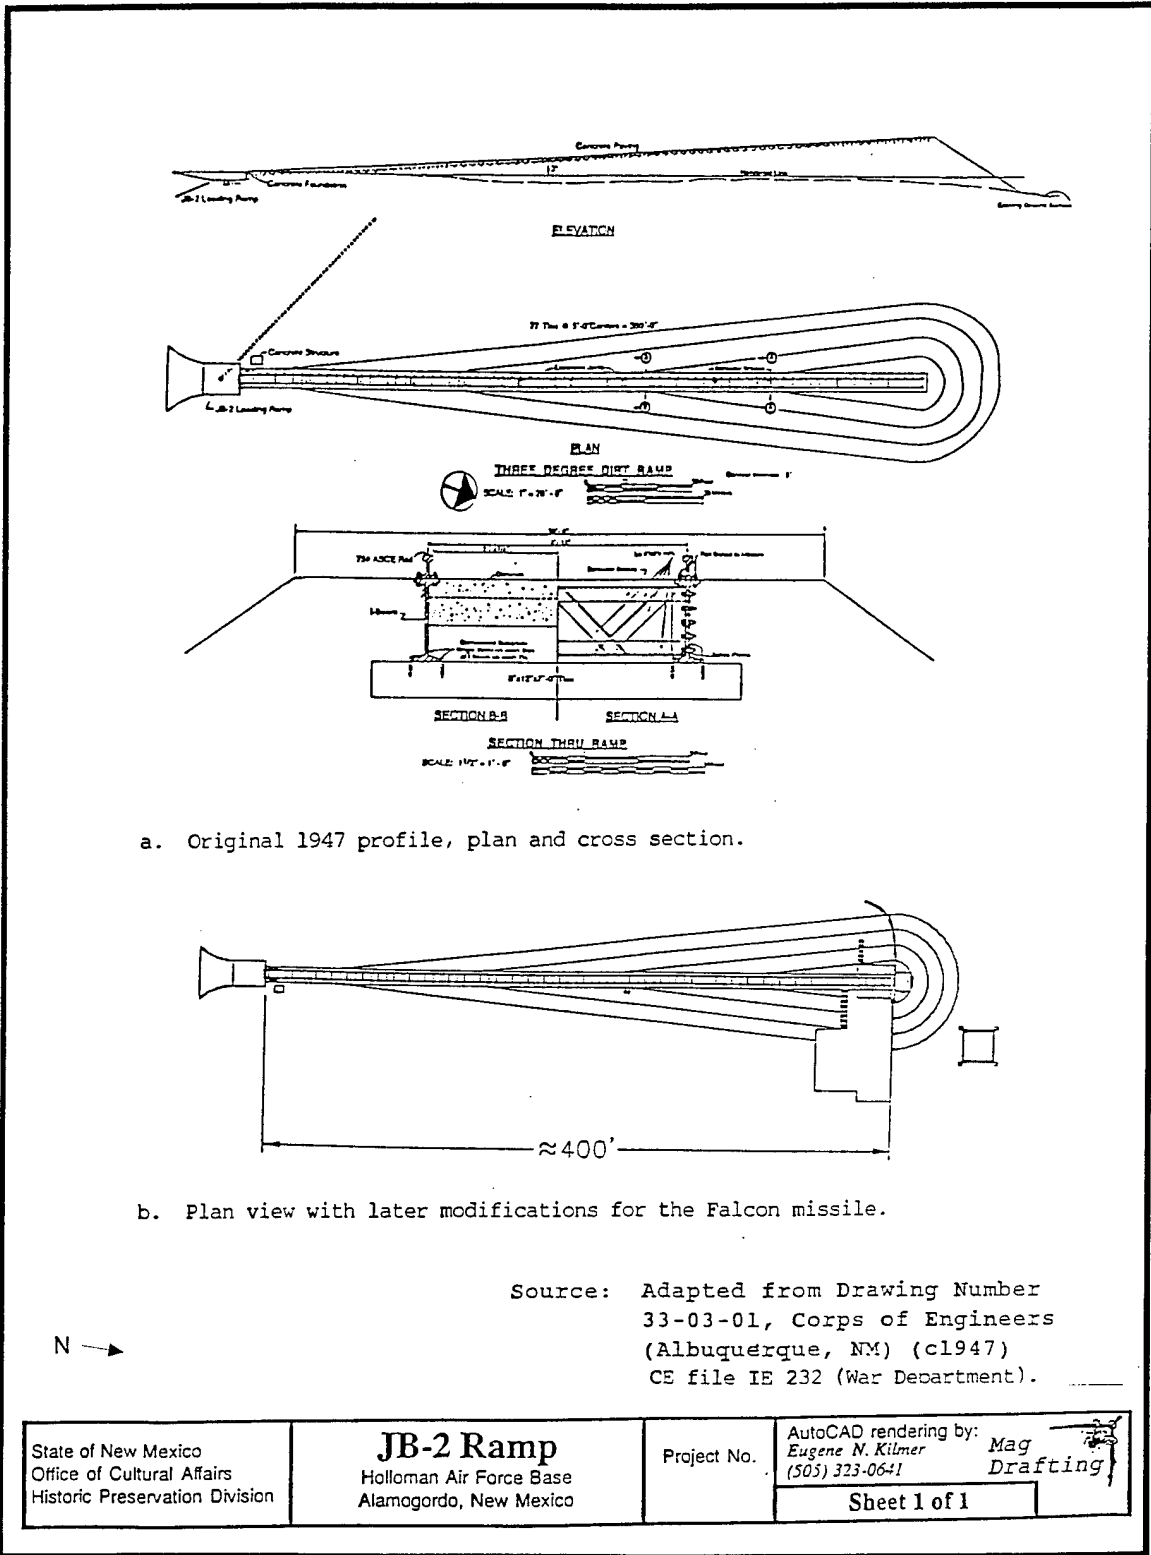
Figure 75. JB-2 Ramp; profile, plan view, and cross section, ca. 1947, and plan view with later modifications as it appeared in 1996.

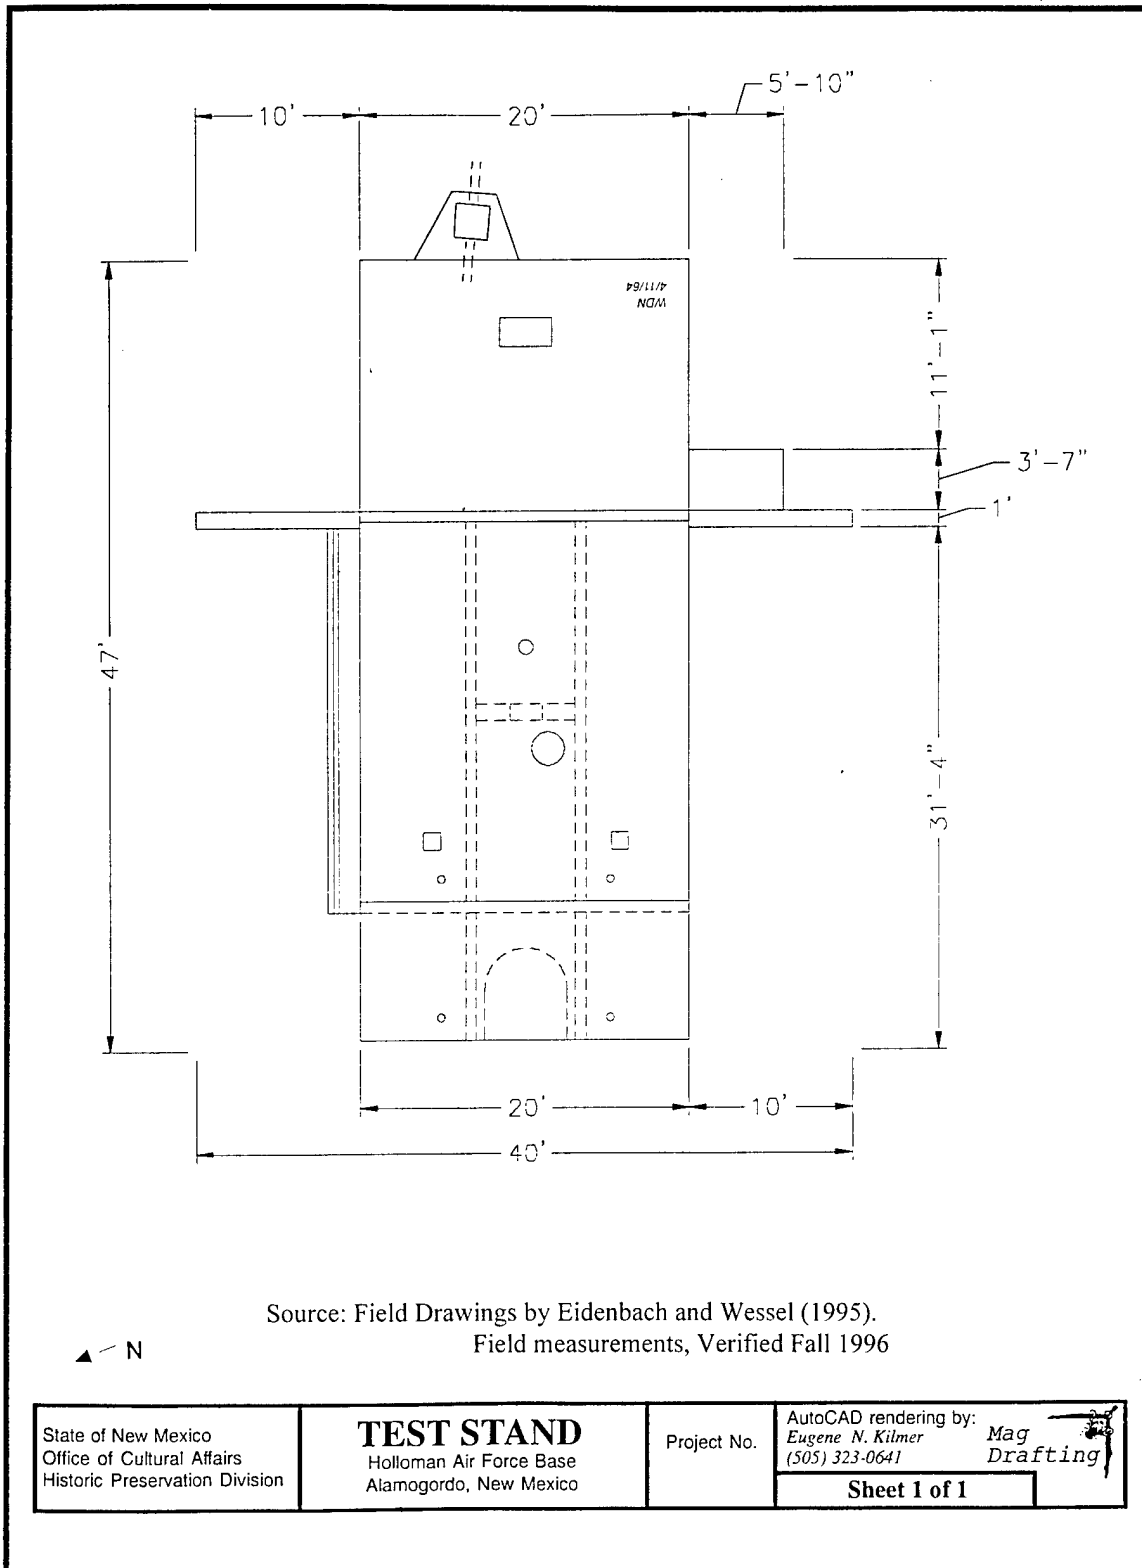
Figure 77. Test Stand plan view in 1996.

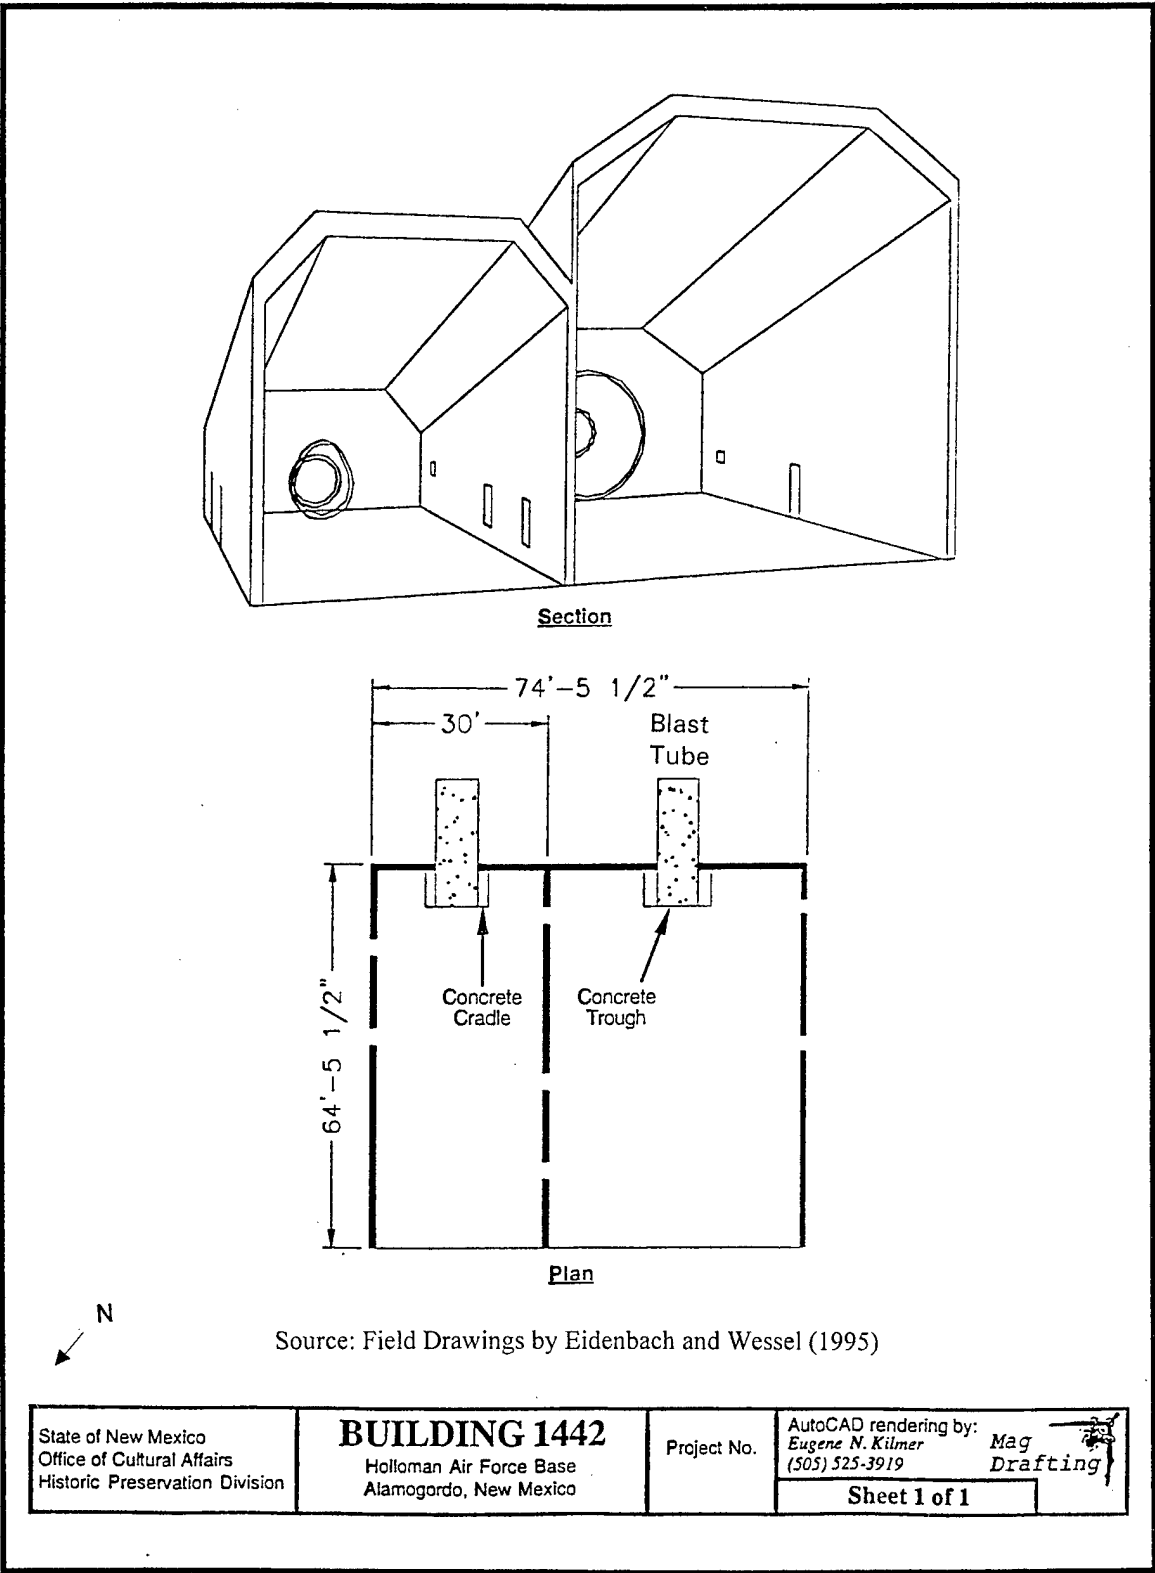
Figure 85. Building 1442, floor plan and 3-D profile of Able 51/ZEL site launch facility, ca. 1994.

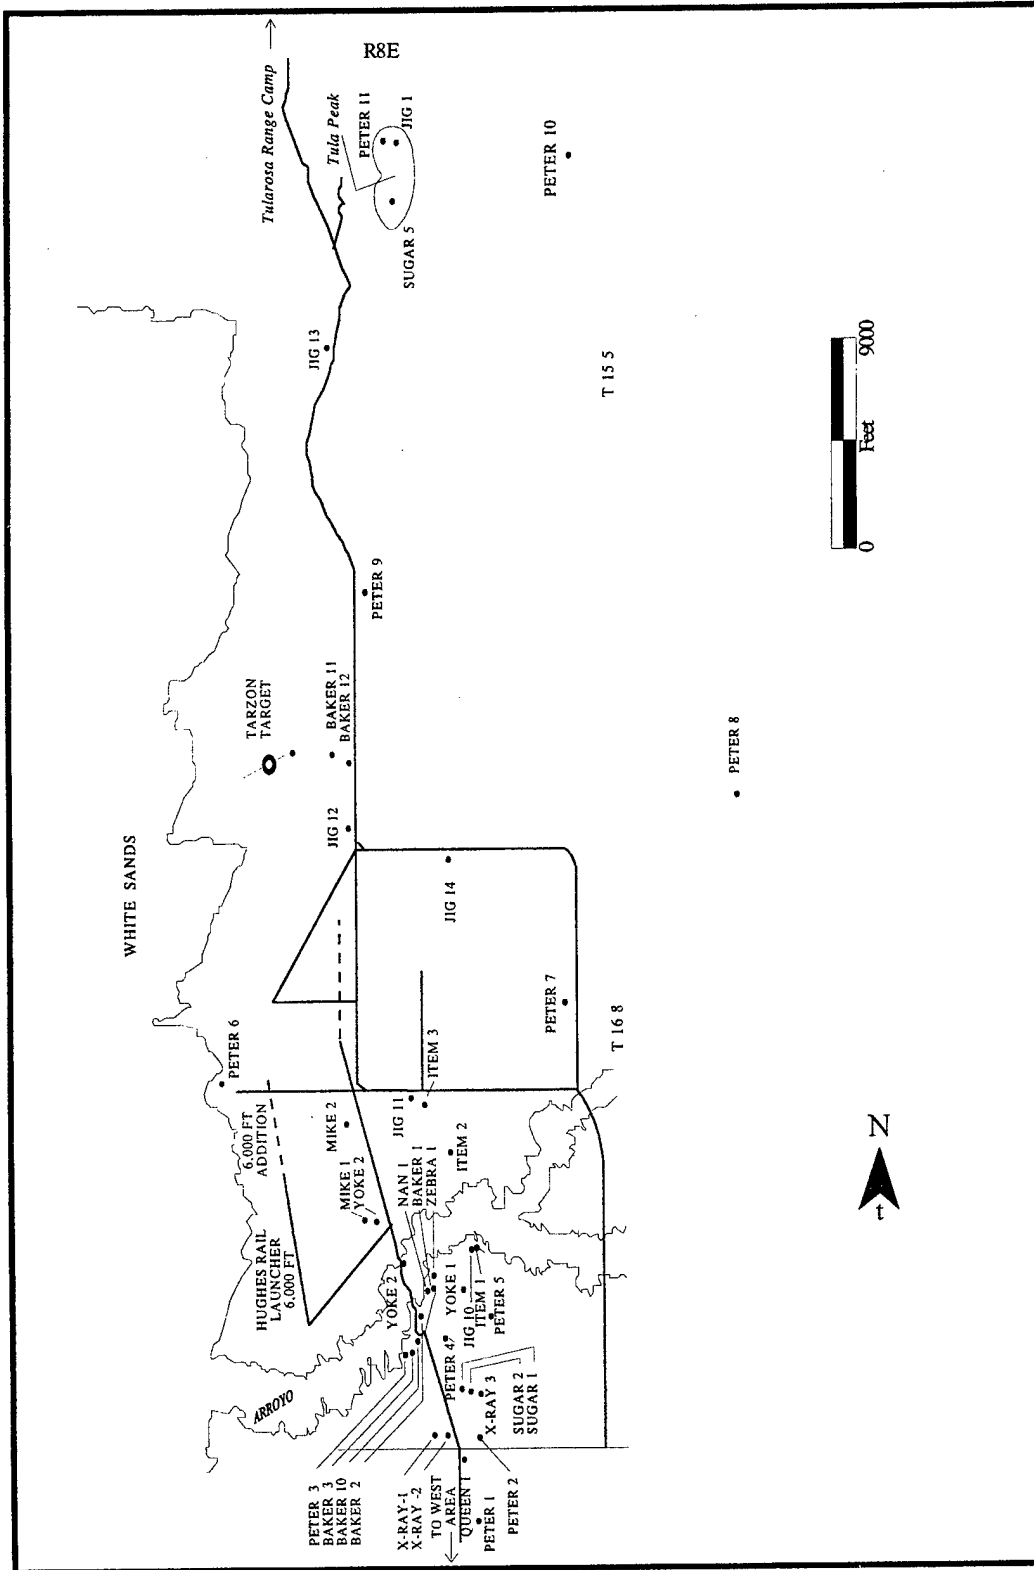
Figure 86. "Present arrangement of the optical and electronic instrumentation at HAFB", ca. 1949 (adapted from Holloman Air Development Center 1949:7).

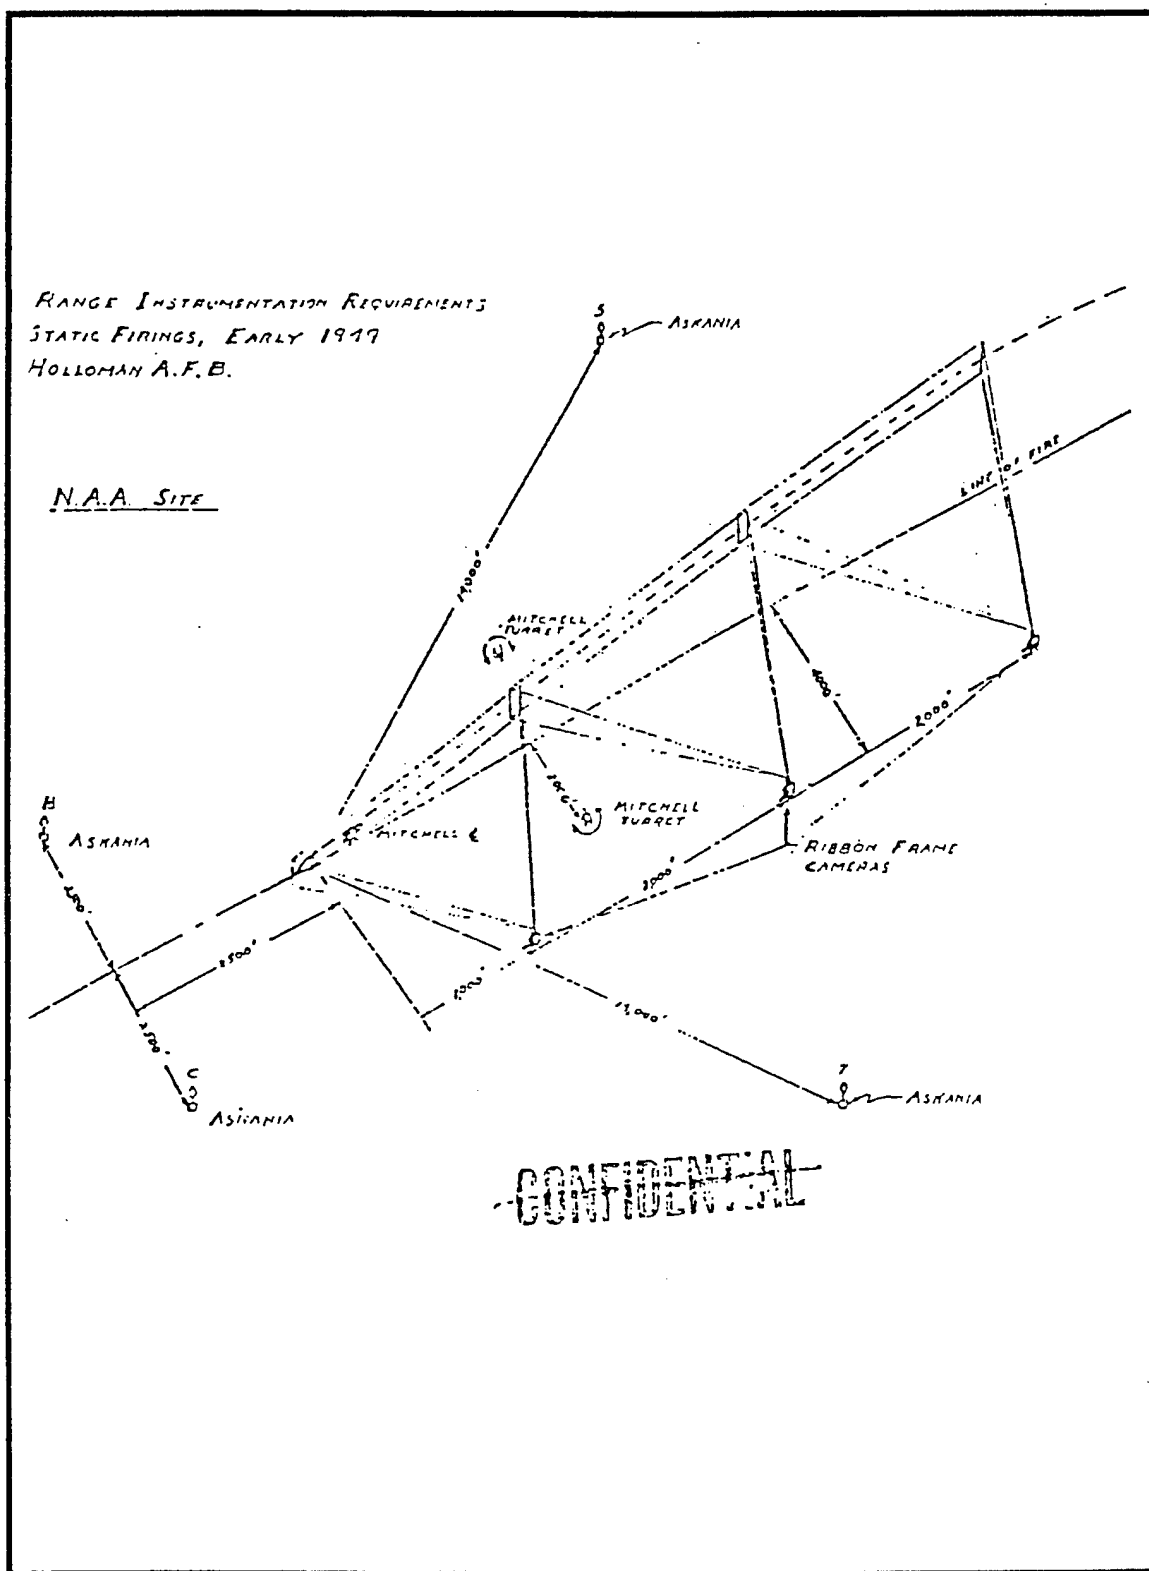
Figure 87. Typical arrangement of instrumentation at HAFB: range requirements for the Nativ program, ca. 1947 (Ramo 1948).

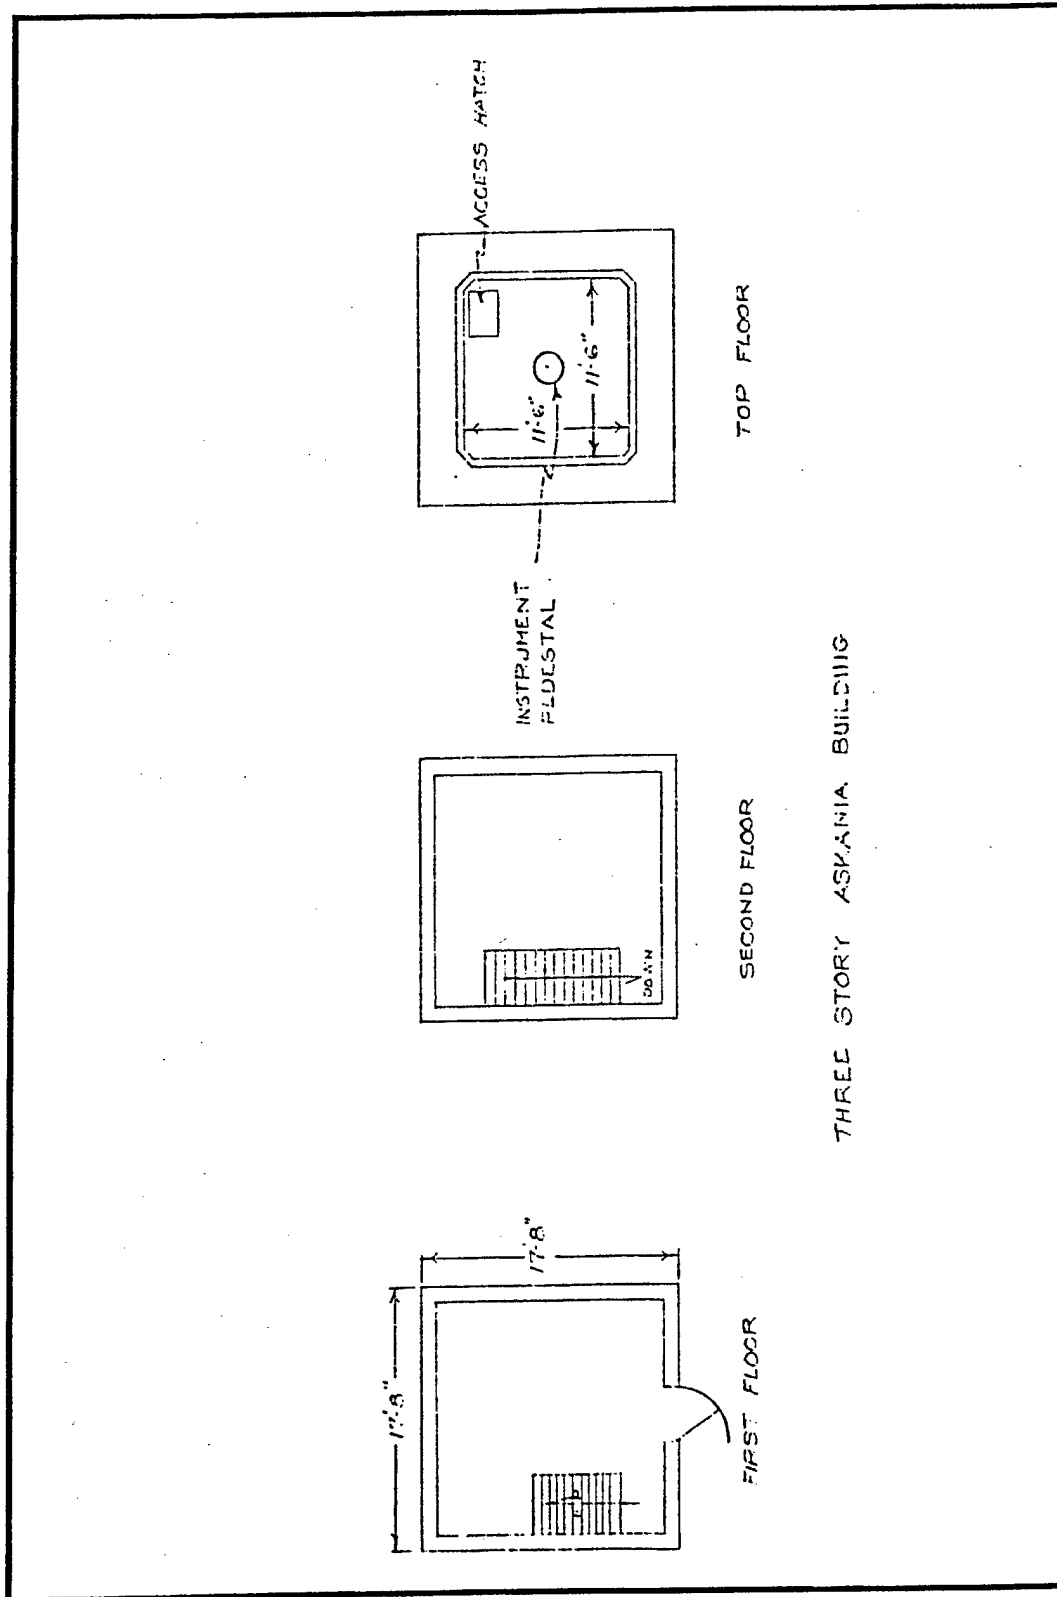
Figure 90. Building 900 (Mart site), plan view of "three story Askania building", ca. 1964 (Dynalectron Corporation 1964).

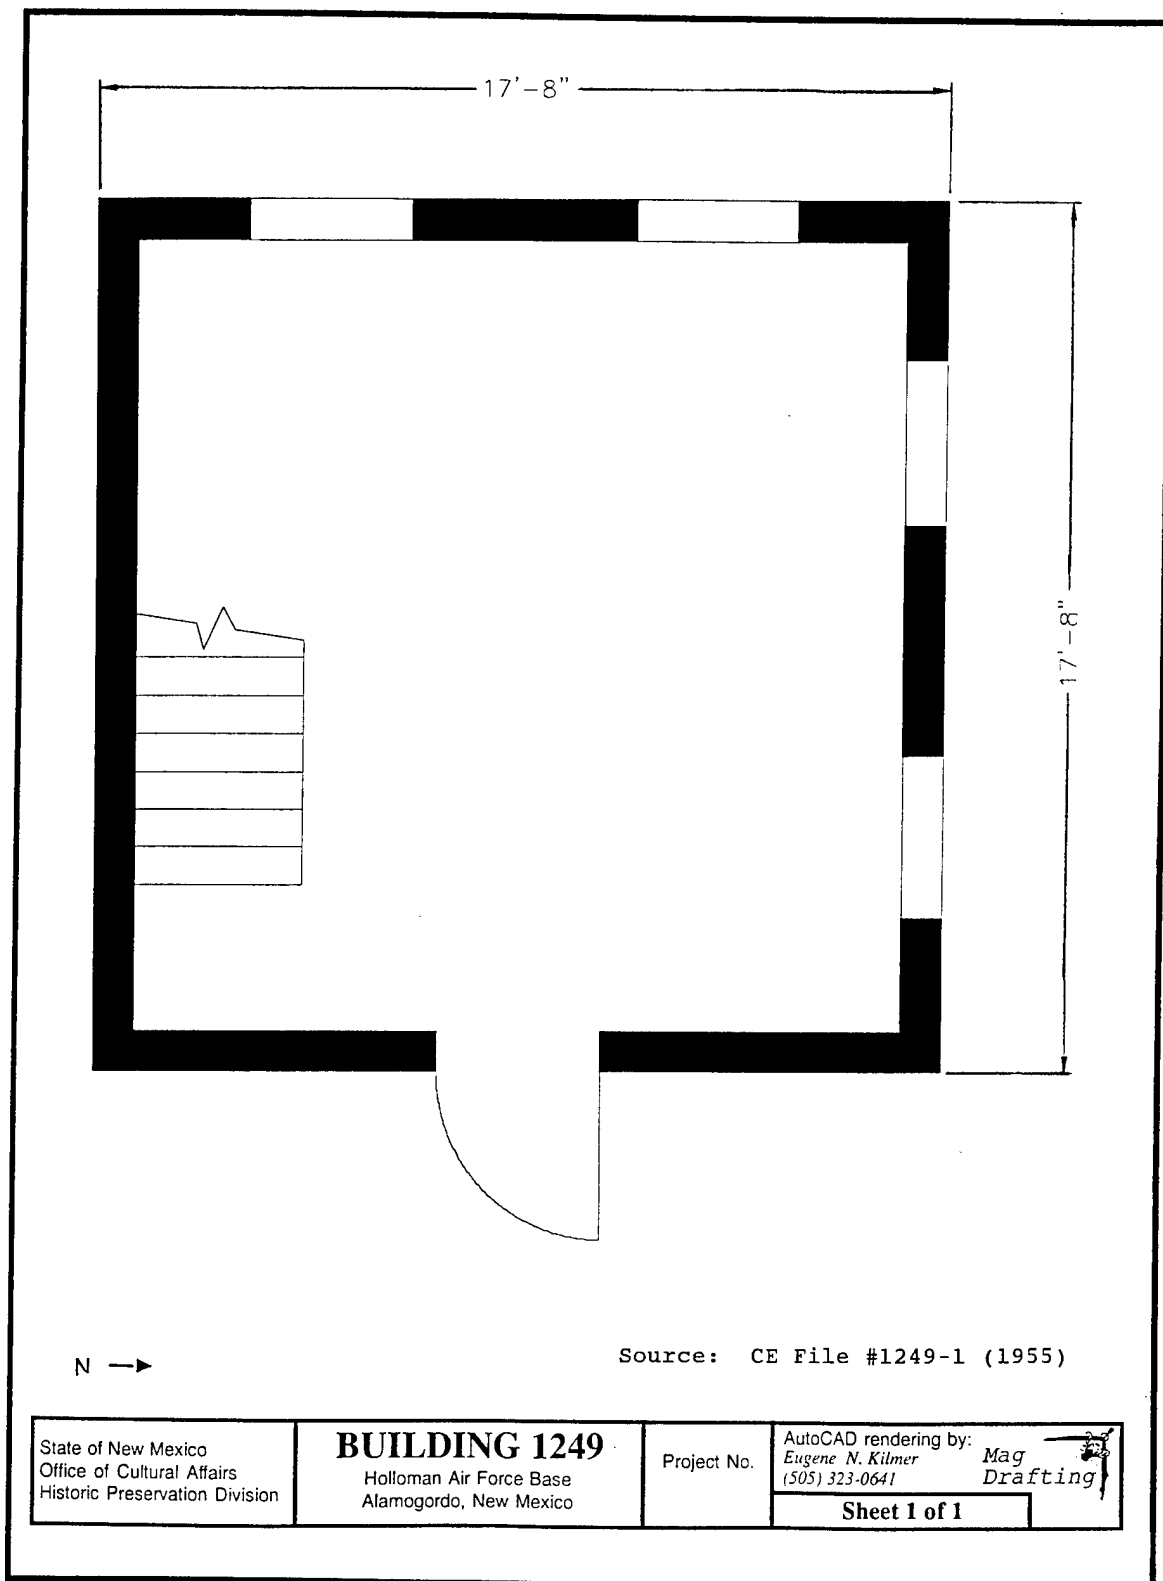
Figure 96. Building 1249, plan view of a Missile Theodolite Station, ca. 1955.

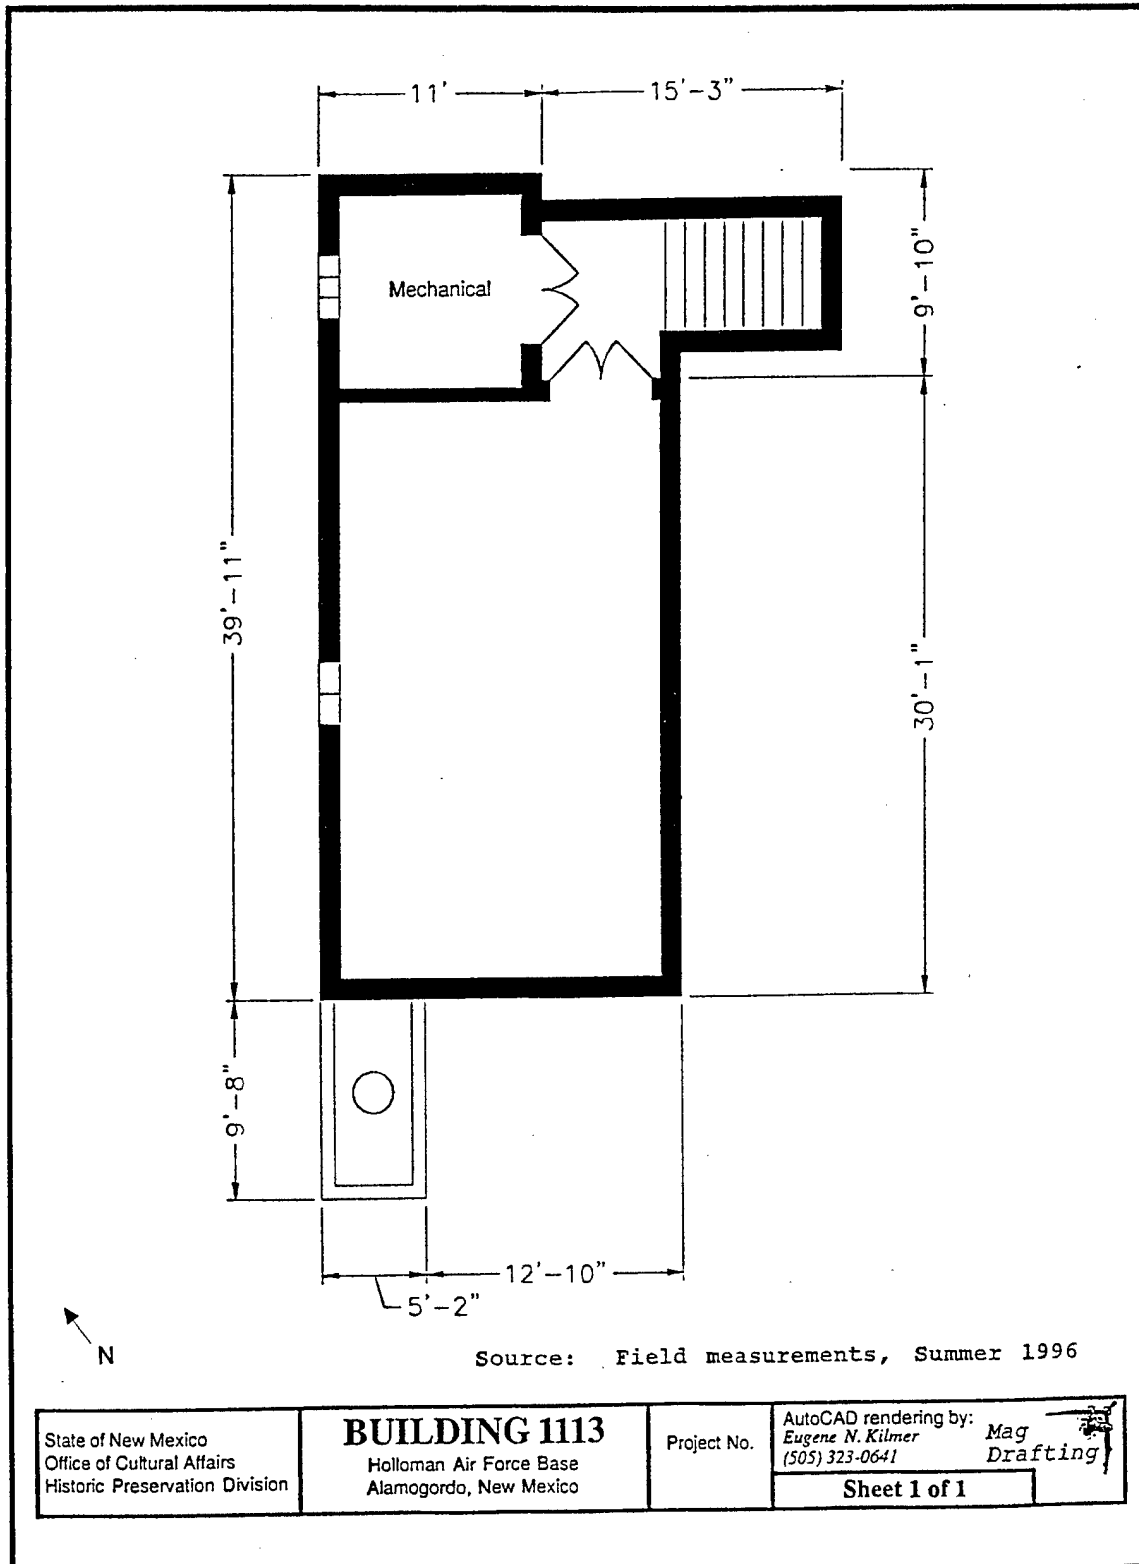
Figure 99. Building 1113, floor plan of a Timing-Communications Distribution Station, 1996.

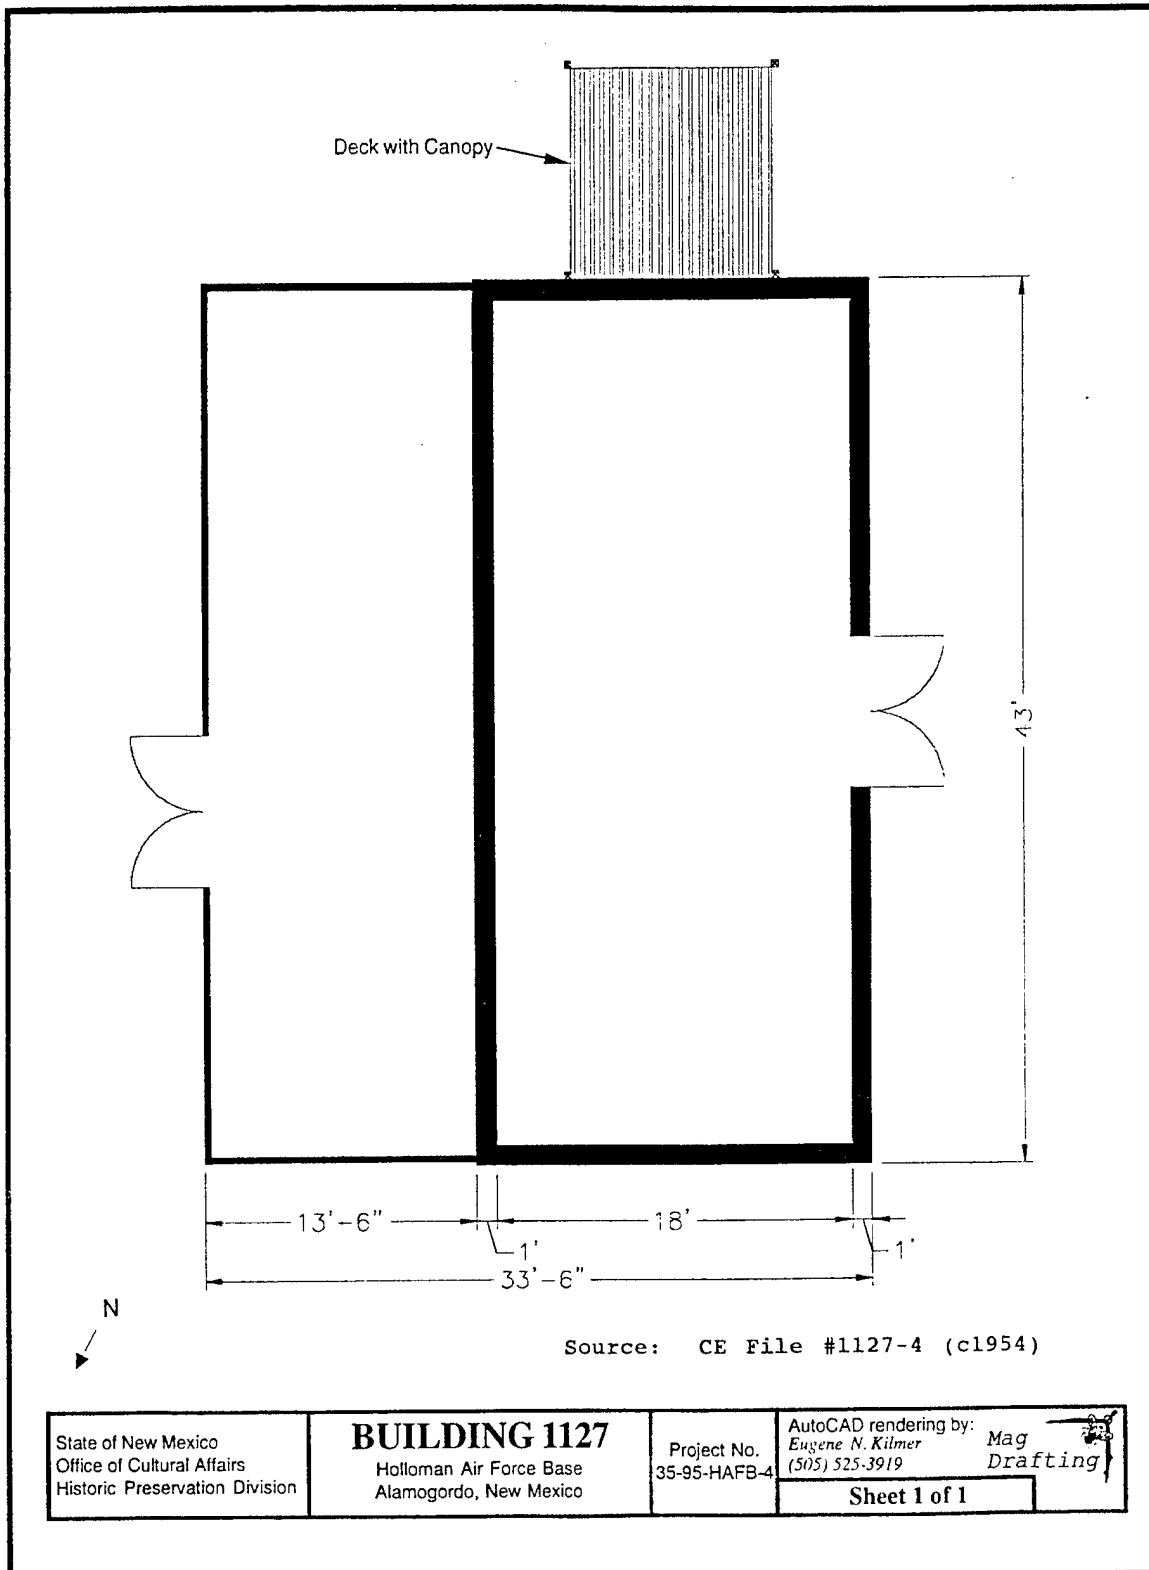
Figure 104. Building 1127, the Rocket Motor Conditioning facility, floor plan, ca. 1954.

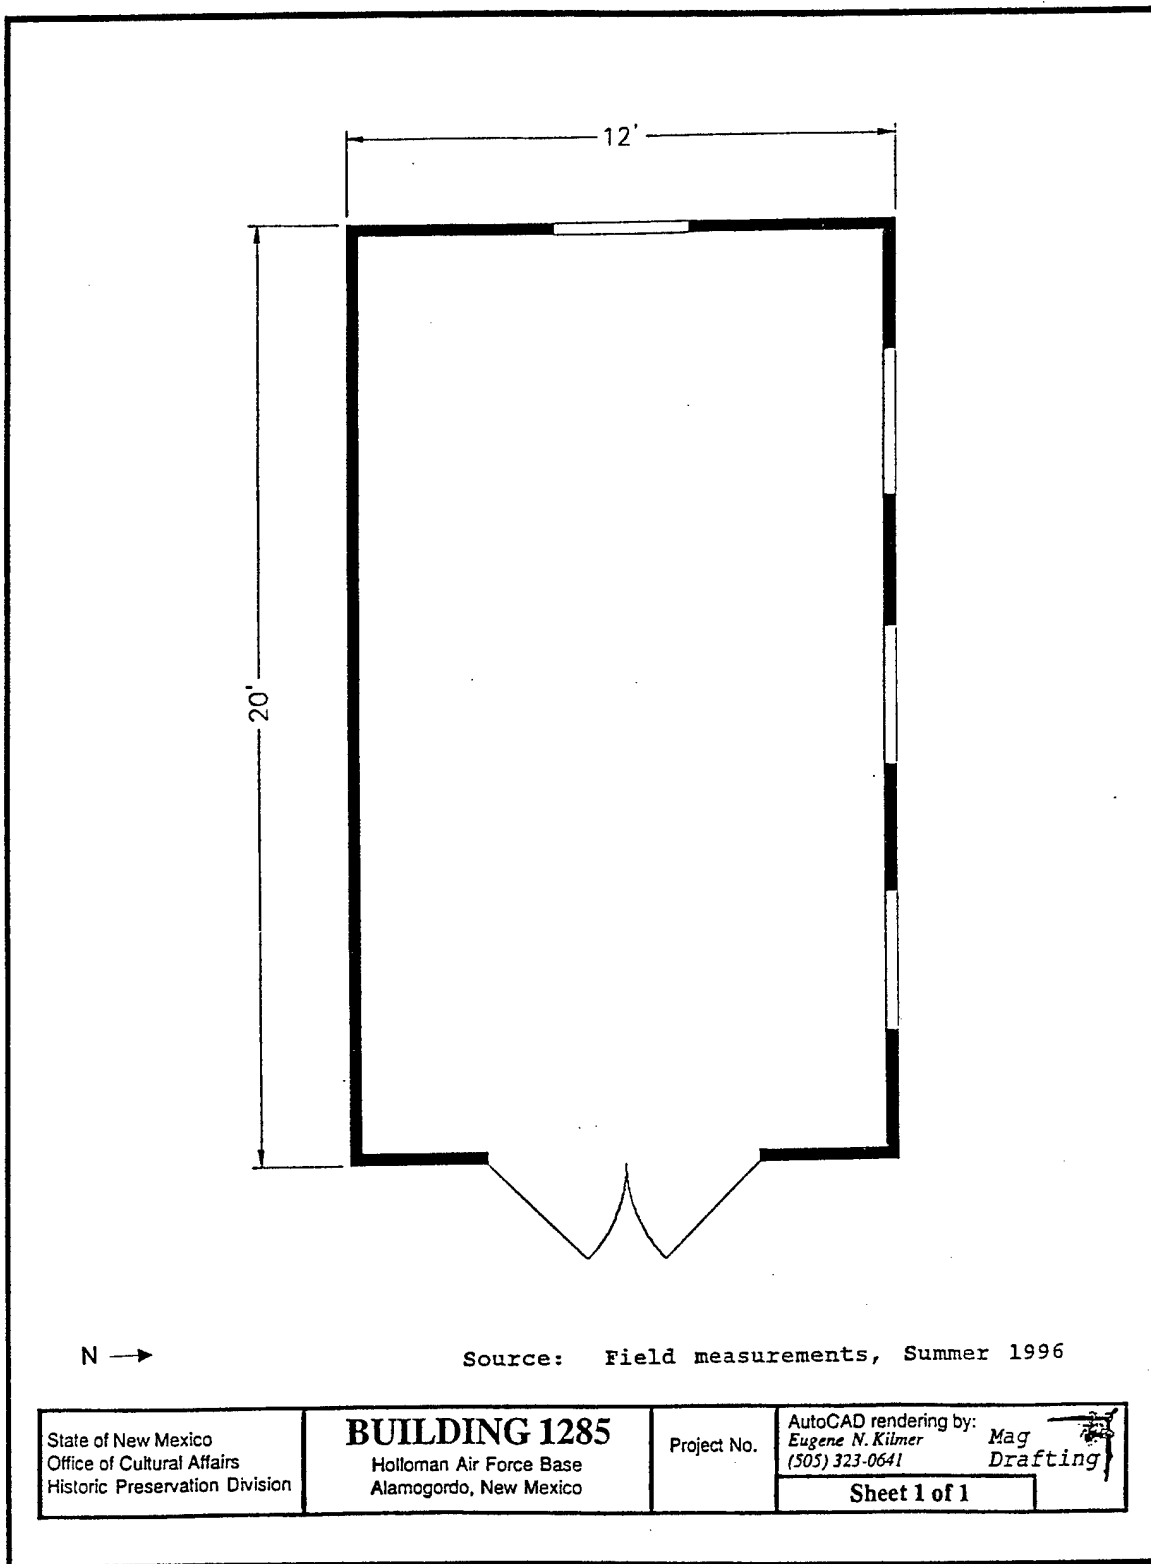
Figure 106. Building 1285, floor plan of Research Equipment Storage facility in 1996.
