"AIRPLANES, COMBAT AND MAINTENANCE CREWS, AND AIR BASES"

The World War II and Early Cold War Architectural Legacy
of Holloman Air Force Base (ca. 1942-1962)

by
Martyn D. Tagg

Holloman Air Force Base
Cultural Resources Publication No. 6

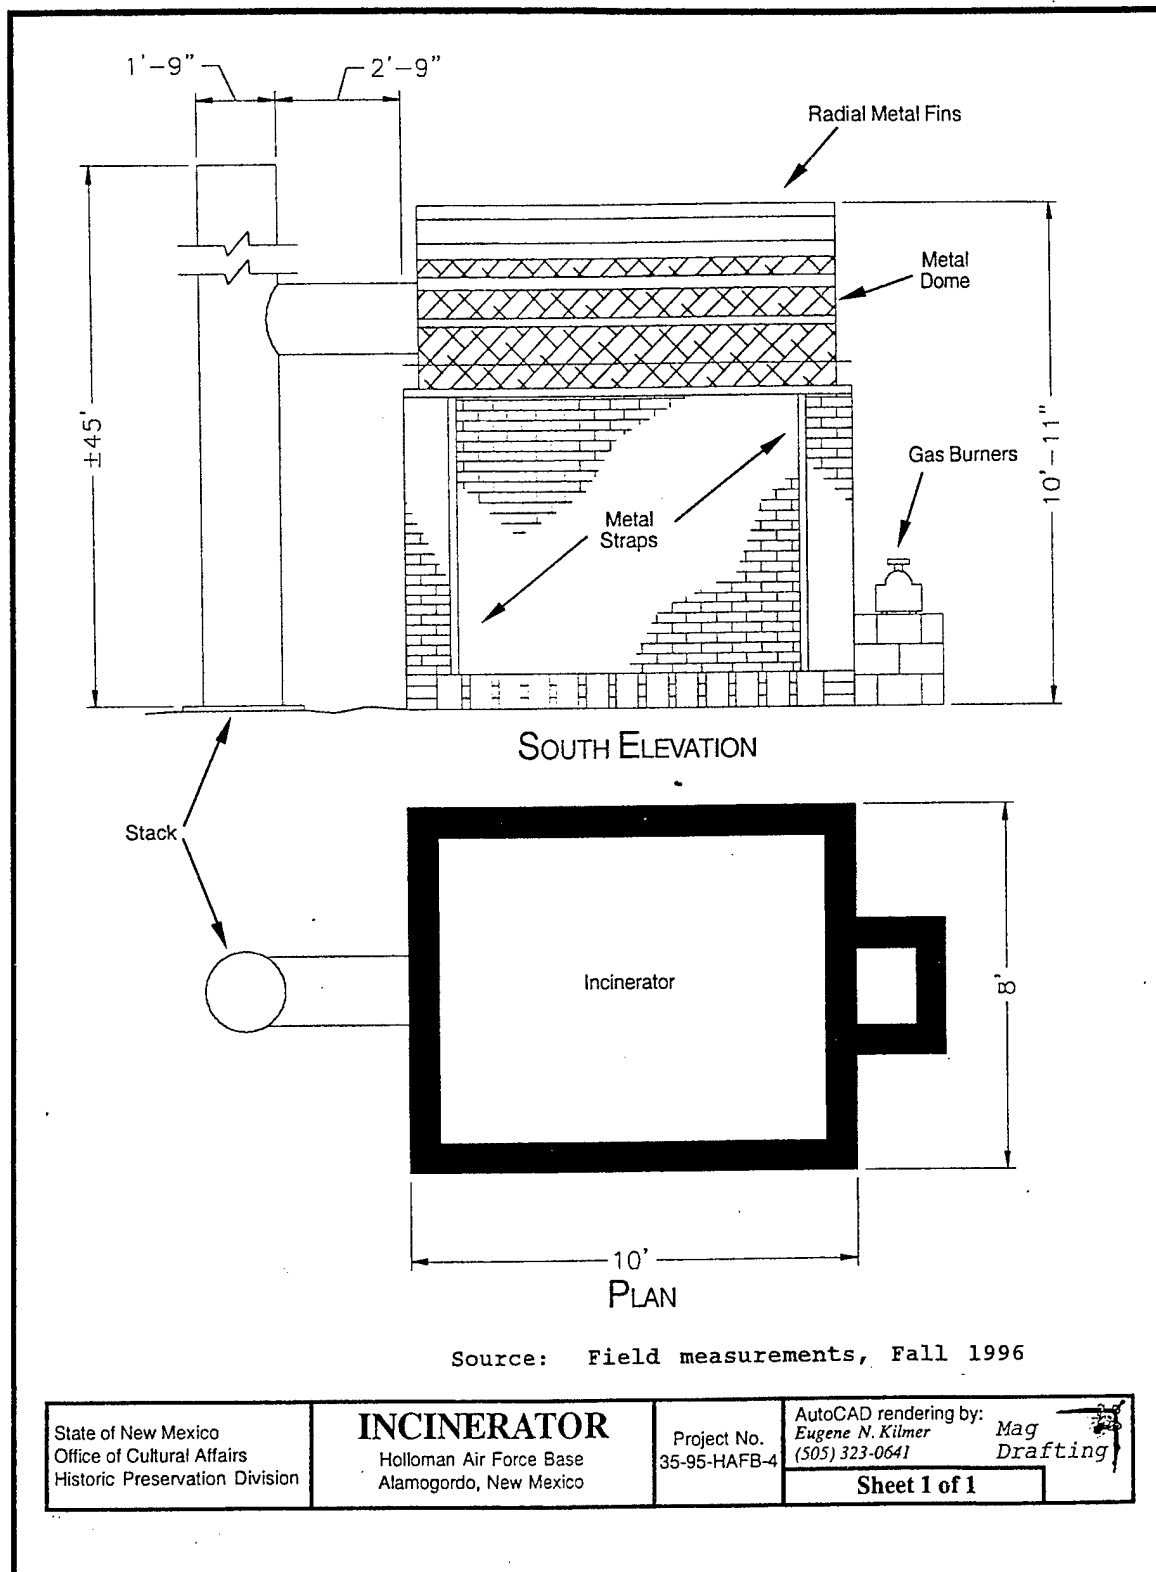
Figure 108. Incinerator, facility plan view and profile, 1996.
