⑨ BUREAU OF SHIPS GROUP
TECHNICAL INSPECTION REPORT

⑥ OPERATION CROSERoad.
FAILURES OF MASTS, YARDARMS,
BOOMS AND RIGGING E.U.J.

JOINT TASK FORCE ONE

FAILURES OF MASTS, YARDARMS, BOOMS, AND RIGGING

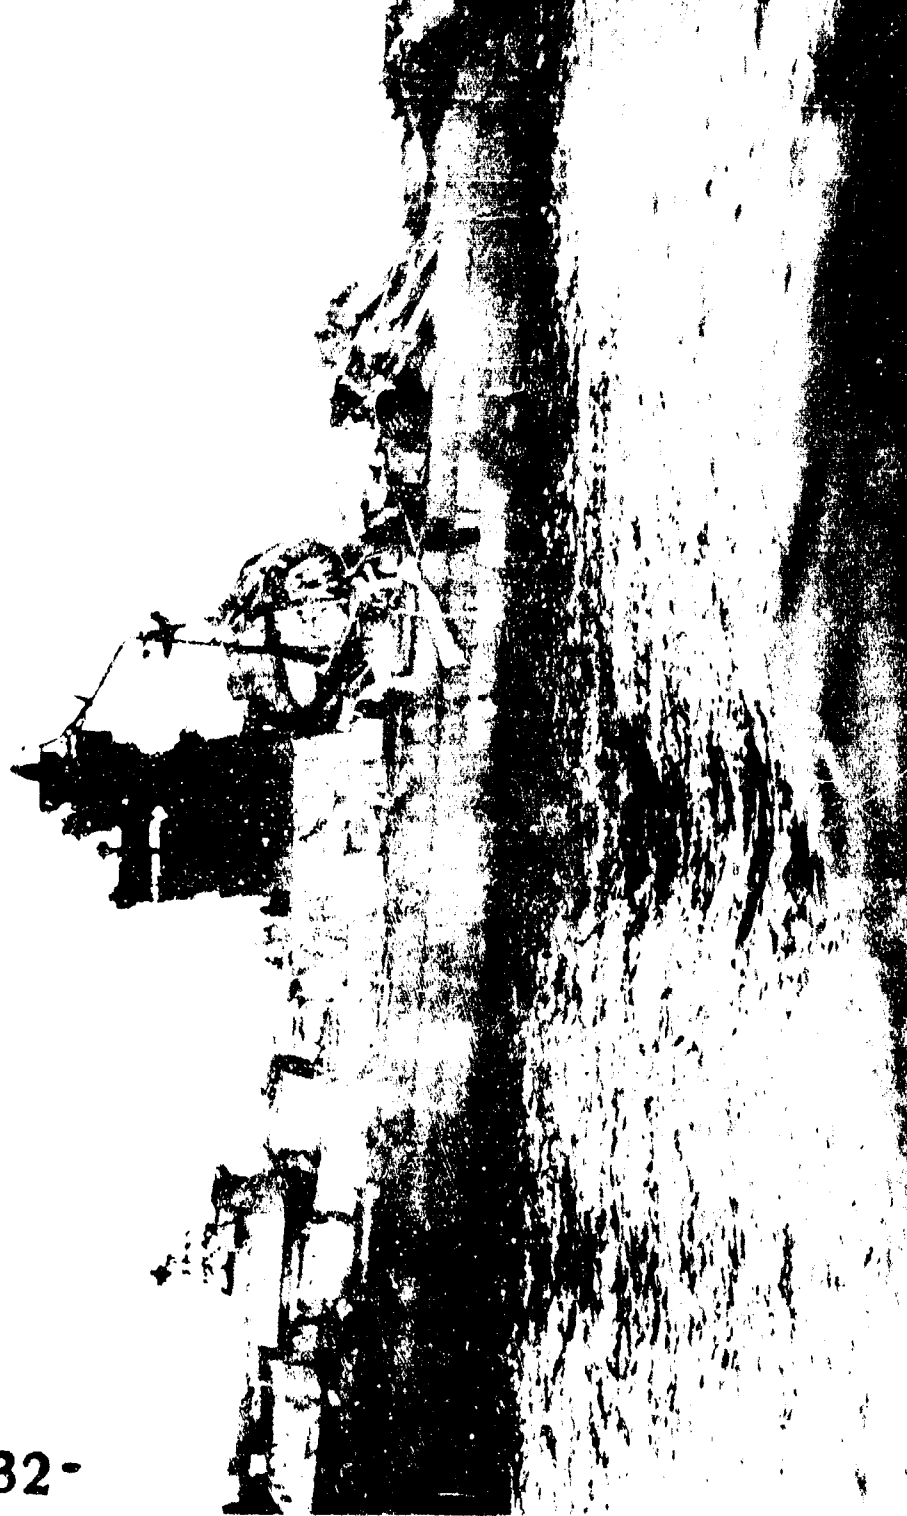
AA-CR-62-1832-

AA-CR-62-1832-4. SAKAWA (Ex-Jap Cruiser). View looking at port beam after Test A. Note that forward superstructure leans forward as does foremast and tripod. Note flattening of superstructure aft of forward tripod.

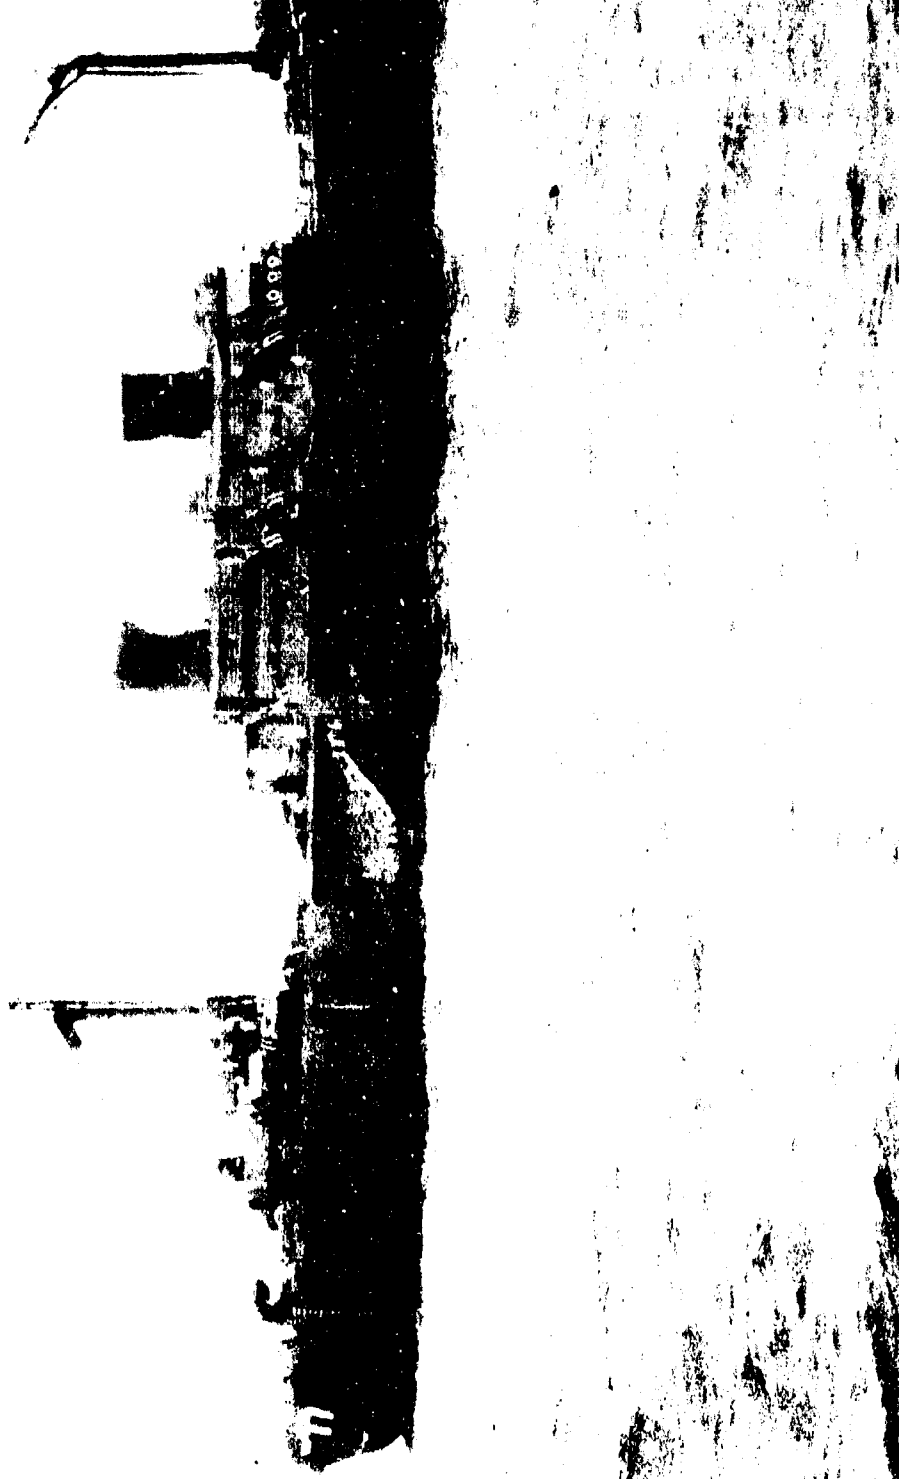
3. The maintopmast is bent about 110 degrees out of its normal vertical position and in the direction of the blast travel. See photos 227-49-116, 1906-9, 1906-12 and 1921-12; pages 26 , 37, 38 , and 39 . The bend occurs just above the crosstree level and, as in the case of the foremast, the mast is fractured at the bend. The mainmast cargo booms, which were stowed in clamps along the mast, are useless due to their severe deformation. Photos 1922-2 and 1905-11; pages 40 and 41 show severe kinking of the starboard boom about 10 feet above the hinge pin. The port boom is bent in an easy curve.

AB-CR-227-49-116. USS CRITTENDEN (APA77). View looking at starboard beam after Test A.

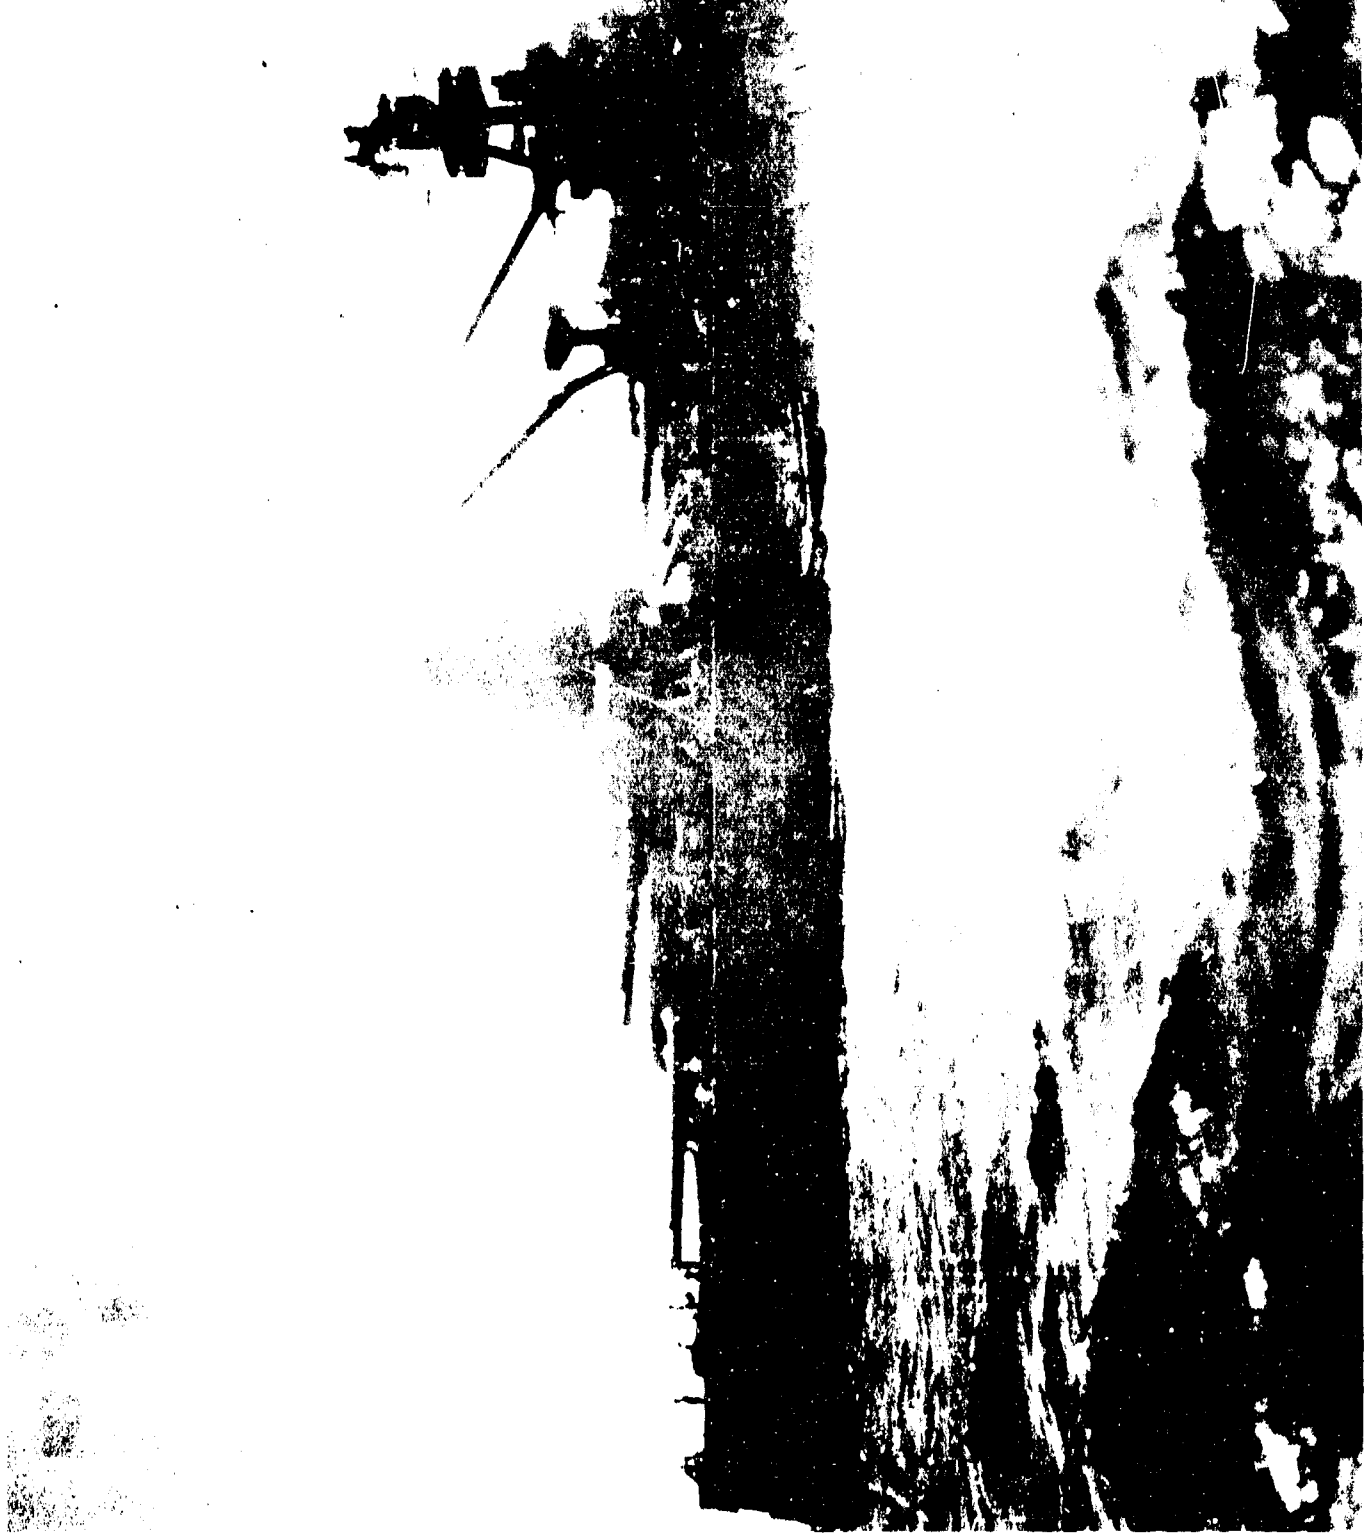
1. Photos 196-166-30, 33, 34, and 227-91-40, 42 and 45; pages 48, 49, 50, 51, 52, and 53 inclusive; are for comparative purposes. All life lines, which were not protected by structure, were blown away. Life line stanchions are distorted and about half are missing. The jack staff, beginning about 6 feet above the deck, is bent about 30 degrees out of the vertical and in the direction of the blast wave, which was about 135 degrees relative. The 8 inch diameter SG radar pole mast collapsed about 4 feet above the main radar platform, and is bent forward and about 45 degrees to port. The change in vertical position is about 100 degrees, so that the pole rests on the port side of the 5 inch diameter pipe yard arm at the SK radar platform level. There is no discernible fracture in the pole. The port yardarm is bent and distorted as a result of the pole mast having hit it, and the yardarm clamps loosened allowing the arm to slide about 6 inches to port. The marked bend of the pole is due to the inability of the collapsed pipe section to support the offset weight which resulted from the initial bending caused by the blast. The starboard wing of the SK radar plot frame is bent up about 40 degrees from normal. The overhead of the director station at the 07 level is supported by pilasters, all of which were bent in the direction of the blast. The 15 inch pole mast, which supports this director station, is bent smoothly in a direction of about 300 degrees relative and about 20 degrees out of the vertical. Photos 2091-3, 2094-1, and 3; pages 54, 55, and 56 are views of the conditions in this area. The photographs show the rigging is still connected. Below the 06 level, there are two areas of damage to the foremast tripod, both of which are just below the rangefinder platform, one port and one starboard. Here, as shown in photos 2094-7, 8, 9, 10; 1783-1, 2 and 2135-3; pages 57, 58, 59, 60, 61, 62, and 63, the blast wave acted on the overhang of the platform with sufficient force to pull these brackets out of the tripod legs. There is no perceptible deformation of the tripod legs. No damage to the deck connections at the foot of the legs or to any of the tripod supports is observable.

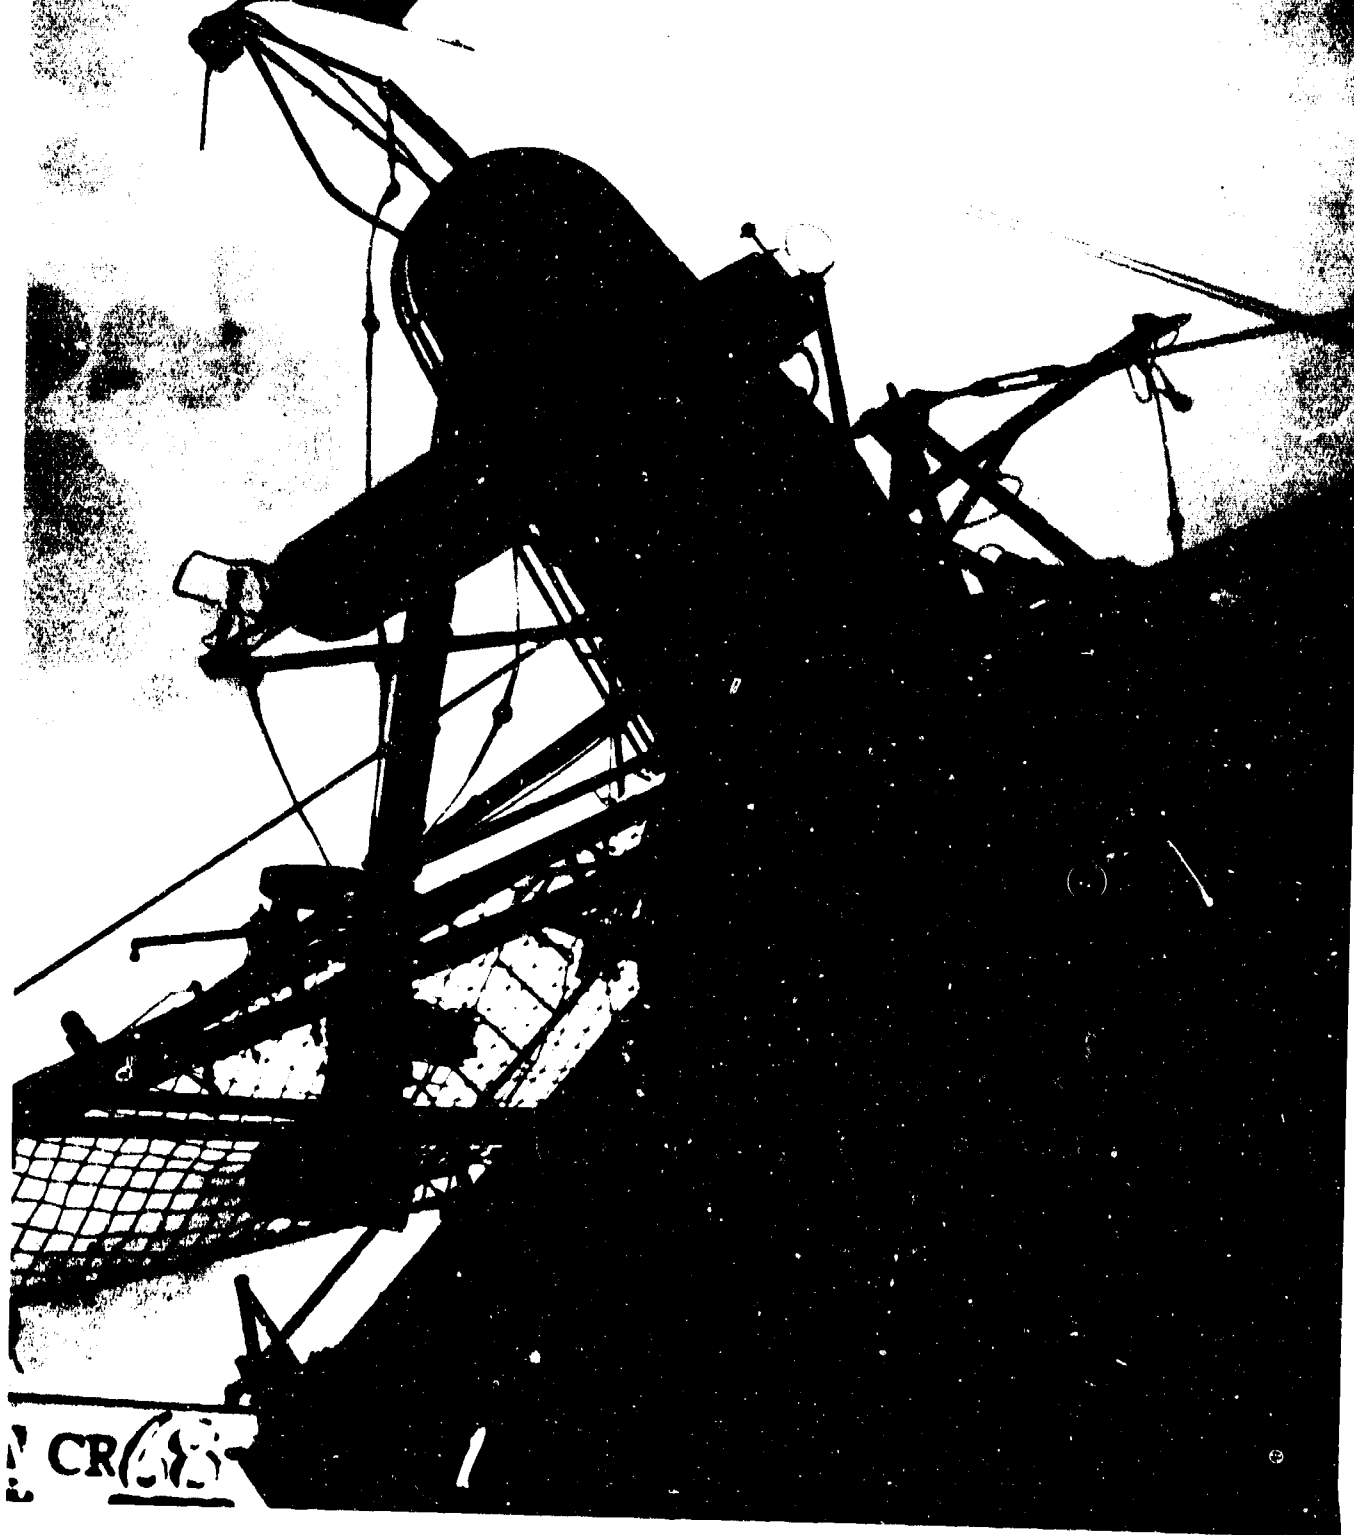
AA-CR-68-2094-1. USS ARKANSAS (BB33). Forward yardarms, SK radar pole and platform.

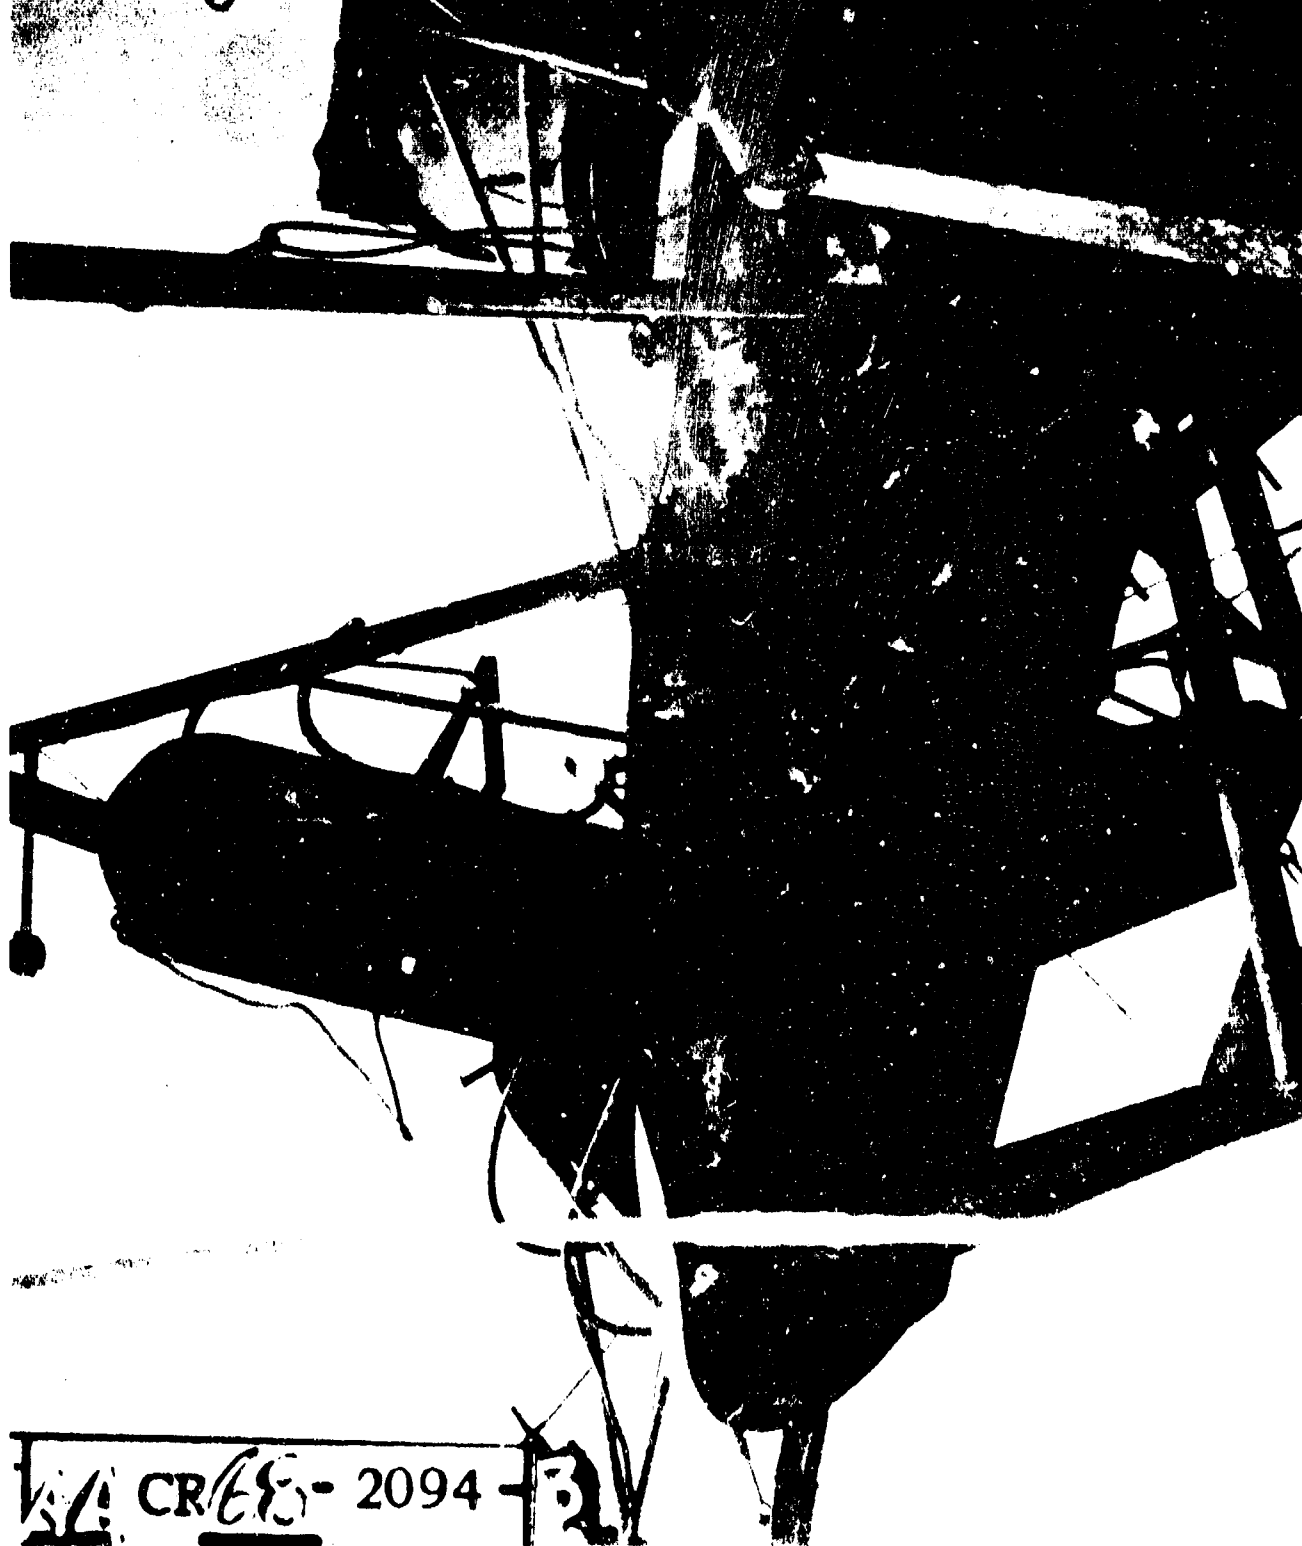
AA-CR-68-2094-3. USS ARKANSAS (BB33). SK radar platform and forward tripod showing deformation of starboard wing. Note that struts appear unaffected.

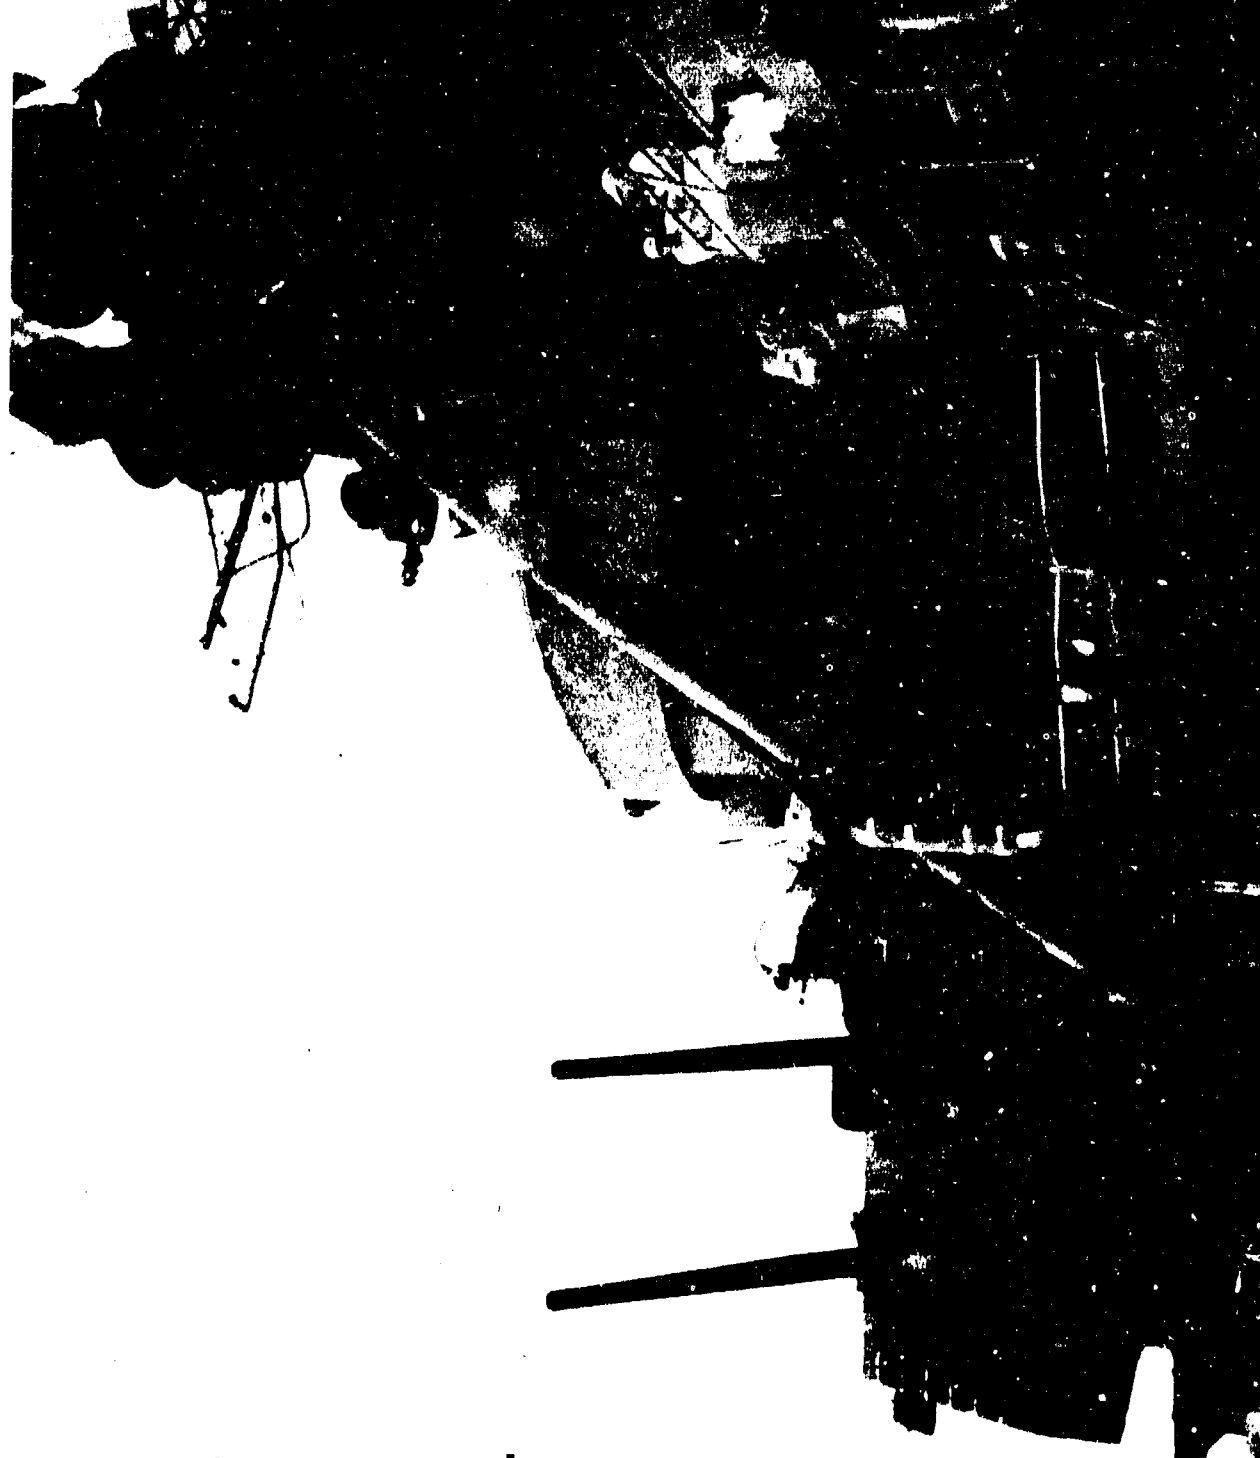
AA CR80-1900-| 5

AA-CR-80-1900-5. USS NEVADA (BB36). View, port side, looking forward at boat boom, frame 86.

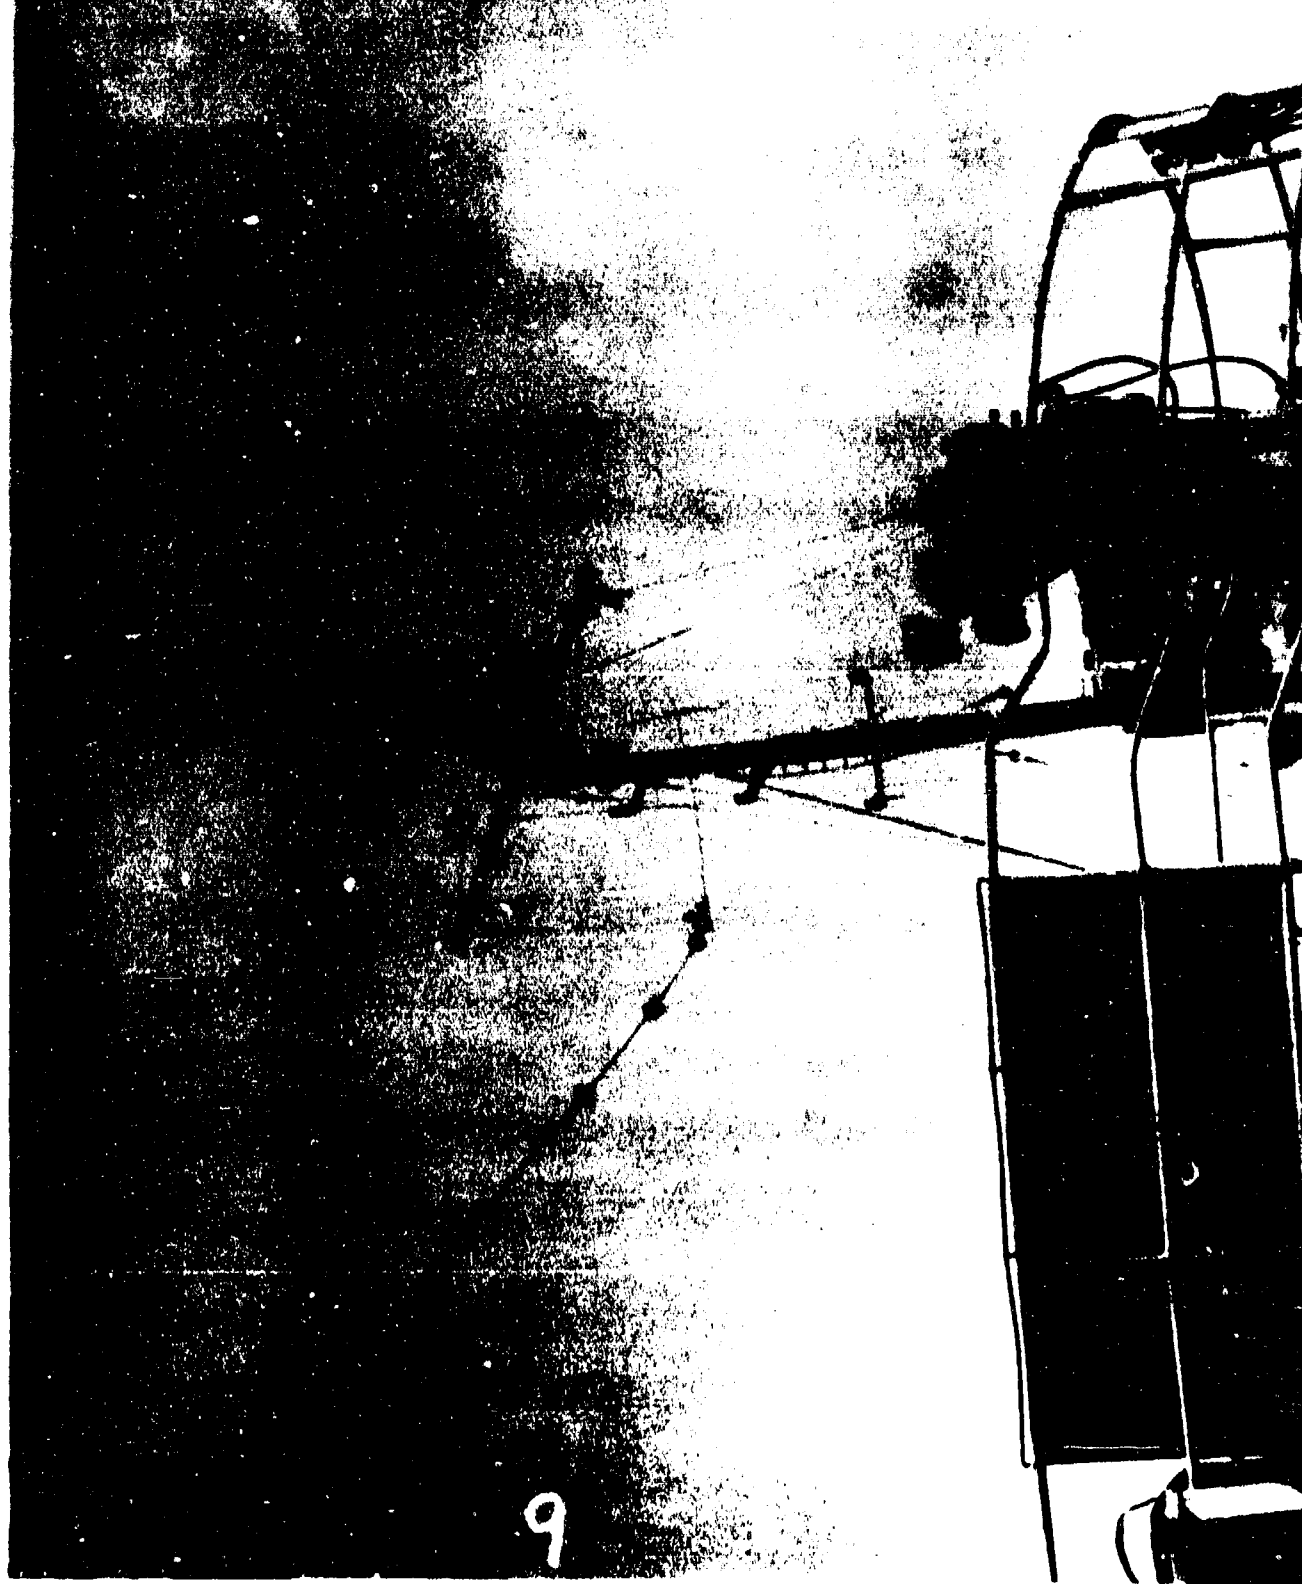
AA-CR-100-2200-9. U.S.S. RHIND (DD404). Foremast from frame 133.

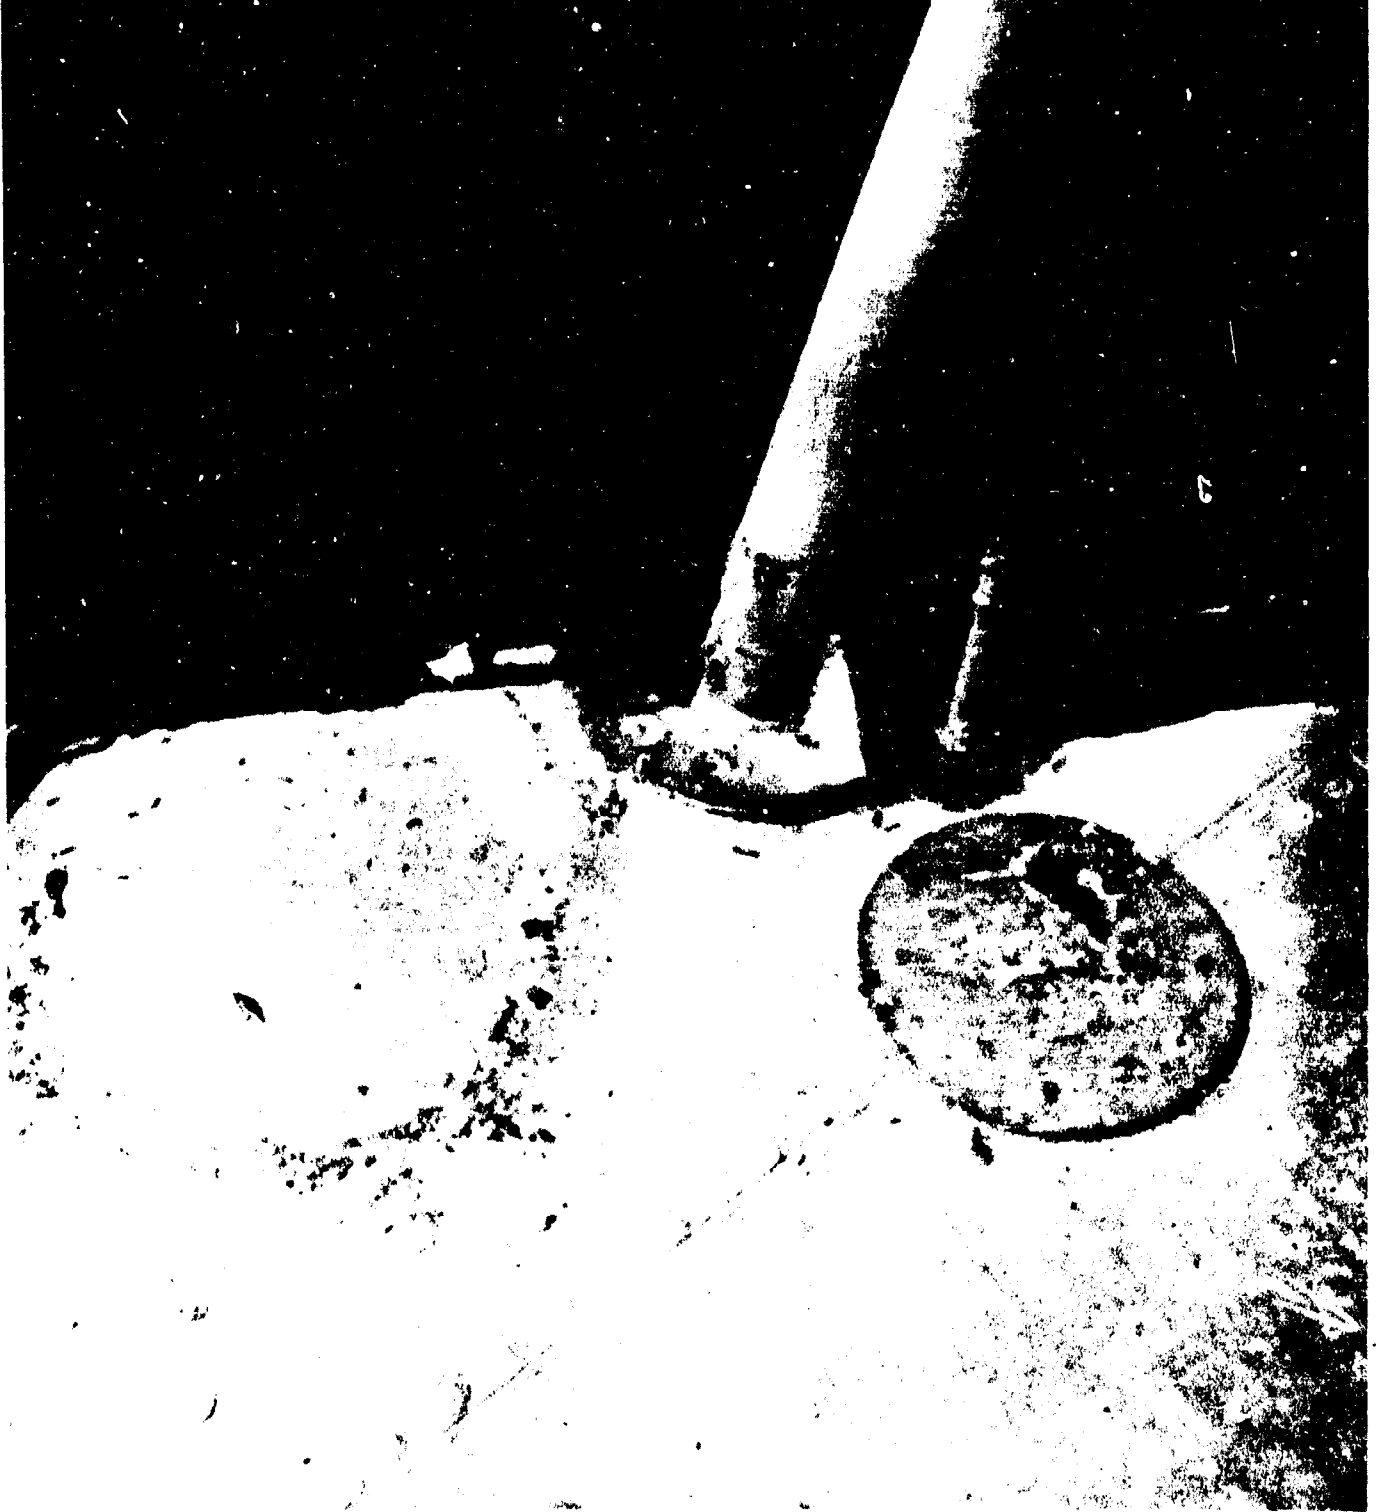
AA-CR-100-2200-7. U.S.S. RHIND (DD404). Base of after strut to after tripod.

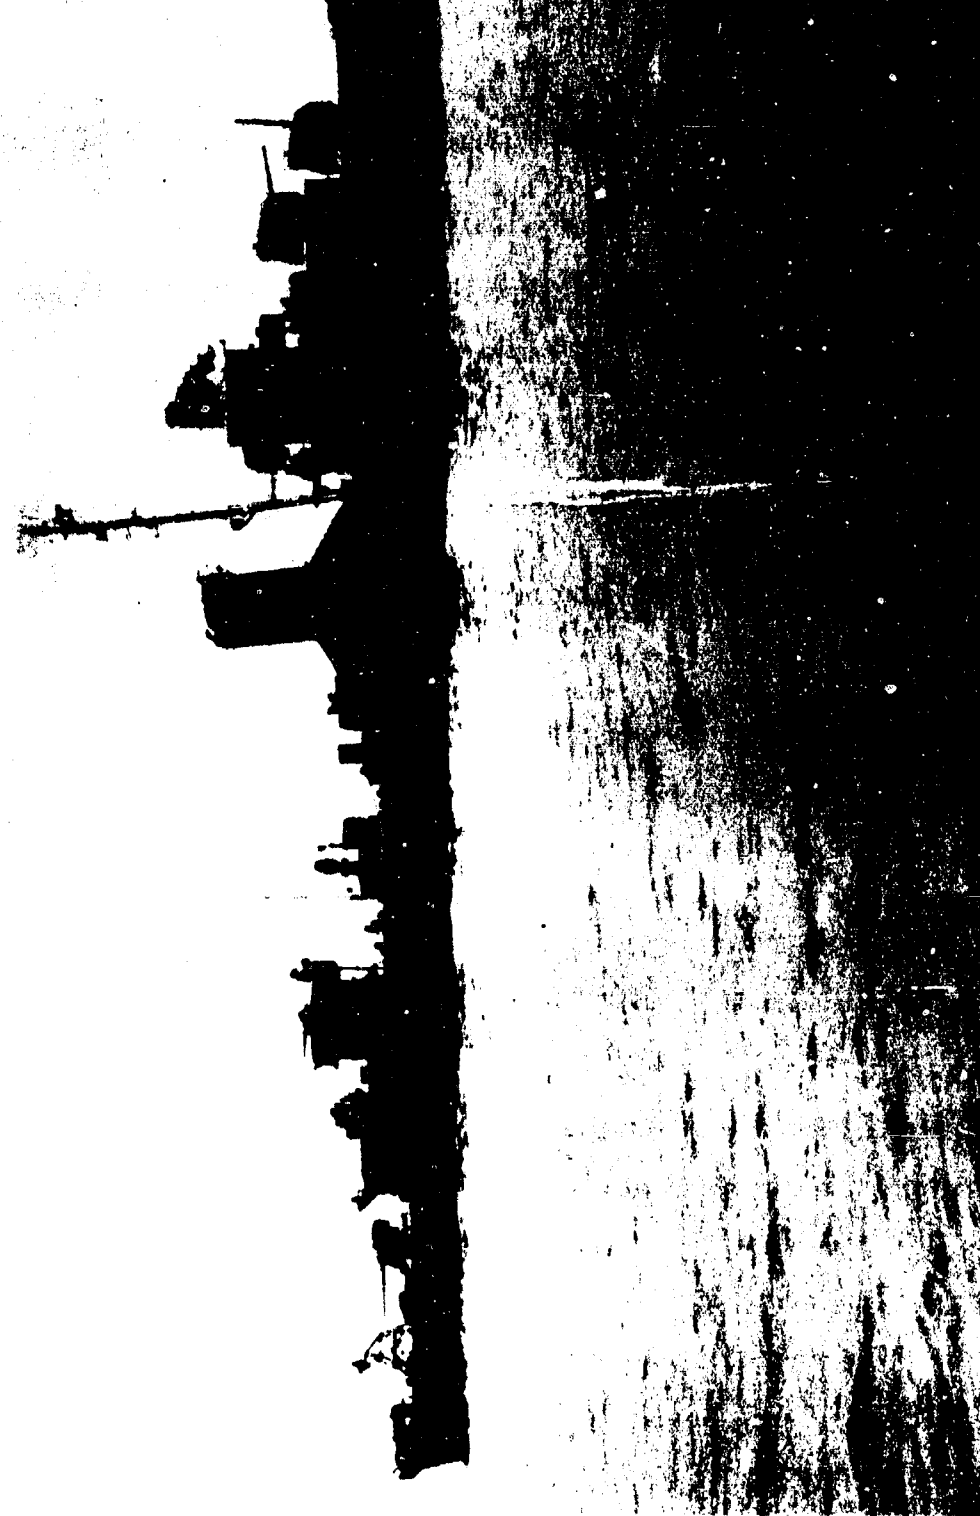
AB-CR-227-243-24. U.S.S. RALPH TALBOT (DD390). Starboard beam
after Test Baker.

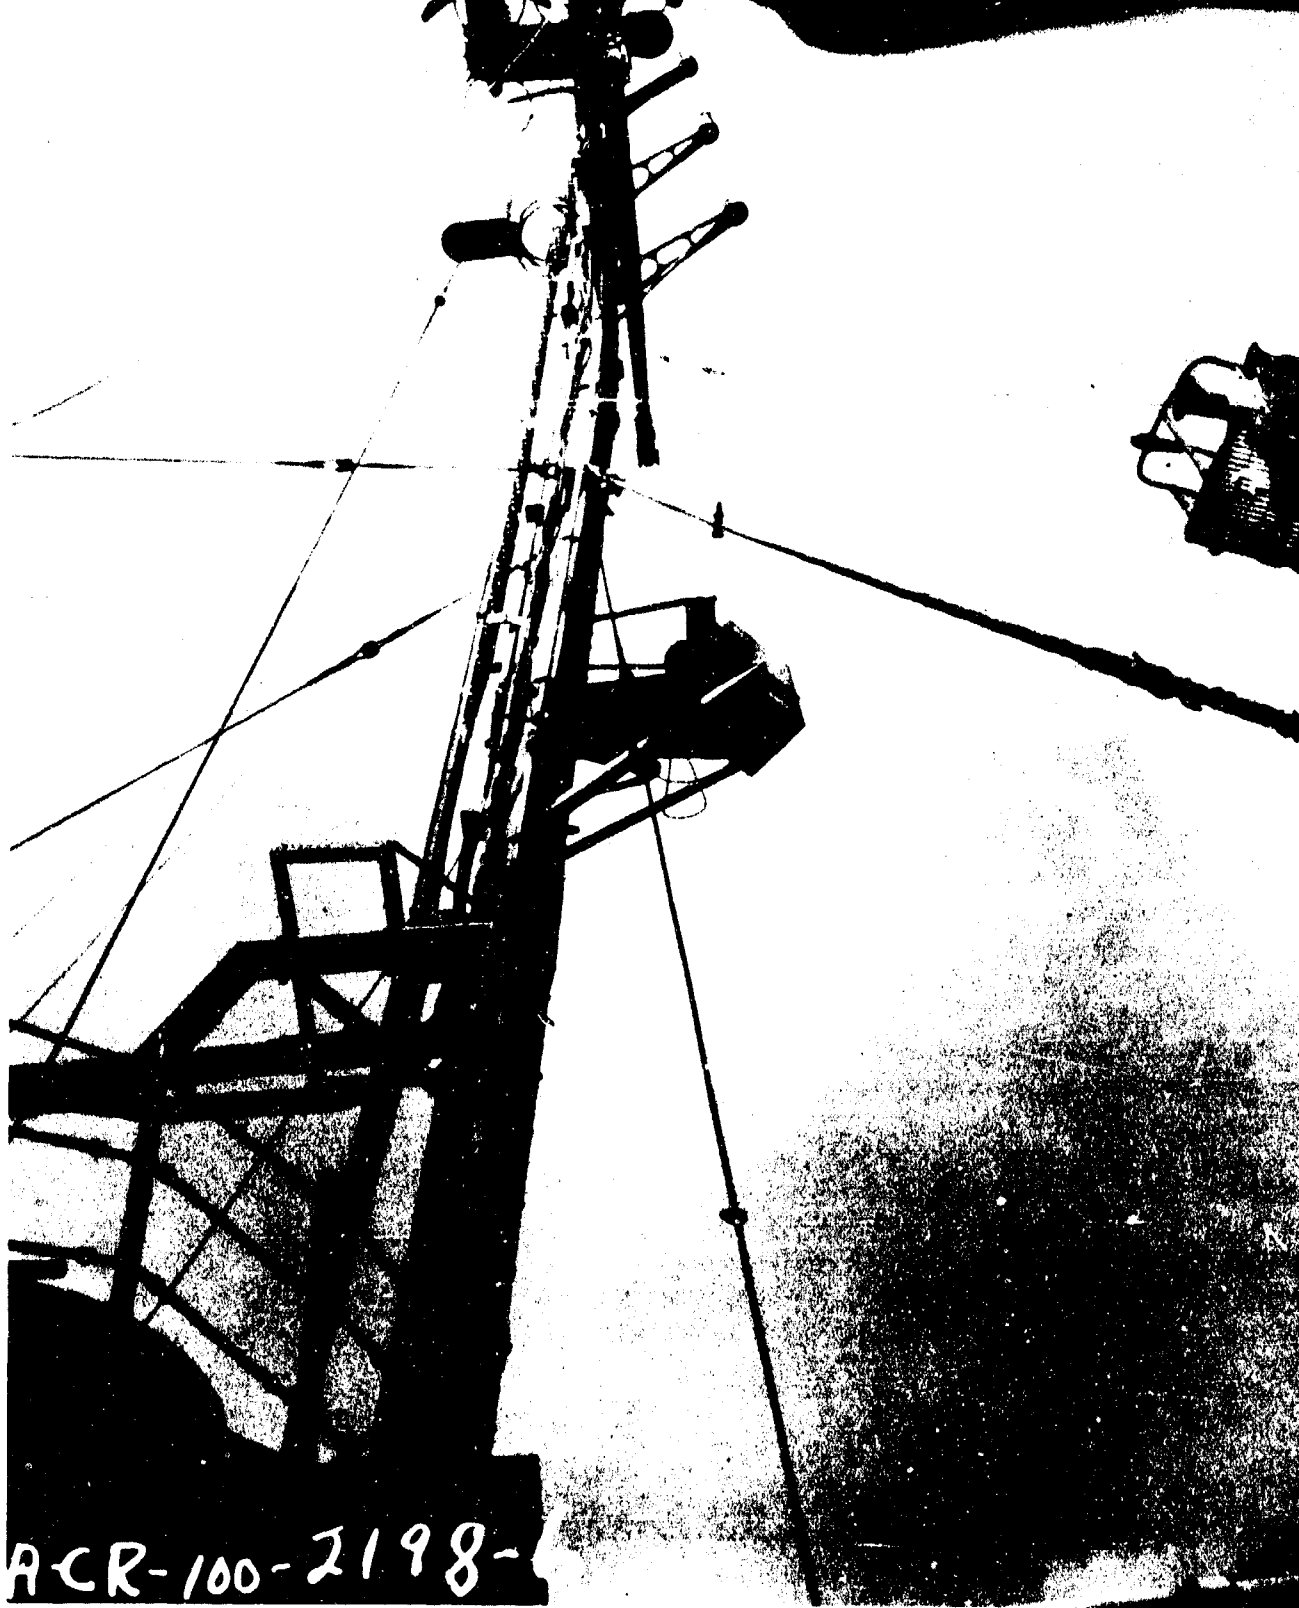
AA-CR-100-2198-6

AA-CR-100-2198-6. U.S.S. RALPH TALBOT (DD390). View looking up foremast from port side.

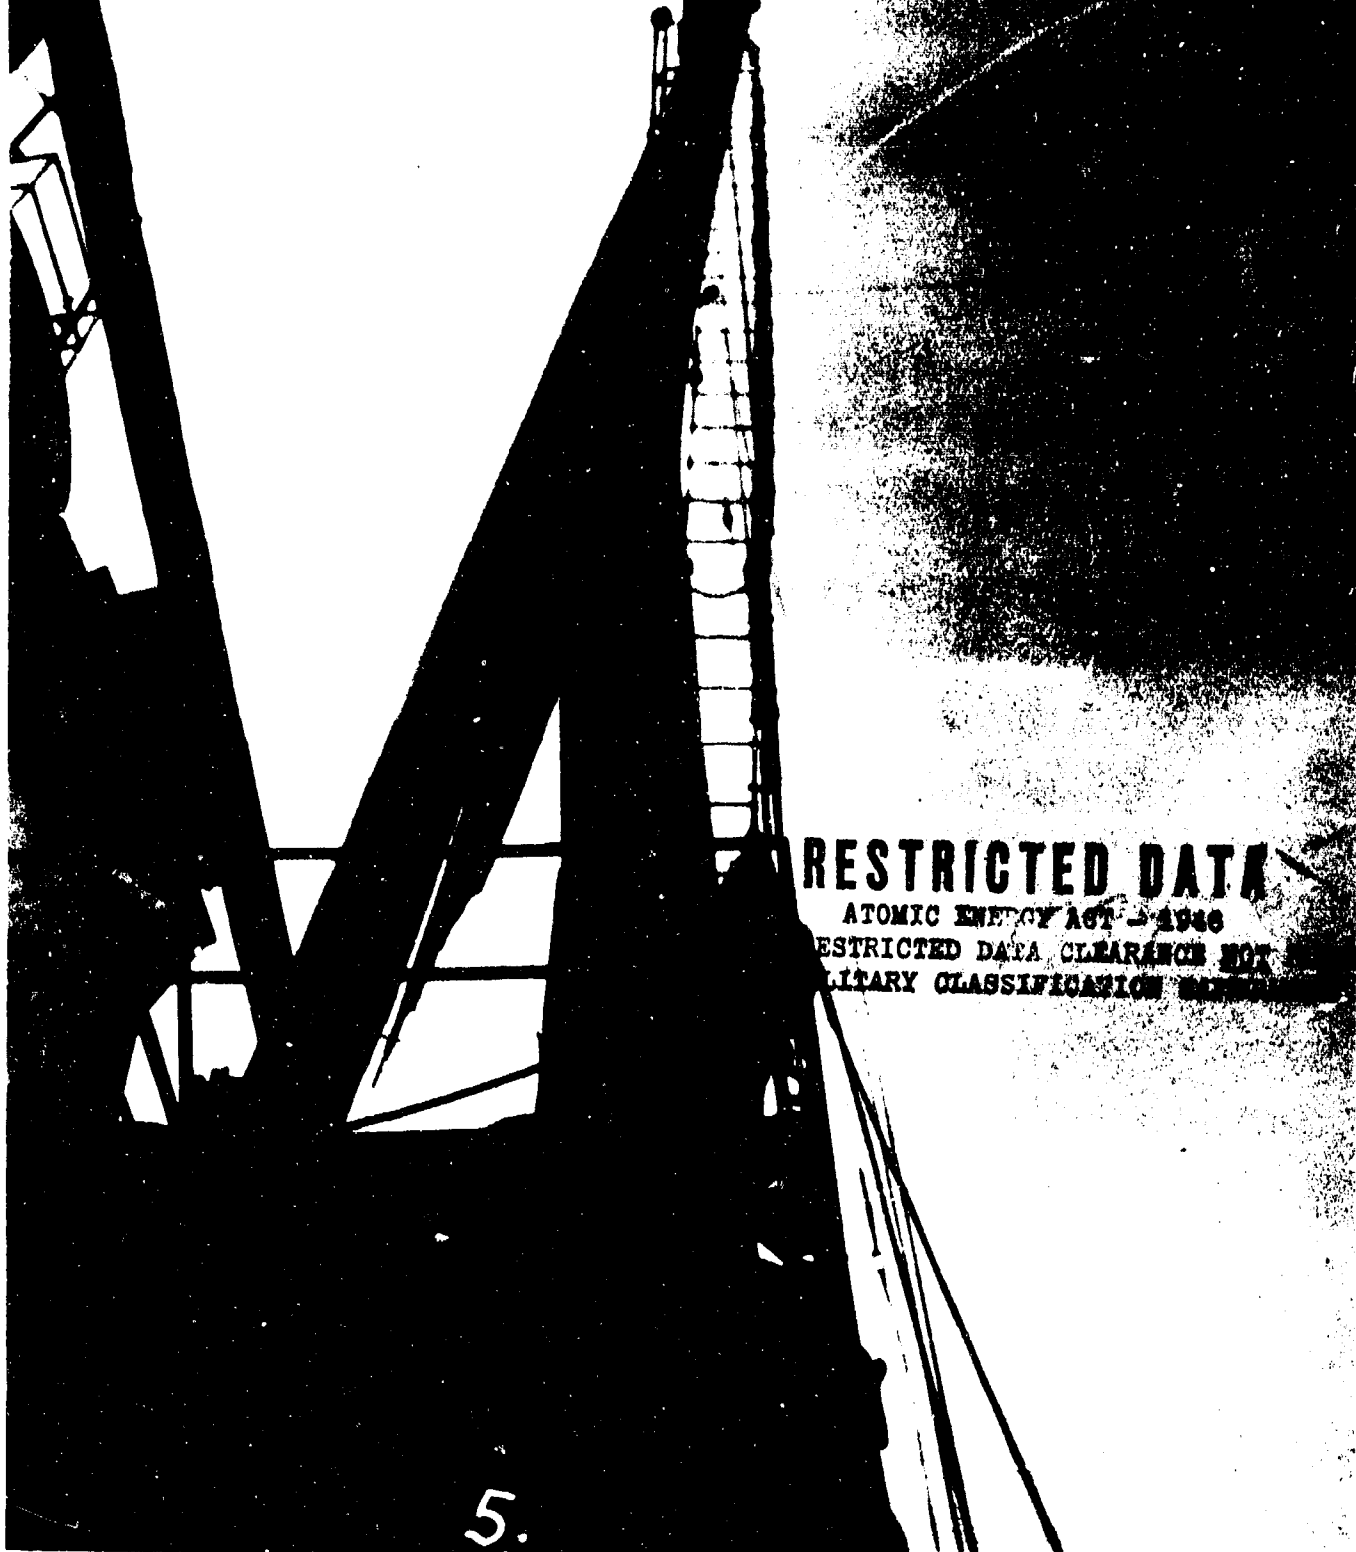
AA-CR-92-1774-5. PRINZ EUGEN (IX300). Broken mast, looking up, after Test Able.
