DIRECTOR OF SHIP MATERIAL

JOINT TASK FORCE ONE

FINAL REPORT

FOR TESTS ABLE AND BAKER

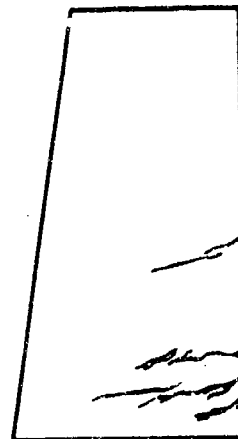
BOW FACE  
PORT WALL

HAIRLINE

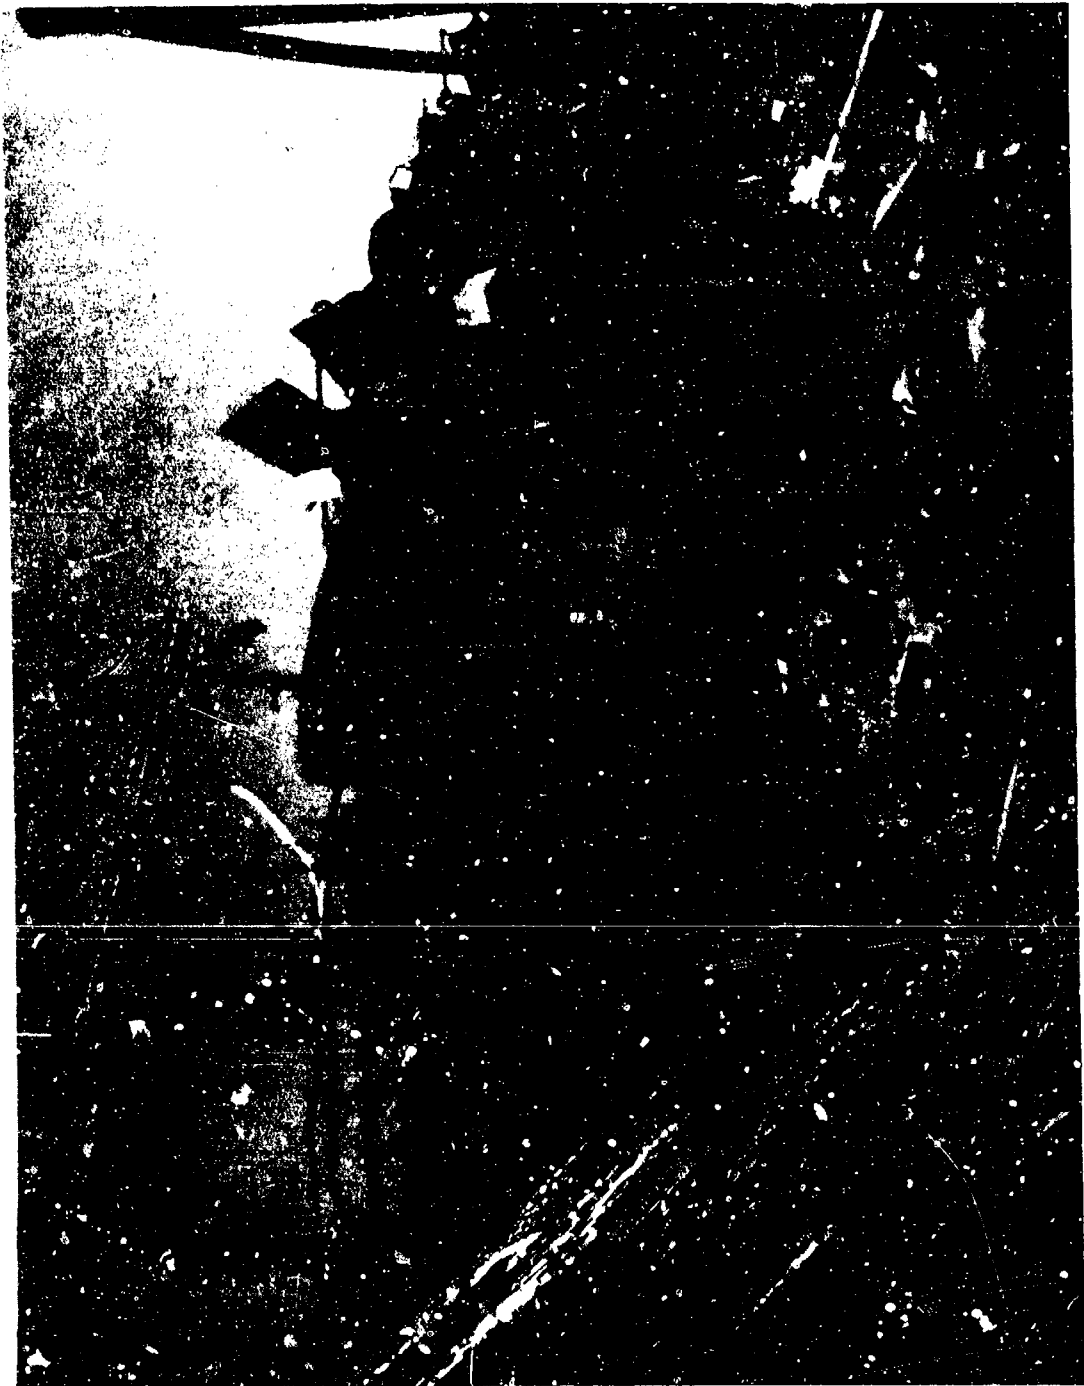
View of Port Side of Midship Deck House

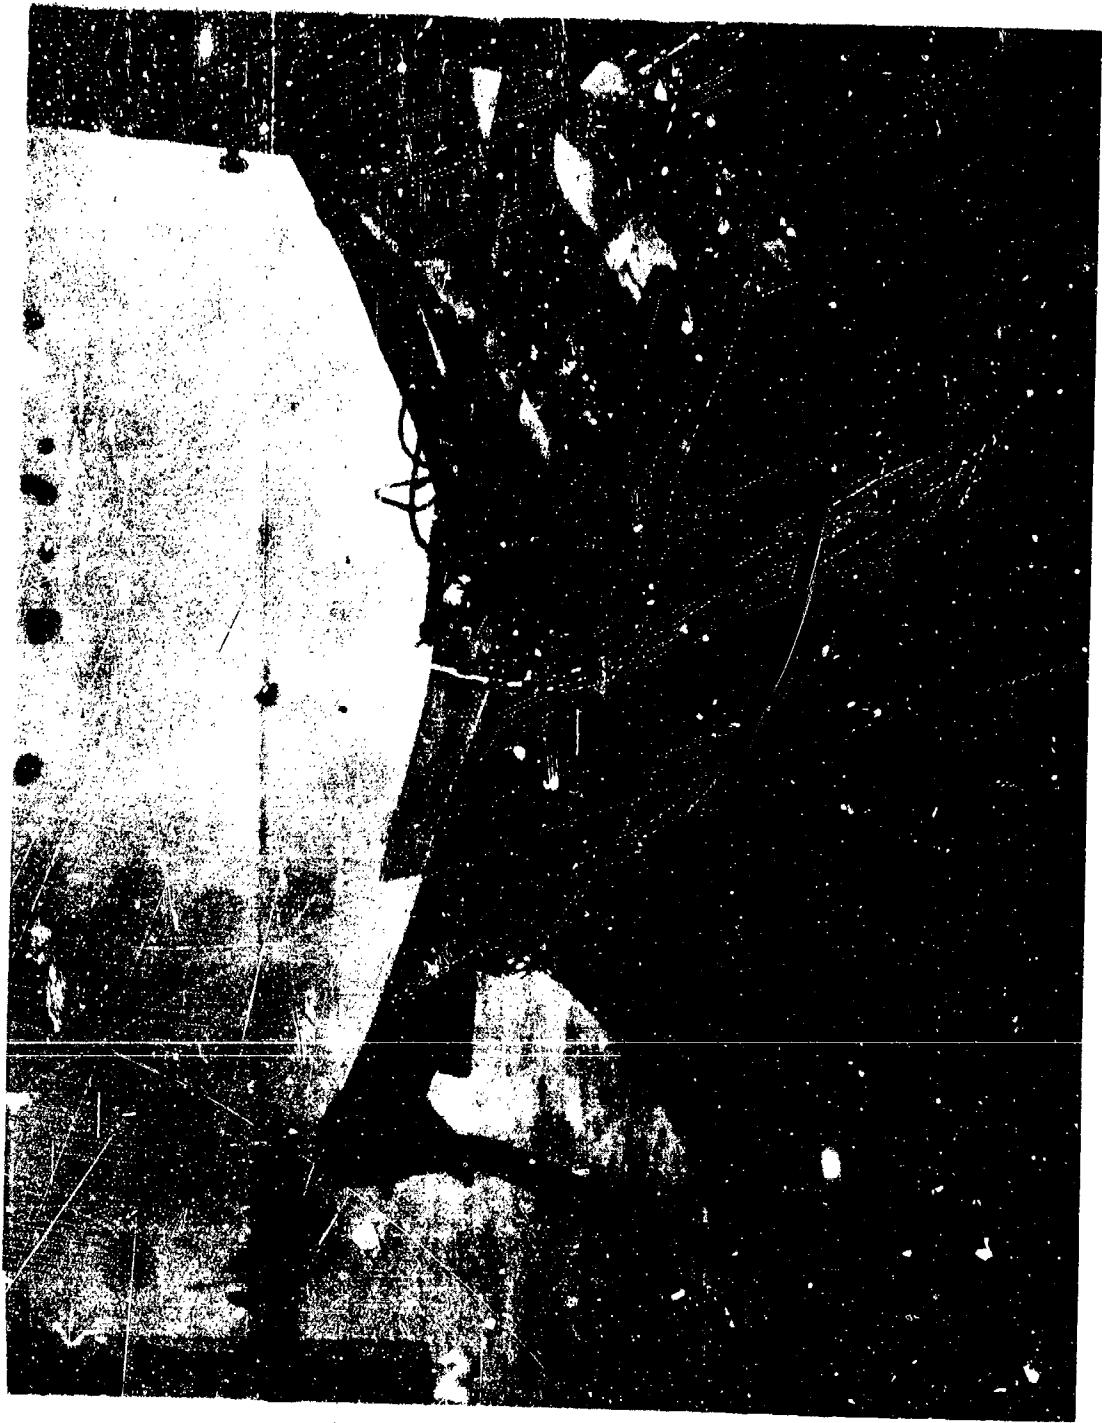
Poop Deck - Port Side, Dished-in Deck

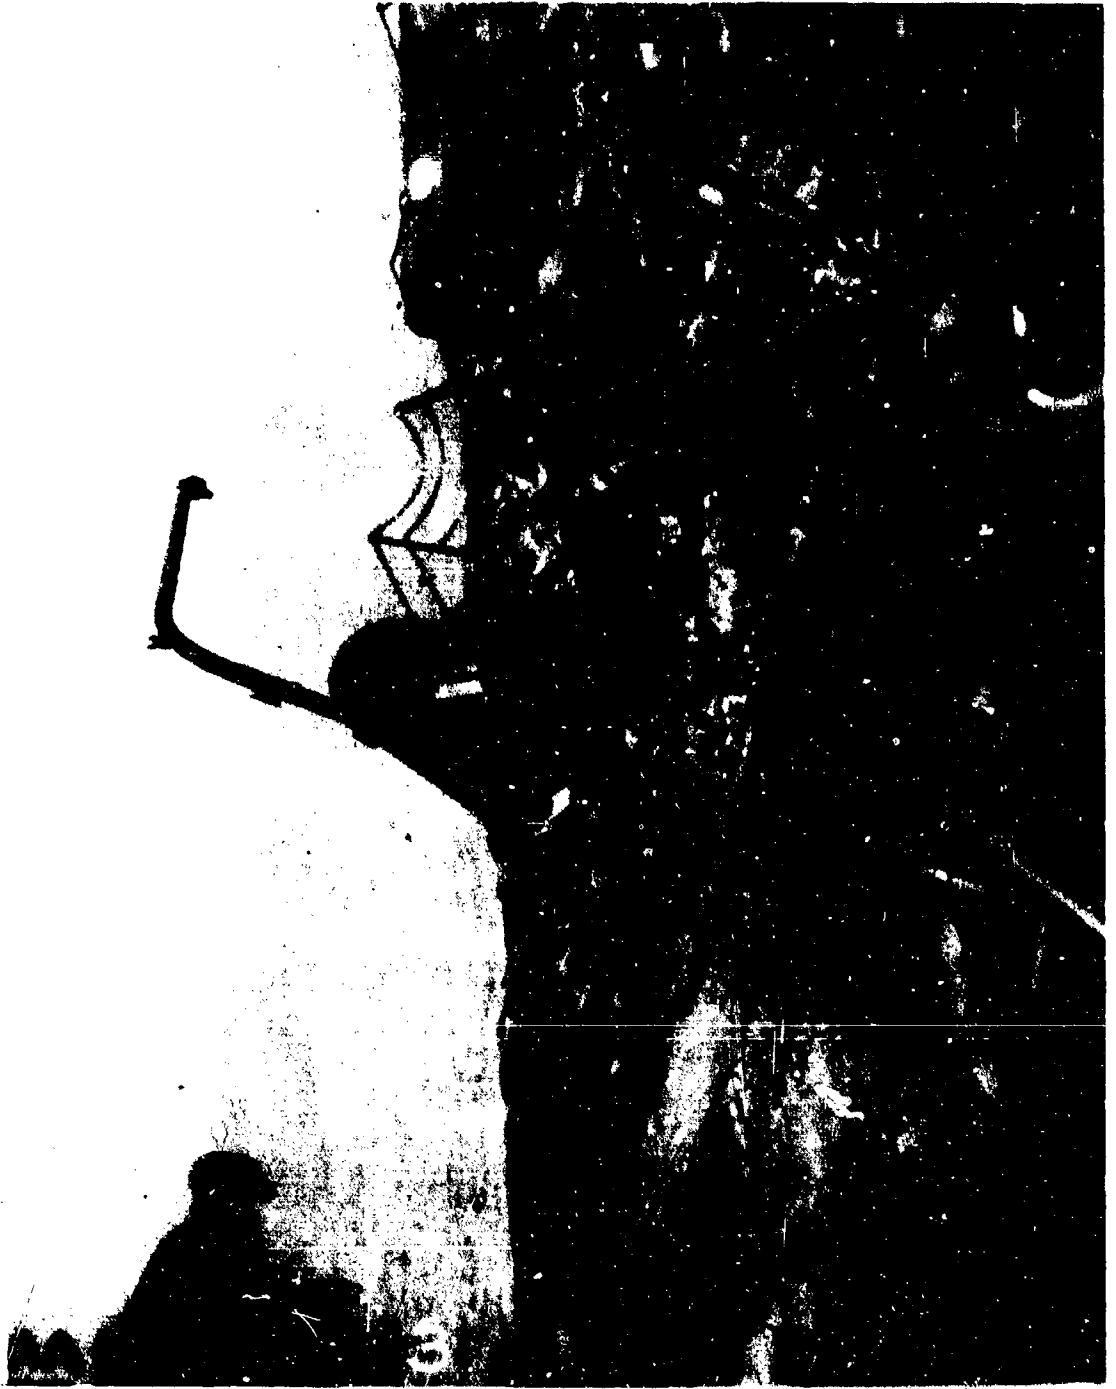
Poop Deck - Starboard Dished-in Deck

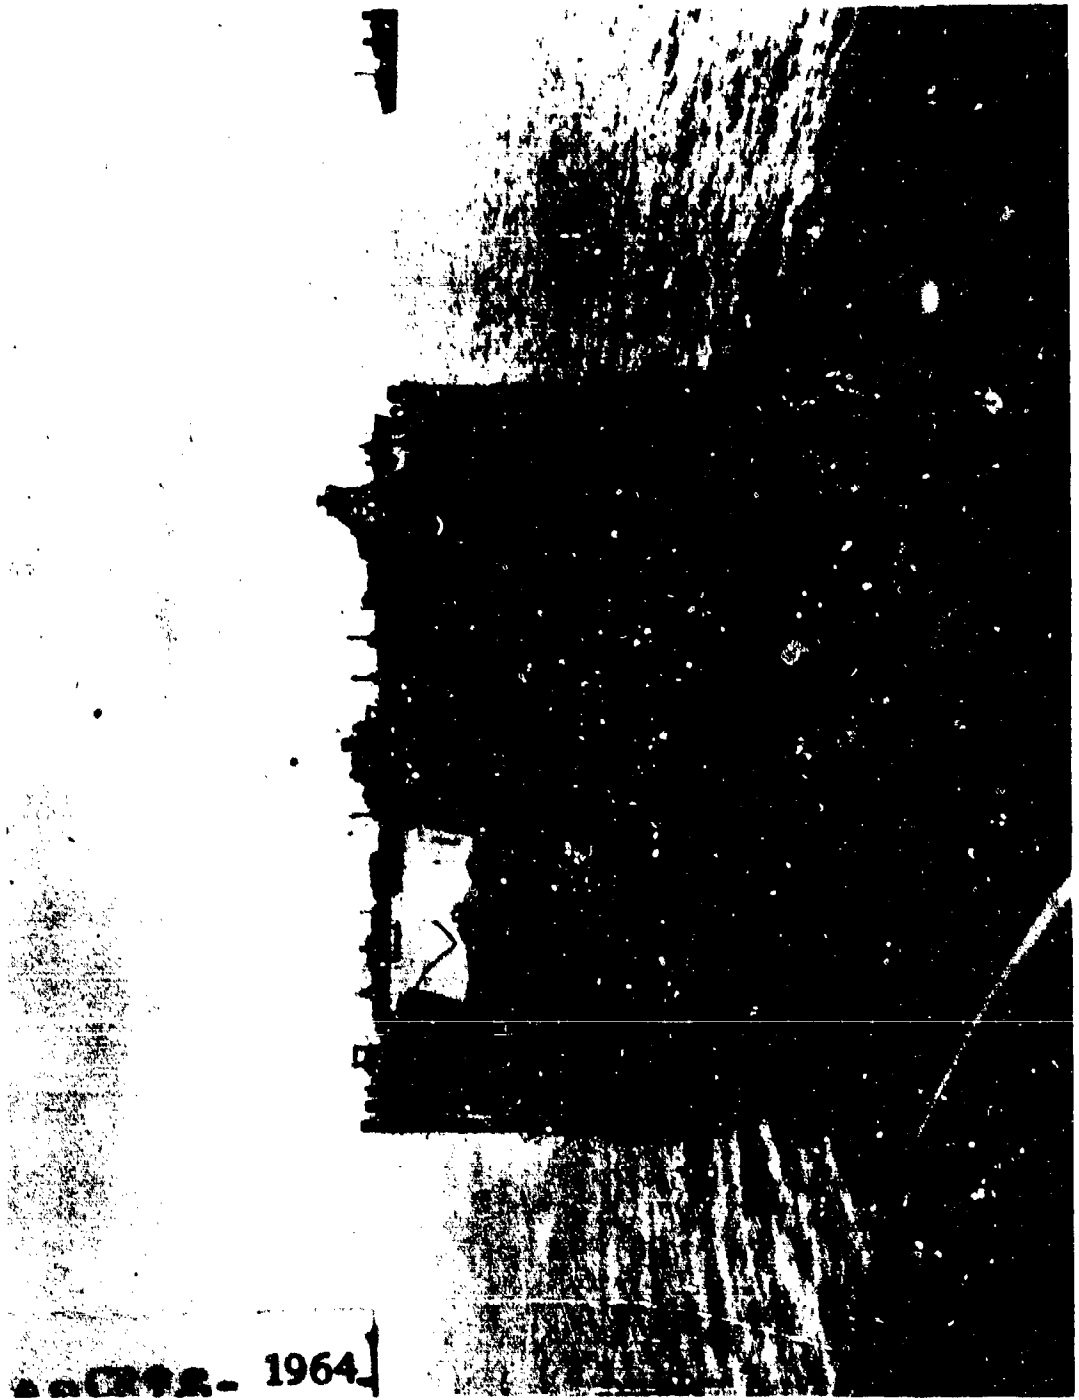
Hatch Opening on Stern Showing Bent Clips

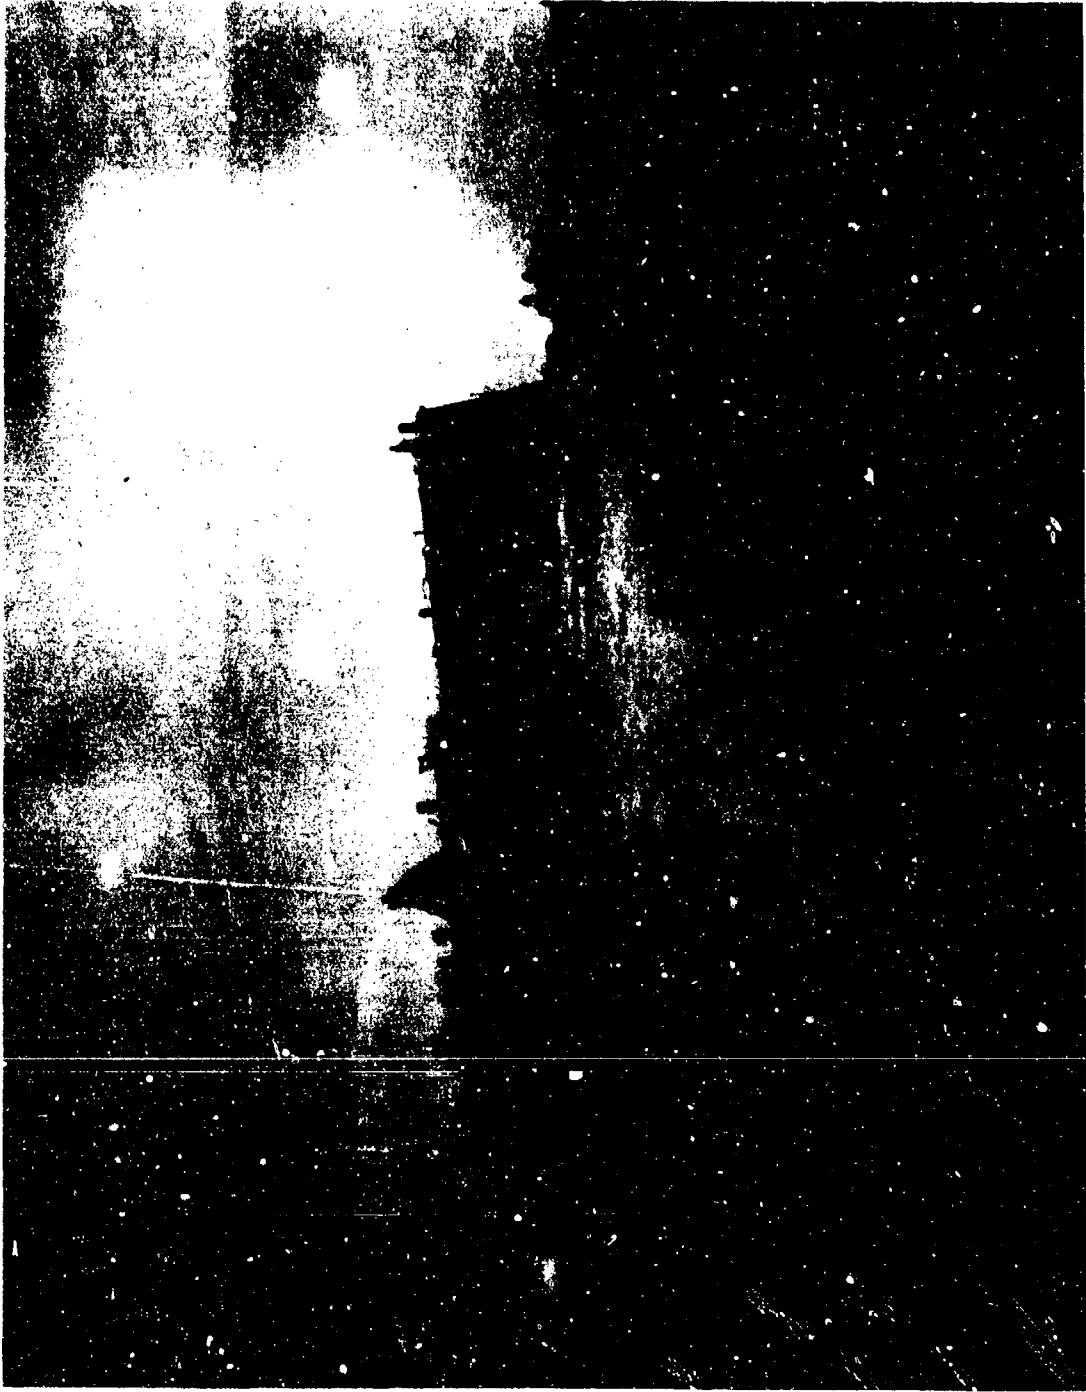
Do:	4	Crack in Transverse Bulkhead at Frame 44, Port Wing Wall
Do:	5	View of Dock Under Tow - Stern
Do:	7	" " " " " - Starboard Bow
Do:	8	View of Dock Under Tow - Port Bow
Do:	9	" " " " " - Port Quarter

Crack in Transverse Bulkhead at Frame 44, Port Wing Wall

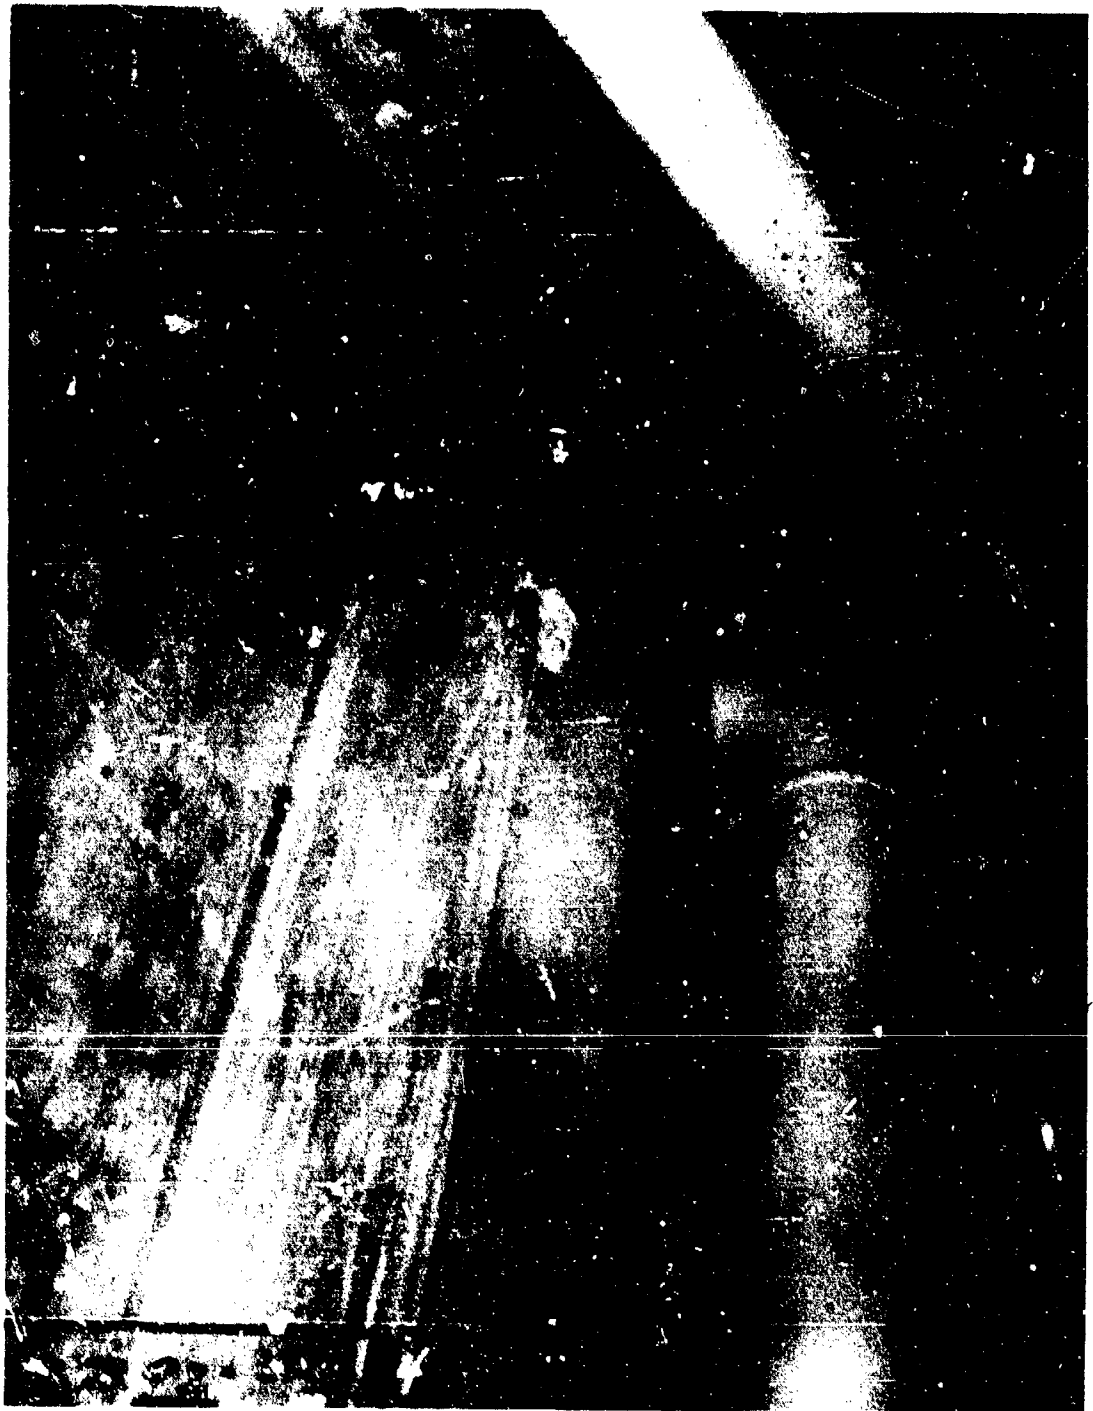
Blast Shadow Inside Face Starboard Wing Wall - Frame 49 to 56
